MINERALS PROGRAM INSPECTION REPORT
PHONE: (303) 866-3567

MINE NAME: Solberg Pit	MINE/PROSPECTING ID#: M-1981-044	MINERAL: Sand and gravel	COUNTY: El Paso
INSPECTION TYPE: Monitoring	INSPECTOR(S): Timothy Cazier, P.E.	INSP. DATE: March 24, 2021	INSP. TIME: 14:00
OPERATOR: Solberg Gravel LLC	OPERATOR REPRESENTATIVE: Jason Ulmer	TYPE OF OPERATION: 112c - Construction Regular Operation

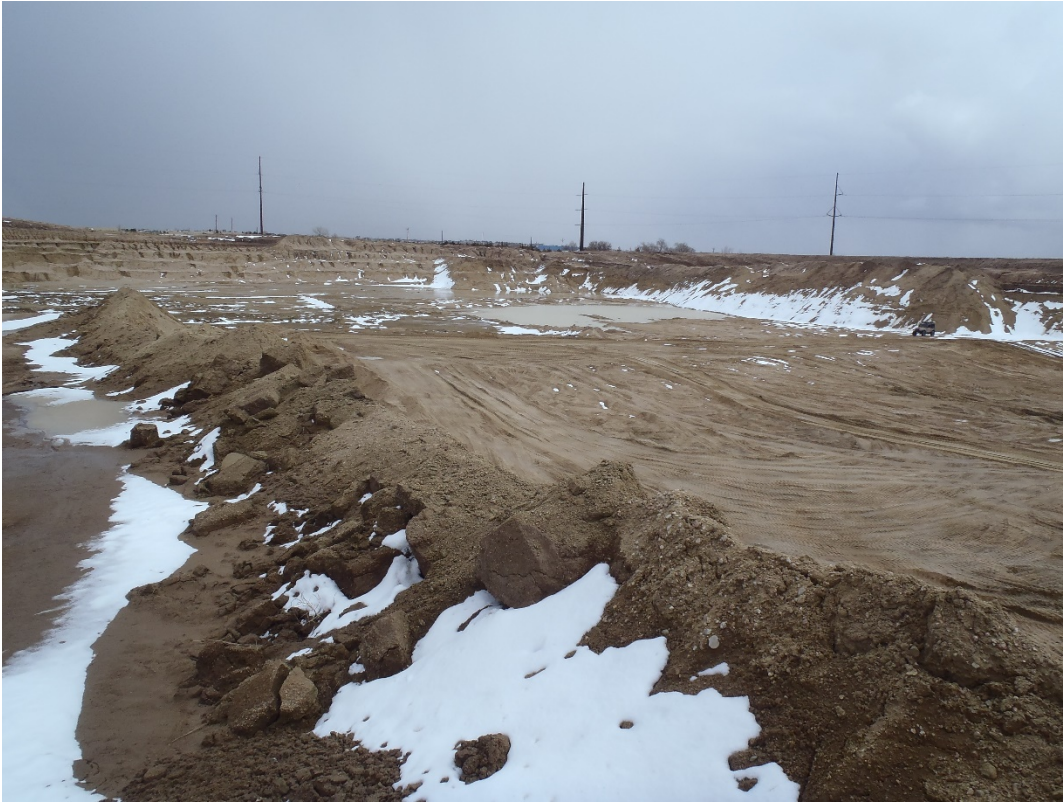
Backfilling and Grading: The mine has expanded to the southeast (see **Photo 1**) since the previous inspection. This area is being mined deeper than the northern portions of the pit. Mr. Ulmer indicated this deeper excavation would be backfilled with material for the older fines stockpiles (see **Photo 2**), heretofore on the southern limit of the mine disturbance positioned towards the west edge.

Hydrologic Balance: Some stormwater was observed in the pit (see **Photo 1**). Sediment laden water was observed in the wash ponds (see **Photo 3** and **4**) and the water surge pond to the south of the wash plant (see **Photos 2** and **5**). According to the 1990 conversion application (the last time Exhibit G was updated), groundwater is approximately 100 feet below the undisturbed ground. Assuming this is correct, no exposed groundwater was observed. Also based on the 1990 conversion application Exhibit G, no product washing was planned for this operation. The only planned water use was for dust control, which was to be obtained locally from domestic sources, usually the permittee's ranch. **The current water usage is not in accordance with the approved permit and must be updated with the TR required as part of the corrective action listed in the Problem on Page 1 of this report.**

Highwalls were estimated to vary between 20 and 40 feet in height (which is within the AM-02 approved "maximum of 40 to 50 feet with an average of 30 feet") and appeared stable (see **Photos 1 and 6**).

Photo 1. Deepest portion of southern pit & stable east & south highwalls (looking SE).

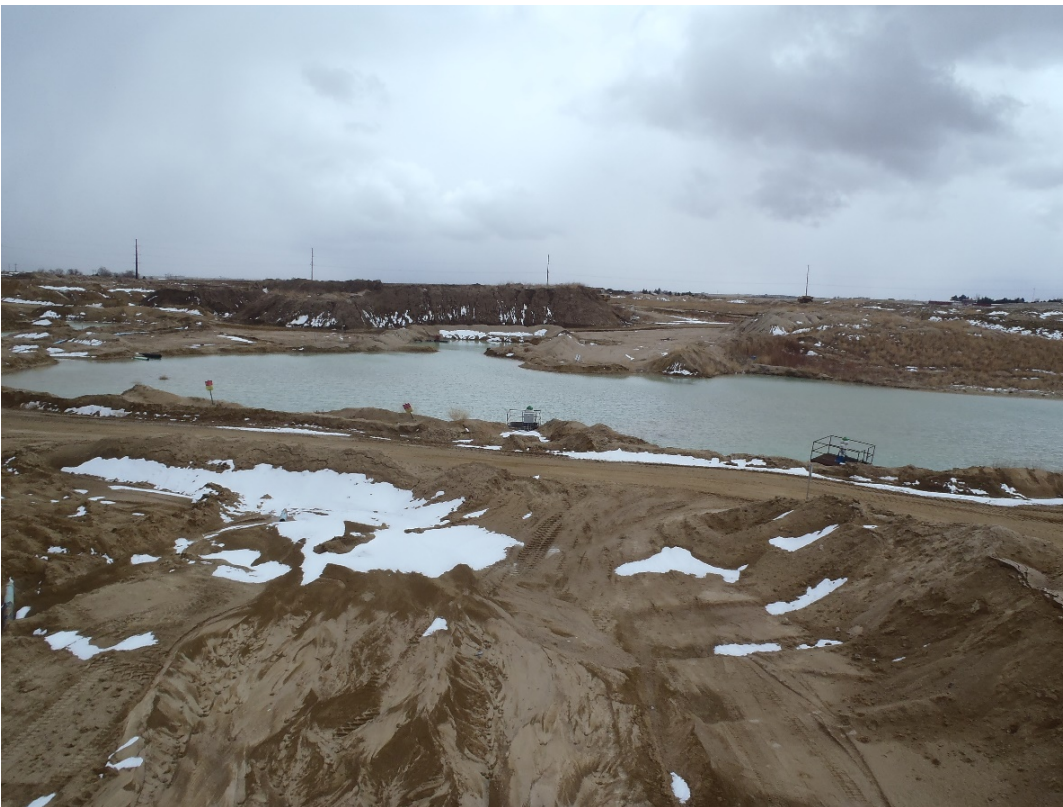
Photo 2. East end of surge pond for clarifier (looking SSE from clarifier).

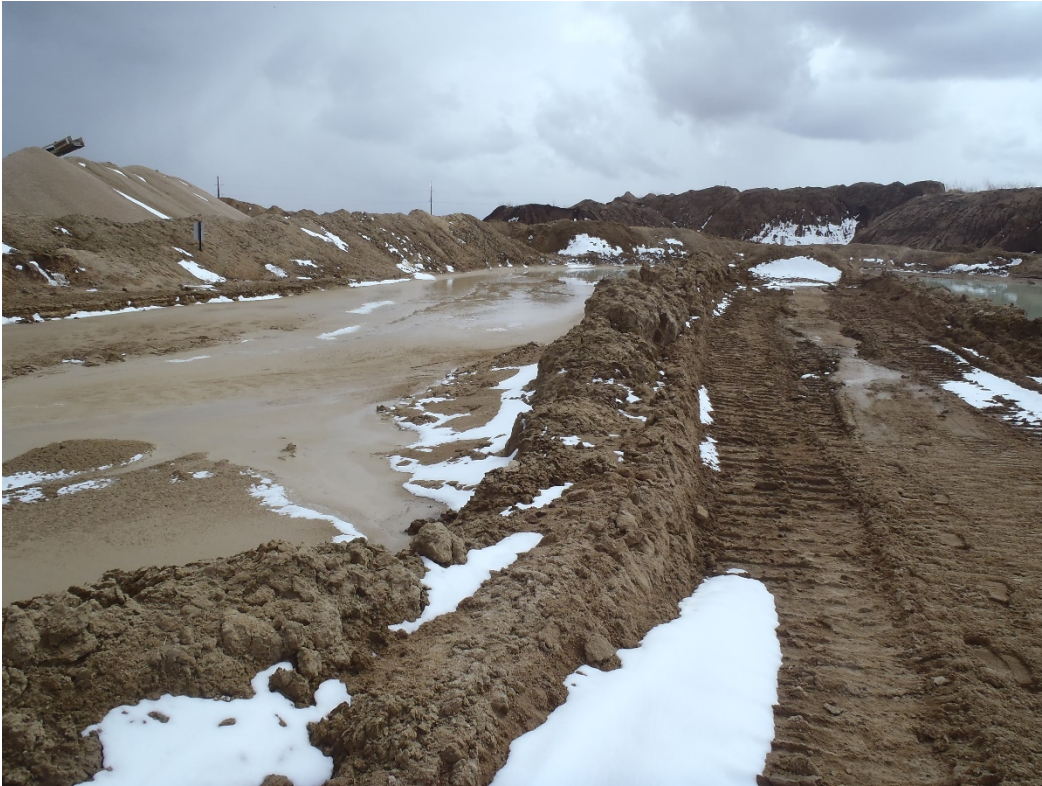
Photo 3. Northeast settling pond (east side of clarifier, looking ENE).

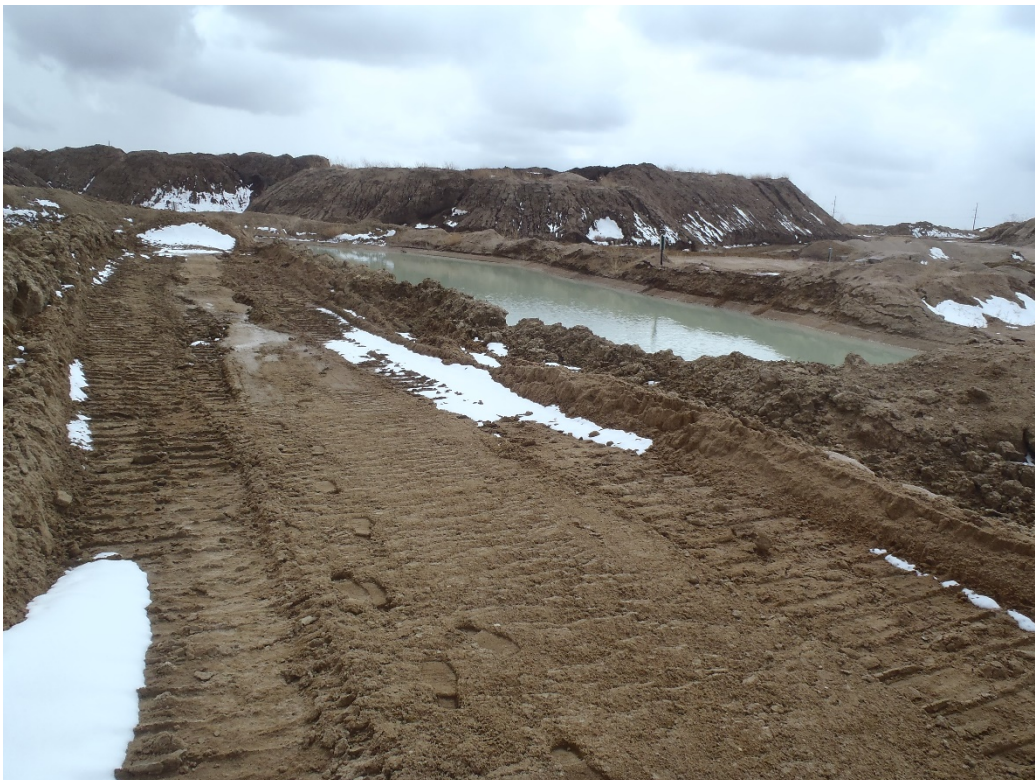
Photo 4. Center east settling pond (east side of clarifier, looking ESE).

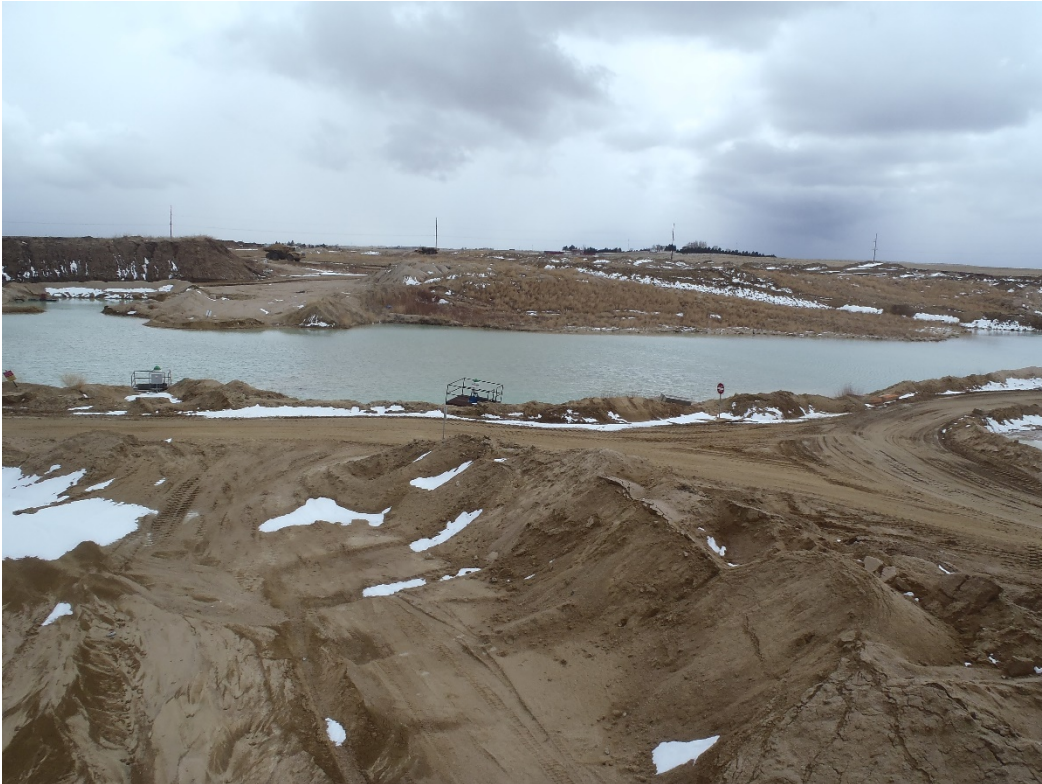
Photo 5. West end of surge pond for clarifier (looking SSW from clarifier).

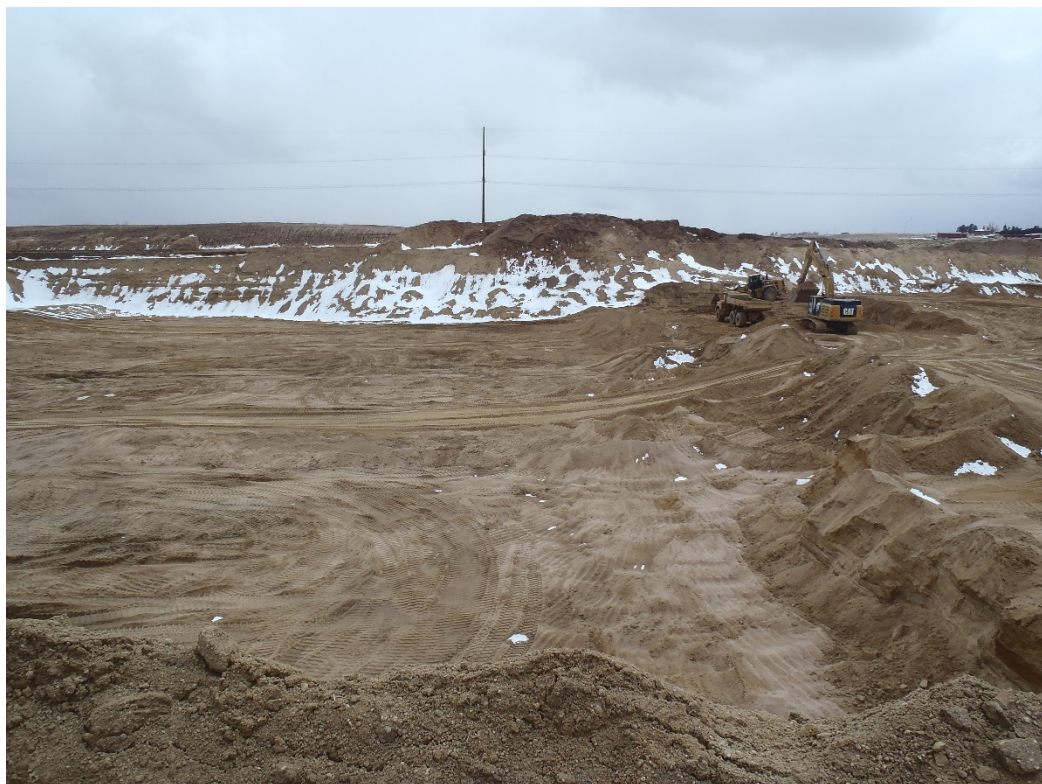
Photo 6. Active southern pit & stable south highwall (looking south).

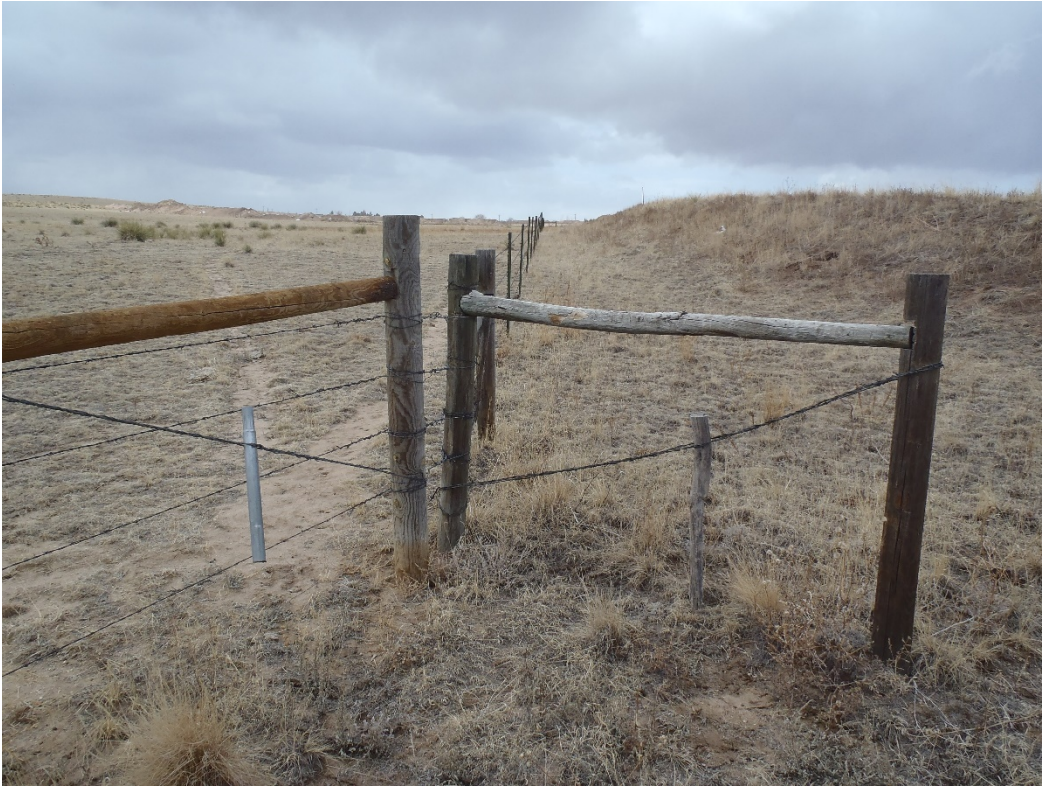
Off-site Damage: The operation appeared to be confined to the affected area boundary, based on Google Earth review and site observations. Mr. Ulmer pointed out the fence the landowner/Permittee (Solberg Gravel) moves as the lease with the Operator (Pioneer Sand) expands to additional area (see **Photo 7**).

Photo 7. Active mining fence boundary (west side, looking NW – mining to the right/east side).

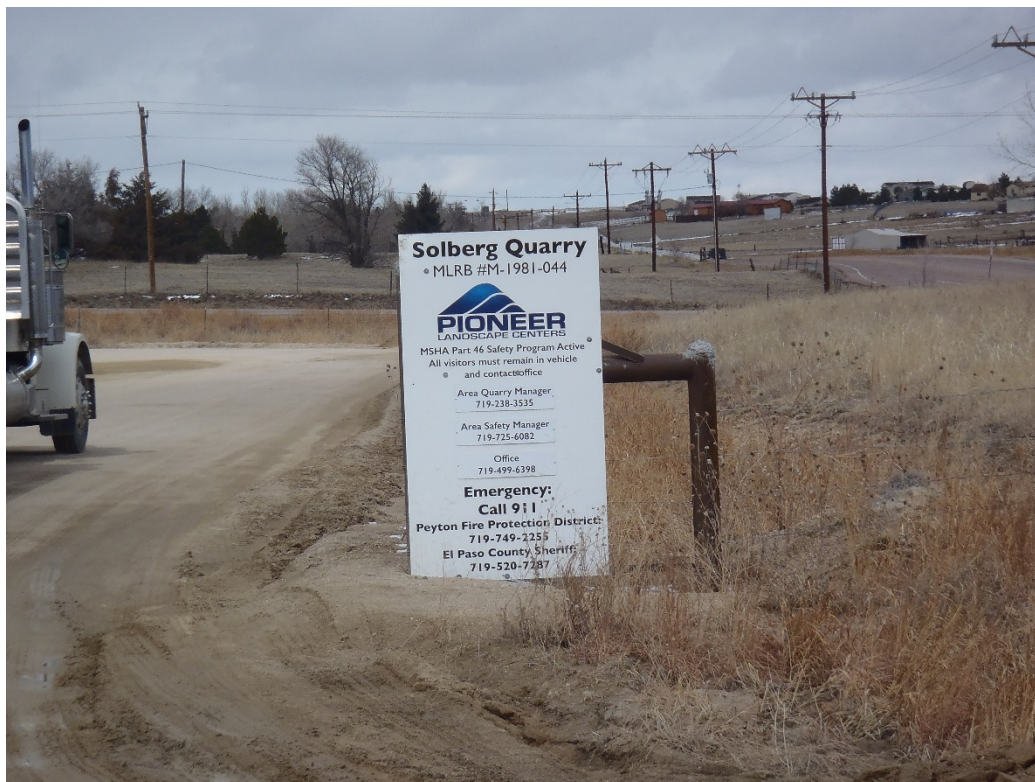
Roads: Dust control was not being implemented on the day of the inspection as the weather provided sufficient moisture. Haul and access roads are primarily sand (see **Photo 8**) and did not appear to be a source of sediment that could be tracked offsite.

Signs and Markers: The permit sign was properly posted (see **Photo 8**) and the permit boundary is marked with t-post and wire fencing.

Photo 8. Permit sign at entrance and typical sandy haul road (looking north).

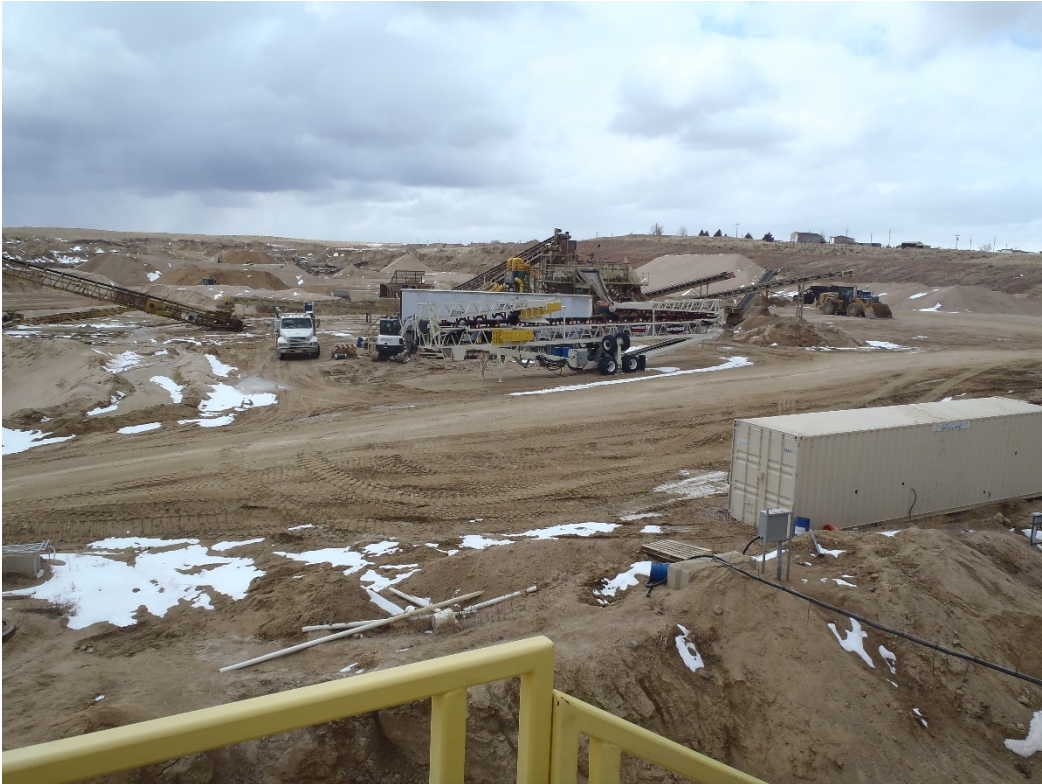
Support Facilities On-site: Five screen plants (see **Photo 9**), a new clarifier (see **Photo 10**), five loaders, an excavator, and three articulated haul trucks (see **Photo 11**) were observed on site.

Photo 9. One of five screen plants (looking NW from clarifier).

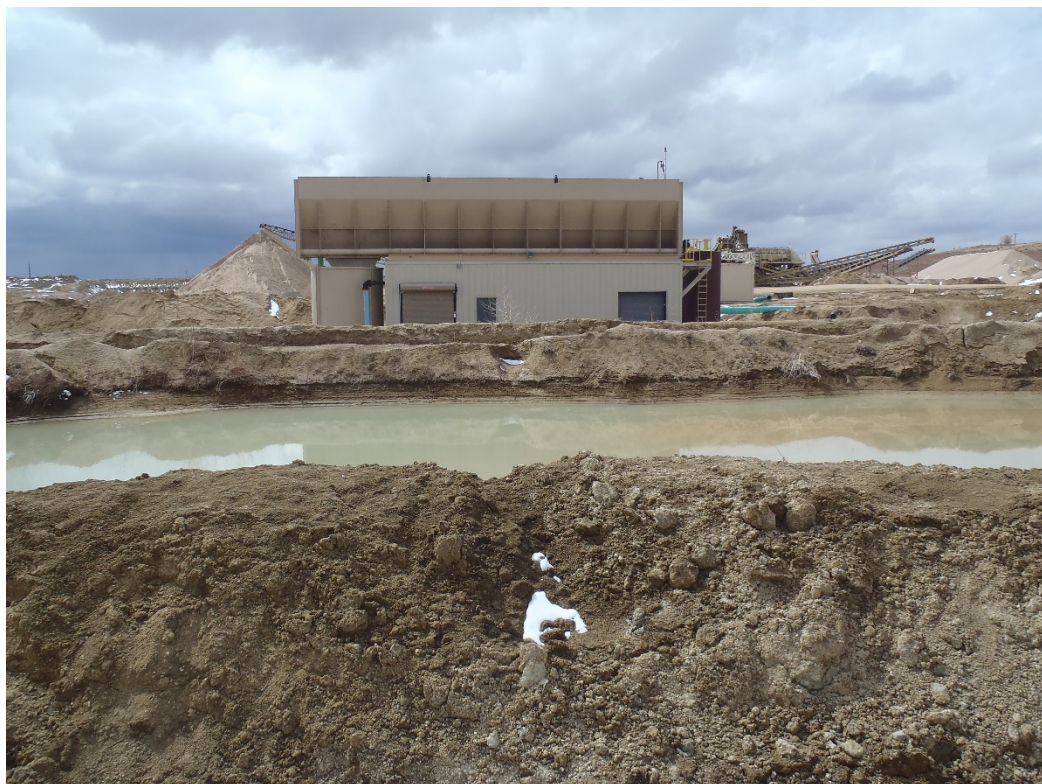
Photo 10. Wash plant clarifier (looking west, settling pond in foreground).

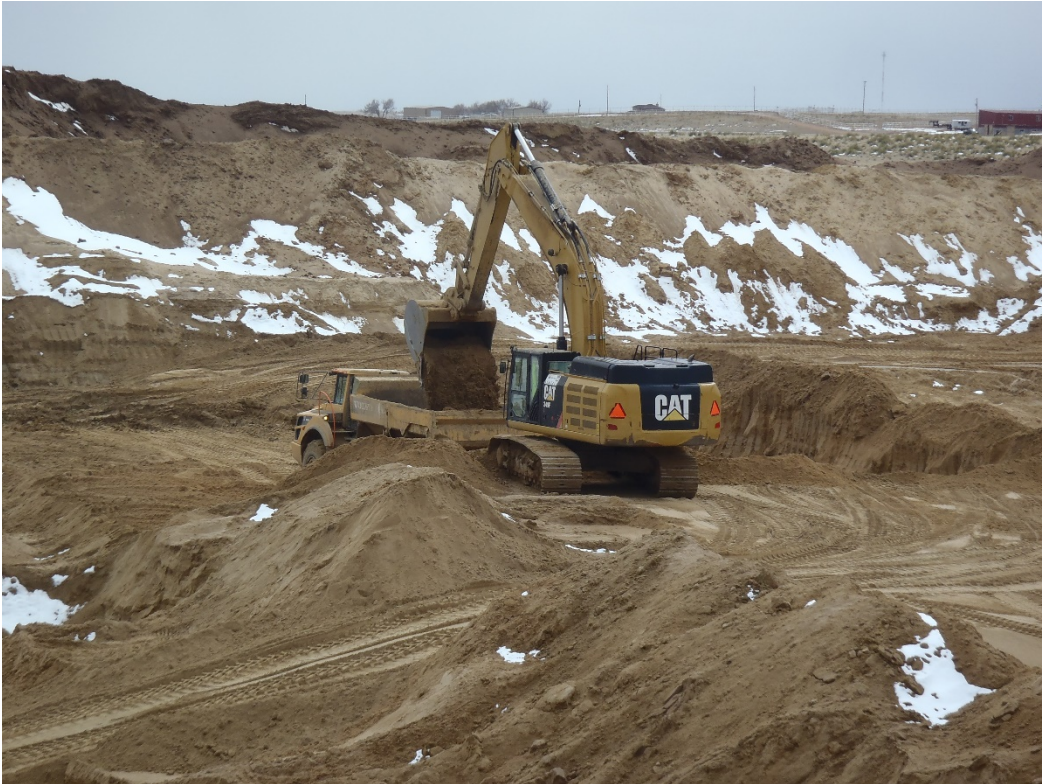
Photo 11. Excavator & articulated haul truck (south/active pit, looking SW).

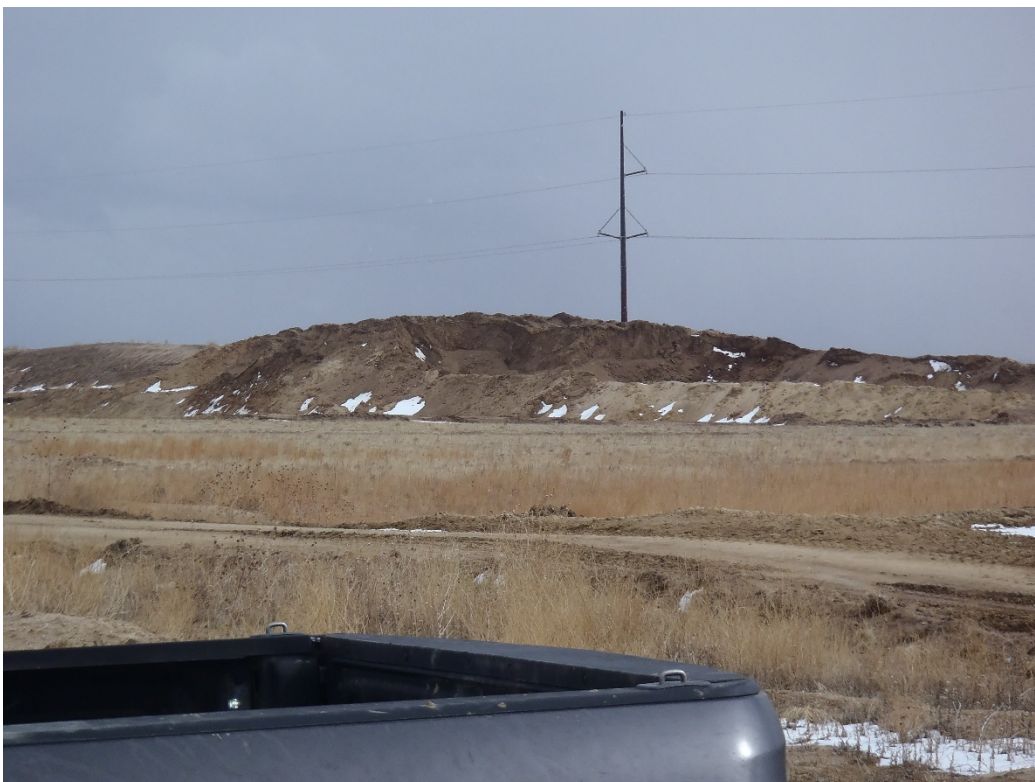
Topsoil: A topsoil stockpile was observed on the south side of the pit (see **Photo 12**).

Photo 12. Topsoil stockpile (south side of active pit, looking SE).
