<p align="center">Solid Minerals Inspection Report Bureau of Land Management Tres Rios Field Office 29211 Hwy 184 Dolores, CO 81323</p>			
Type of Operation	Notice Level 3809 Expl'n	Project Name	Wedding Bell/Radium
Serial Number	COC-80448	Company/Org.	Standard Minerals
Inspection Date	May 13, 2021	Others Present	None
Inspection Time	All Day	Inspected By	James Blair
Report Date	May 19, 2021	Legal	T45N, R18W, Sec 23, 21, 16
Preparer Signature		Supervisor Signature

On Thursday, May 13, 2021 I inspected the Standard Minerals proposed notice-level 3809 exploration plan. The inspection lasted the entire day. Conditions were sunny with scattered clouds, with a temperature around 70°F. The proposed drill sites are accessed using reclaimed drilling roads from previous drilling projects that occurred several years prior, or via overland travel from existing roads. I drove to each site in a clockwise fashion from the 14Y road and then the U29 and Montrose Co. II-13 roads. It would be faster to drive back from the Rimrock and Groundhog blocks by U-29 than by continuing clockwise out and coming up the Fawn Springs Bench road near the Van 4 mine. Photographs and notes were taken at each locatio

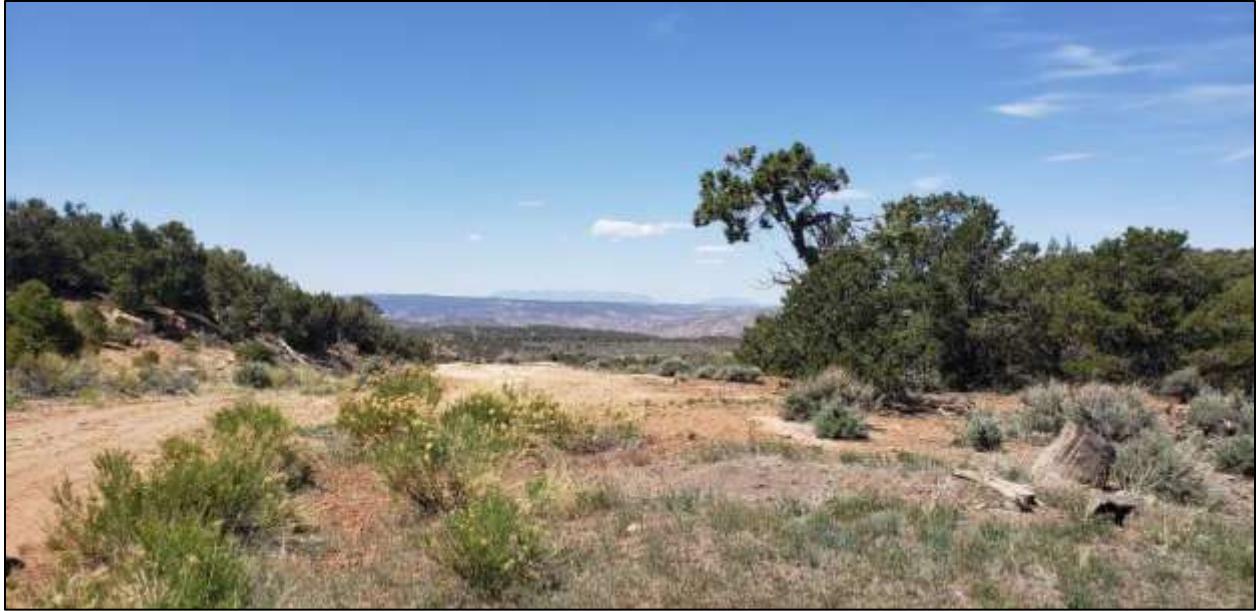
Figure 4 - The top of the 14R road looking southwest from Dry Creek Basin toward the Abajo Mountains. Road is in good condition and is well travelled. (Not on map)

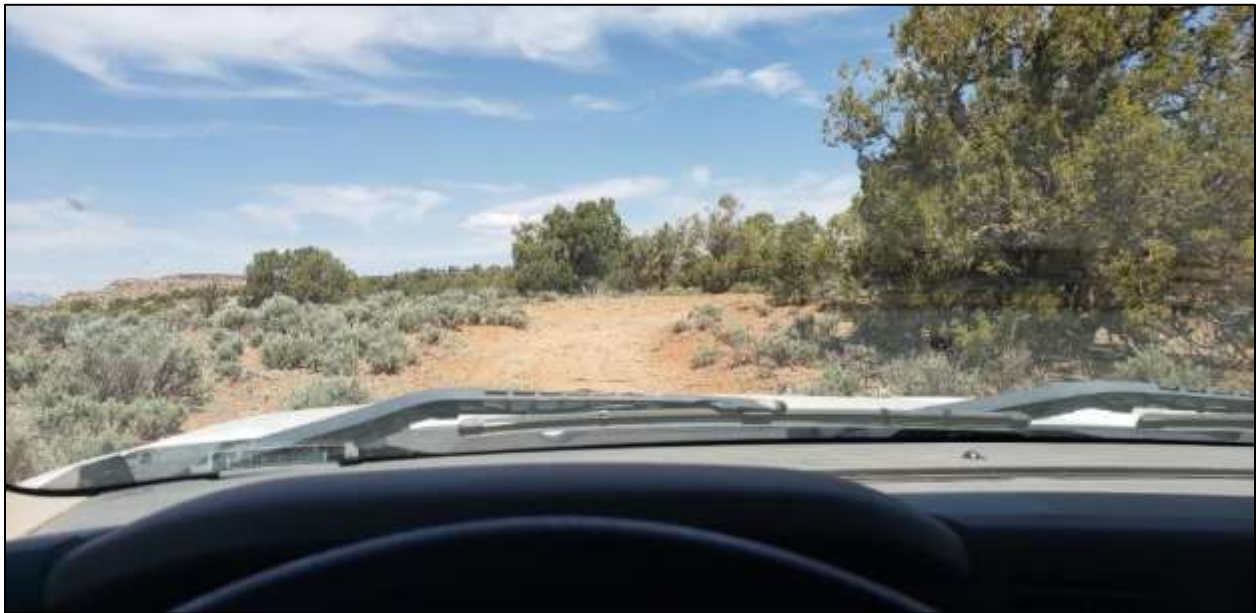
Figure 5: The access road looking north from the junction with 14Y road. This is an old, reclaimed drill road. Extra effort should be made to reclaim this portion near the 14Y road so that UTV's don't continue to drive down it.

- 2) It is very important to make the first part of the Section 23 access near the 14Y road un-drivable as possible.
- 3) Consider moving SDH3 and SDH4 to the main road alignment. Consider moving SDH7 to the end of the "existing" road. Consider moving SDH11 to one of the sites identified in this report.

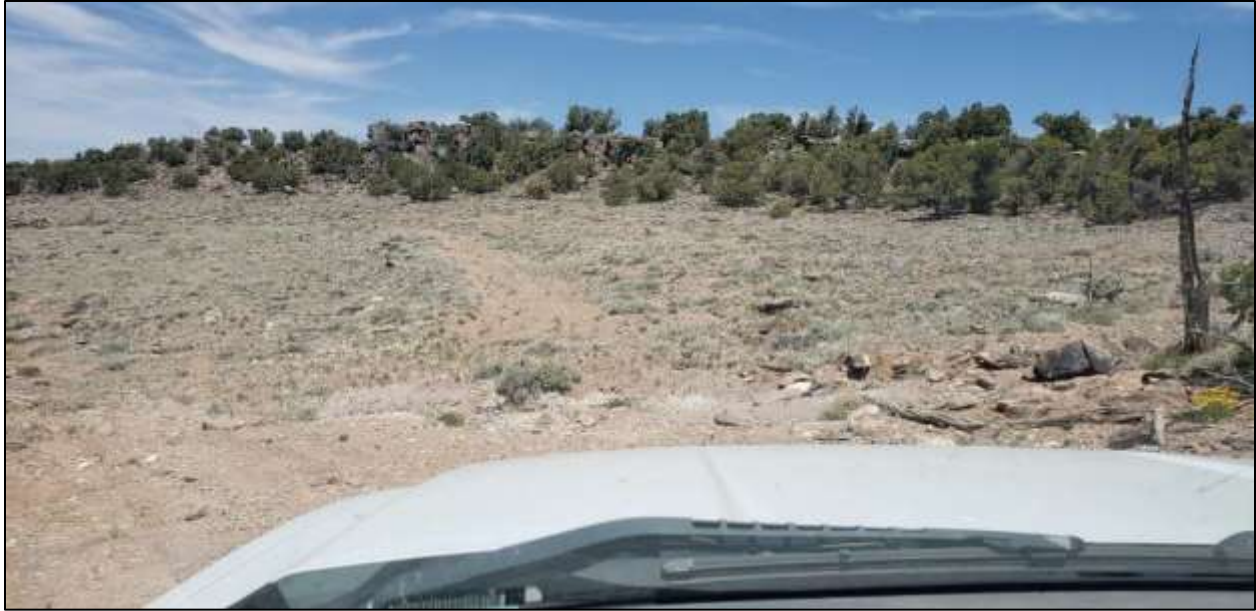
Figure 6: A gully eroded across the roadway. This will need to be filled in with rocks prior to crossing, and the drive-around blocked off. During reclamation, any fill should be removed, but the drive-around should be left. May be a good place for a large boulder in the road. 38.131742, -108.821510

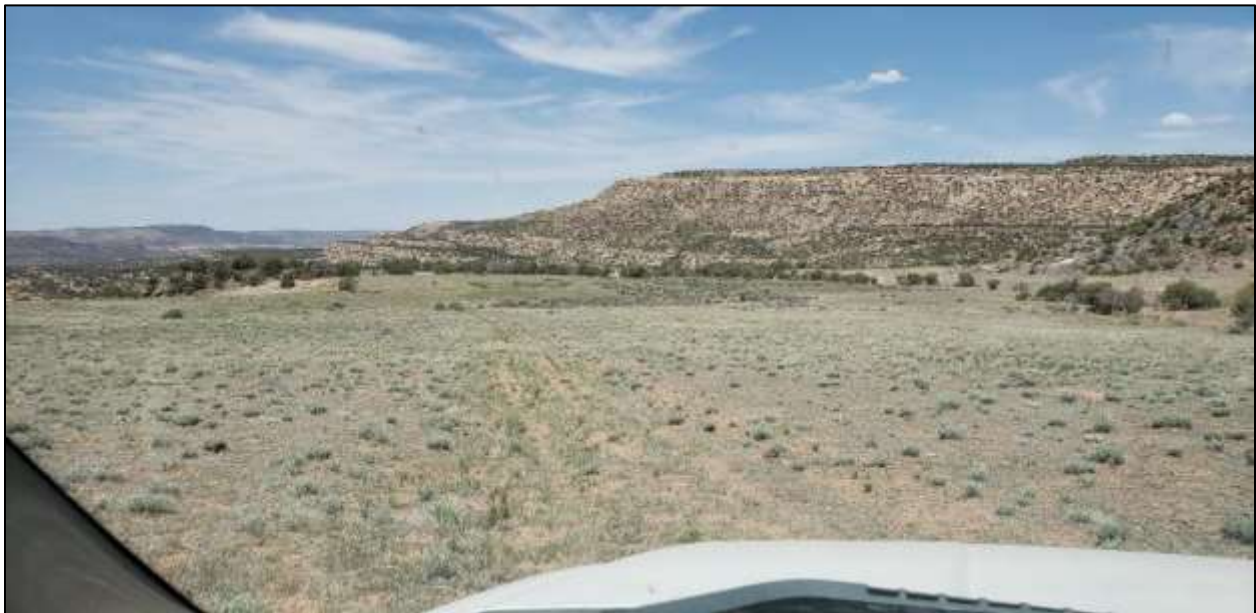
Figure 7: The roadway, taken just past the previous photograph, near sites SDH10 and SDH11. Note that the wheel tracks are very faint in this location. Care should be taken to minimize the number of times this site is driven across, to keep the ruts from getting more incised. The ruts should be raked and seeded, and brush scattered across where practical. Some sort of barrier (boulders, logs) should be placed across the road south of this location at a topographic choke point to prevent UTV's and ATVs from driving up and down and making this a permanent roadway.

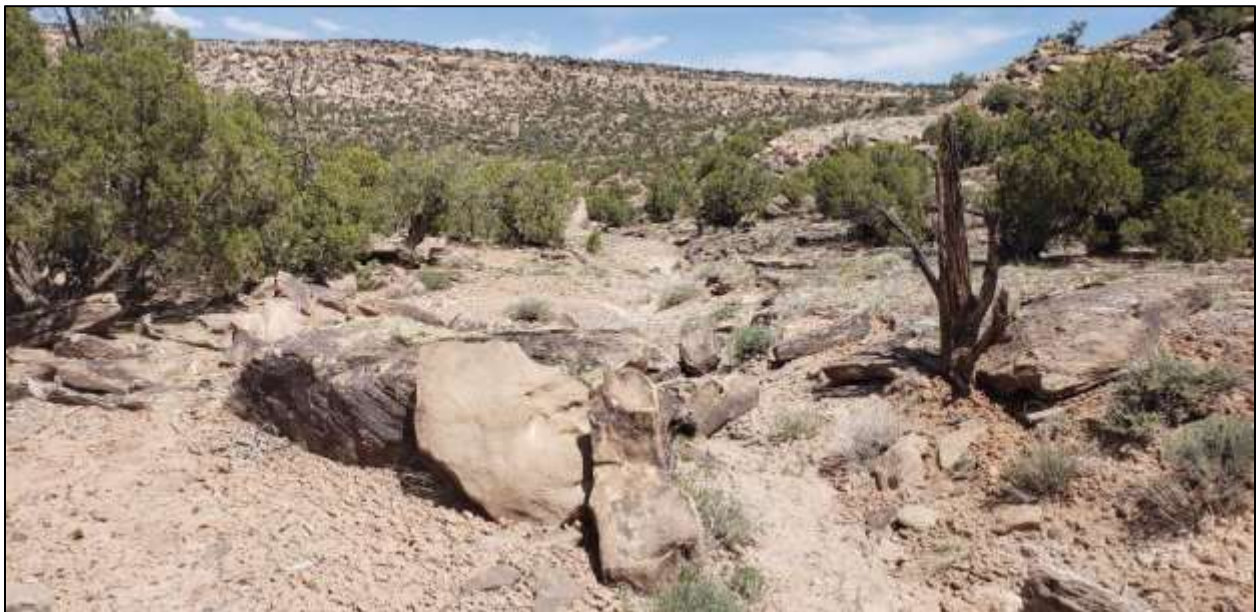
Figure 9: Boulders that have been placed across the access route presumably during the reclamation of the last drilling project. These will need to be moved on the way in and put back in place on the way back out. It looks like they have been pretty effective at preventing atv/utv's from driving the reclaimed road. Located between SDH1 and SDH2.

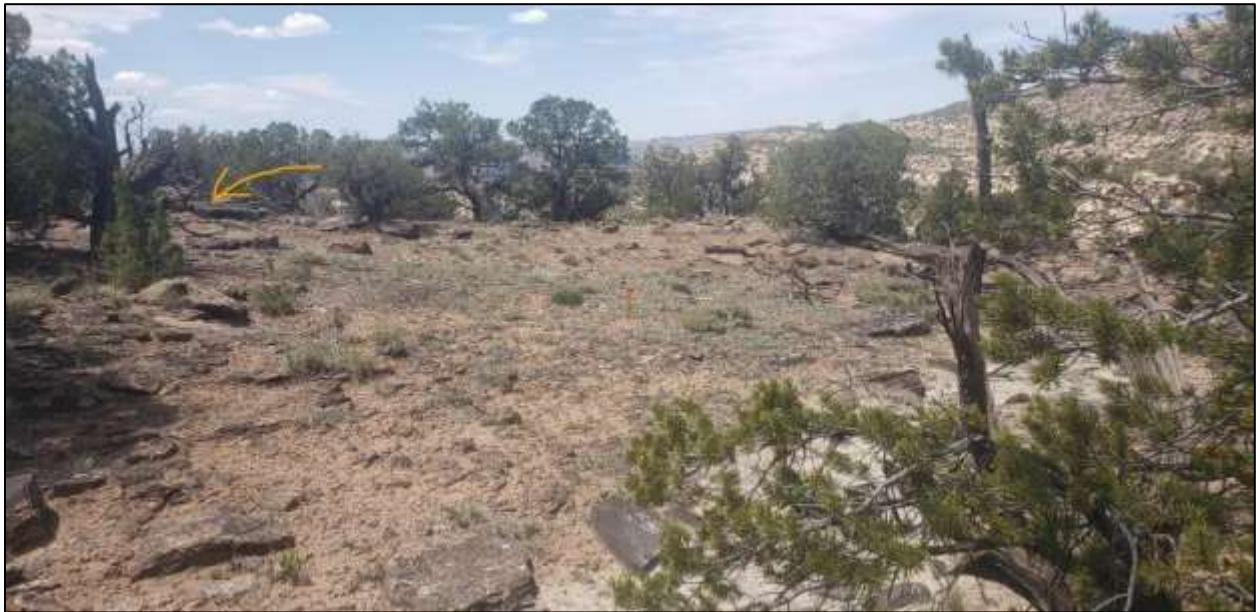
Figure 11: Drill Site SDH-2 looking west. The roadblock rocks are visible on the left edge of the photo (orange arrow). Note the brush scattered across the road. It appears that this spot has been drilled before, but that natural reclamation is basically at full extent.

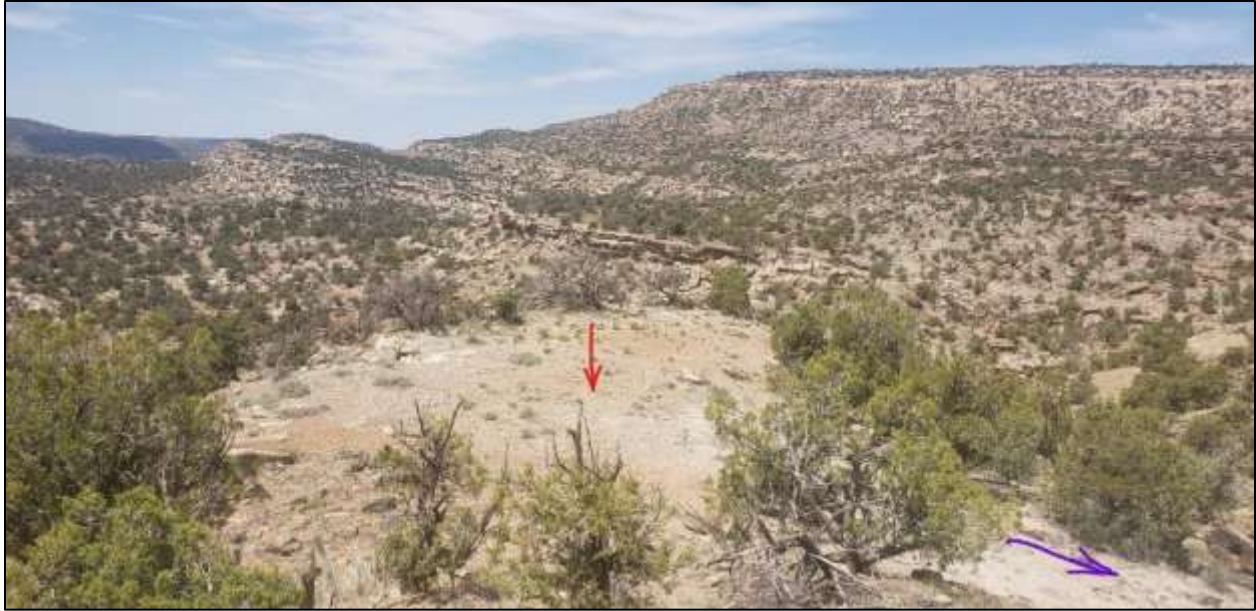
Figure 12: Looking west at SDH3 from the access road. The red arrow shows the location of the drill stake. The blue arrow shows the secondary access road to SDH3 and SDH4. Moving the drill site up to the location where the photo was taken on the road above would eliminate a substantial amount of disturbance and result in a lower bond, but if the location needs to be at the stake for geologic reasons, or because the road alignment above doesn't have enough space, then drilling at the staked location may be needed.

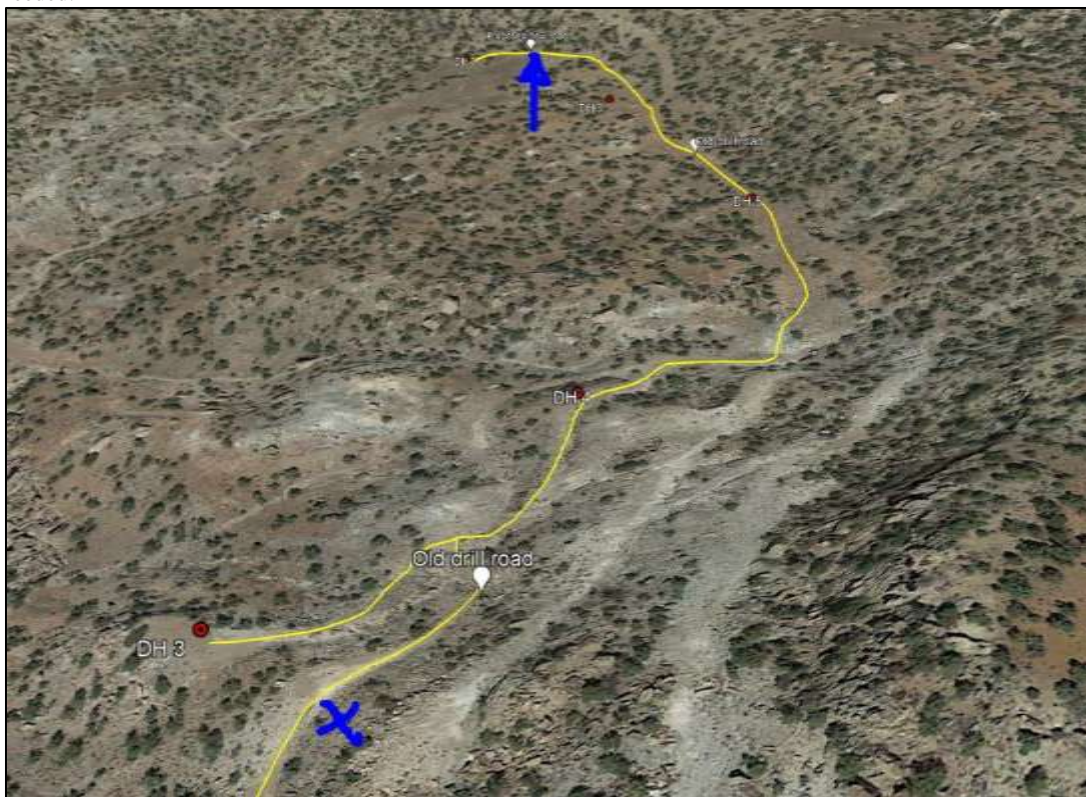
Figure 13: A screen capture of a google earth image showing the locations of drill holes SDH3 to SDH7. The previous photo of SDH3 was taken at the blue X. SDH3 could be relocated to the X location and eliminate ~200 feet of disturbance. The blue arrow shows where SDH7 could be placed to avoid disturbance on relatively erodible aeolian soil.

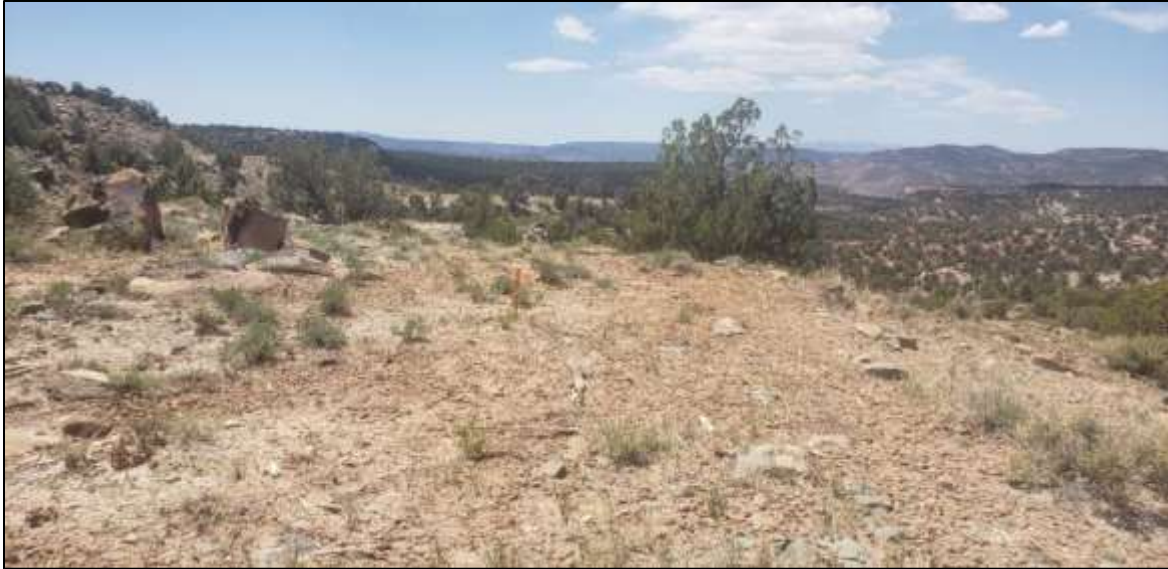
Figure 14. Drill site SDH4 looking southwest. A lot of rocks will need to be moved to get to this location and from this location to the next. The vegetation at this location already looks a little bit thin, though it has mature forbs and wheat grass. I suspect this more a function of the lack of duff dead leaves and pine needles than a lack of vegetation. Care should be taken not to blade any vegetation unless absolutely needed.

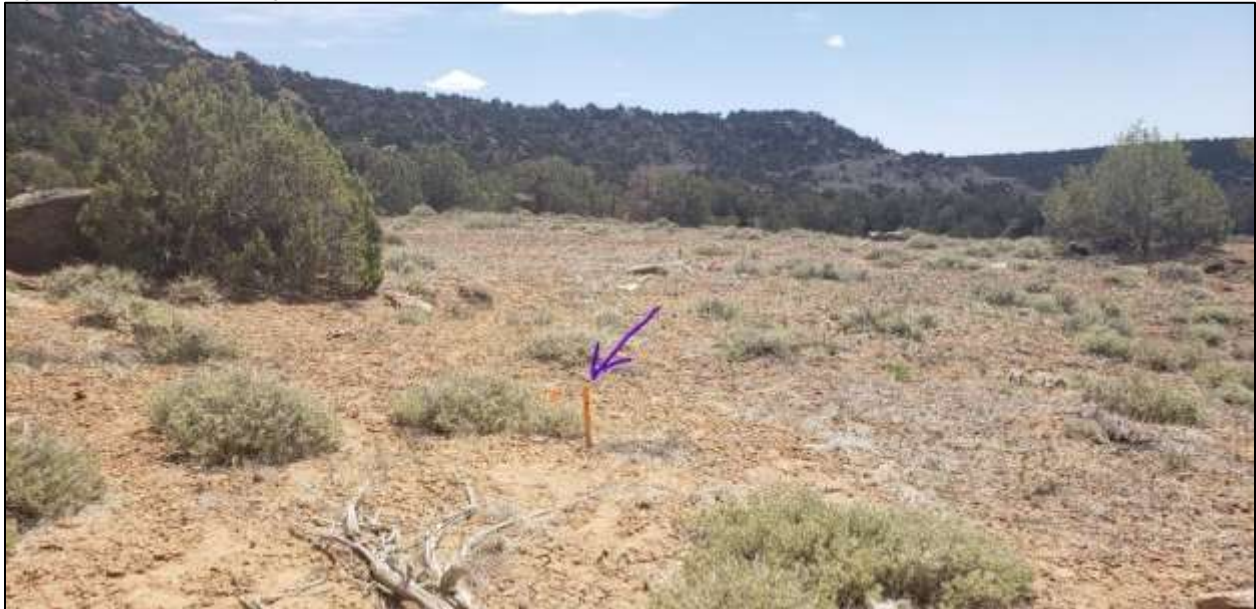
Figure 19: The proposed location of SDH7 looking south. The area is aeolian soil that is erodible. Moving the drill site to the beginning of the "proposed new road" marked with a blue arrow in figure 11. Avoiding the new disturbance would lower the bond and allow it to be reclaimed and returned faster.

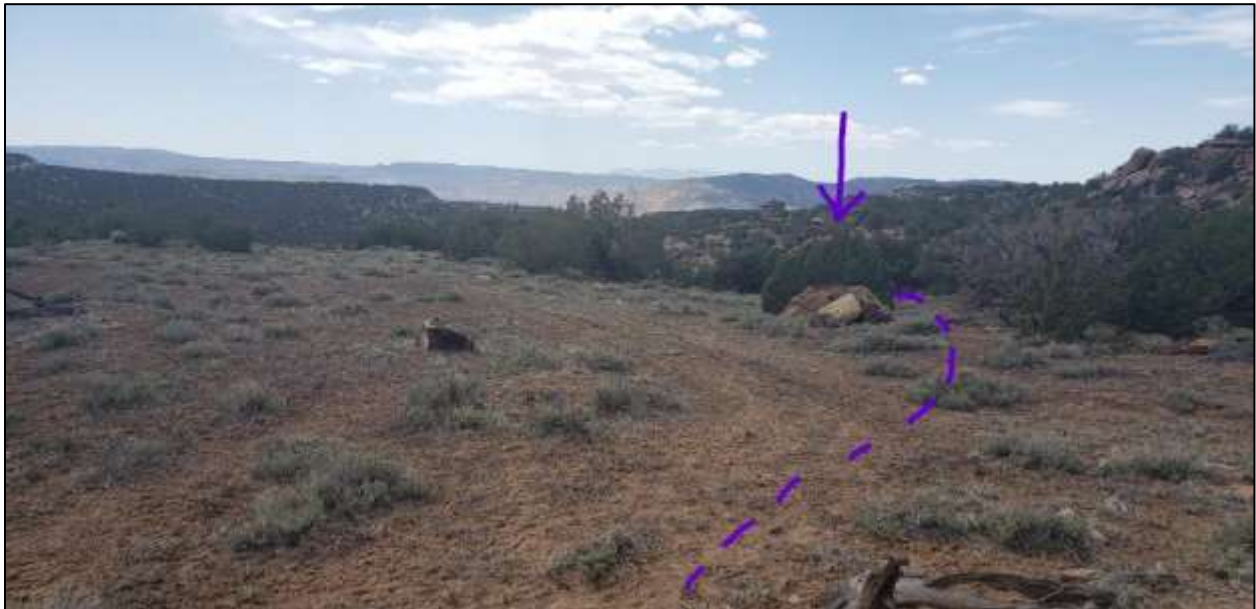
Figure 21: A view looking south southwest from the blue X in figure 18 towards the proposed SDH7 location. The blue arrow indicates the location of the DH7 stake, which is obscured behind a juniper. The blue dashed line shows the proposed access route. Note that the area is fragile aeolian soil. Moving the drill site to the point where this photo was taken, at the blue X in figure 18, would result in approximately 100 feet less disturbance on an area that had not been previously disturbed. There are very faint 2-tacks, probably from several years or even decades prior just from somebody driving over it a few times at most.

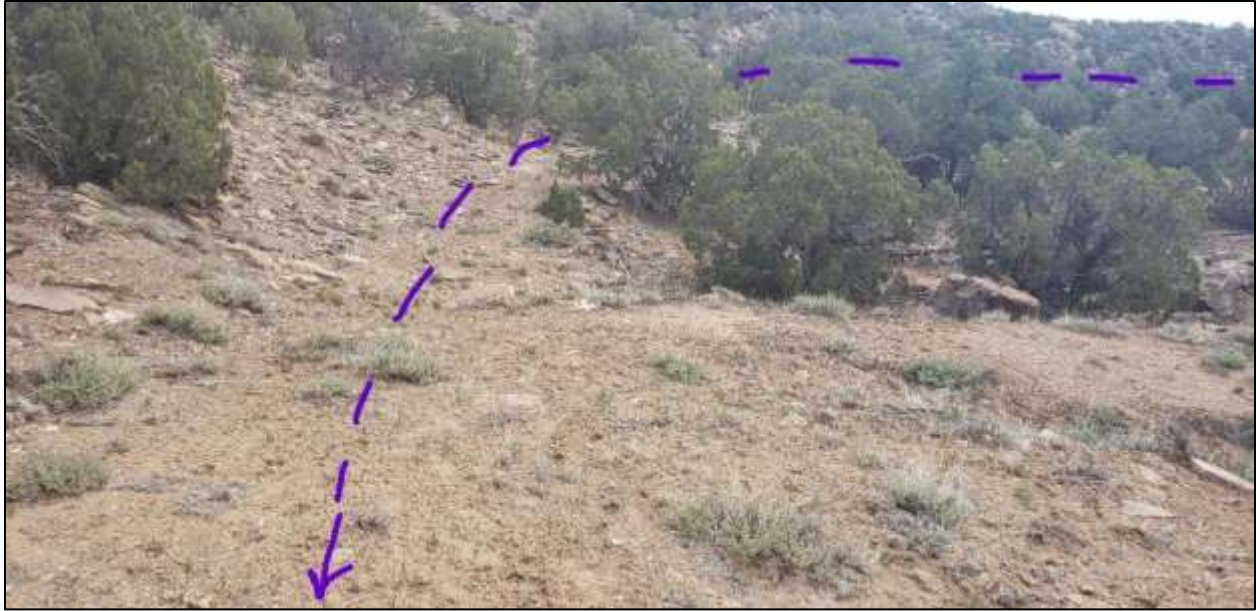
Figure 22: A photo looking east along the existing road alignment from the blue X in figure 18. I propose moving drill site SDH7 to this location, at the blue arrow in this photo. The dashed line shows where the road goes behind the bushes. Reclamation in the area is mature.

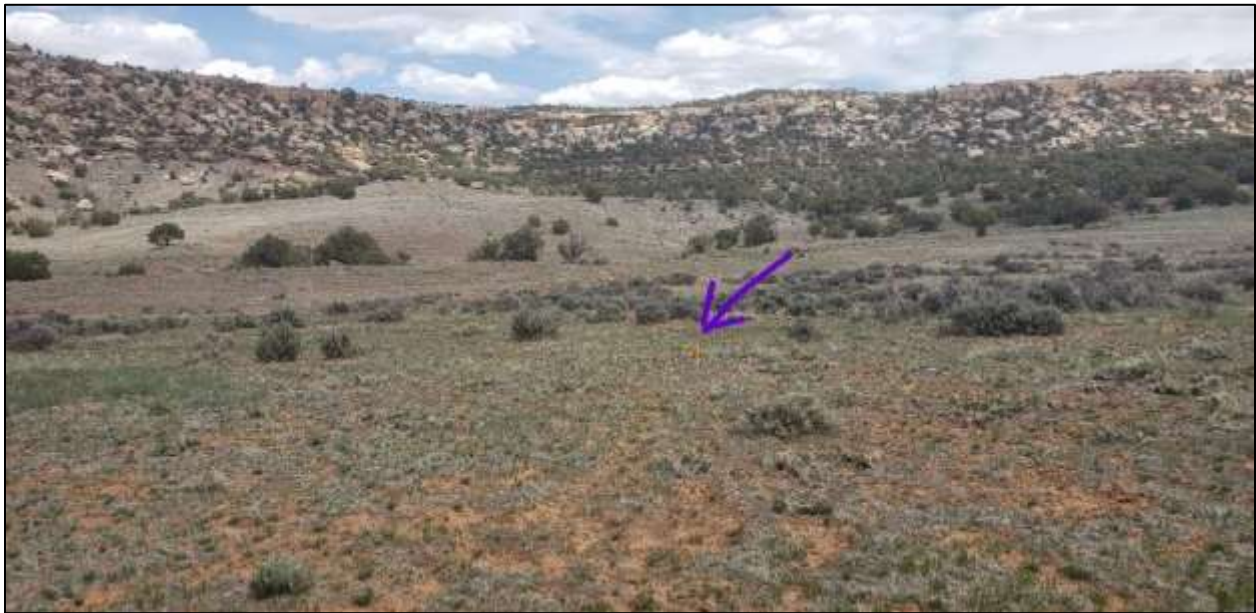
Figure 23: View of drill stake SDH8 (blue arrow) looking towards the north. Cheat Grass was present on the ground at DH8.

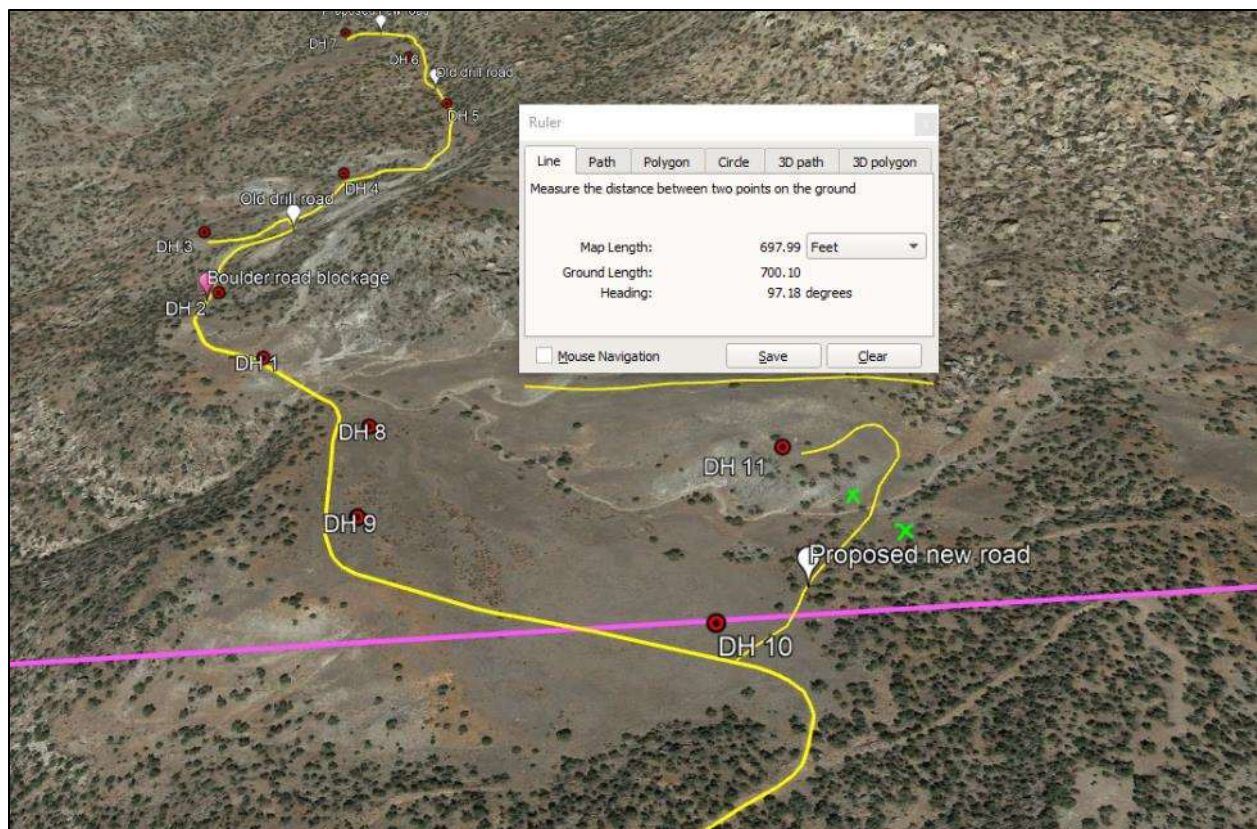
Figure 26: Google Earth screen capture image showing the locations of SDH9, SDH10, and SDH11. Lime colored X's show alternate potential DH11 sites that would cut off over a hundred yards of overland travel. The navigation box in the photo is ~700 feet across, as indicated by the yellow “measure tool” line below the box.

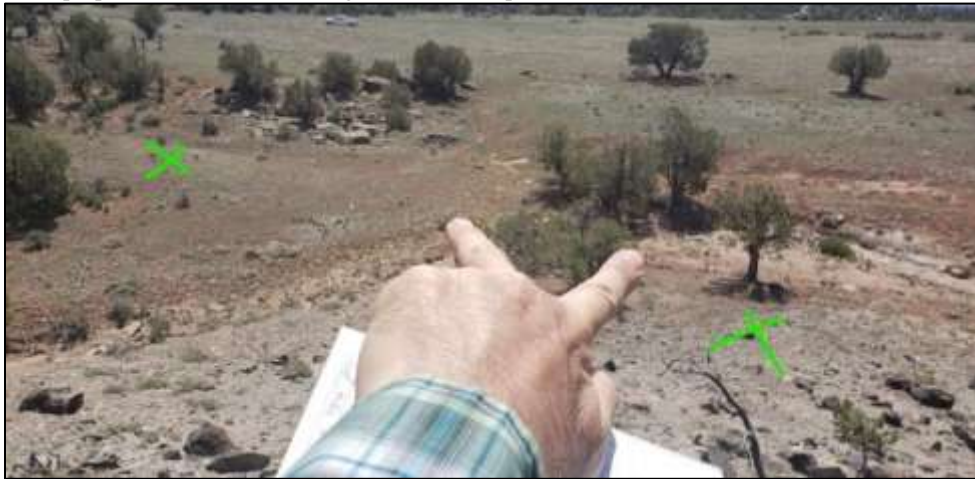
Figure 29: Standing atop the knoll just south of SDH11. My fingers are pointing at two alternate sites for this drill hole also marked by Xs in figure 24. The X on the left side is probably better since no dry wash crossing would be needed.

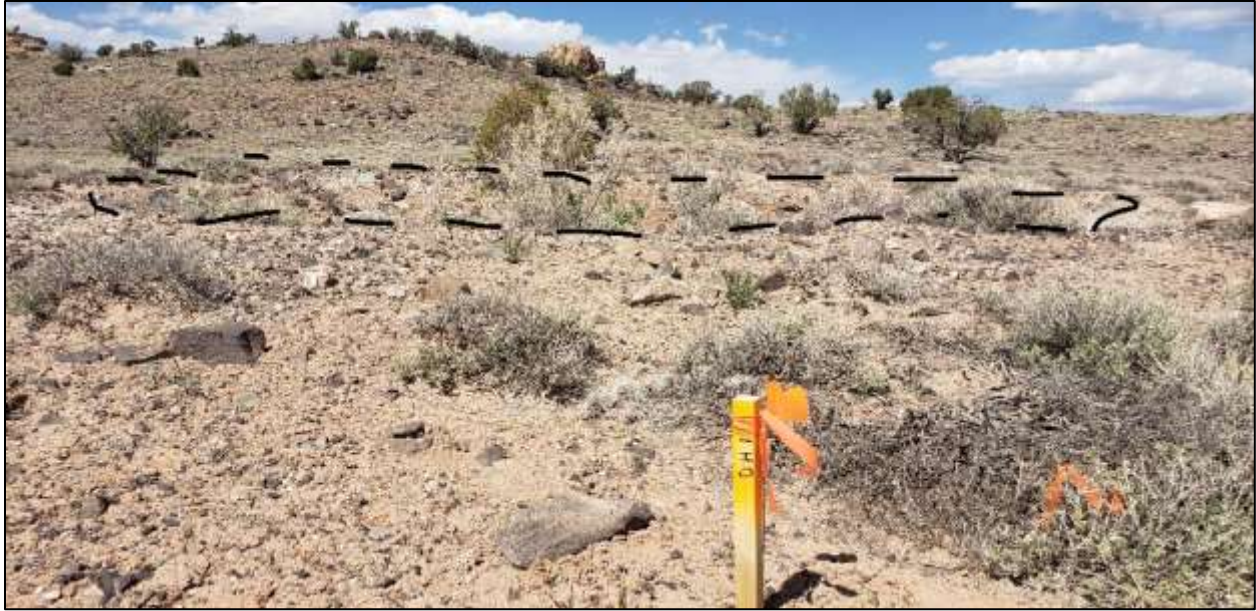
Figure 36: A northeast looking view of GDH1. Note the presence of an open discovery pit/sump from the previous generation of reclamation. The sump was unreclaimed, but volunteer vegetation has come in. I recommend that the sump be re-used for this exploration project, and then backfilled with the spoil that was excavated from the original pit.

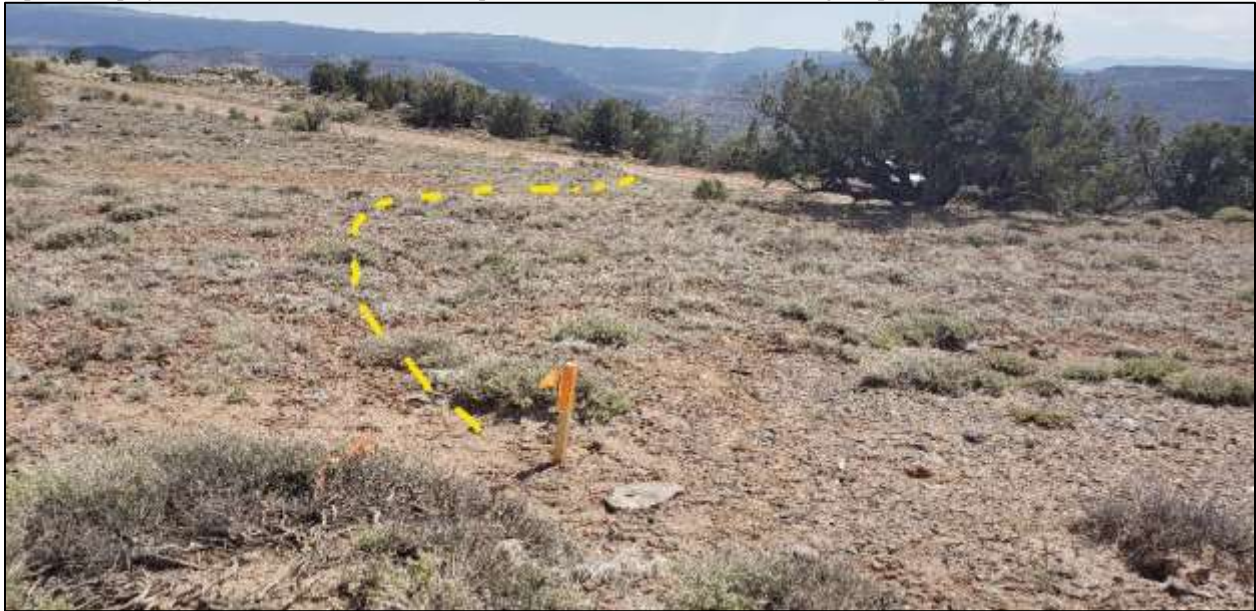
Figure 37: A view of proposed location GDH1, showing the proposed access alignment (yellow dash). It doesn't look as if this has been a travel route in the past, however it also doesn't look like it will need to be bladed or improved. The view is looking southwest.

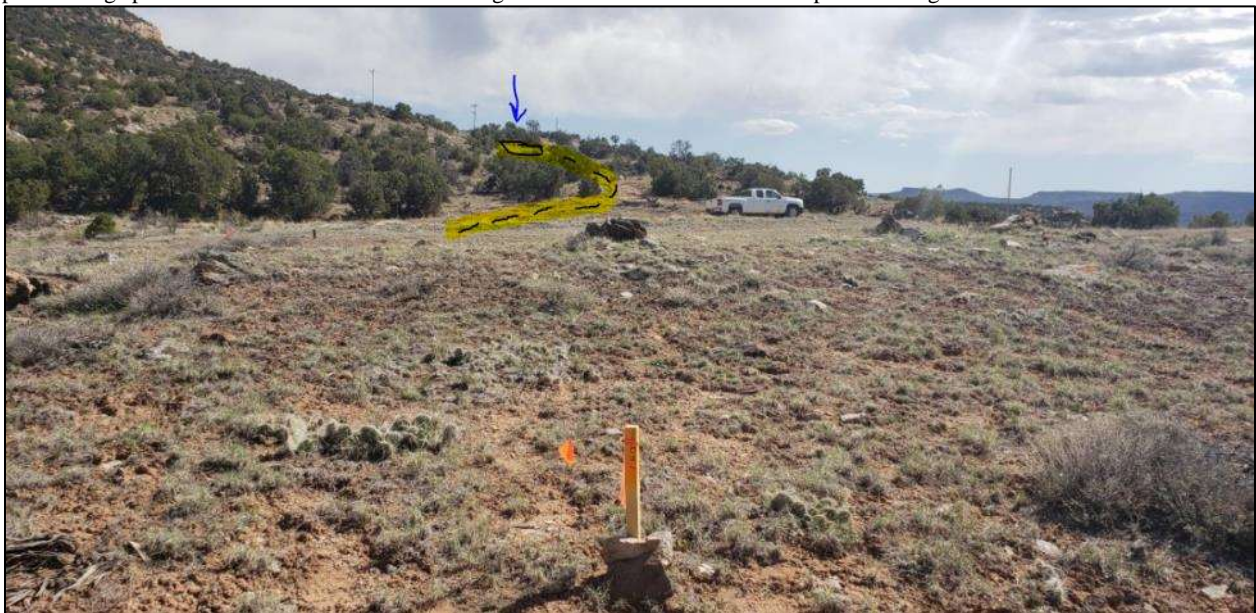
Figure 39: Proposed drill site location RDH1. The RDH1 stake is in the lower middle of the photo. The photo is looking south. Note that there is no readily observable track from the road to the drill site. Scattering brush and rocks across the roadway will be important to have successful reclamation without campers and ATVs utilizing them. The view is looking south. RDH2 location is indicated by the blue arrow, and the access to it by the dashed line highlighted in yellow.

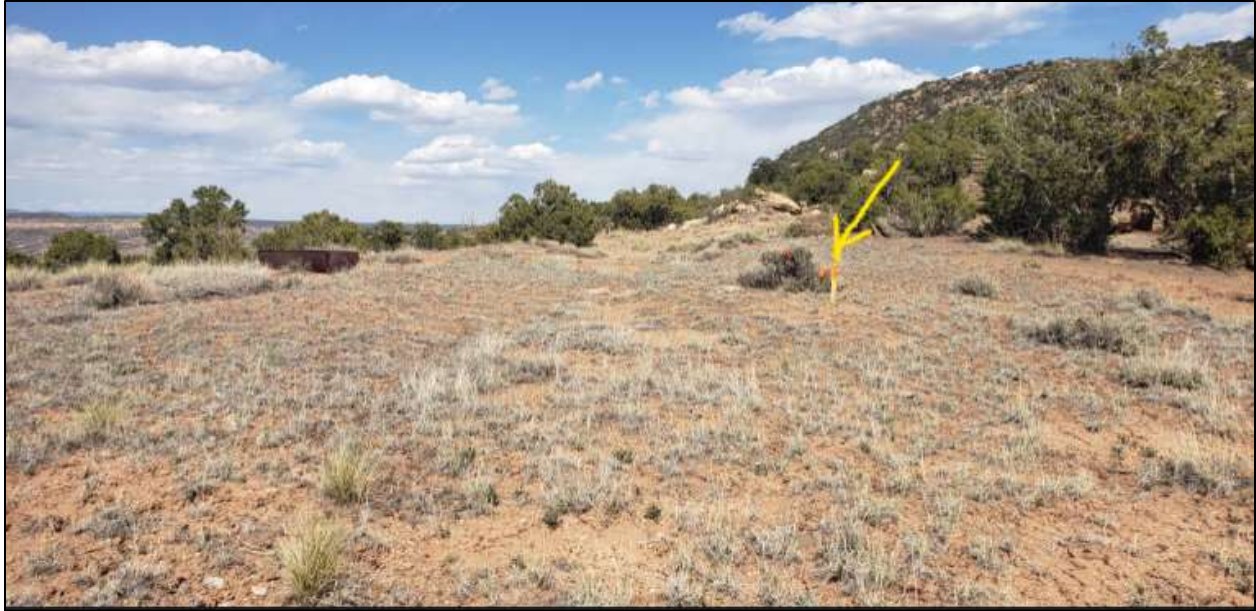
Figure 42: Photograph looking east of the stake for RDH2. Note that the site is not heavily disturbed and is on aeolian soil. Scattering branches and rocks across the disturbed area of the pad would be helpful to reclaim the site and prevent additional vehicles from travelling across it.
