MINERALS PROGRAM INSPECTION REPORT
PHONE: (303) 866-3567

MINE NAME: Robinsons Sons Gravel Pit No. 1	MINE/PROSPECTING ID#: M-2008-076	MINERAL: Sand and Gravel	COUNTY: Las Animas
INSPECTION TYPE: Monitoring	INSPECTOR(S): Daniel Cunningham	INSP. DATE: April 26, 2021	INSP. TIME: 10:00
OPERATOR: Robinsons Sons, Inc.	OPERATOR REPRESENTATIVE: None	TYPE OF OPERATION: 112c - Construction Regular Operation	
REASON FOR INSPECTION: Normal I&E Program	BOND CALCULATION TYPE: Complete Bond	BOND AMOUNT: \$52,815.00	
DATE OF COMPLAINT: NA	POST INSP. CONTACTS: None	JOINT INSP. AGENCY: None	
WEATHER: Clear	INSPECTOR'S SIGNATURE:

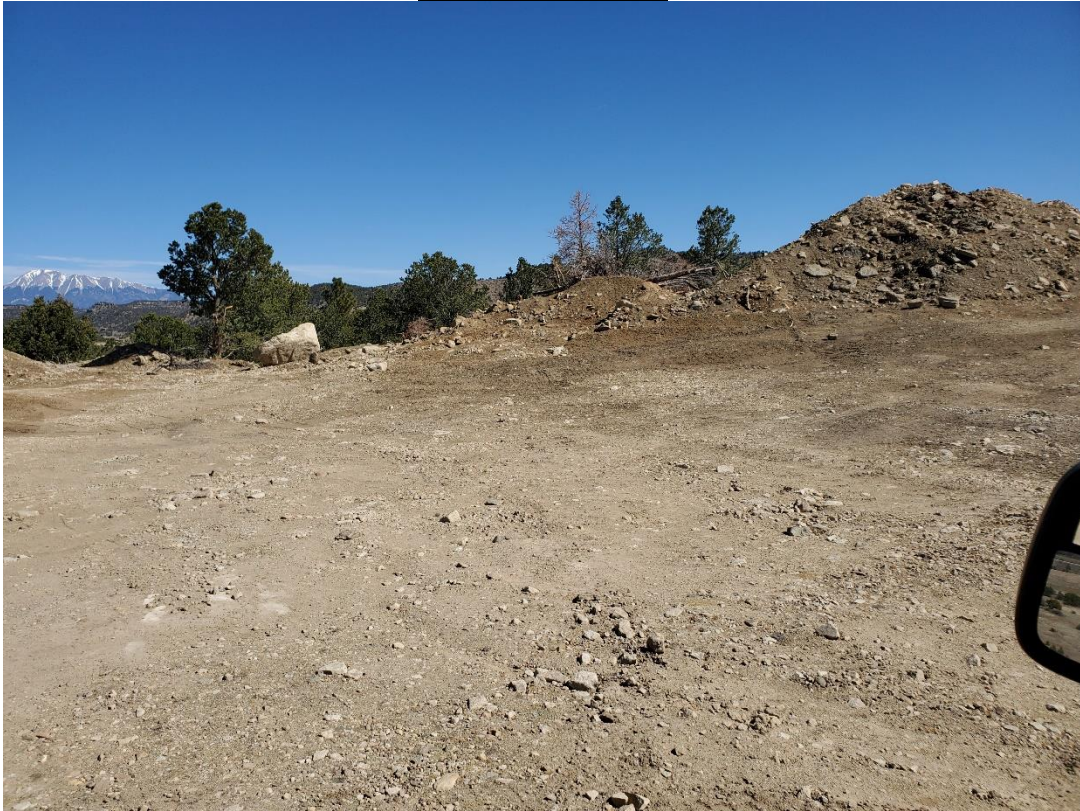
Area 2 has additional reclamation work done. The massive stockpiles have decreased and some areas have been graded.

The Operator has conducted a significant amount of reclamation work and is encouraged to continue working towards the Boards order. The Division recommends that the Operator grade out the erosional issues in area 1, lay down topsoil throughout area 1 and 2, consolidate all stockpiles of material into one area, and breach the area that is retaining water. Based off of the Divisions estimates, if the Operator completes all the above mentioned steps the reclamation bond will be below what is currently requested by the Board.

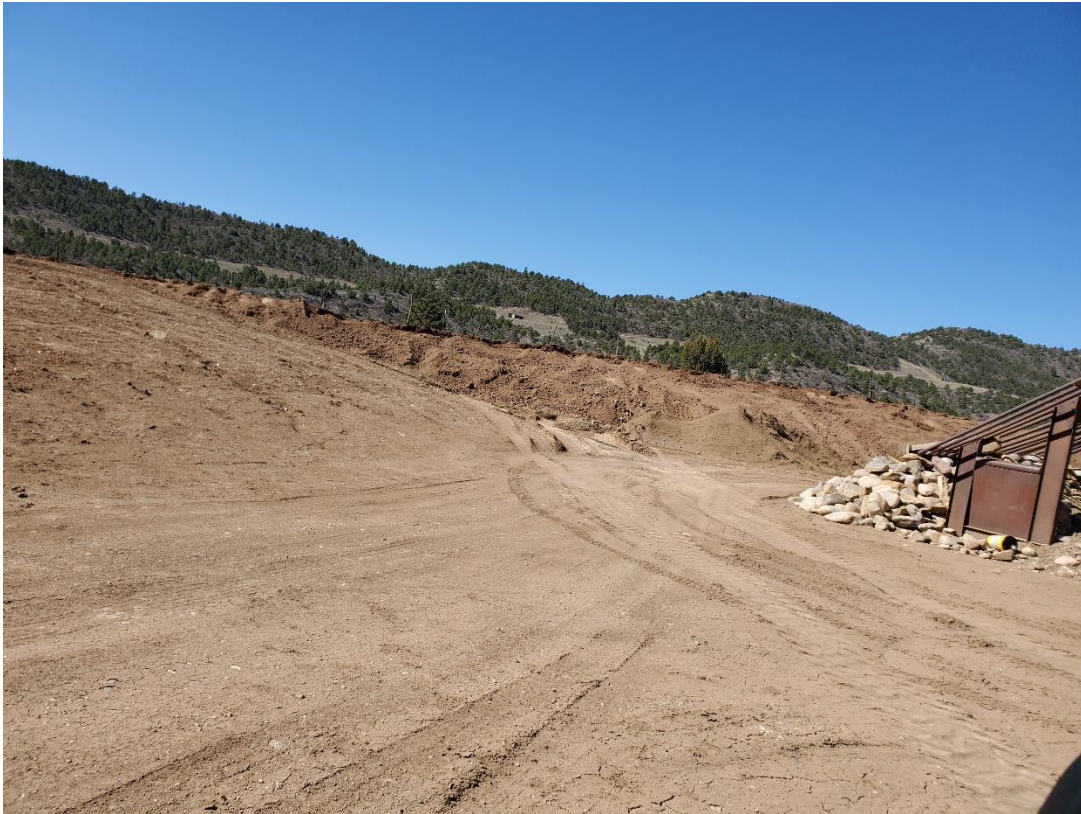
The Operator has conducted a lot of reclamation work in Area 1. The previously noted highwall has been torn down and graded, except for a small 10 ft. section on the east end. Stockpiles in the area have decreased and trash piles have been consolidated.

Highwall Torn down

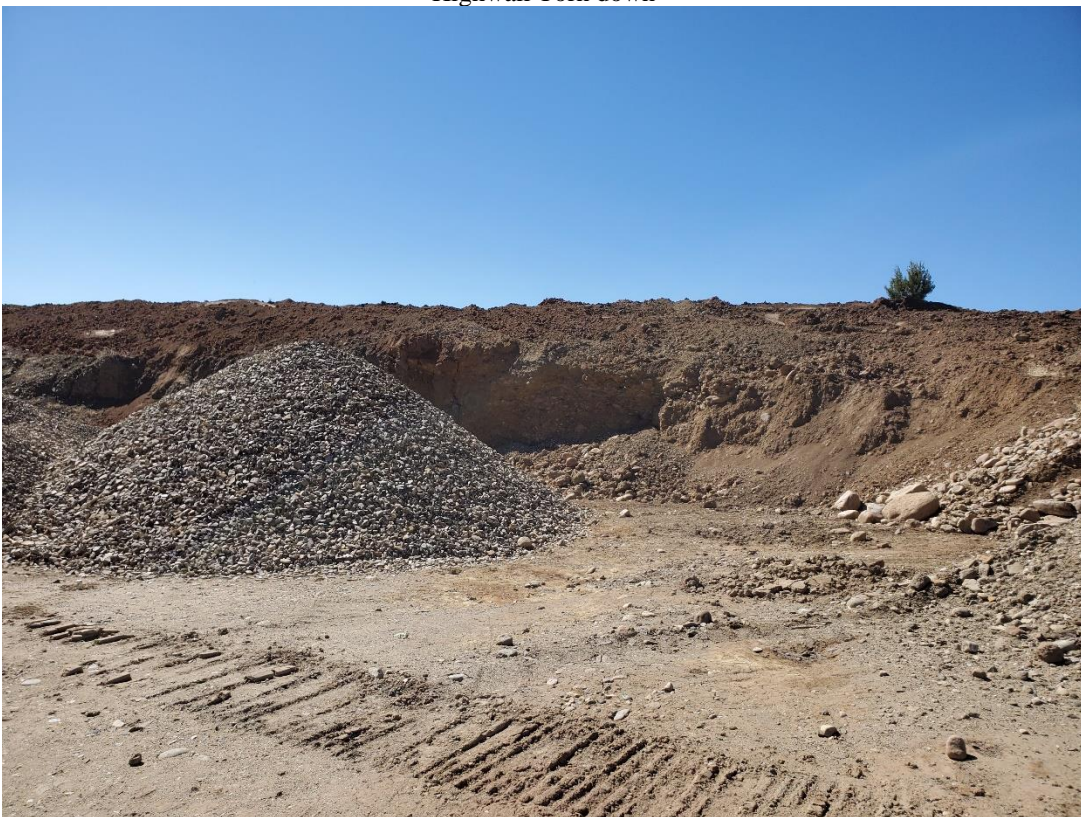
Last of the Highwall

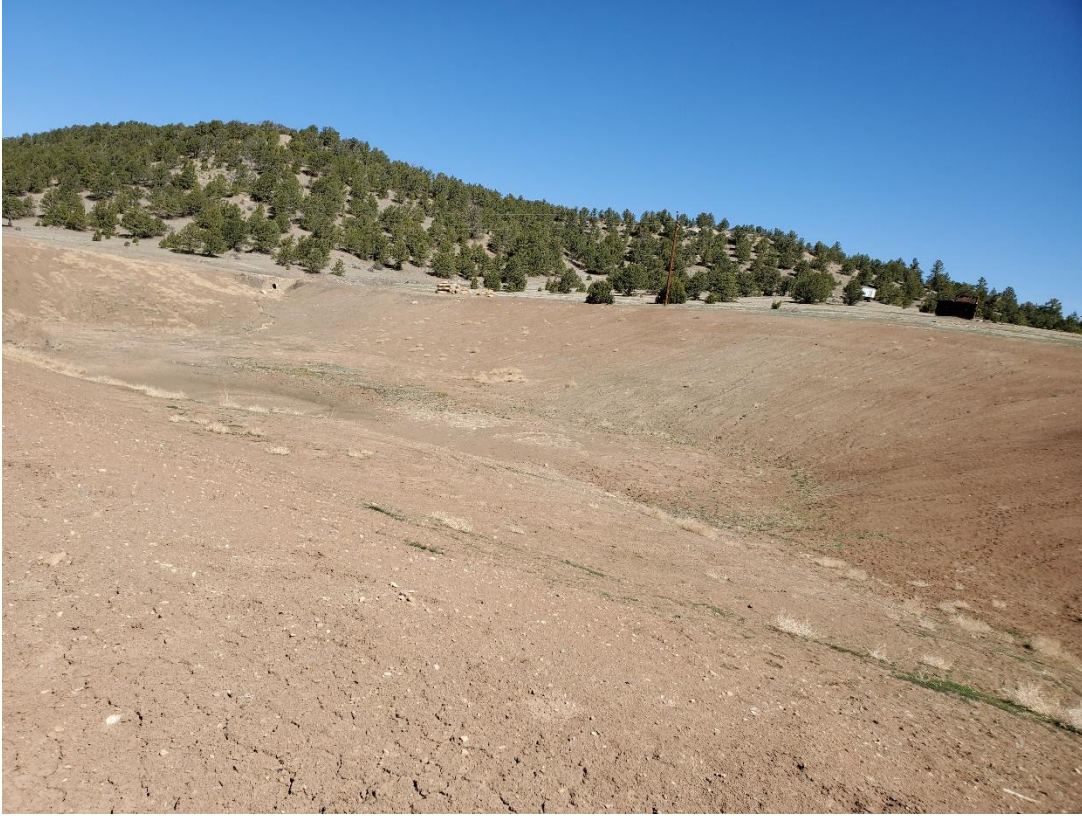
Area where water has been seen in the past
