COLORADO
Division of Reclamation,
Mining and Safety
Department of Natural Resources

Permit Number: C-1981-014 Mine Name: Southfield Mine Operator: Energy Fuels Coal, Inc. Operator Address: Mr John Adams P.O. Box 773457 Steamboat Springs, CO 80477	County: Fremont Operation Type: Underground Permit Status: Revoked Ownership: Private
	Operator Representative Present: None
Operator Representative Signature: (Field Issuance Only)

Inspection Start Date: May 25, 2021 Inspection Start Time: 09:30 Inspection End Date: May 25, 2021 Inspection End Time: 09:35		Inspection Type: Aerial Inspection Inspection Reason: Normal I&E Program Weather: Clear	
Joint Inspection Agency: None		Joint Inspection Contacts: None	
Post Inspection Agency: None		Post Inspection Contacts: None	
Inspector(s): Zach Trujillo Brock Bowles	Inspector's Signature:

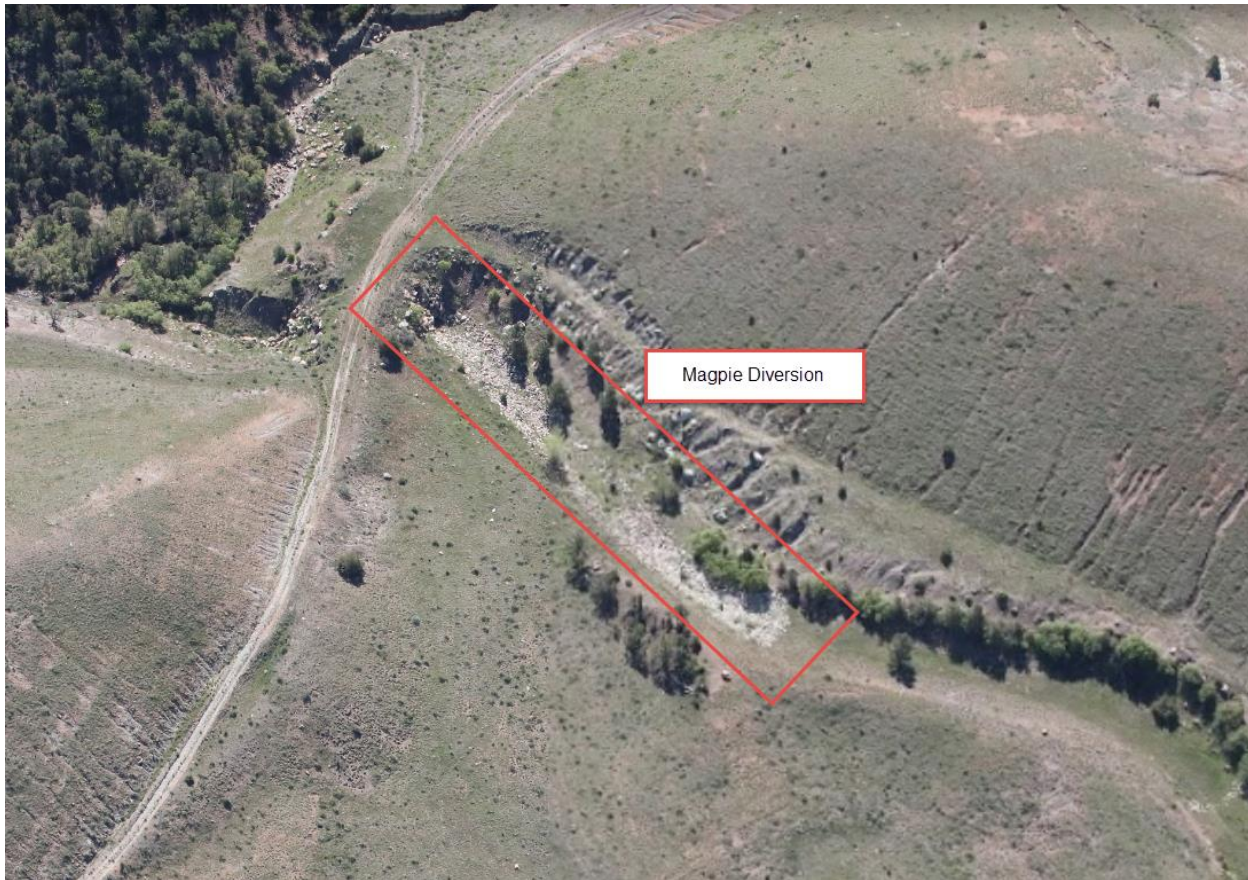
The remaining portion of the Magpie Diversion was inspected. The diversion remains stable and well armored with rip-rap. No signs of erosion or cutting within the diversion was observed.

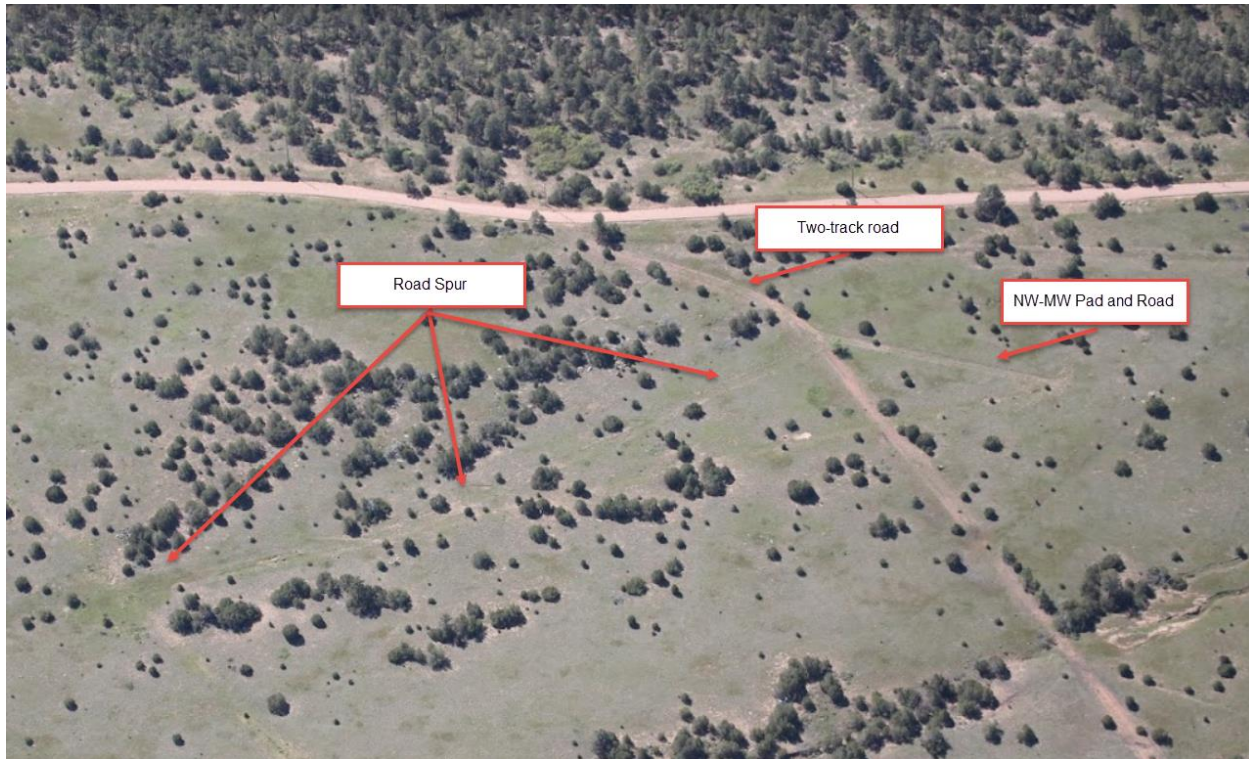
The reclaimed road and road spur associated with the NW-MW pad was stable. The road spur remains well vegetated. The two track road off of County Road 15 continues to “self-heal” and establish vegetation due to lack of use.

The reclaimed access road associated with the reclaimed substation appears to be used consistently as the road has become well established.

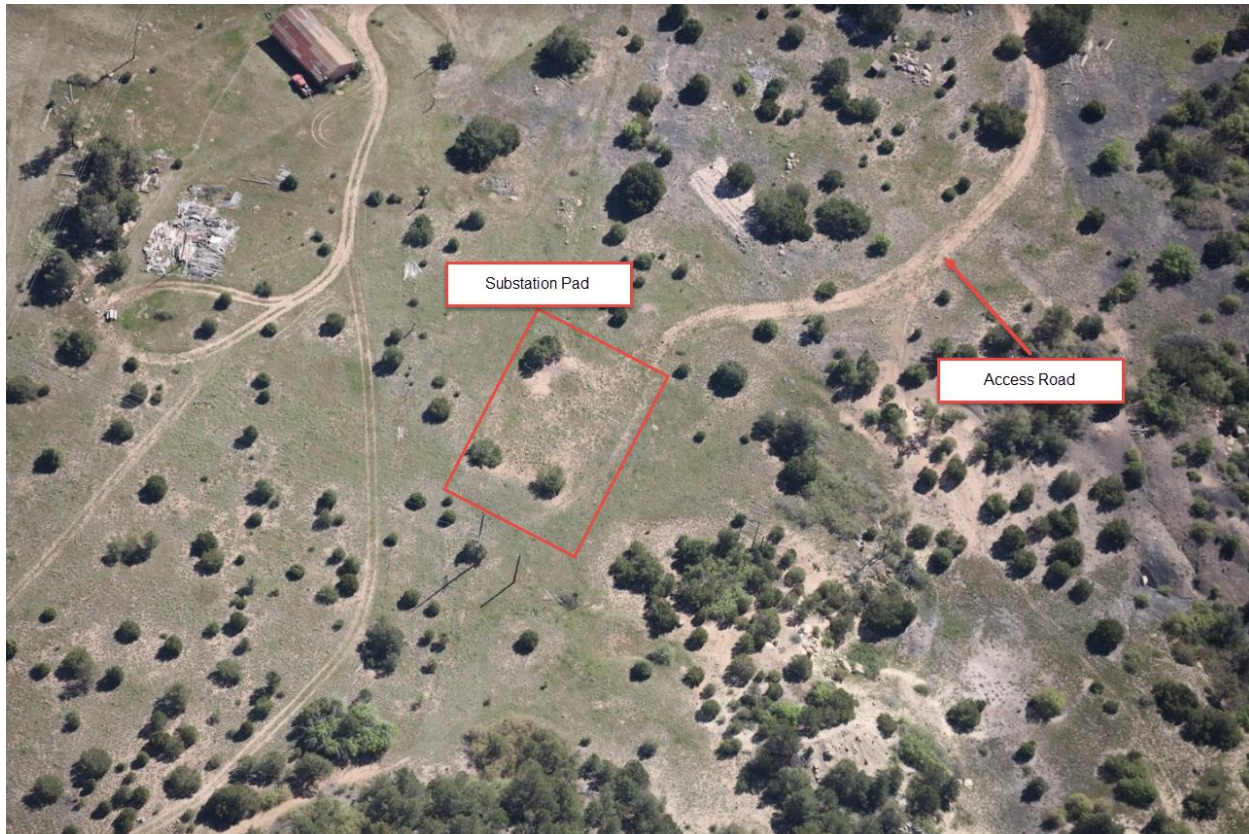
The reclaimed substation pad continues to establish itself with vegetation. The area has begun to blend into the adjacent undisturbed lands. No issues were observed.
