MINERALS PROGRAM INSPECTION REPORT

MINE NAME: Schwartzwalder Mine	MINE/PROSPECTING ID#: M-1977-300	MINERAL: Uranium	COUNTY: Jefferson
INSPECTION TYPE: Monitoring	INSPECTOR(S): Amy Eschberger, Michael Cunningham	INSP. DATE: May 18, 2021	INSP. TIME: 09:00
OPERATOR: Colorado Legacy Land, LLC	OPERATOR REPRESENTATIVE: Elizabeth Busby, Billy Ray, Jim Harrington	TYPE OF OPERATION: 112d-2 - Designated Mining Operation	
REASON FOR INSPECTION: Normal I&E Program	BOND CALCULATION TYPE: None	BOND AMOUNT: \$8,900,000.00	
DATE OF COMPLAINT: NA	POST INSP. CONTACTS: None	JOINT INSP. AGENCY: None	
WEATHER: Clear	INSPECTOR'S SIGNATURE:

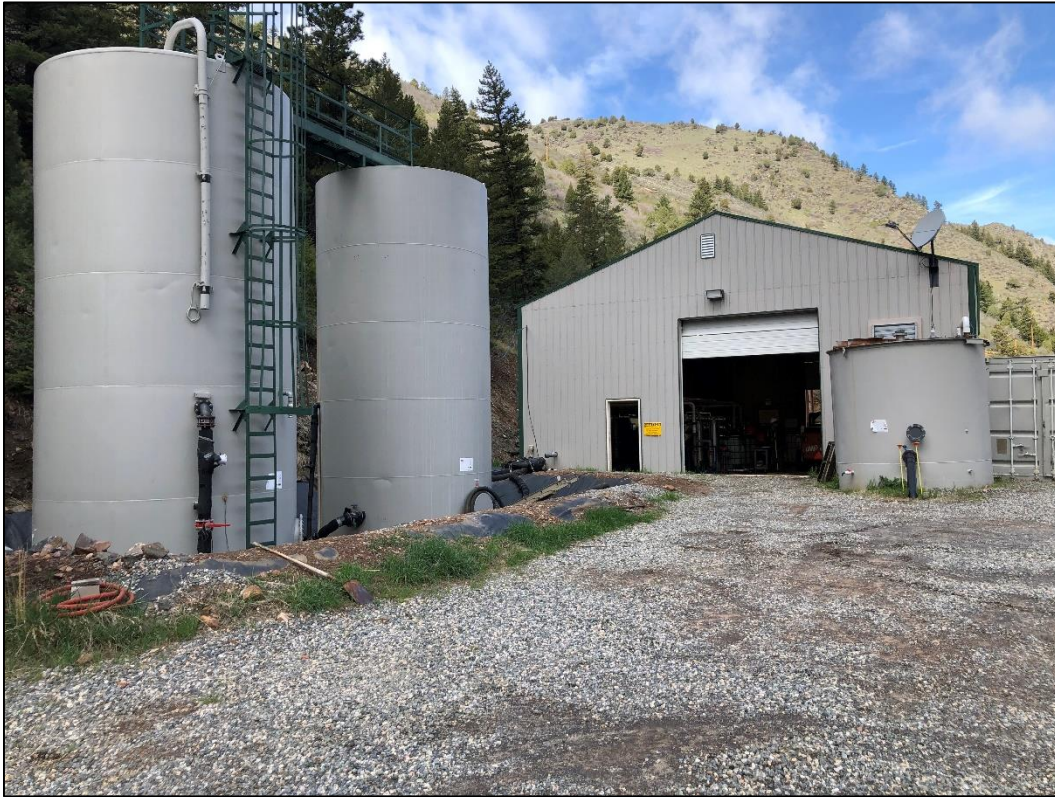
At the time of the inspection, the mine pool was at 198 feet below the Steve Level, which is 48 feet below the required 150 foot depth. The water treatment plant was brought back online on May 10, 2021. The plant was shut down for the winter on November 1, 2020. This means the plant was offline for about 27 weeks, which, according to the operator, is the longest shut down period thus far. When the plant was brought back online this month, the mine pool was at 188 feet below the Steve Level. When the plant was shut down last November, the mine pool was at 340 feet below the Steve Level. Therefore, the mine pool ascended 152 feet during the recent winter shut down period. The last in-situ injection treatment of the mine pool was completed in January of 2020. Depending on the mine pool chemistry observed over the year, the operator may complete another in-situ injection treatment of the mine pool this fall. The operator continues to collect daily average mine pool elevations and quarterly water quality samples from the mine pool and reports this data with other site sampling data in its quarterly monitoring reports submitted to the Division.

Photo 1. View looking northwest at water treatment plant on top of mesa. This plant was brought back online as of May 10 of this year, after a 27-week winter shutdown period.

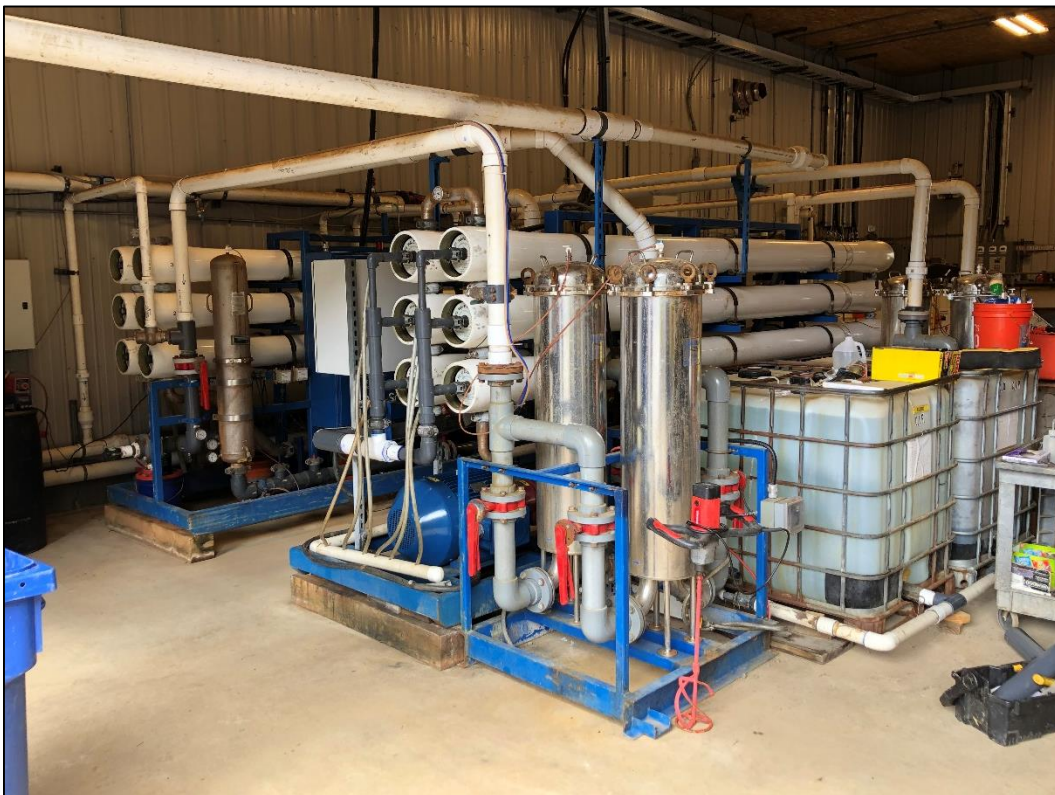
Photo 2. View of Reverse Osmosis System present inside water treatment plant.

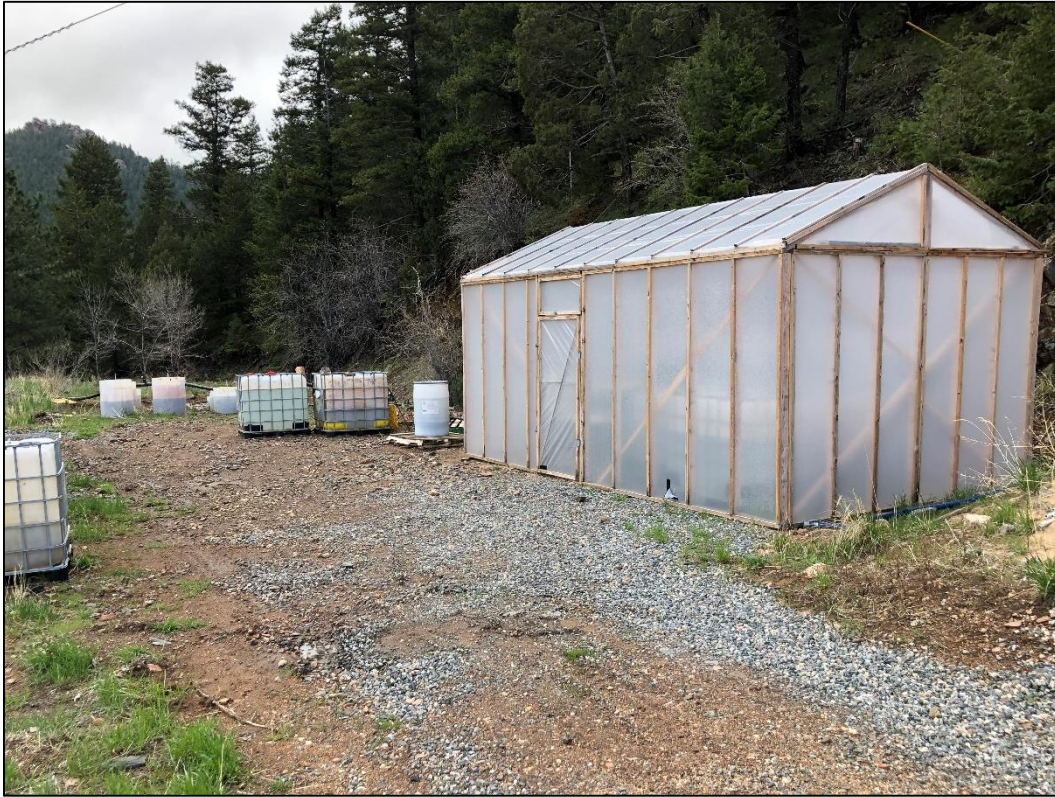
The wetland and biochemical reactor (BCR) pilot-scale study which was conducted on top of the mesa, east of the water treatment plant, has concluded. According to the operator, the results of this study were promising with regard to the potential biological treatment of uranium on site. This passive treatment system may be proposed as part of the final reclamation plan for the site in a future permit revision. The materials used in this study (e.g., tanks, hoses, small greenhouse) have not yet been removed from the site.

Photo 3. View looking southeast at materials that remain from concluded wetland and biochemical reactor pilot-scale study which was conducted on top of mesa, east of water treatment plant.

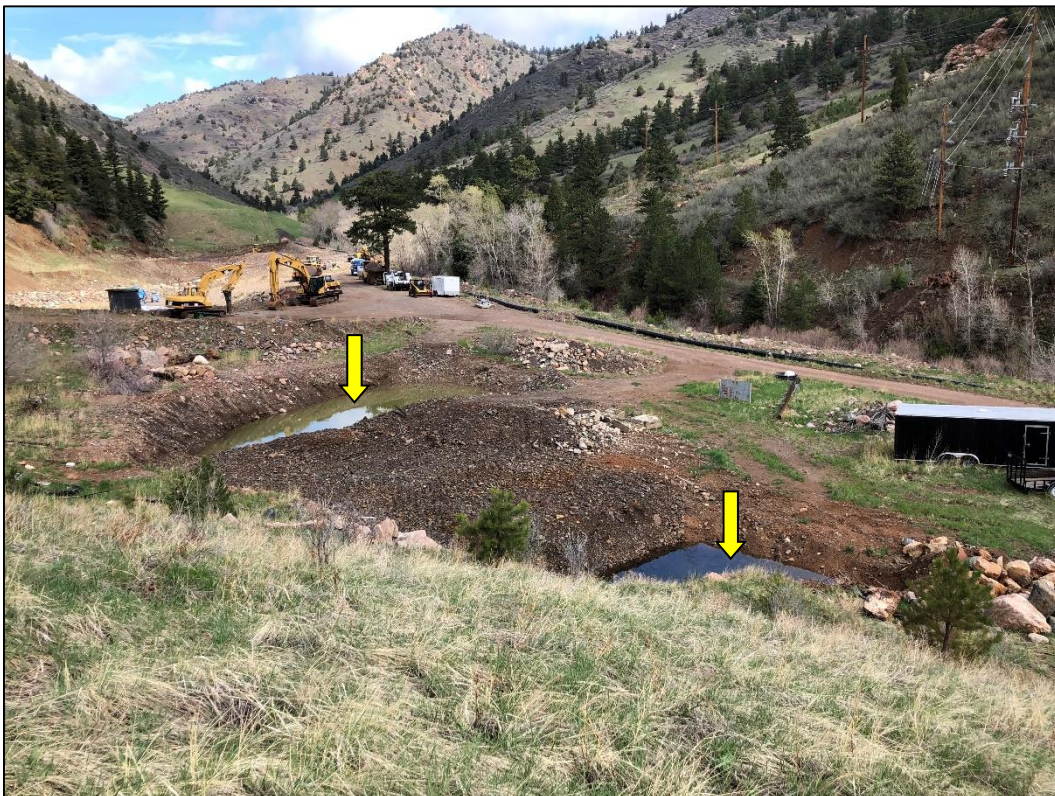
As mentioned above, evidence of a wet spring was observed throughout the site. Water was ponded in low-lying areas, including in the excavated areas in the valley, and Ralston Creek was running high. The creek flows were not being captured above the upgradient cutoff wall and routed around the mine site via the bypass pipeline as usual. The creek was flowing in the channel below the upgradient cutoff wall. According to the operator, no water quality issues have been observed thus far at the creek monitoring location below the mine site (SW-BPL) with the creek flowing across the site. This is attributed to the installation of the NWRP diversion channel (which is addressing the seep issue) and the progress made in excavating contaminated alluvial soils from the valley. Additionally, the current high creek flows would act as a dilution factor for any minor contamination that may be present. The operator also informed the Division that any water remaining in excavated areas after 72 hours would be pumped to the plant for treatment and ultimately discharged at the operator's permitted outfall location.

Photo 4. View looking northwest from top of mesa across valley excavation project area. Note standing water in excavated pits (indicated) from recent storm events. This water will be pumped to plant for treatment (if needed) and ultimately discharged at operator's permitted outfall.

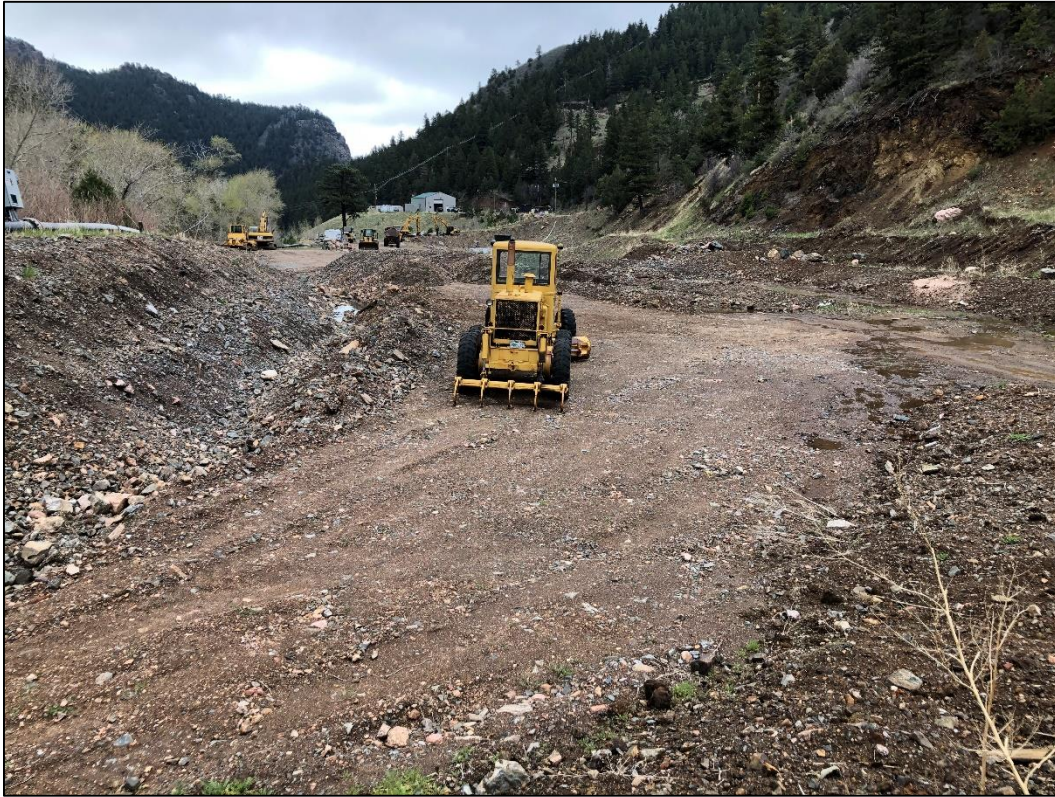
The valley excavation project, in which radionuclide-impacted alluvial valley soils are excavated and disposed of underground (on site), had recommenced the day before this inspection. This project start-up was delayed by the frequent precipitation events occurring in the area this spring. The operator estimates they have approximately 3-4 weeks left of hauling excavated material to the CV Glory Hole in the Minnesota Mine, before this disposal location reaches its capacity. As of the Division's approval of Amendment No. 5 (AM-5) on January 13, 2021, the operation is also approved to dispose of the excavated alluvial soils in the Black Forest Mine. This mine will provide an additional capacity of approximately 15,000 cubic yards. The portal of this mine is located near the valley floor and is currently covered by steel grating with a locked gate. While evidence of the recent heavy rain storms that occurred in this area was observed throughout the site, including ponded water in low-lying areas and high creek levels, no discharge was observed from the Black Forest Mine portal. According to the operator, only minor drippings have been observed inside the mine this spring. This is consistent with the operator's description of the Black Forest Mine (in AM-5) as a "dry" mine. The operator expects to complete the valley excavation project this year. However, final surveys of the project area may extend into 2022.

Photo 5. View looking southeast across northern portion of valley excavation project area.

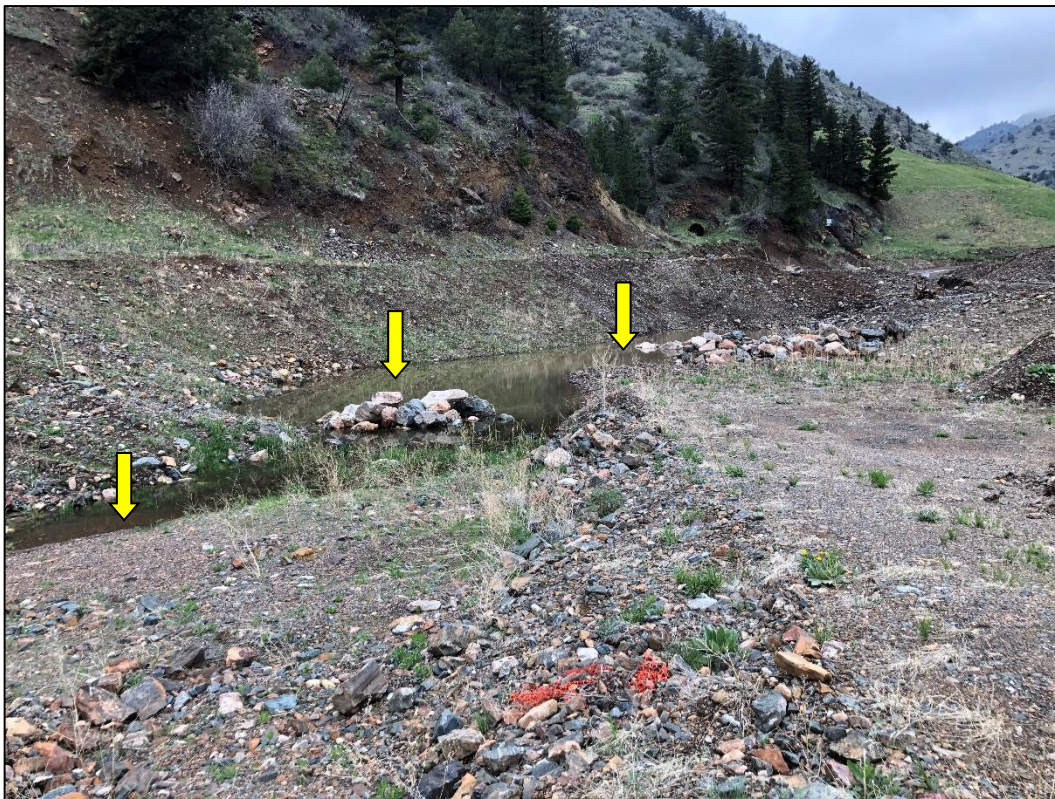
Photo 6. View looking northwest across central portion of valley excavation project area. Note standing water in excavated pit (indicated) from recent storm events. This water will be pumped to plant for treatment (if needed) and ultimately discharged at operator's permitted outfall.

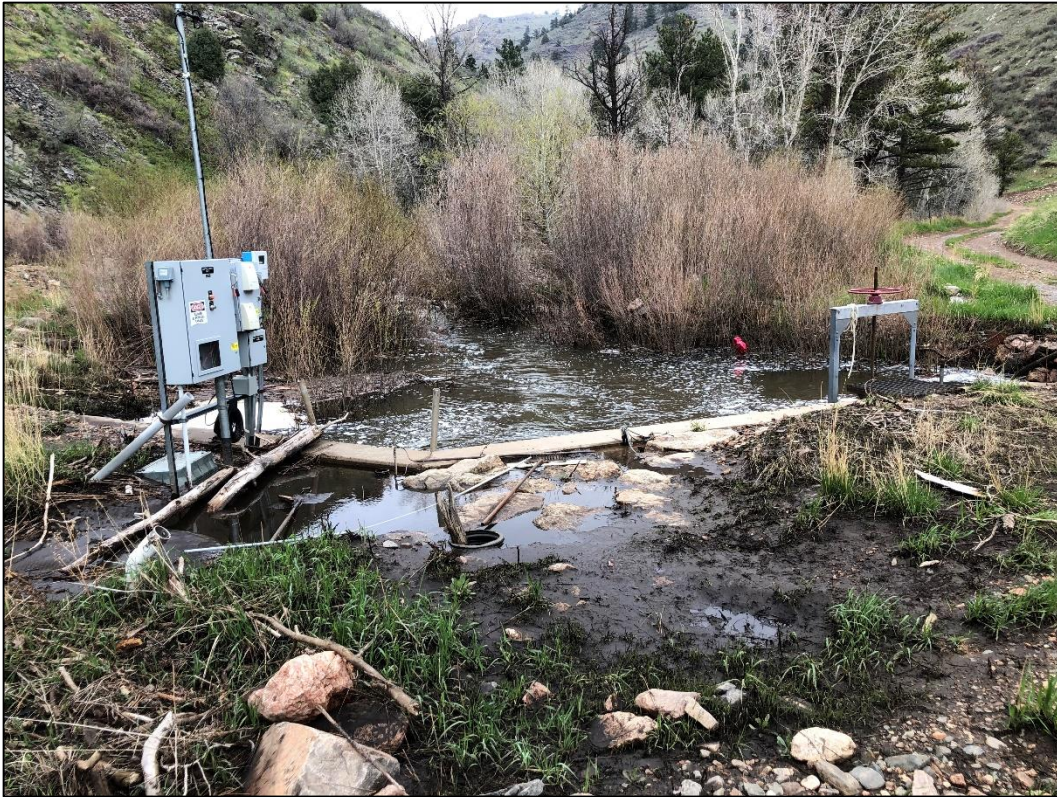
Photo 7. View looking upstream at upgradient cutoff wall/headgate in Ralston Creek. Note creek running high upstream from cutoff wall and standing water present in area during inspection.

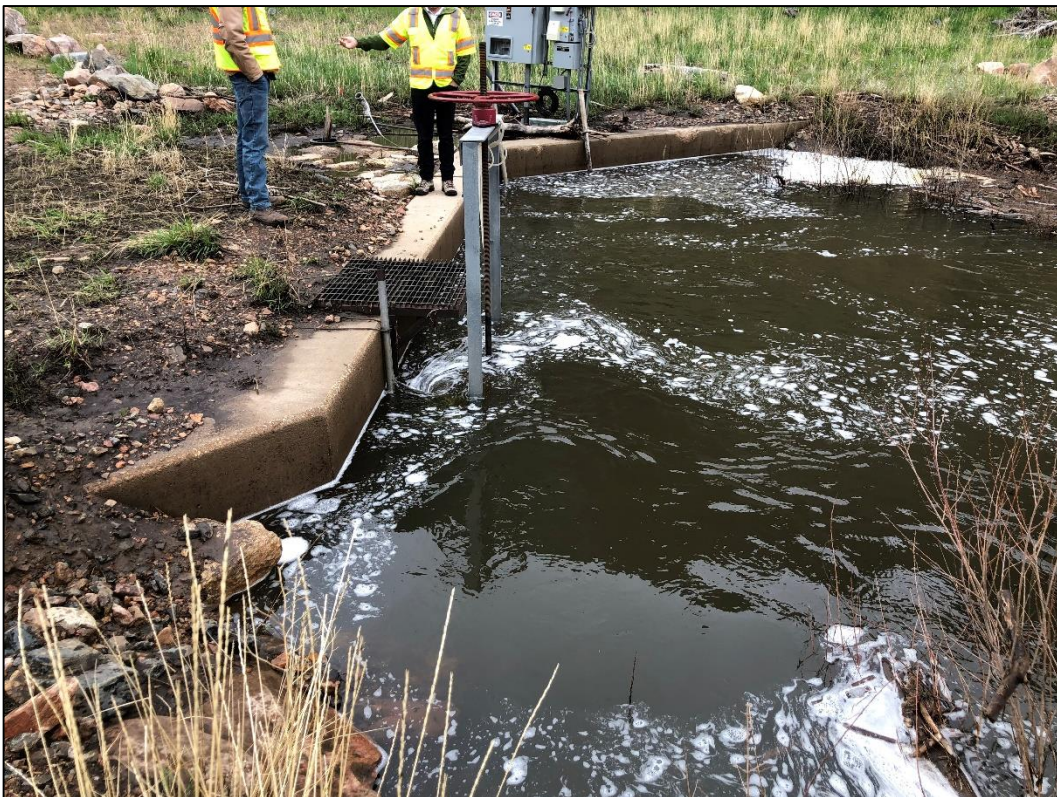
Photo 8. View looking south at upgradient cutoff wall/headgate in Ralston Creek, showing creek running high upstream of cutoff wall during inspection.

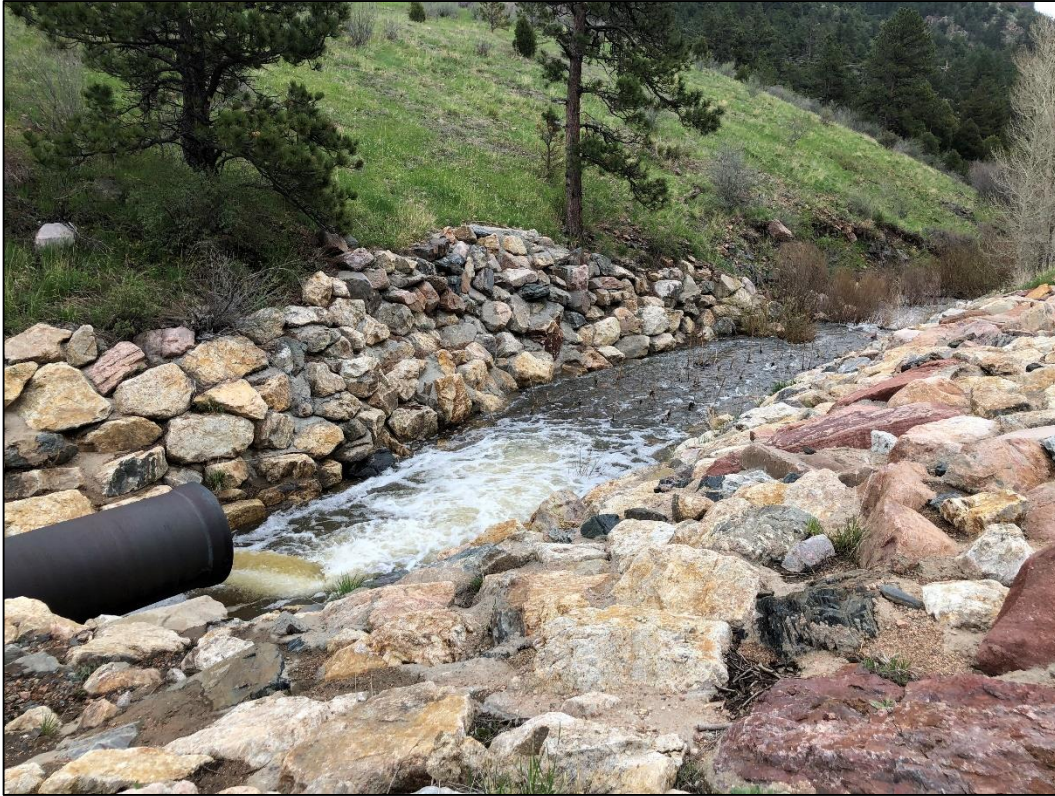
Photo 9. View looking downstream from upgradient cutoff wall/headgate in Ralston Creek, showing creek flowing downstream of cutoff wall during inspection.

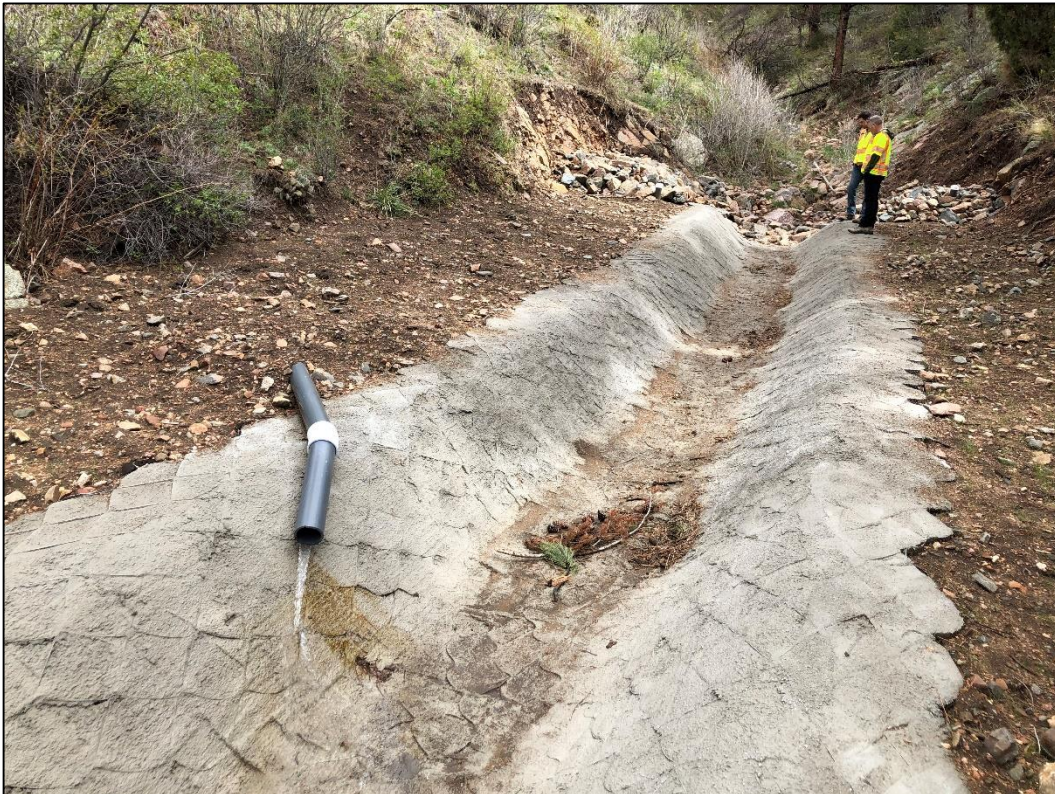
diversion channel consists of a three-liner base system composed of a geosynthetic liner sandwiched between two non-woven geotextile liners, and a four-inch thick layer of Geoweb panels installed across the top of the liner system and filled with concrete. A water capture structure (seal wall) was installed at the upstream end of the channel in the ephemeral drainage above the NWRP. A buried perforated pipeline was installed upstream of the seal wall which transitions to a solid pipeline prior to daylighting approximately 50 feet downstream of the seal wall to discharge into the channel. A riprap-lined energy dissipation basin was installed at the downstream end of the channel. Overflow from this basin will flow across a road crossing constructed out of a gravel-filled Geoweb system. During the inspection, water was discharging from the outlet pipe into the channel at a rate of approximately 5 gallons per minute (no measurements were obtained). Some water was ponded inside the riprap-lined dissipation basin. The channel was free of any significant debris and appeared to be functioning as designed. No evidence of seeps was observed at the toe of the NWRP. This would suggest the diversion channel is adequately addressing the seep issue, especially given the significant amount of precipitation that has occurred in the area this spring. It should be noted, the Division observed some germination of the grass seed planted in disturbed areas adjacent to the channel last fall.

Photo 10. View looking north/northeast (upgradient) at upper section of NWRP diversion channel, showing pipeline from water intake structure which daylights to discharge into channel approx. 50 feet downgradient from seal wall. Note water flowing from pipeline during inspection (at estimated 5 gpm).

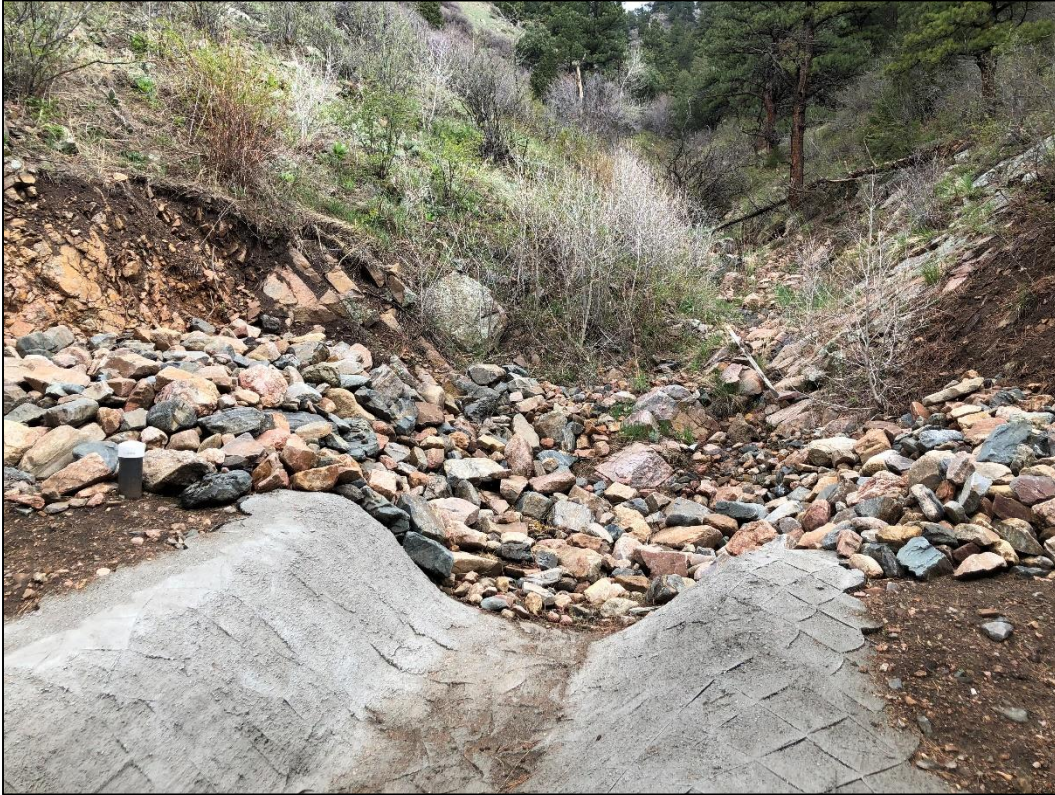
Photo 11. View looking north/northeast at riprap-lined water intake structure constructed at upgradient end of NWRP diversion channel in ephemeral drainage above pile.

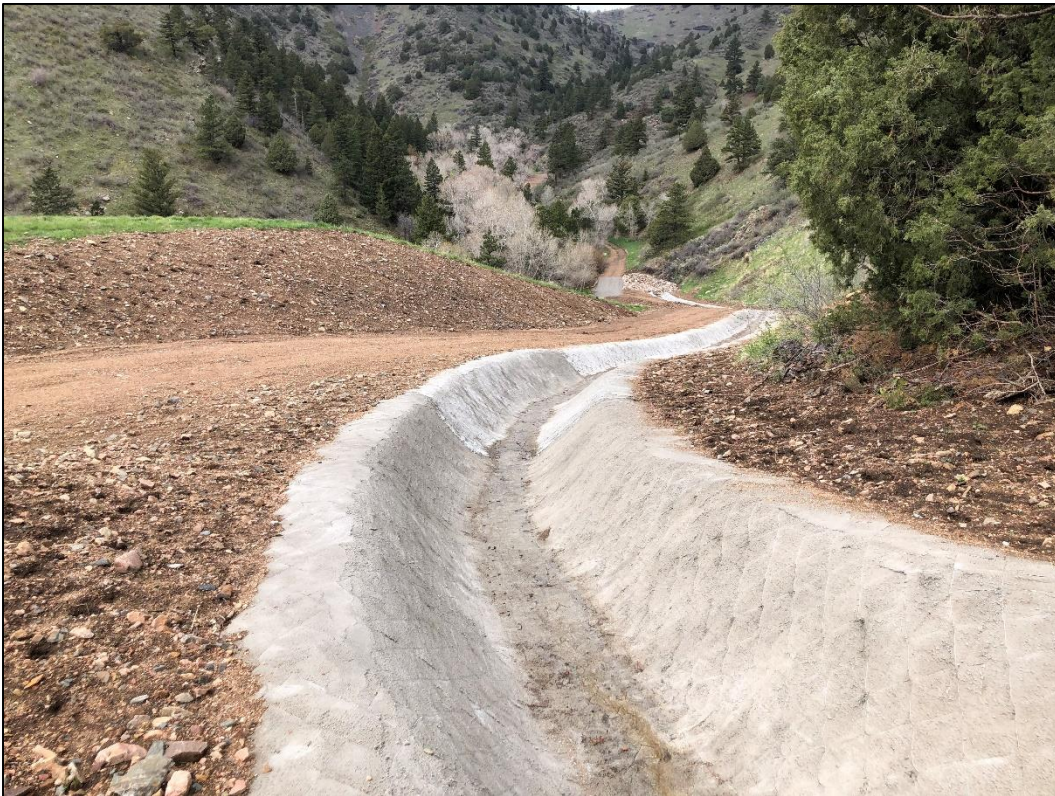
Photo 12. View looking southwest (downgradient) at section of NWRP diversion channel which curves around hillside. Note channel free of debris and functioning as designed.

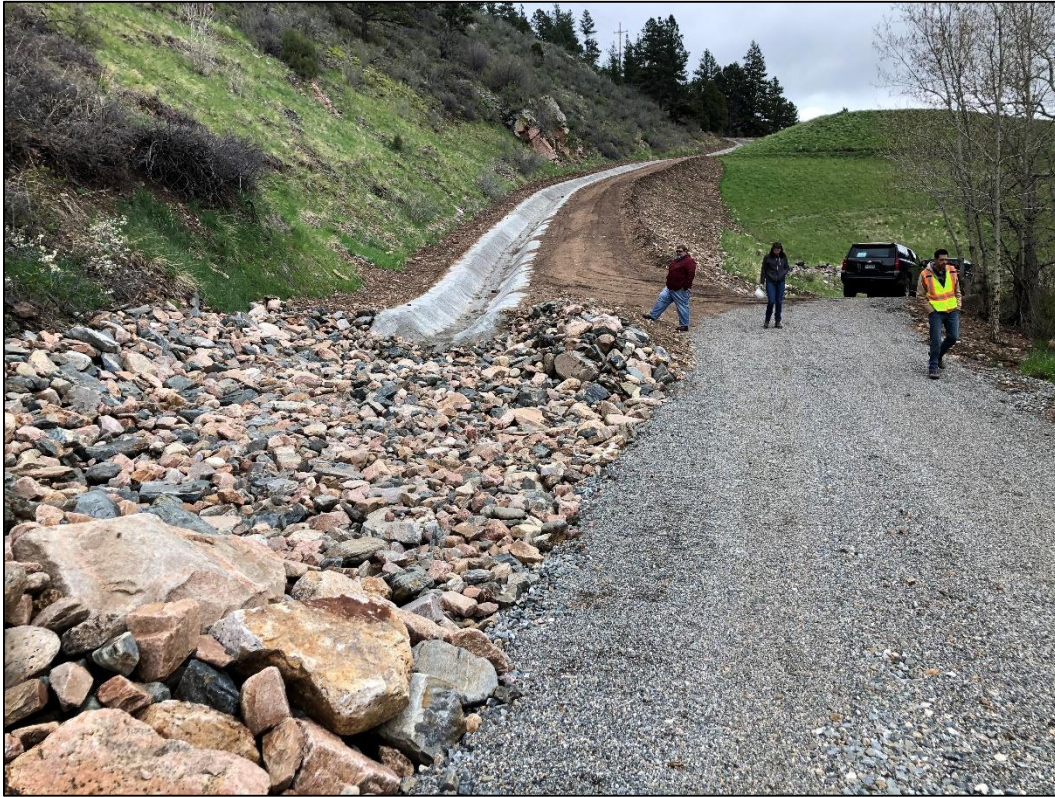
Photo 13. View looking east/southeast at riprap-lined energy dissipation basin (at left) constructed at downgradient end of NWRP diversion channel and road crossing (at right) constructed of gravel-filled Geoweb system.

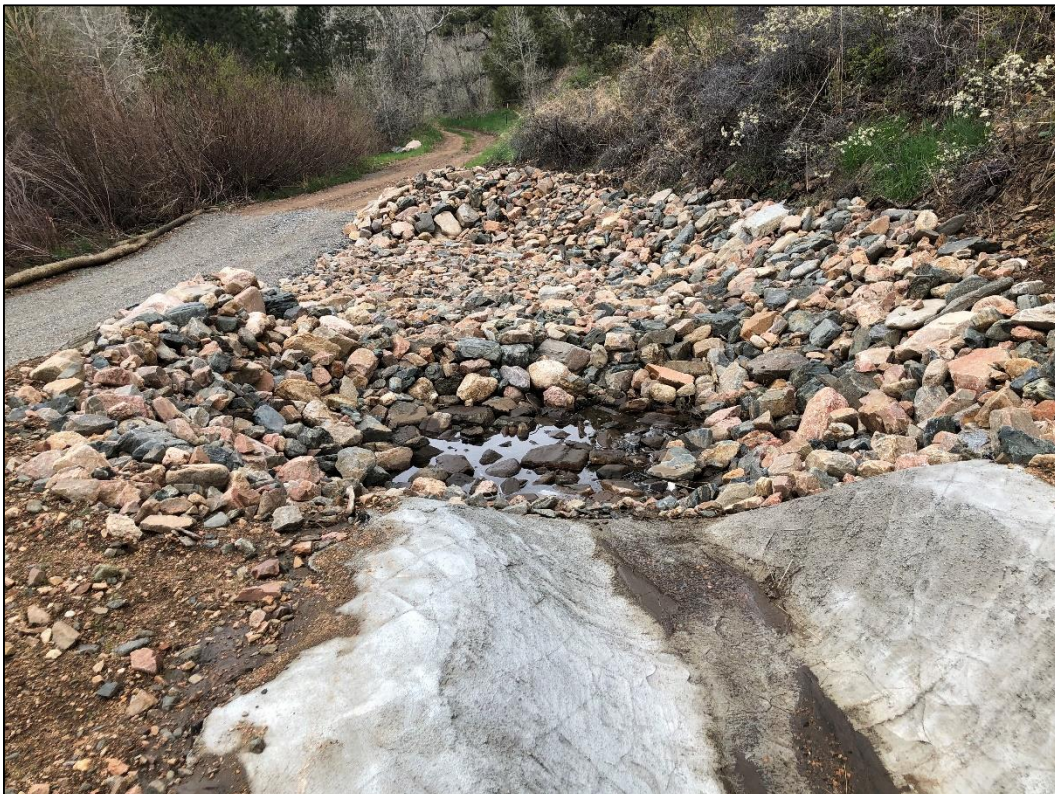
Photo 14. View looking west/northwest at riprap-lined energy dissipation basin constructed at downgradient end of NWRP diversion channel, showing some water ponded in basin during inspection.

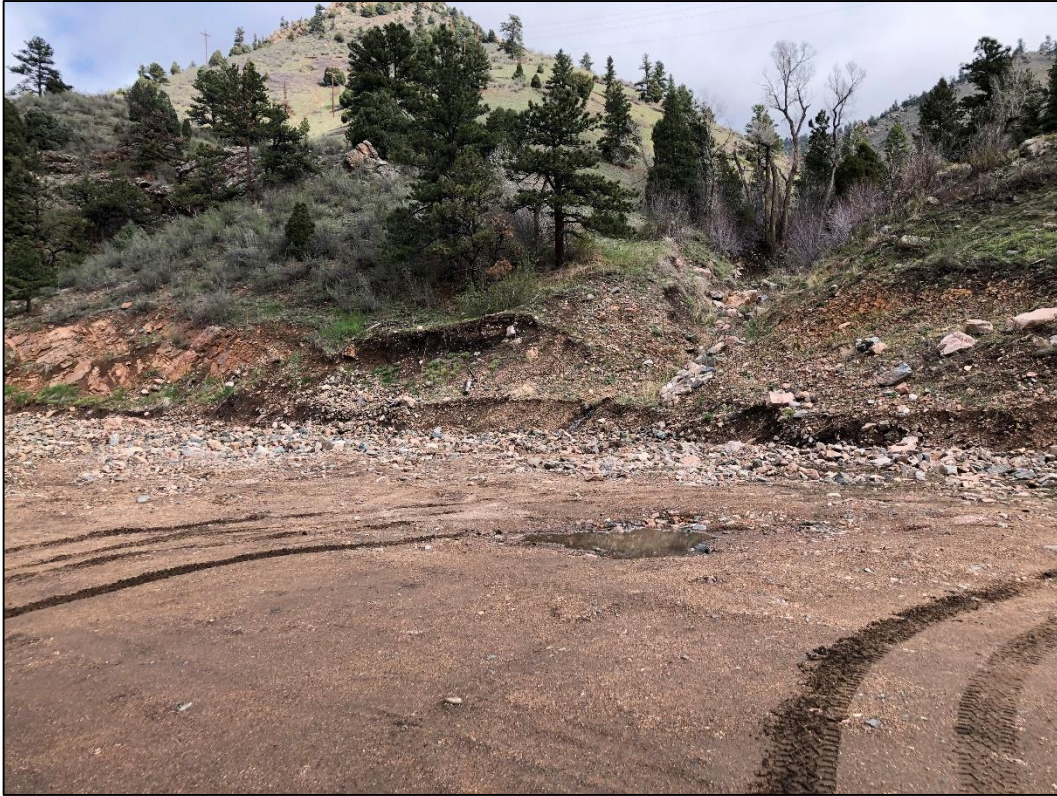
The Division observed the borrow area located up the valley from the NWRP, where rock and fill material was derived for the diversion channel project. The material excavated in this area was deposited at the base of an ephemeral drainage during the September 2013 flood events. While the borrow area is located outside of the approved mine permit area, the operator demonstrated that reclamation of this area is included in their 404 permit held with the U.S. Army Corps of Engineers. In its inspection report signed on December 10, 2020, the Division informed the operator that any additional activities in the borrow area besides reclamation (approved under the 404 permit) would require the area to also be permitted through our office. The operator has discontinued mining activities in this area as advised by the Division, and all equipment has been removed from this area. It did not appear that reclamation of this area has been initiated at this time.

Photo 15. View looking north across borrow area located up valley from NWRP where rock and fill material was excavated from flood deposit for diversion channel project. Mining activities have ceased in this area and reclamation will be completed under operator's USACE permit.

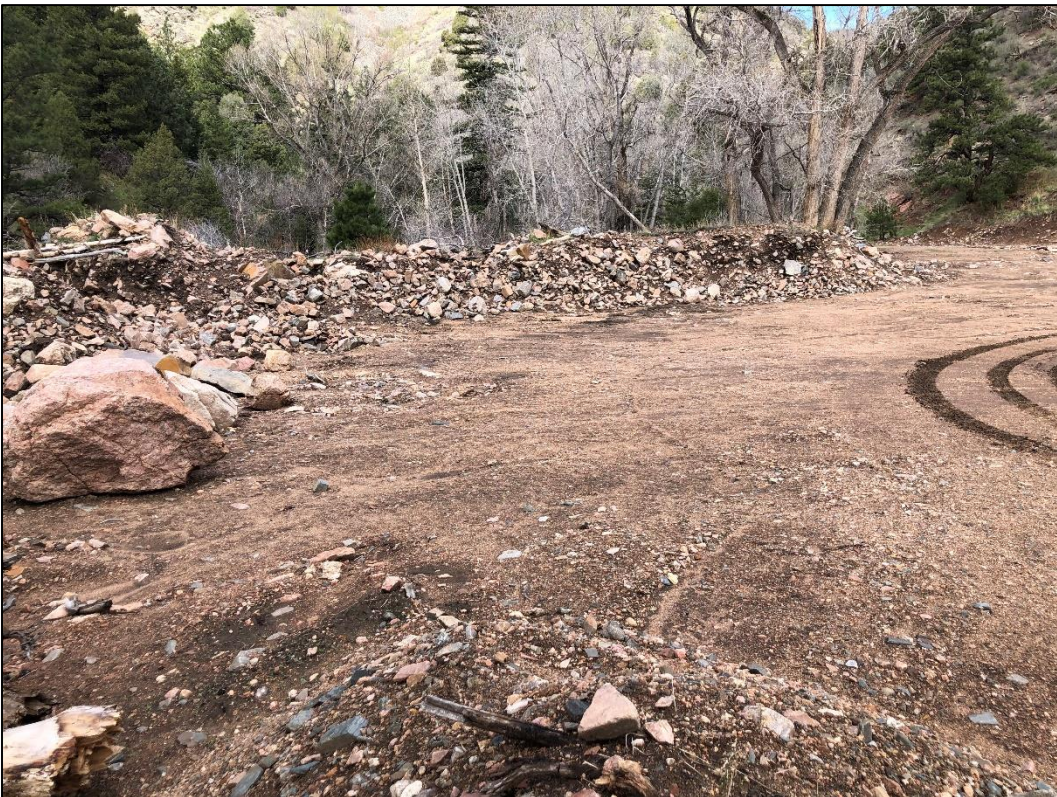
Photo 16. View looking south across borrow area located up valley from NWRP where rock and fill material was excavated from flood deposit for diversion channel project. Mining activities have ceased in this area and reclamation will be completed under operator's USACE permit.
