MINERALS PROGRAM INSPECTION REPORT
PHONE: (303) 866-3567

MINE NAME: Green/Croissant Property Sand and Gravel M	MINE/PROSPECTING ID#: M-2001-022	MINERAL: Sand and gravel	COUNTY: Weld
INSPECTION TYPE: Surety Release Inspection	INSPECTOR(S): Peter Hays	INSP. DATE: May 5, 2021	INSP. TIME: 10:00
OPERATOR: Loveland Ready-Mix Concrete, Inc.	OPERATOR REPRESENTATIVE: Stephanie Fancher-English	TYPE OF OPERATION: 112c - Construction Regular Operation	
REASON FOR INSPECTION: Surety Release Requested/Complaint	BOND CALCULATION TYPE: None	BOND AMOUNT: \$209,700.00	
DATE OF COMPLAINT: NA	POST INSP. CONTACTS: None	JOINT INSP. AGENCY: None	
WEATHER: Cloudy	INSPECTOR'S SIGNATURE:

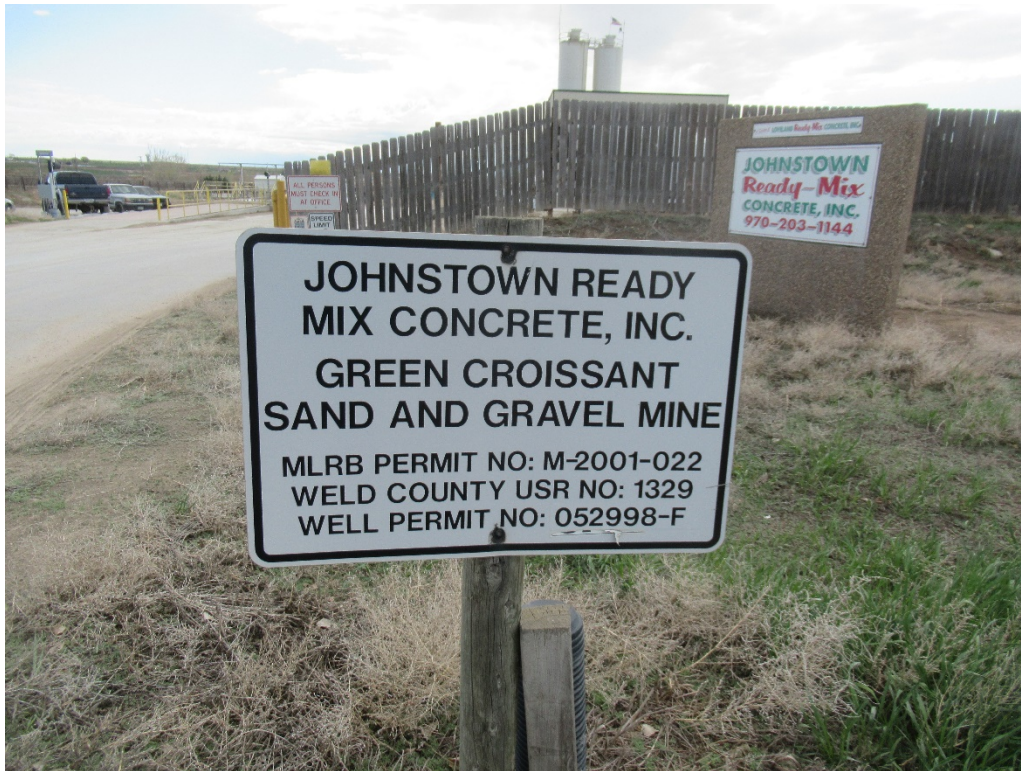
Green Croissant Mine Sign

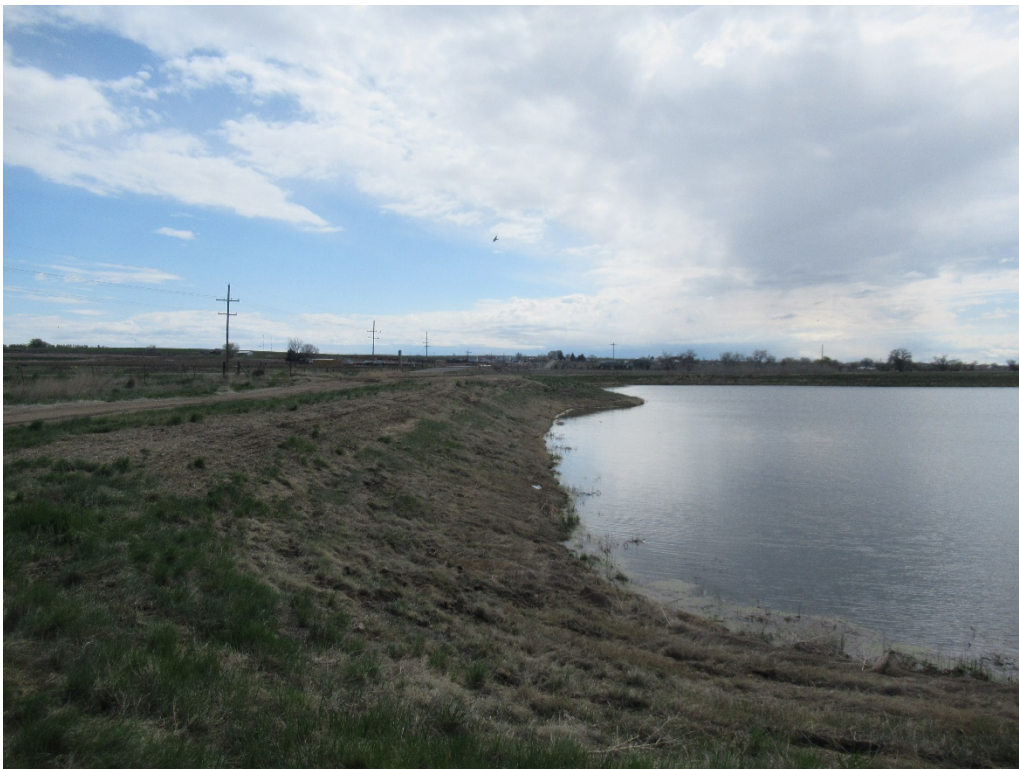
View of the north shoreline from the northwest corner looking east in Cell 4

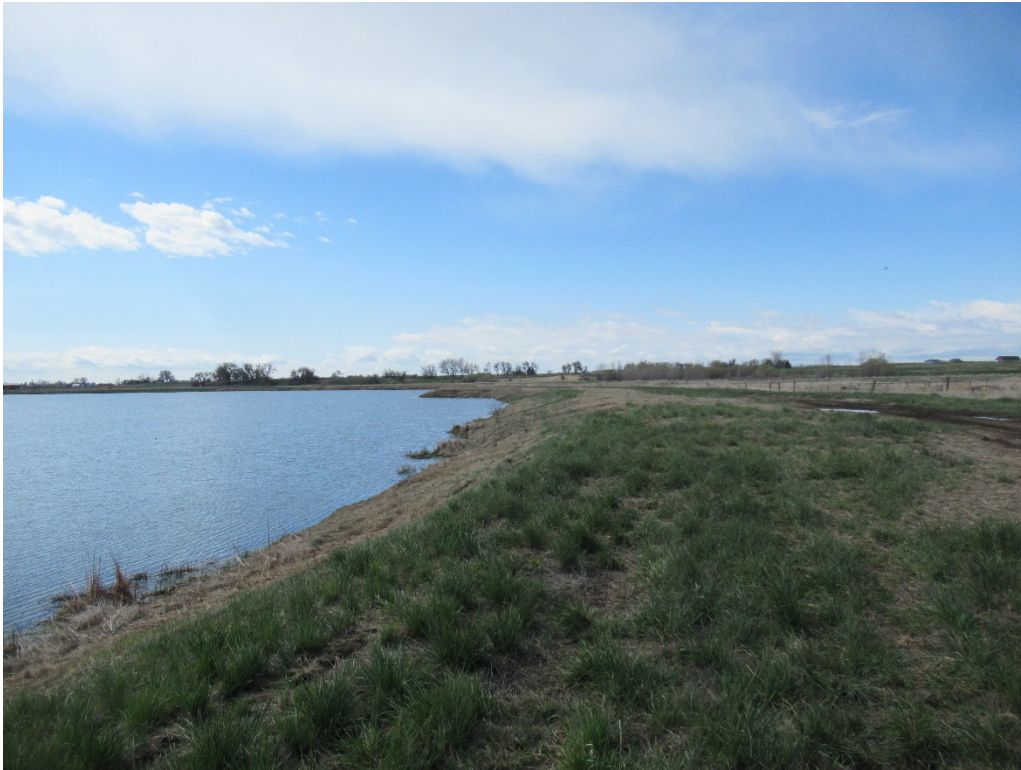
View of the west shoreline from the northwest corner looking south in Cell 4

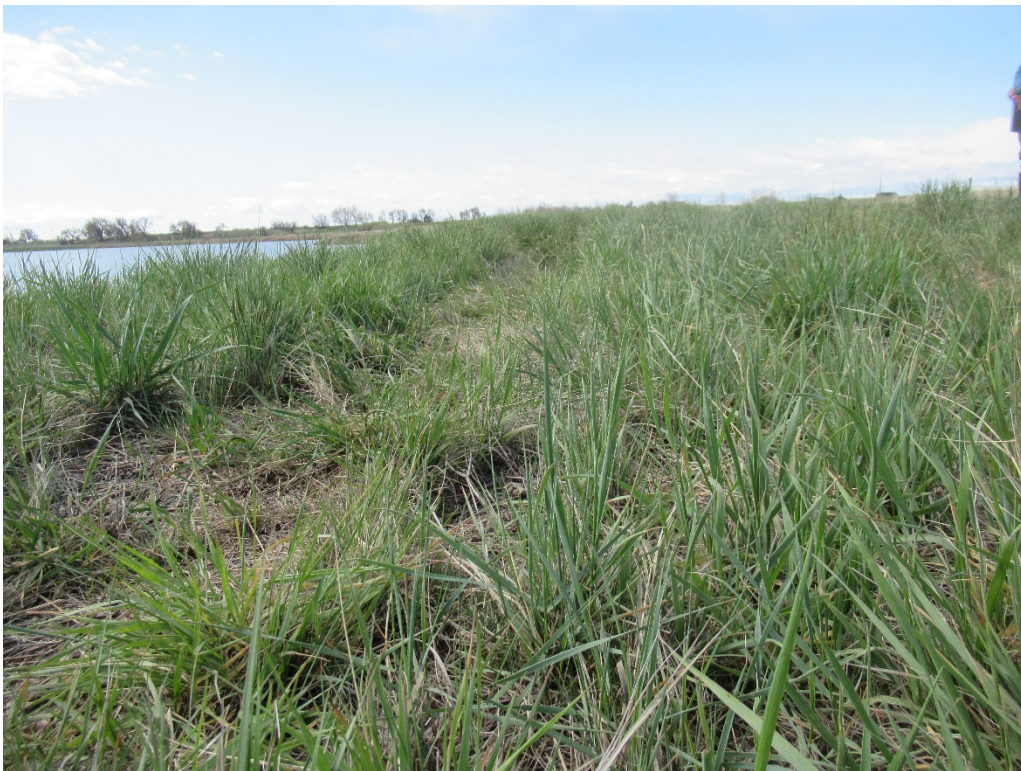
View of well-established vegetation in the northwest corner of Cell 4

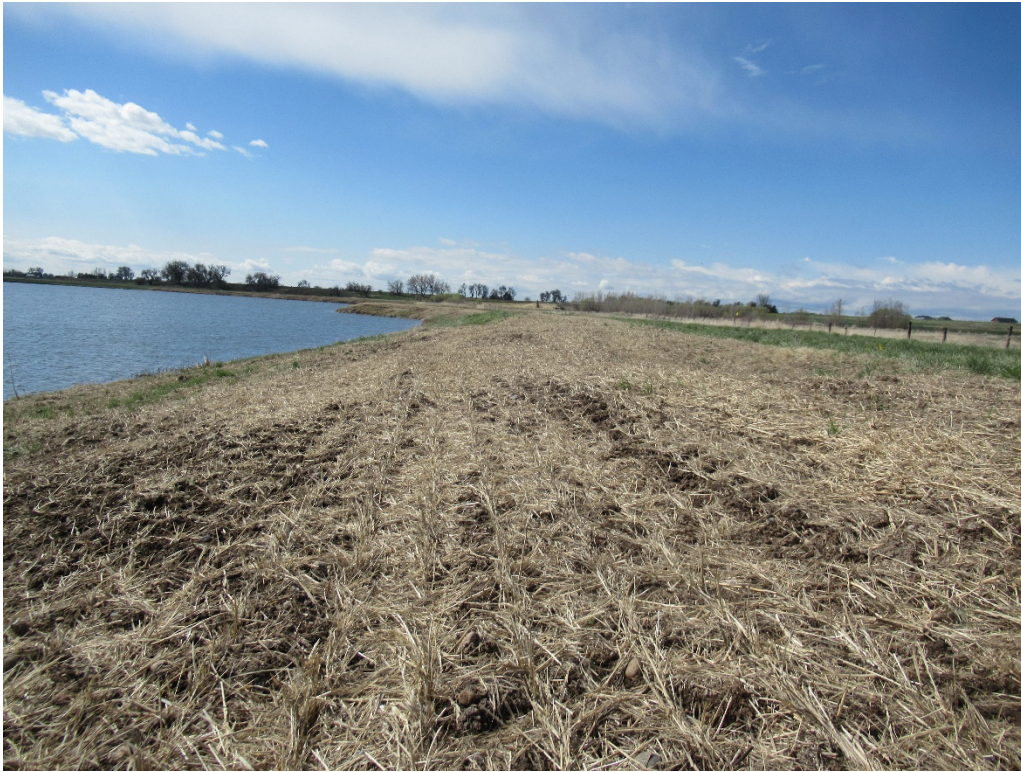
The mining activity in the cell is complete and the cell is in final reclamation. A significant portion of the upland area surrounding the lake was interseeded and mulched the week before this inspection. As stated above the Division will deny the final release request based on the lack of well-established vegetation in Cell 4.

View of recently interseeded shoreline in the northwest corner of Cell 4

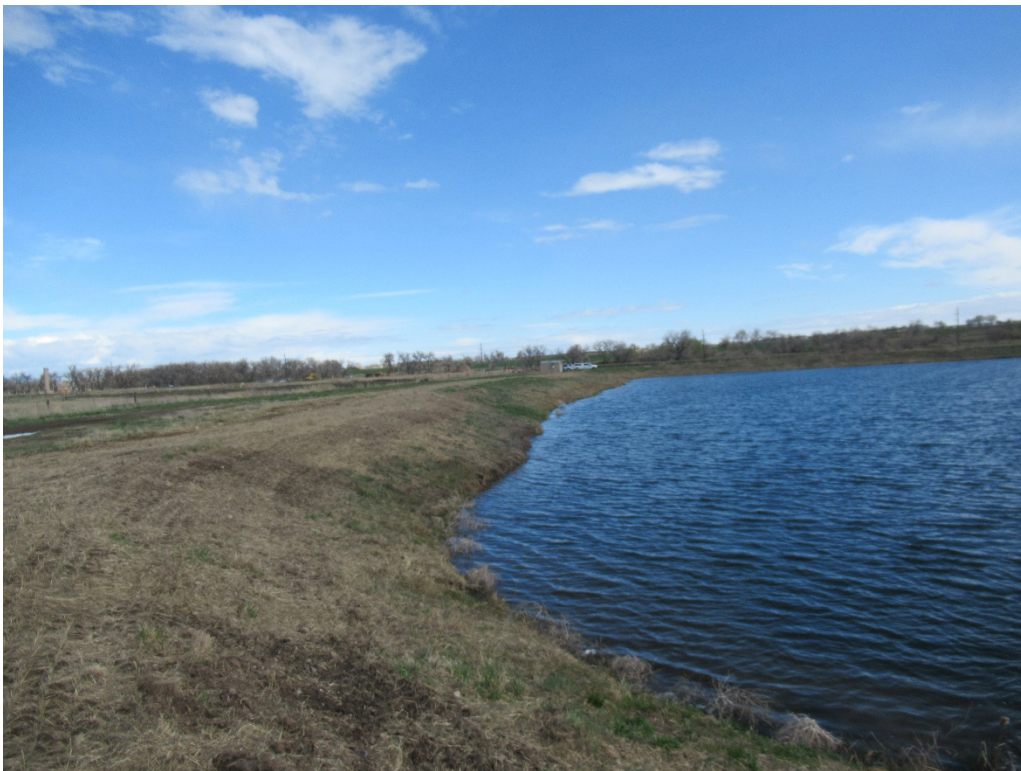
View of the west shoreline looking north in Cell 4

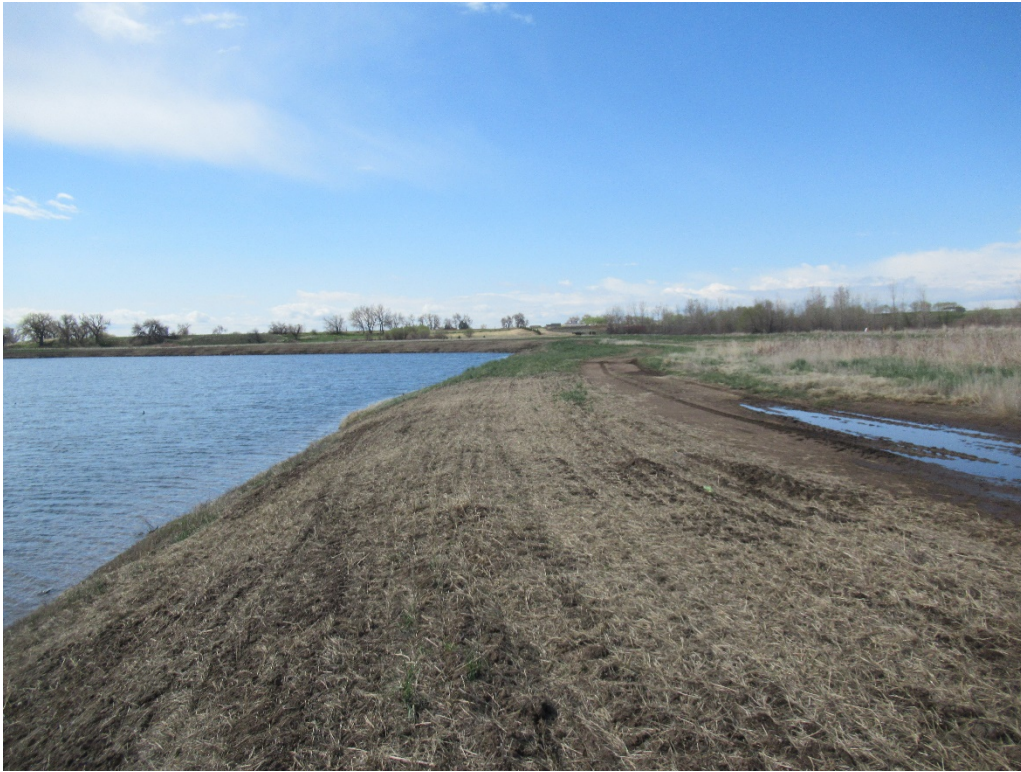
View of the west shoreline looking south in Cell 4

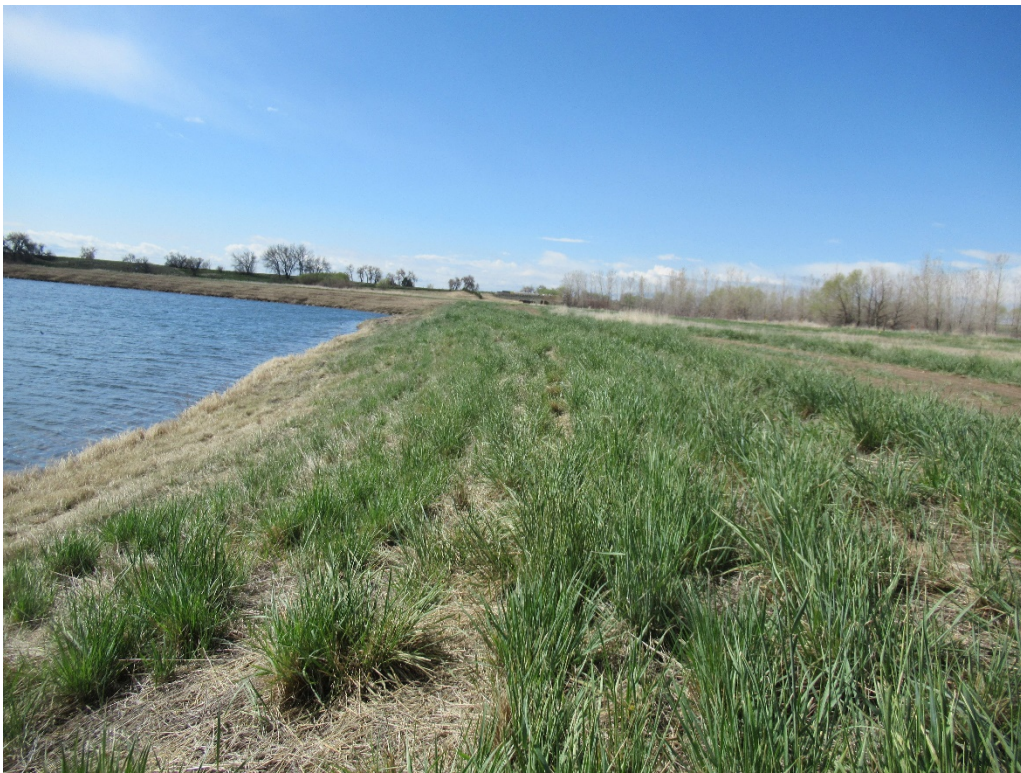
View of the vegetation in the southwest corner of Cell 4

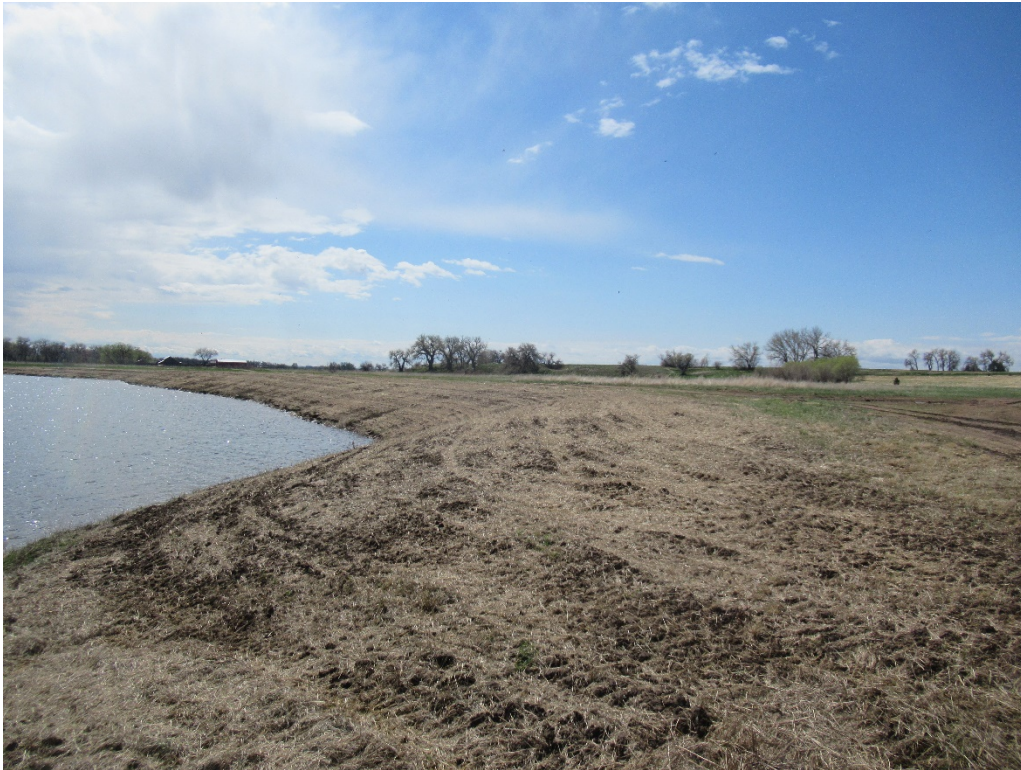
View of the recently interseeded south shoreline looking southeast in Cell 4

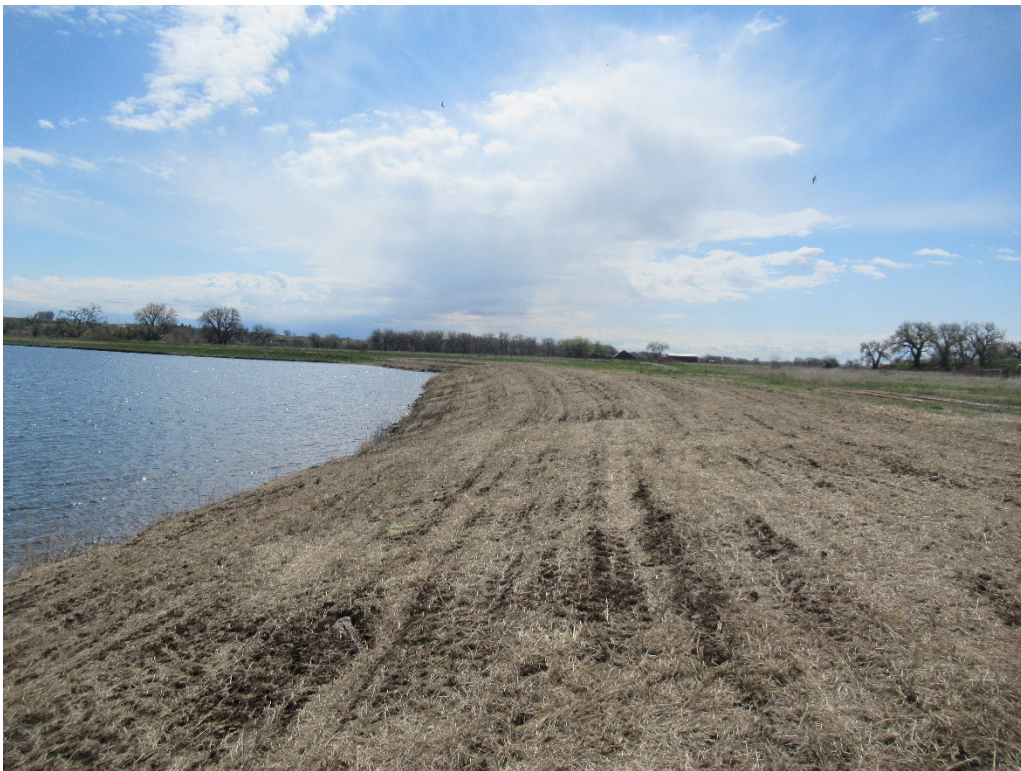
View of the recently interseeded south shoreline looking east in Cell 4

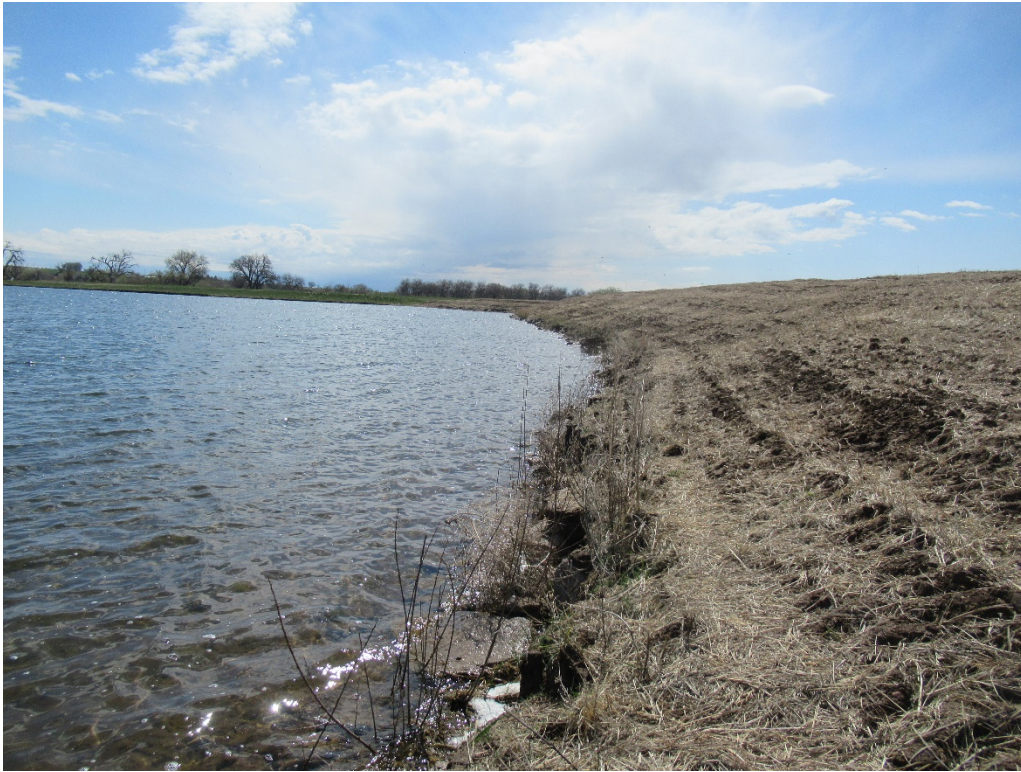
Shoreline cutting typical of wave action erosion, approximately six (6) to twelve (12) inches in height was observed along the shorelines of the lake. These areas were not saturated and the slopes were stable. The Operator will not be required to repair these features, since they appear to be resulting from typical wave action.

View of the shoreline erosion along the south shoreline in Cell 4

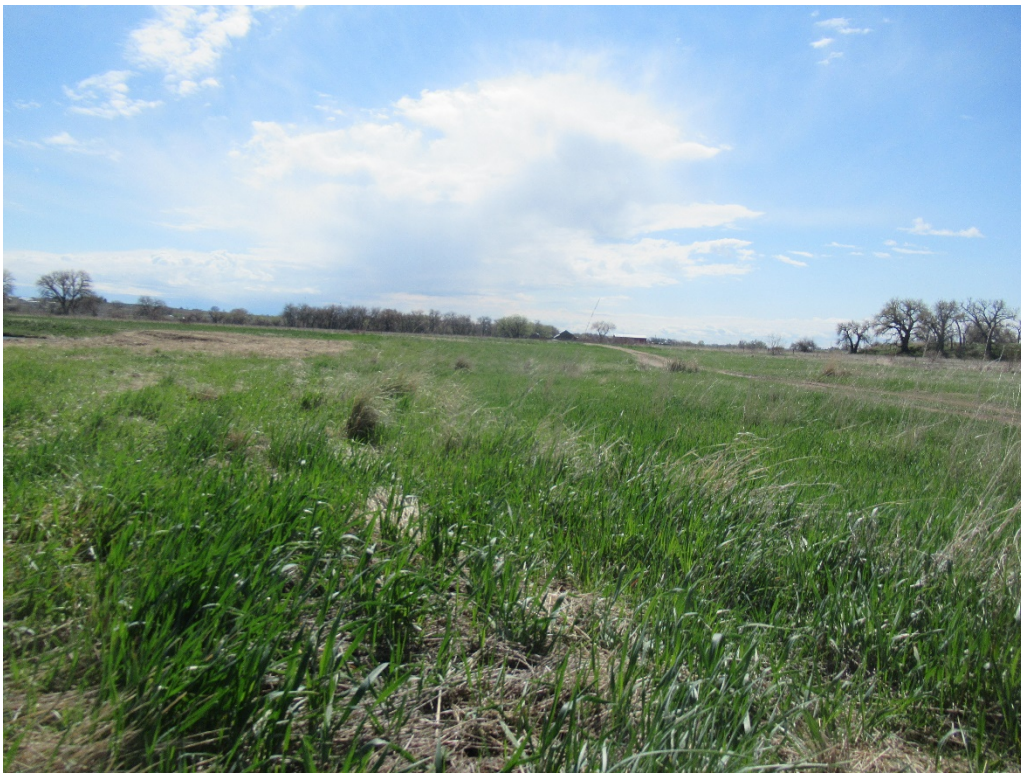
View of the upland area in the southeast corner of the cell looking east in Cell 4

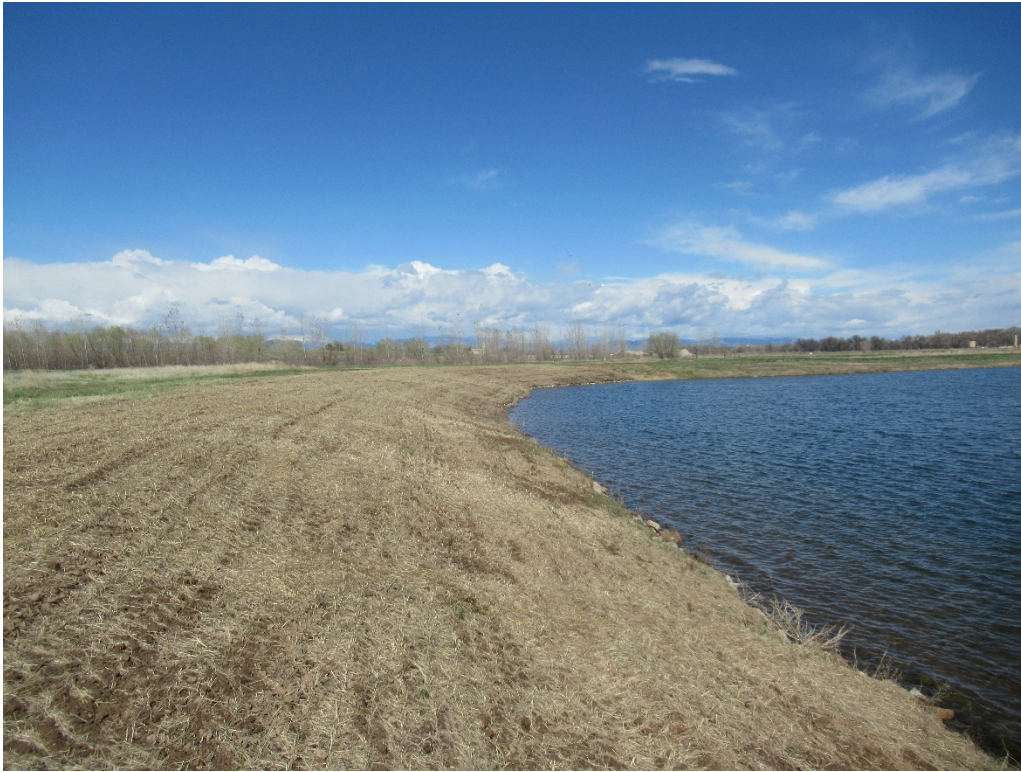
View of the recently interseeded south shoreline looking west in Cell 4

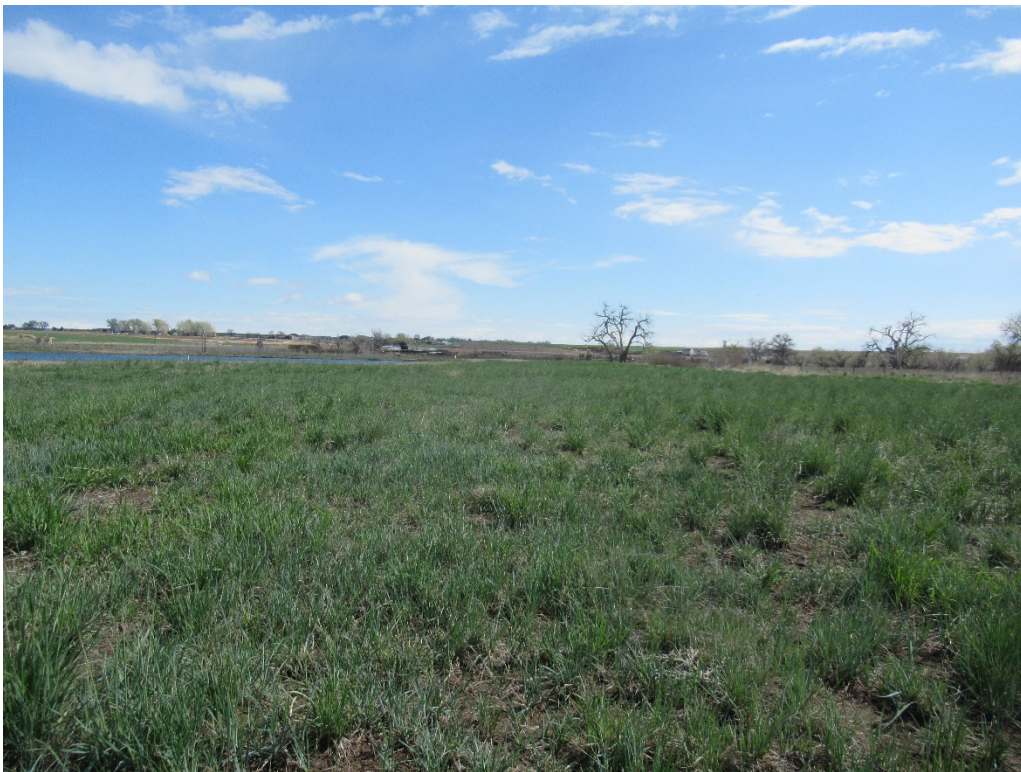
View of the vegetation in the southeast corner of Cell 4

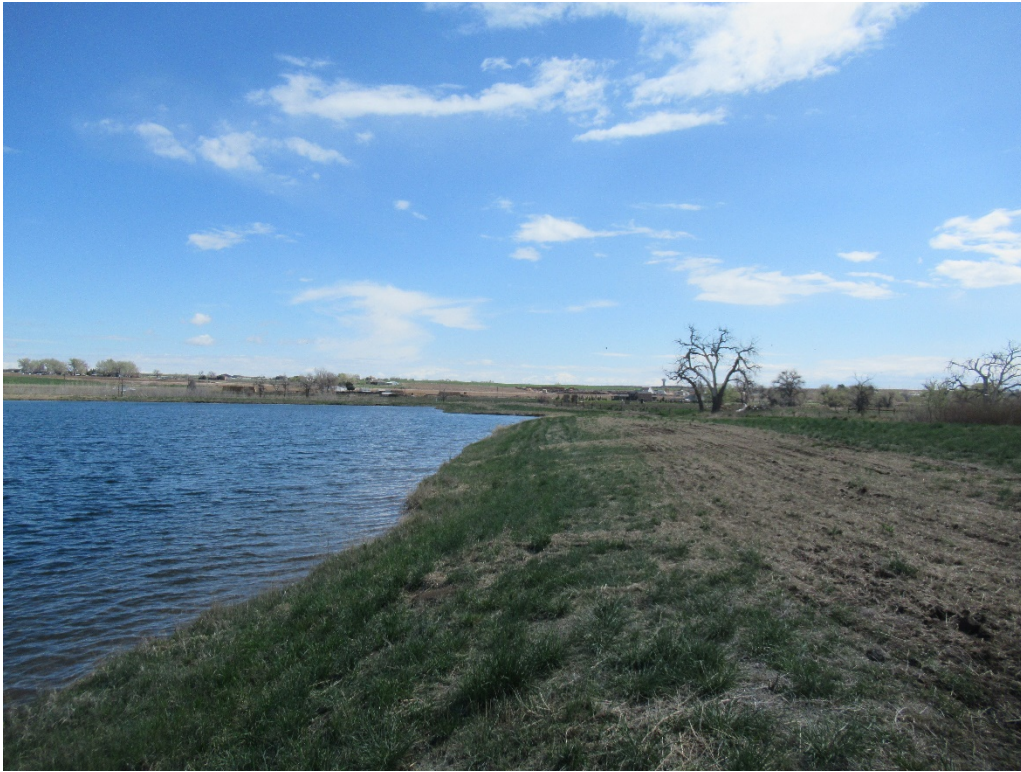
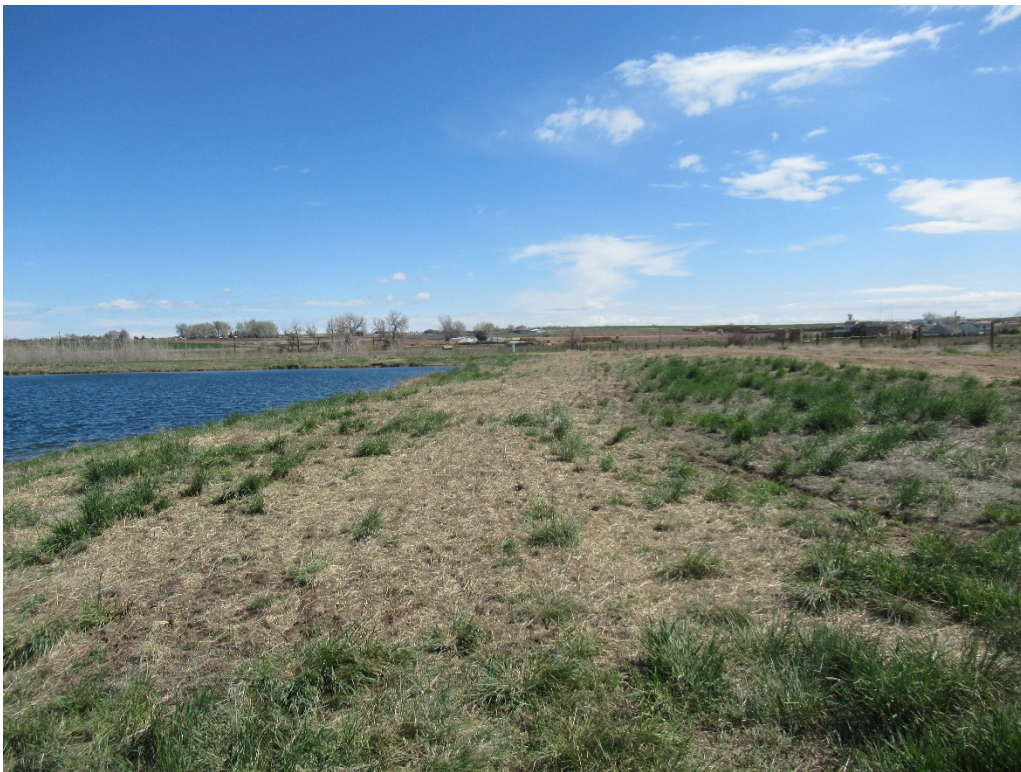
View of the recently interseeded east shoreline looking north in Cell 4

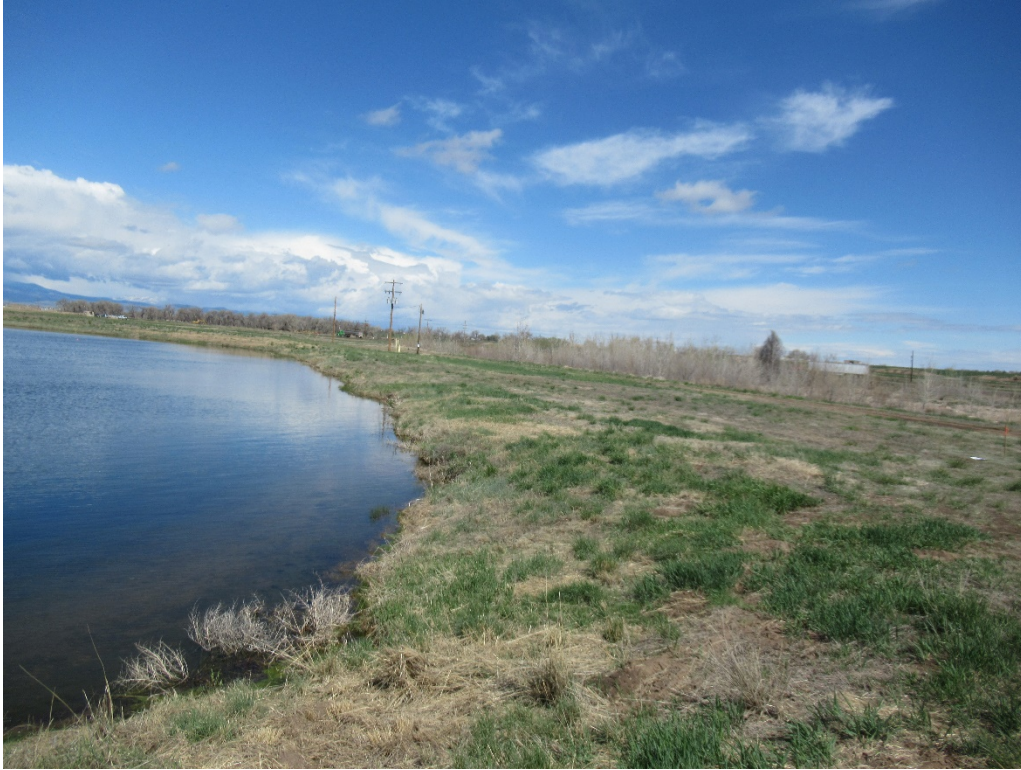
View of the north shoreline from the northeast corner of the cell looking west in Cell 4

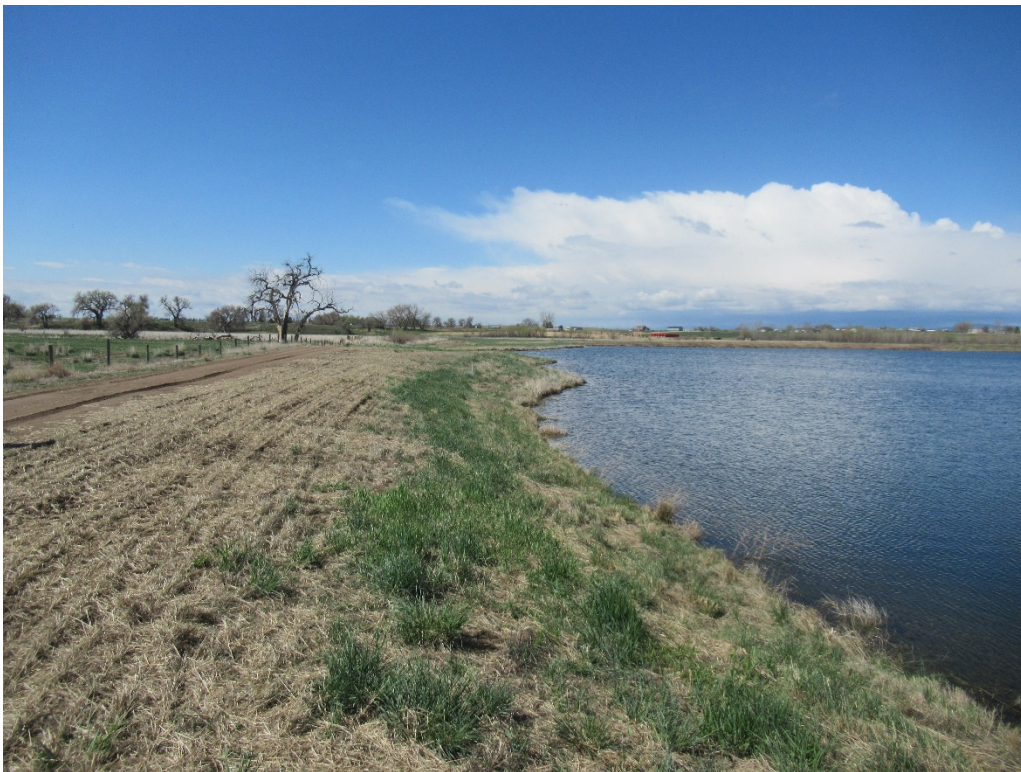
View of the east shoreline from the northeast corner of the cell looking south in Cell 4

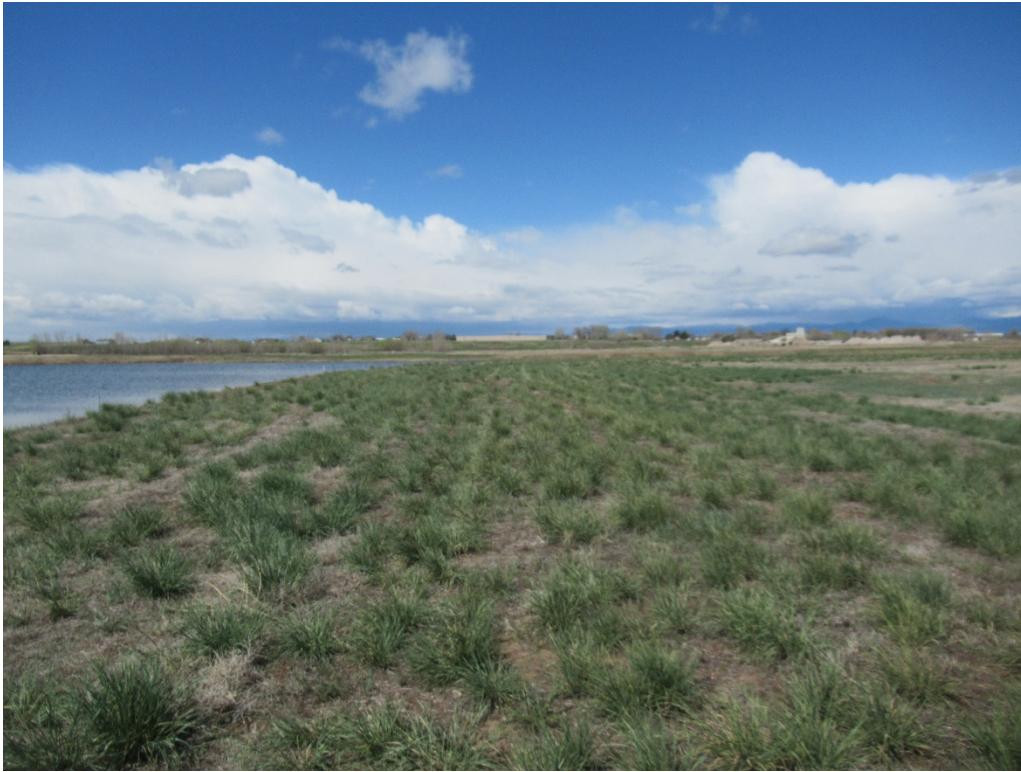
View of the north shoreline looking west in Cell 4

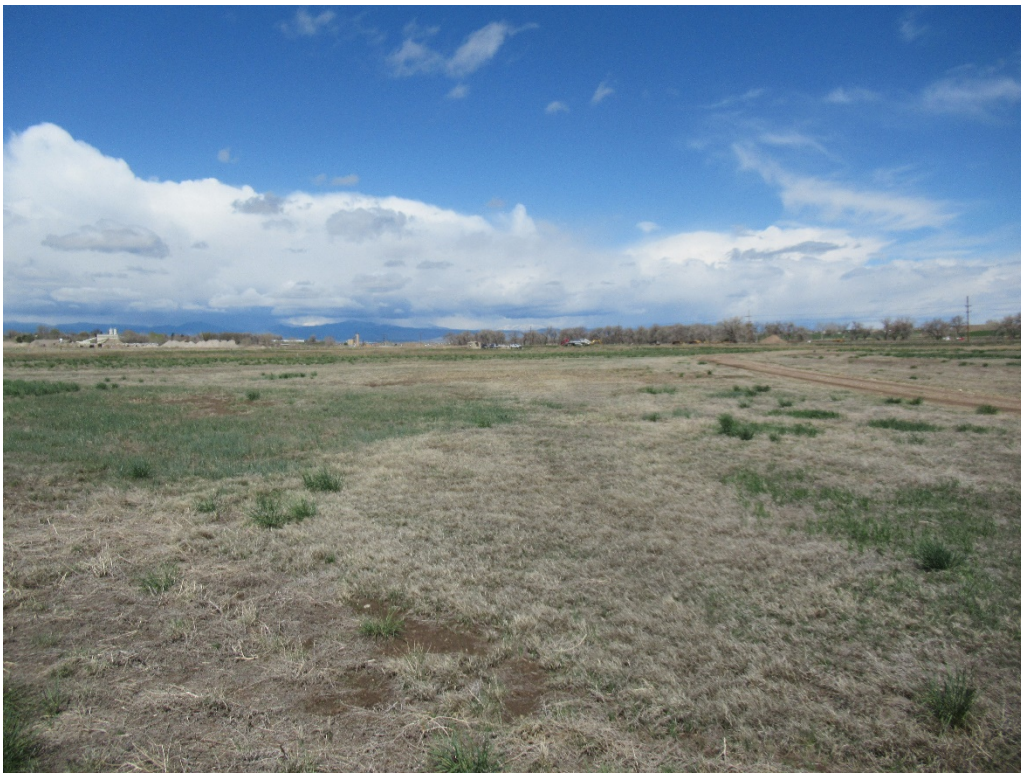
As stated in the previous inspection report, the vegetation in the northeast portion of the Cell near the oil and gas well is poorly established with areas of bare ground. The Division recommends the Operator conduct soil samples to determine if soil amendments are needed to establish vegetation in the area.

View of the area of bare ground around the former oil and gas facility in Cell 4

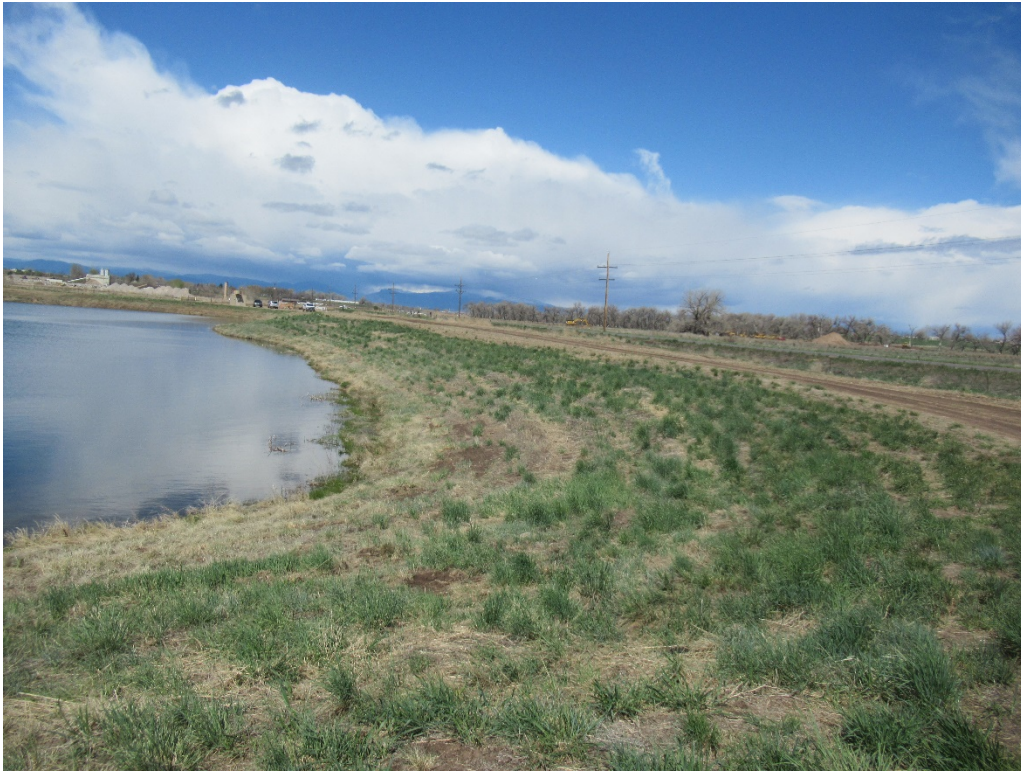
View of the north shoreline looking west of Cell 4

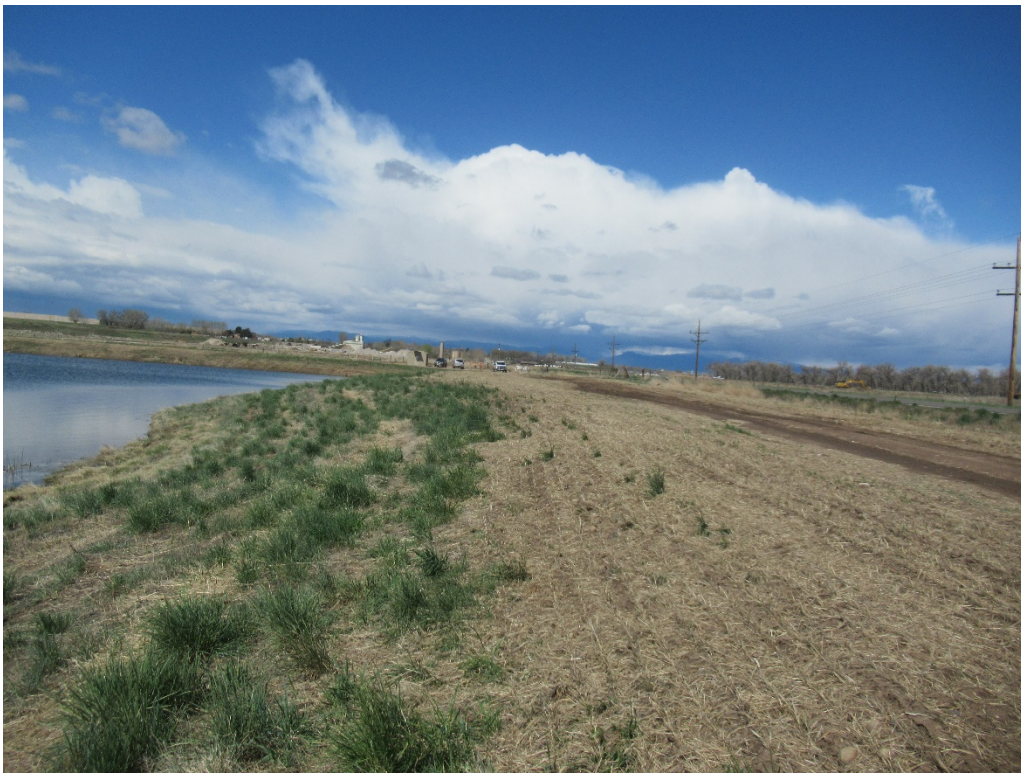
View of the recently interseeded north shoreline in the northwest corner of Cell 4

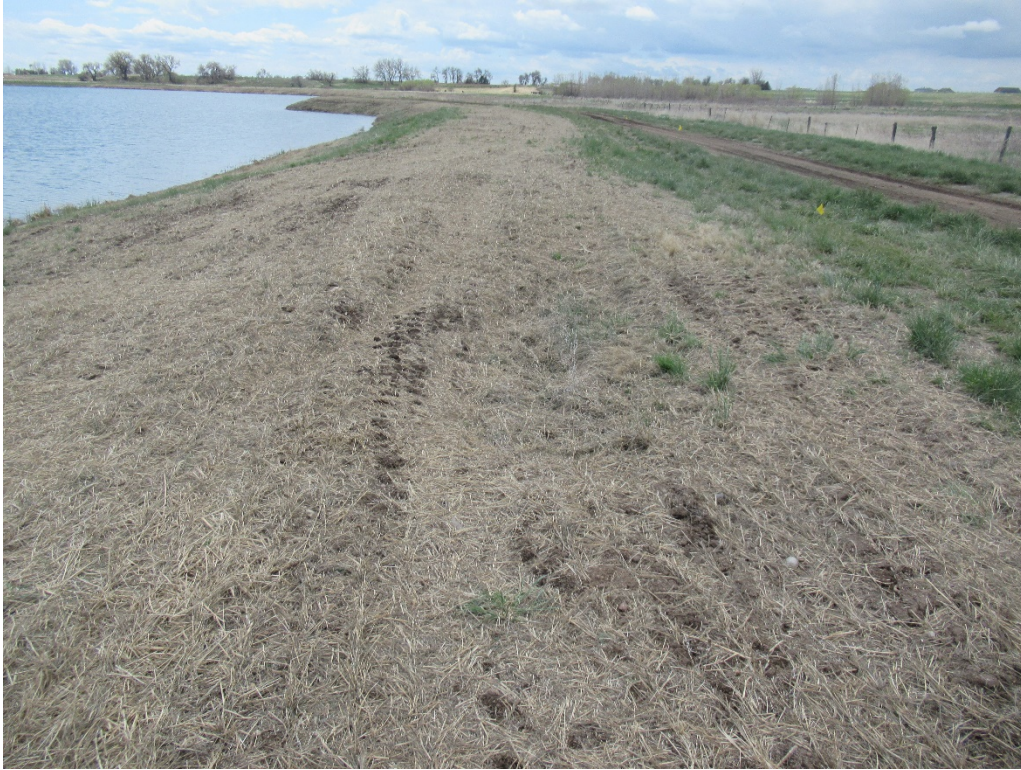
View of the “sink hole” identified by the landowners in the northwest corner of Cell 4

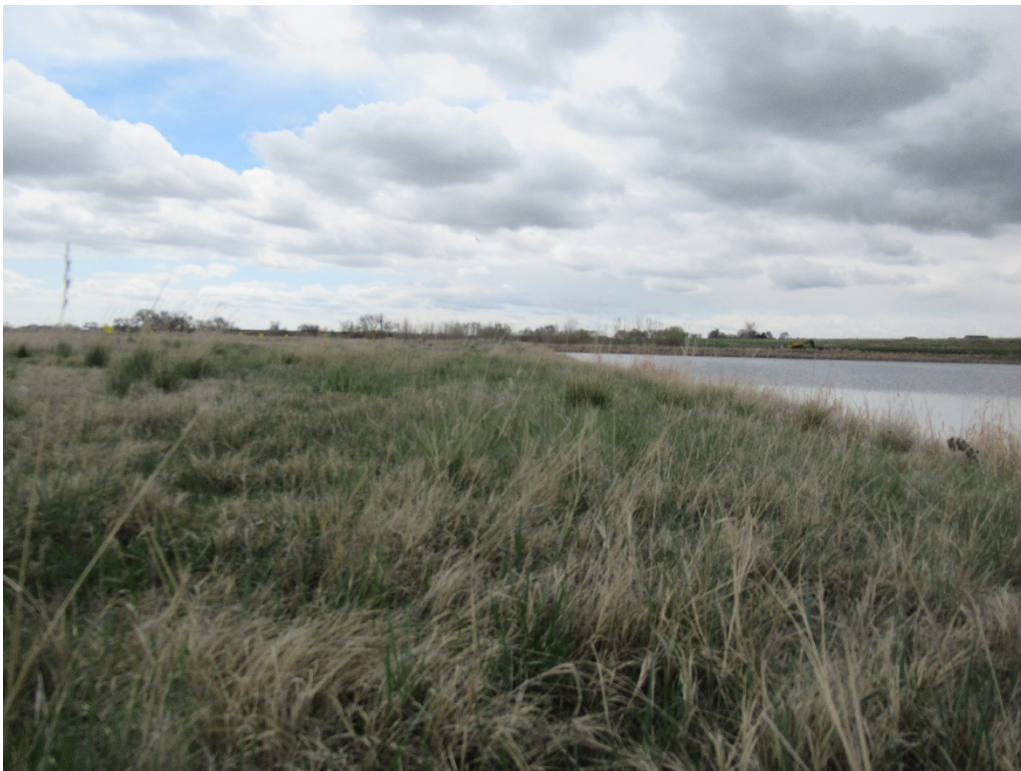
The vegetation along the upland area and shorelines of Cells 1, 2 and 3 not being utilized for the concrete batch plant operation are well-established and consisted of the approved Reclamation Plan seed mixture and volunteered wetland species along the shoreline. The reclaimed slopes were estimated at a 3H:1V slope. The slopes were stable with no erosion features observed during the inspection.

View of the vegetation along the east shoreline of Cell 3

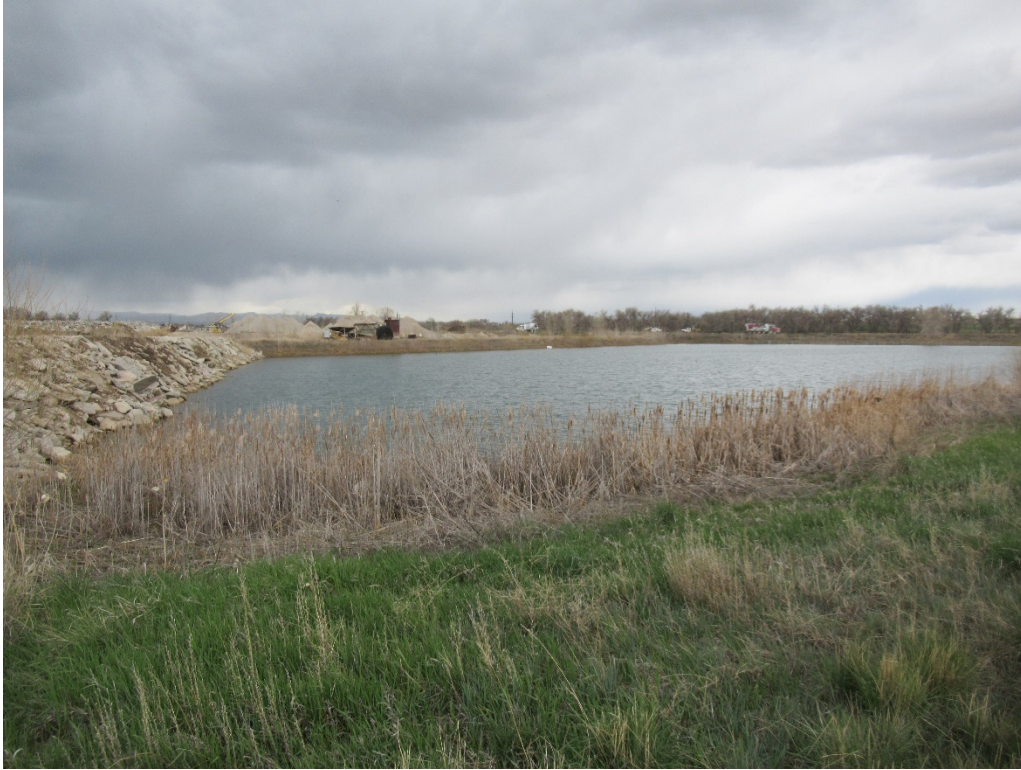
View of the eastern cell of Cell 2 from the northeast corner looking west

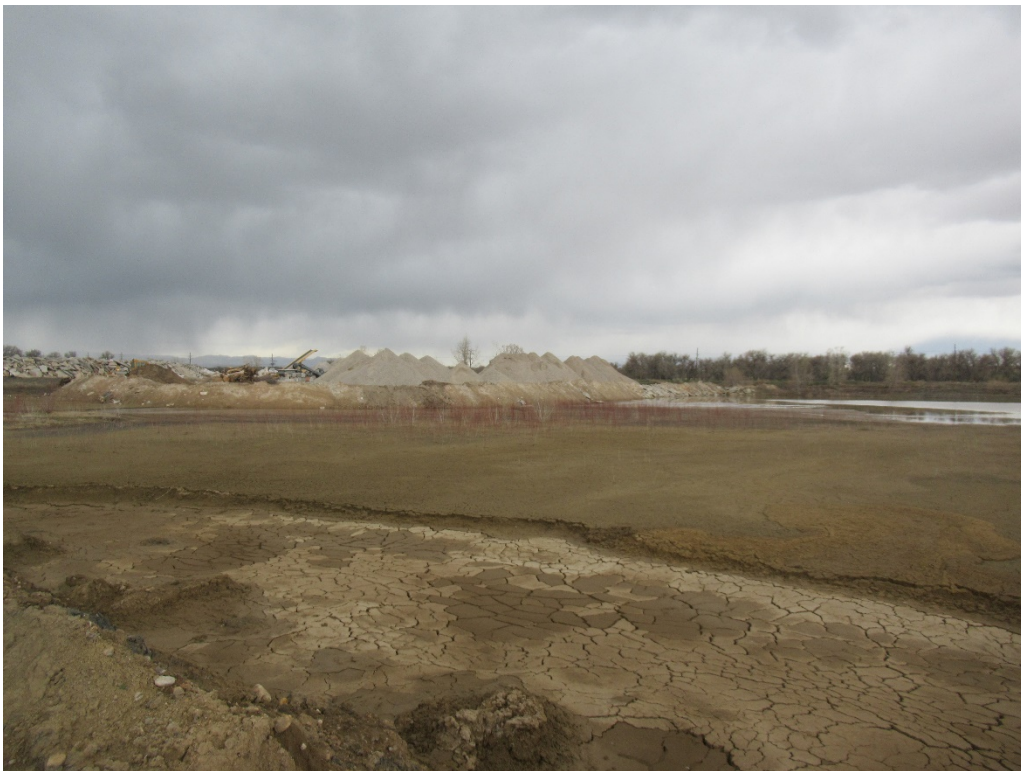
View of the middle cell of Cell 2 being backfill with fines

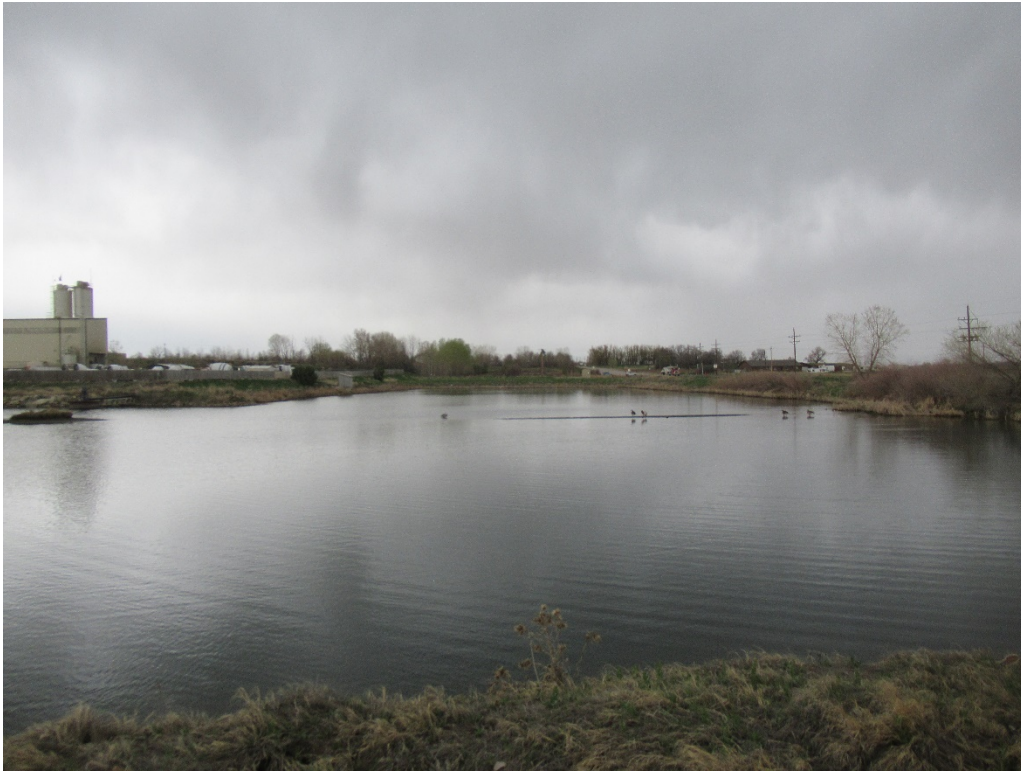
View of Cell 1 from the eastern shoreline looking west
