**MINERALS PROGRAM INSPECTION REPORT**  
**PHONE: (303) 866-3567**

<b>MINE NAME:</b> SPN Pit	<b>MINE/PROSPECTING ID#:</b> M-2020-006	<b>MINERAL:</b> Gravel	<b>COUNTY:</b> Huerfano
<b>INSPECTION TYPE:</b> Monitoring	<b>INSPECTOR(S):</b> Patrick Lennberg	<b>INSP. DATE:</b> May 26, 2021	<b>INSP. TIME:</b> 12:00
<b>OPERATOR:</b> Fremont Paving & Redi-Mix, Inc.	<b>OPERATOR REPRESENTATIVE:</b> None	<b>TYPE OF OPERATION:</b> 112c - Construction Regular Operation

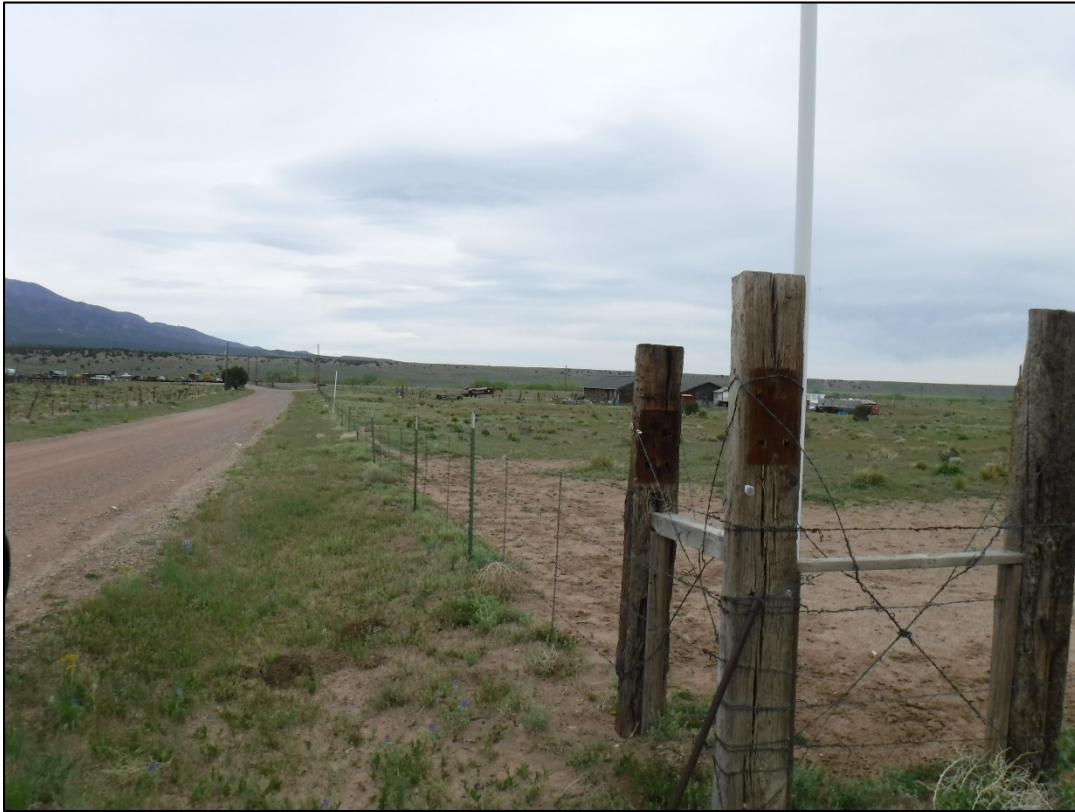
The entrance to the 112c 36.8 acre mine is 1.6 miles north on County Road 614 from the junction of 614 and CO-69. The SPN Pit is approximately 11.3 miles northwest of Walsenburg, CO and 4 miles east of Badito, CO. A mine sign has not been posted at the mine entrance pursuant to Rule 3.1.12. The missing mine sign is being cited as a problem in this report.

**Photo 1:** Looking north across the approved mine entrance location

**CORRECTIVE ACTIONS:** The operator shall, at the entrance of the mine site, post a sign which shall be clearly visible from the access road. The operator shall submit photo documentation that a proper sign has been posted by the corrective action date.

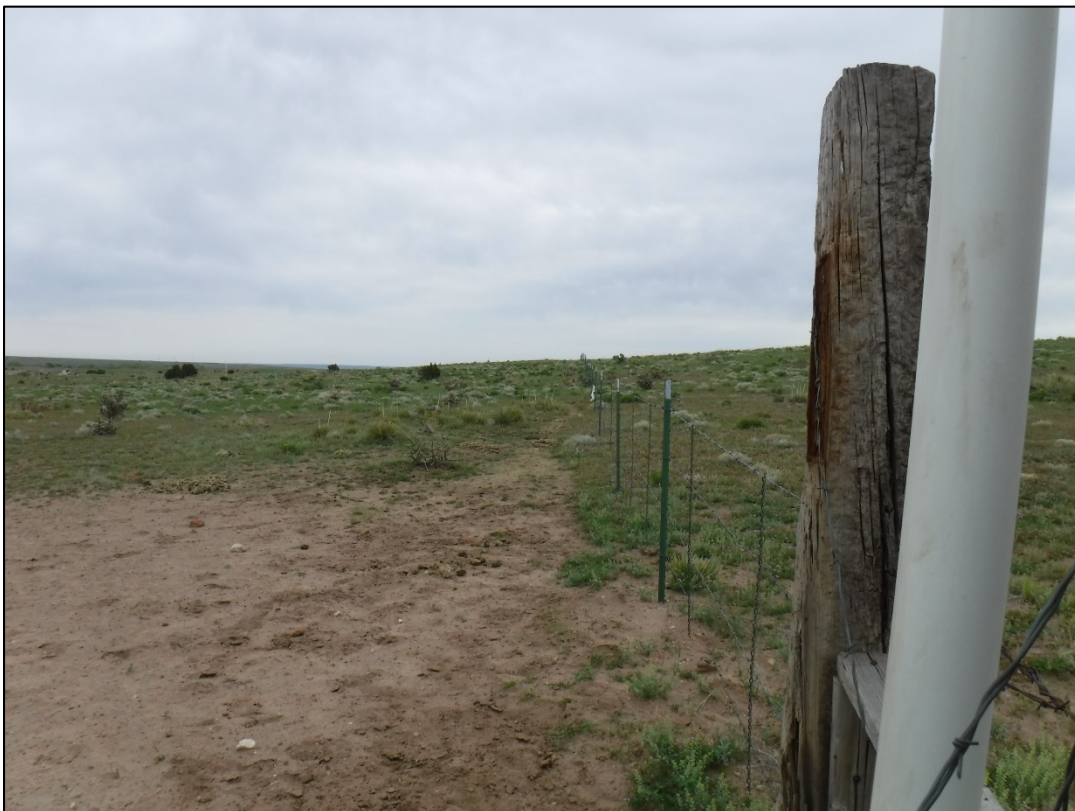
**Photo 2:** Looking east along the southern permit boundary

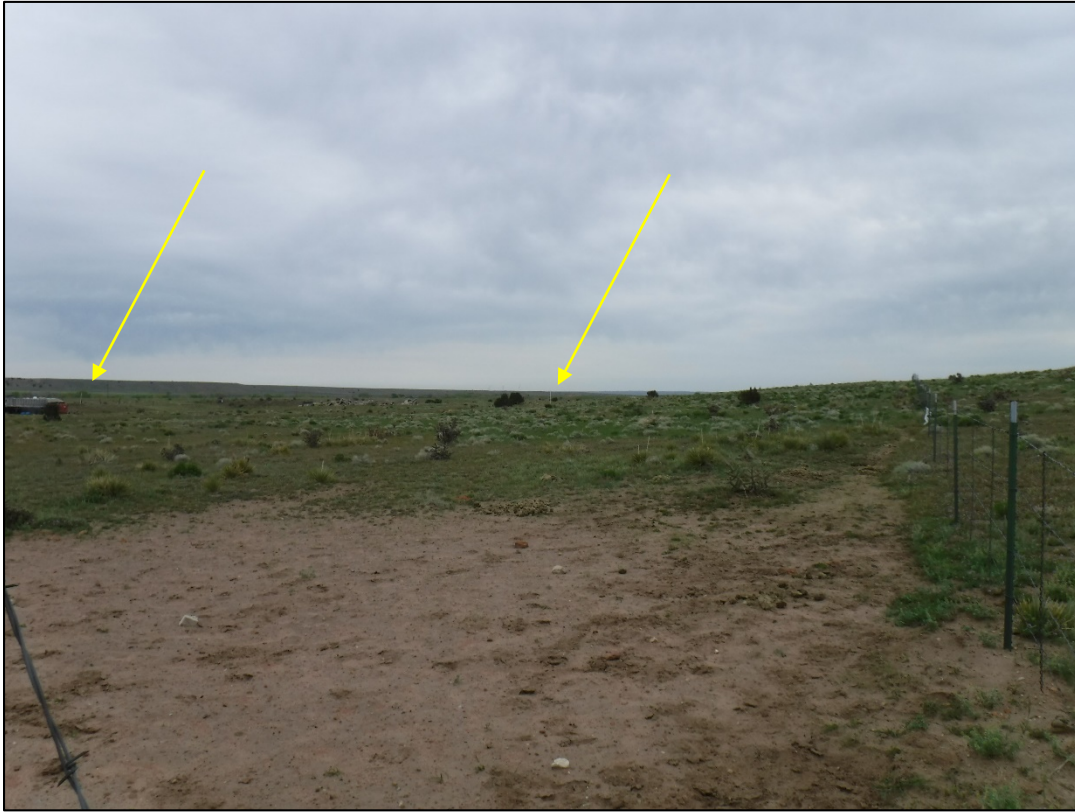
The mine has not begun operation yet. The permit boundary markers are visible from the road and are in the same locations they were in during the pre-operation inspection.

**Photo 3:** Looking northeast across the proposed mine area, permit boundary markers indicated by yellow arrows

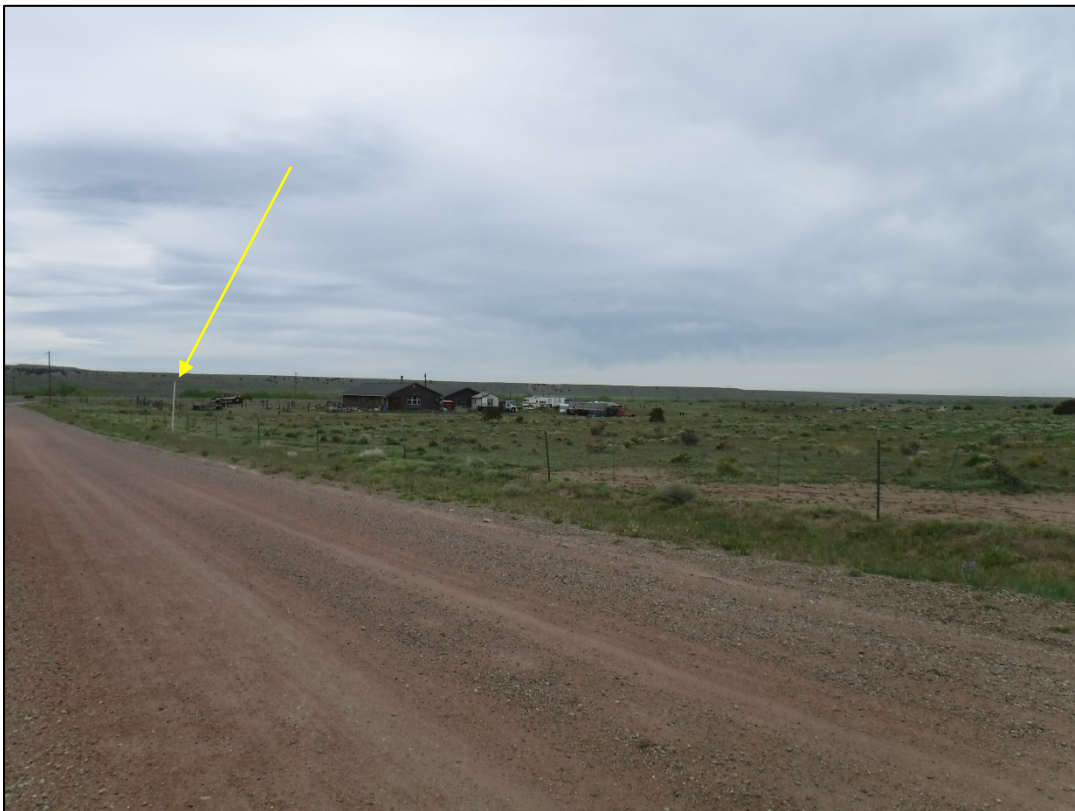
**Photo 4:** Private residence located north of permit boundary, boundary marker yellow arrow
