To: Jerald Schnabel
Continental Materials Corp.
File: April 2021 Monitoring Summary

From: Paul Kos
Denver, CO 80222
Date: May 31, 2021

Reference: April 2021 Geotechnical Monitoring Summary Pikeview Quarry

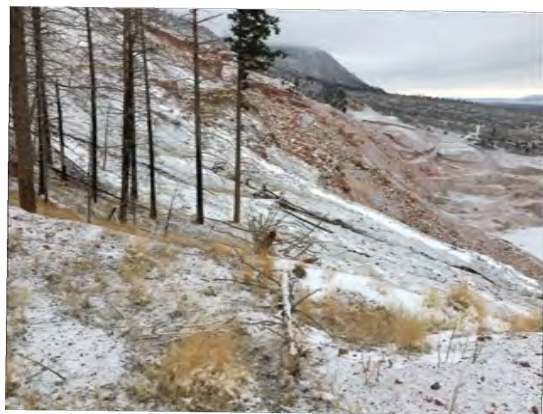
- Crack Free: No cracking was observed on the native granite slopes above the extents of the disturbed area. The hummocky field in the area immediately above the southern extent of the slide shows evidence of cracking but they are not fresh or active. No new or open cracks were found immediately inside or next to the slide area.

6. AREA ABOVE THE SLIDE

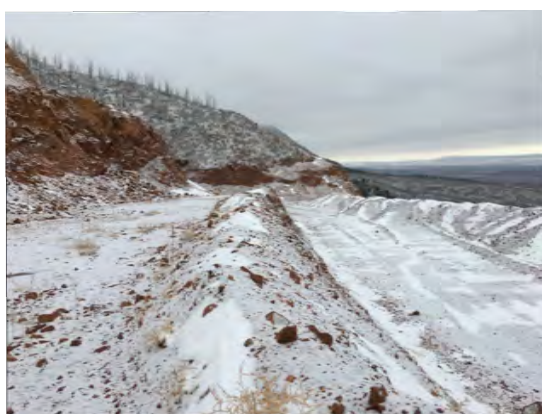
5. VIEW TO THE NORTH ALONG THE RIDGE

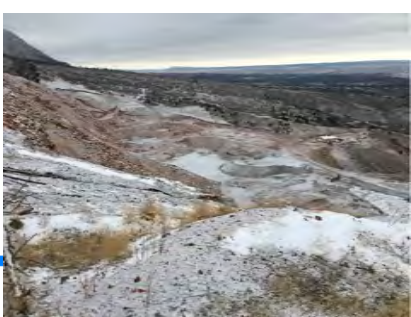
4. FILL DEPOSITED AT TOE OF SLIDE AREA

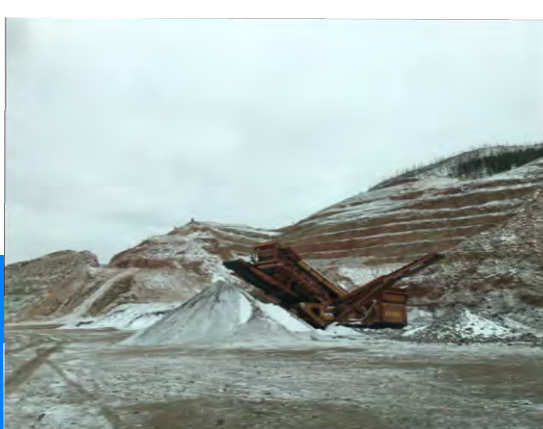
- Fill: Material is being imported and temporarily placed on the "production floor". During the visit, different types of material including mulch and general fill were being deposited here for future placement. (Note 4)

3. PRODUCTION FLOOR AND GRAVEL SCREENER

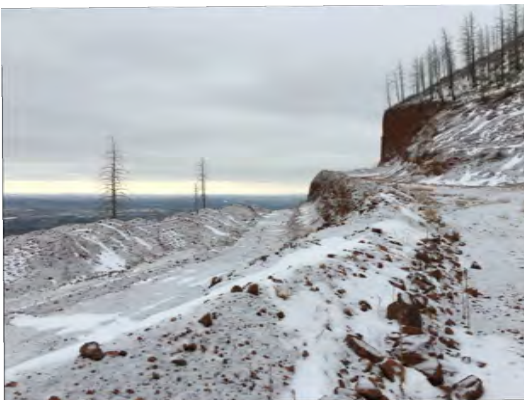
- Due to the presence of fresh snow and wind, certain areas of the site usually visited on a monthly basis were only inspected from a distance during this month's site visit. The areas inspected from a distance during this visit will be inspected in-person the following month. (Note 2)

2. VIEW TOWARD SOUTH PEAK

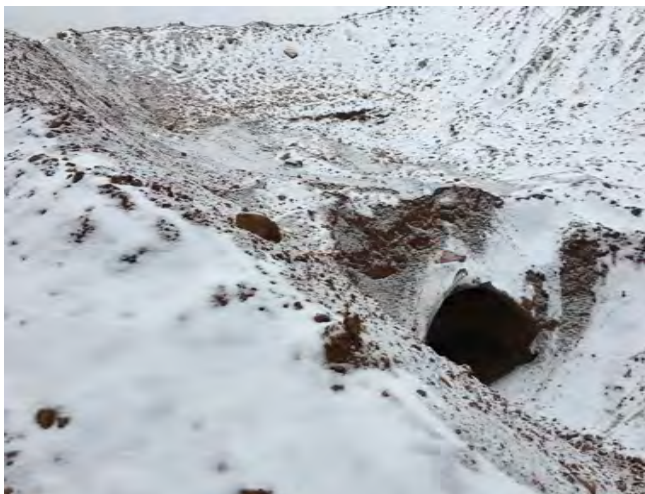
- The culvert remains cleared but partially blocked inside. Future storm events are expected to remove the remaining sediment, but CMC will use a water truck to clean out the inside of the culvert. (Note 1)

1. AREA UPSTREAM OF CULVERT GETTING CLEARED OF DEBRIS

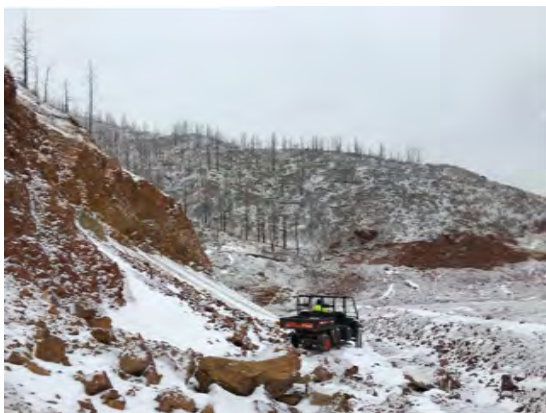
7. VIEW TOWARD NORTH PEAK

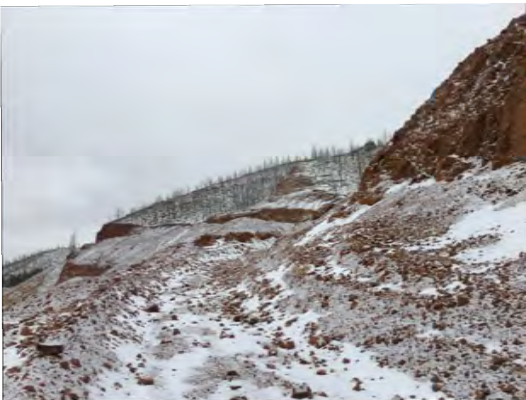
- Gullies and Rills: Gullies and rills have formed on the slopes above the slide area as well as in the burn areas above the quarry. (Note 8)
- Open Cracks: An open crack was observed during this visit. This feature is in an area where cracking is expected to occur as a result of ongoing slope settlement and relaxation. The edges of the crack have eroded suggesting it is not a new feature.

8. RILLS ON SLOPE UNDER PEAK

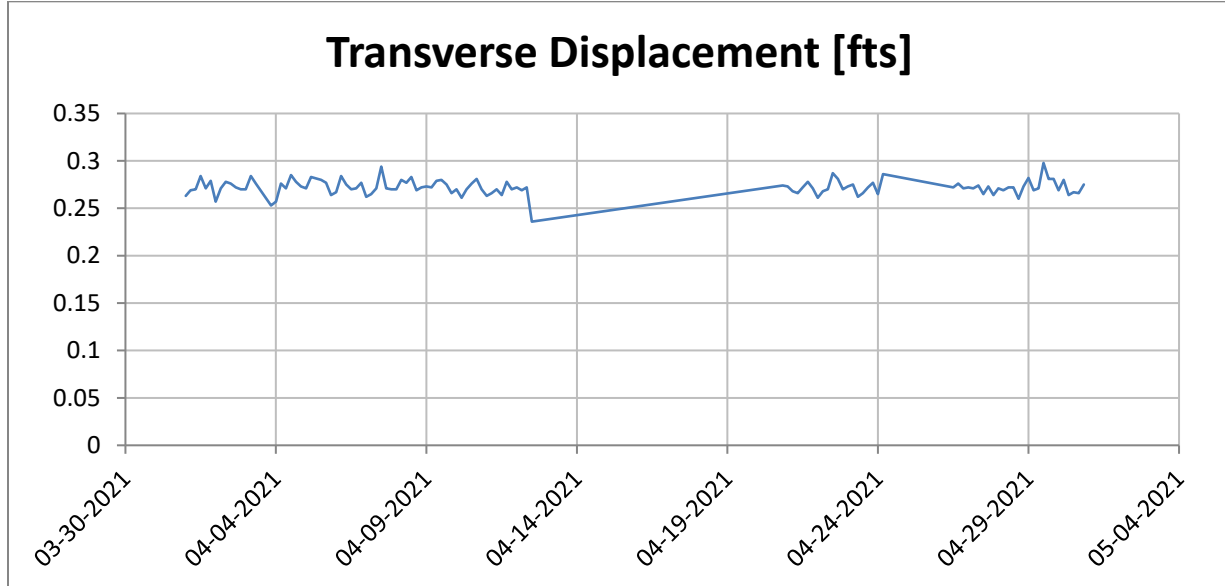
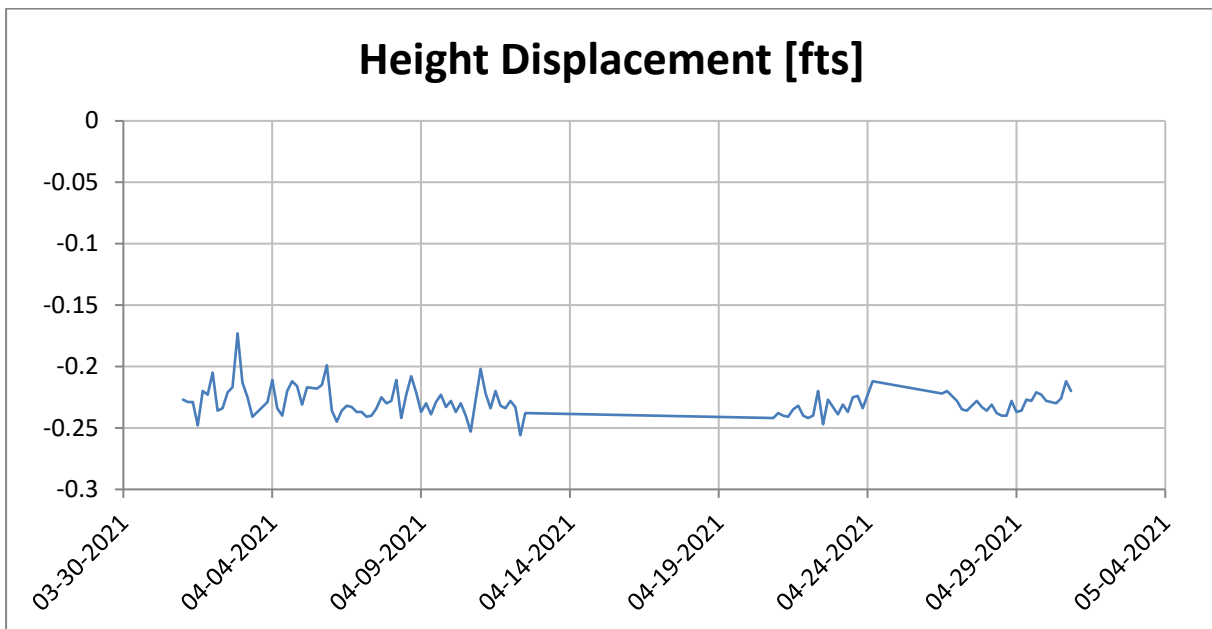
Date	Notes	Actions taken	Issue Resolved
03/29/2021 to 04/03/2021	Storm damaged and moved NP2 Prism	NP2 Prism repaired and back in position	04/03/2021
04/06/2021	Multiple prisms missing after multiple scans	Rain	04/06/2021
04/07/2021	Multiple prisms missing after multiple scans	Rain	04/07/2021
04/21/2021	Prism P69 and Prism P33 not found	Snow	04/21/2021
04/24/2021 to 04/26/2021	Prism CP3 not found	Prism Stolen	04/26/2021

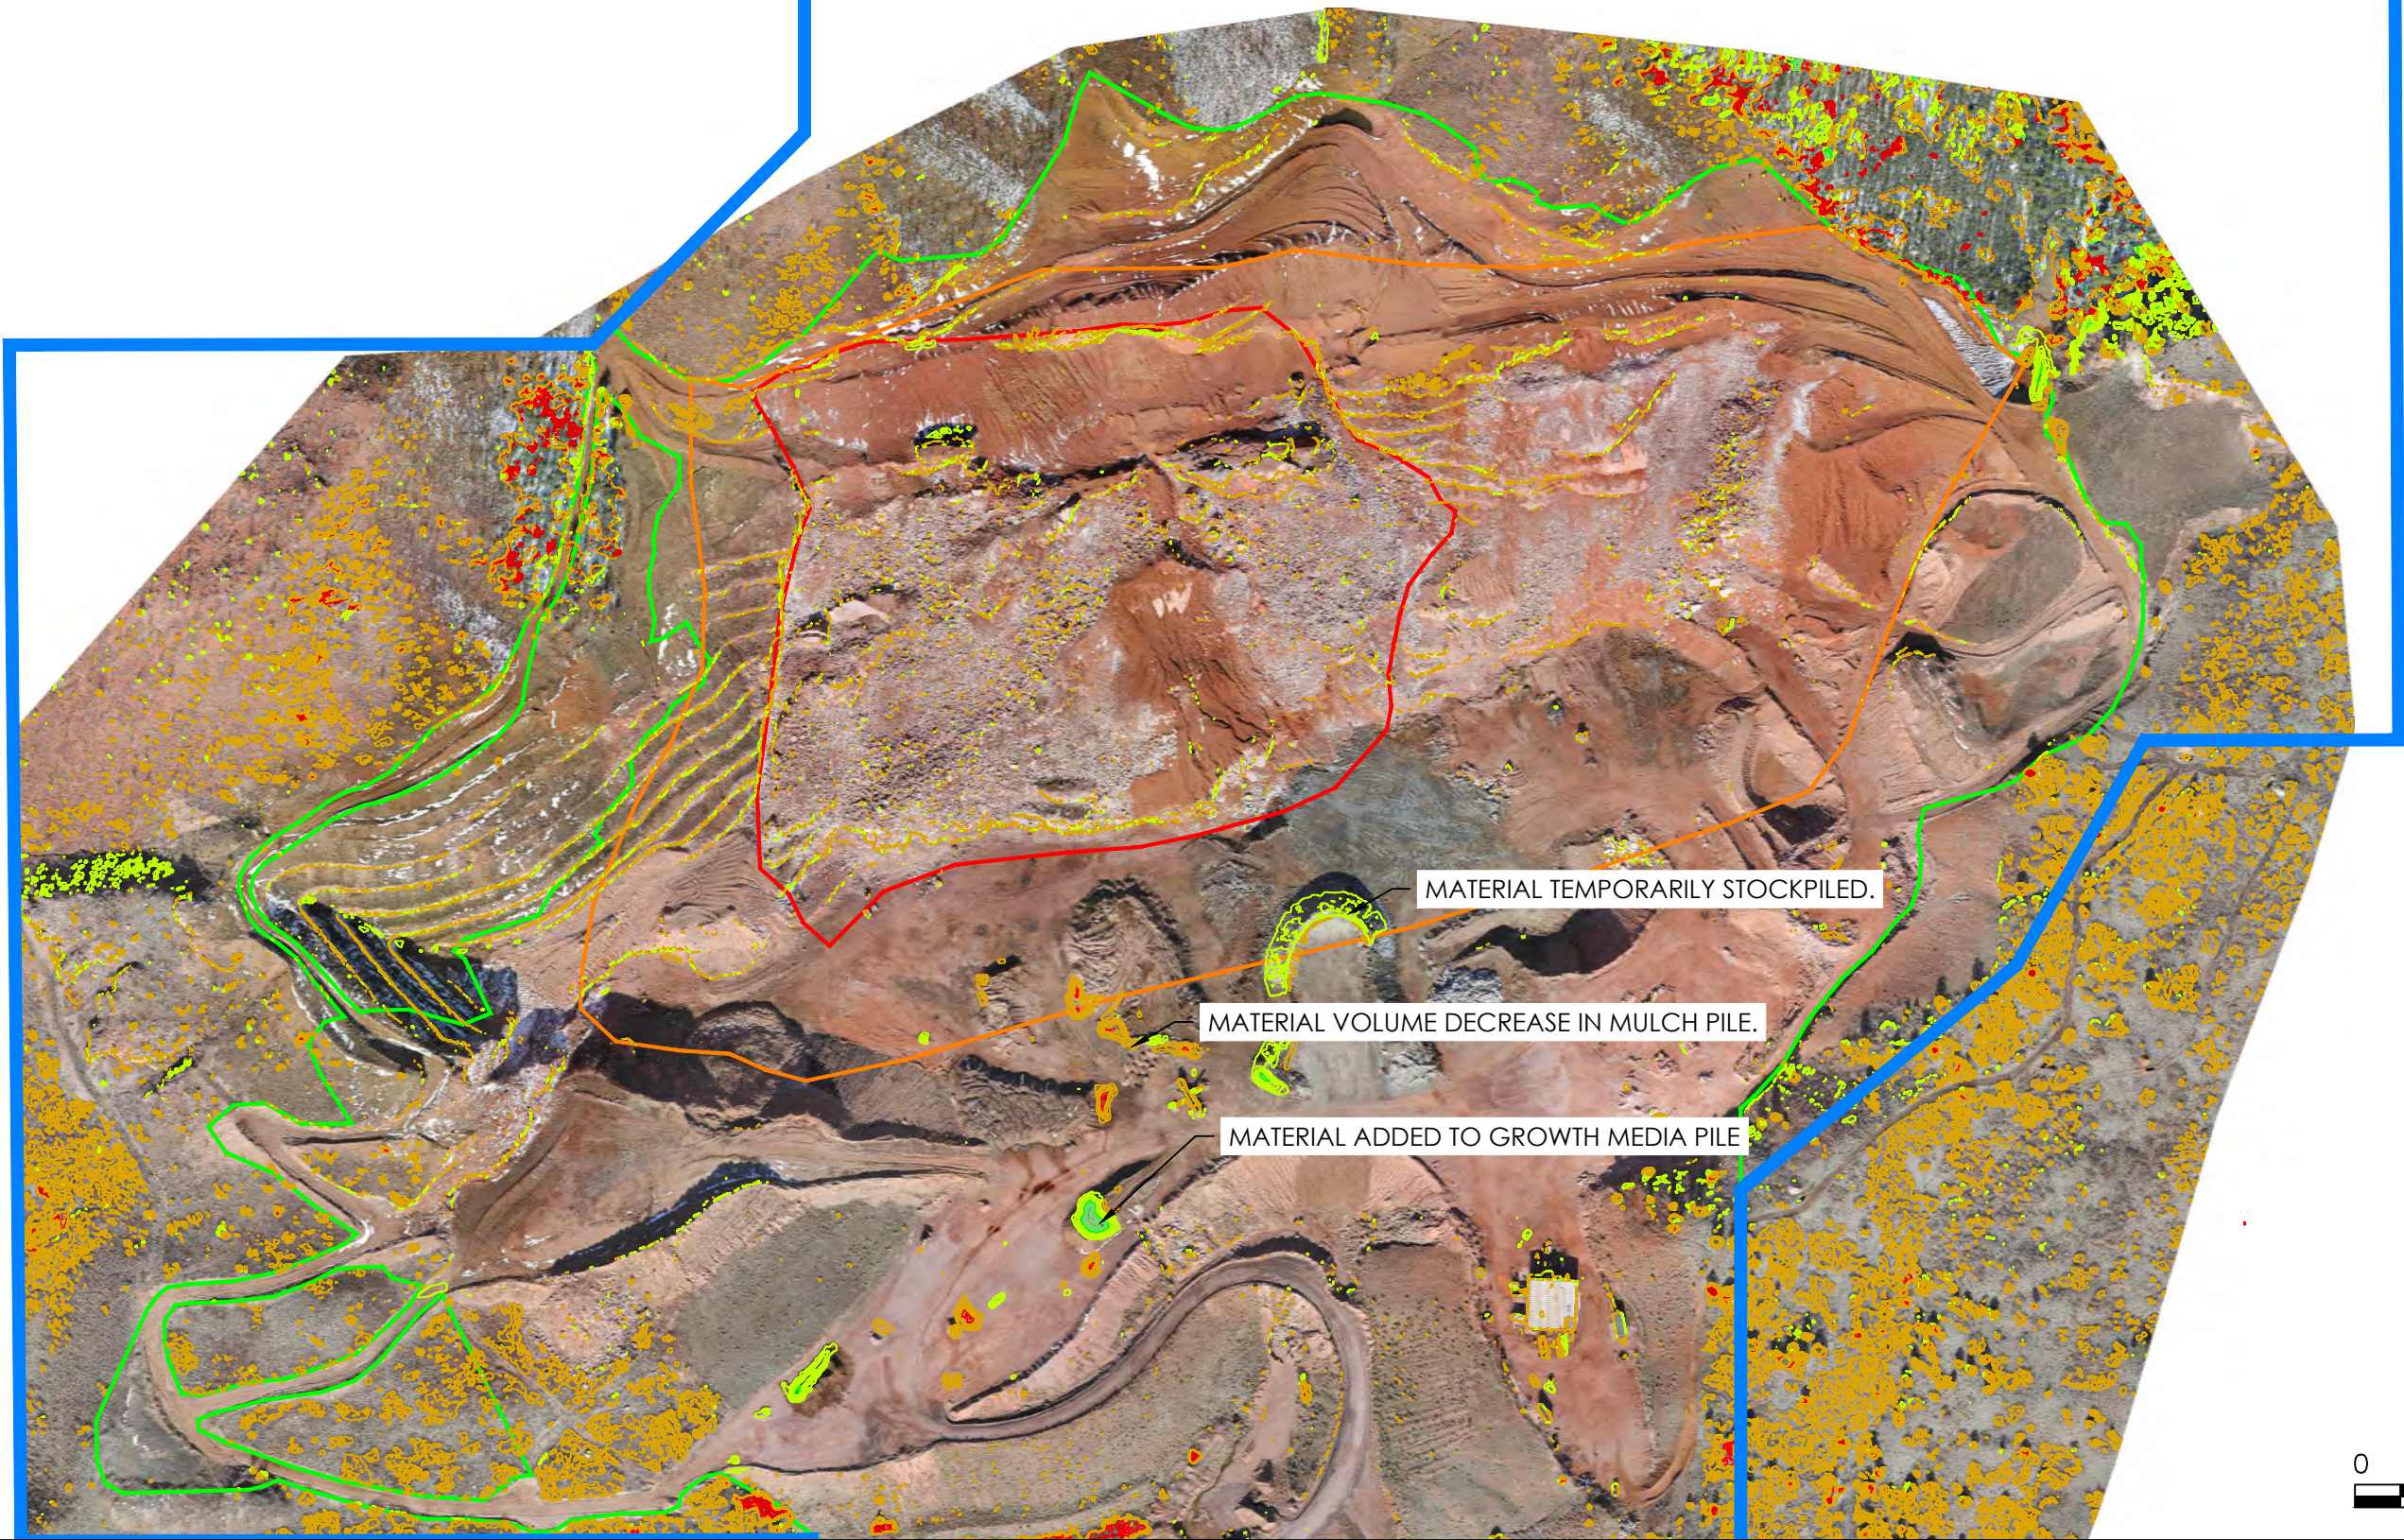
Revision #	Date 2021.05.31
Drawn By PK	Figure No. 5

The March topography was also compared to the April topography to identify changes in the site topography. Comparison of the two surveys showed that approximately 2443 yd³ of fill had been imported and temporarily placed. No slope movements or other changes in topography were identified. The current imagery and topography are included in Figures 1 and 3, and the comparison surface is included as Figure 5 in Appendix C.

As previously reported in the September 2020 monitoring report, there are limitations with the method of comparing drone surveys from different months. The drone data indicate changes in the slopes along each of the reclamation benches, buildings, and areas with trees or shrubs. These areas are stable, and the changes are the result of survey limitations on or near vertical slopes.
