MINERALS PROGRAM INSPECTION REPORT
PHONE: (303) 866-3567

MINE NAME: Koenig Pit	MINE/PROSPECTING ID#: M-1980-120	MINERAL: Sand and gravel	COUNTY: Weld
INSPECTION TYPE: Monitoring	INSPECTOR(S): Peter Hays	INSP. DATE: May 26, 2021	INSP. TIME: 13:30
OPERATOR: Weld County Public Works	OPERATOR REPRESENTATIVE: Clay Kimmi, Jeff York	TYPE OF OPERATION: 112c - Construction Regular Operation	
REASON FOR INSPECTION: Normal I&E Program	BOND CALCULATION TYPE: None	BOND AMOUNT: \$0.00	
DATE OF COMPLAINT: NA	POST INSP. CONTACTS: None	JOINT INSP. AGENCY: None	
WEATHER: Clear	INSPECTOR'S SIGNATURE:

OBSERVATIONS

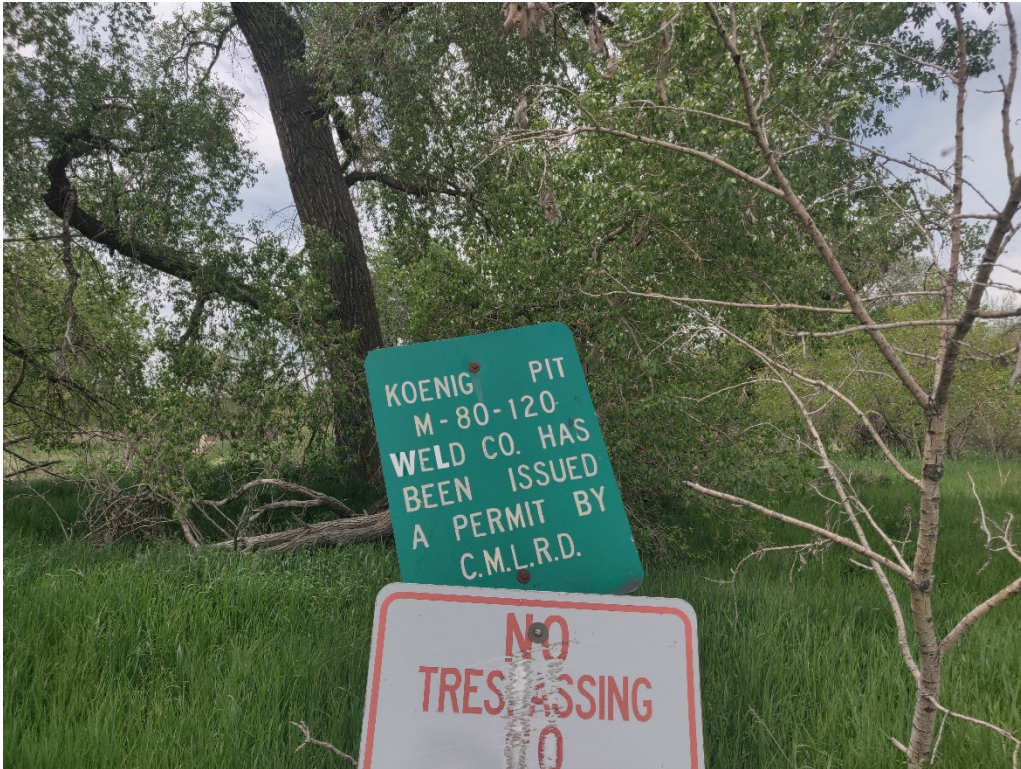
The required mine sign was observed and the site boundaries were delineated with fence on the north, east and south sides and monuments on the west side as required by Rule 3.1.12.

Koenig Pit mine sign

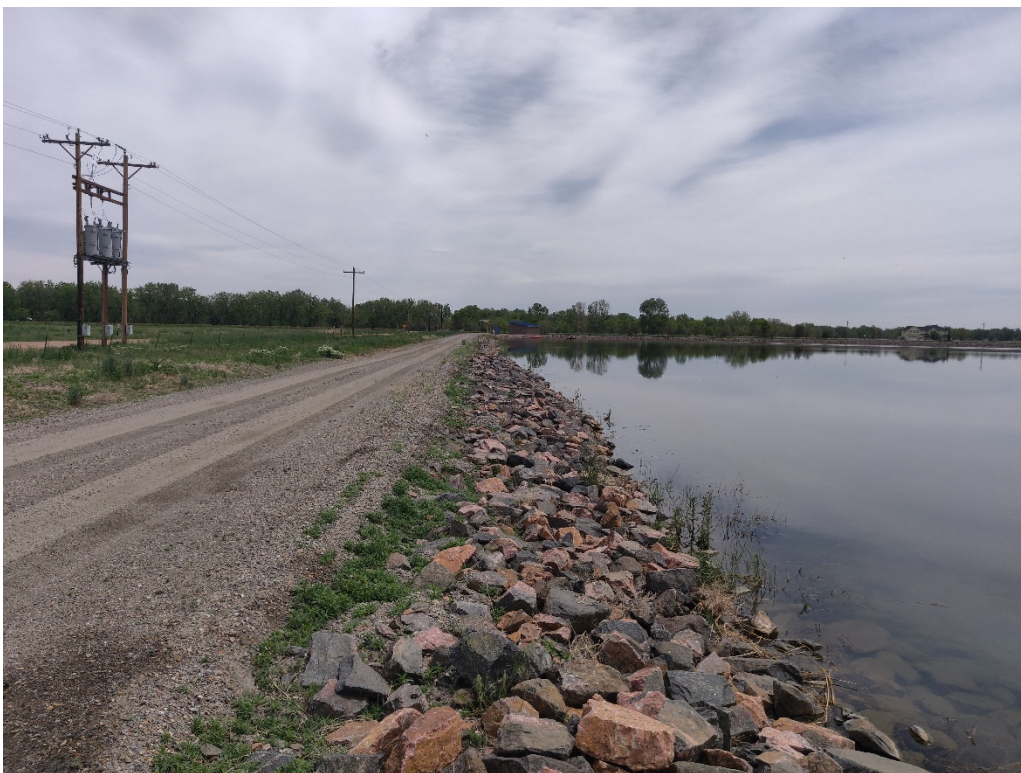
View of riprapped northern shoreline looking east

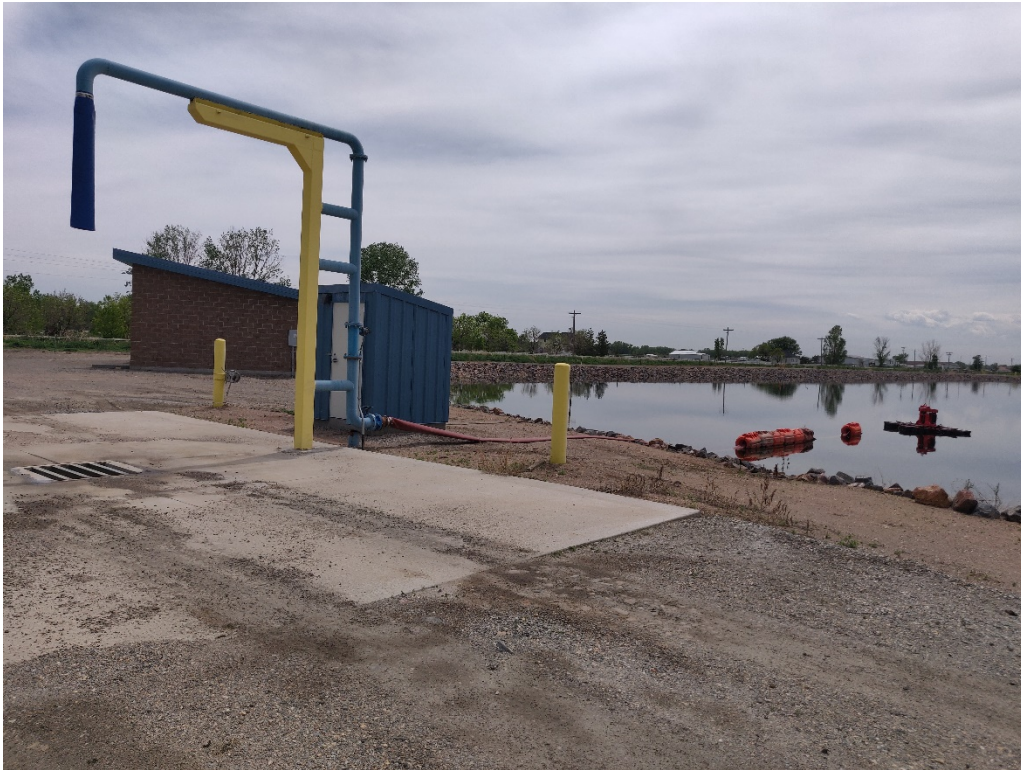
View of the two pump stations located in the northeast corner of the site

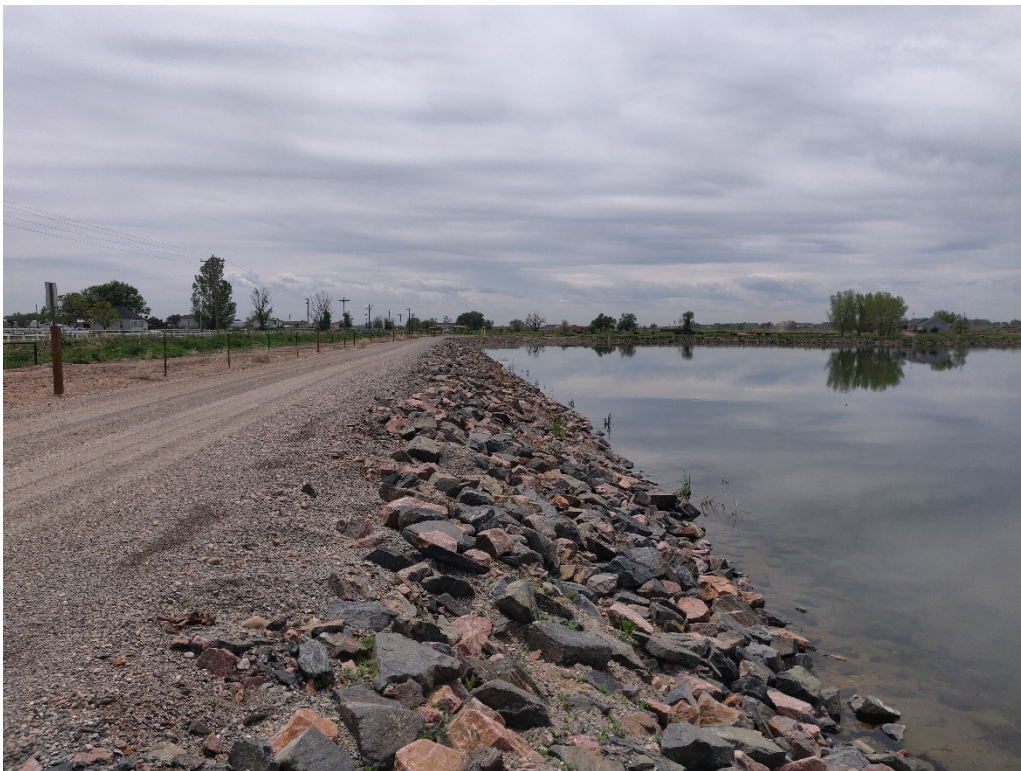
View of the riprapped eastern shoreline looking south

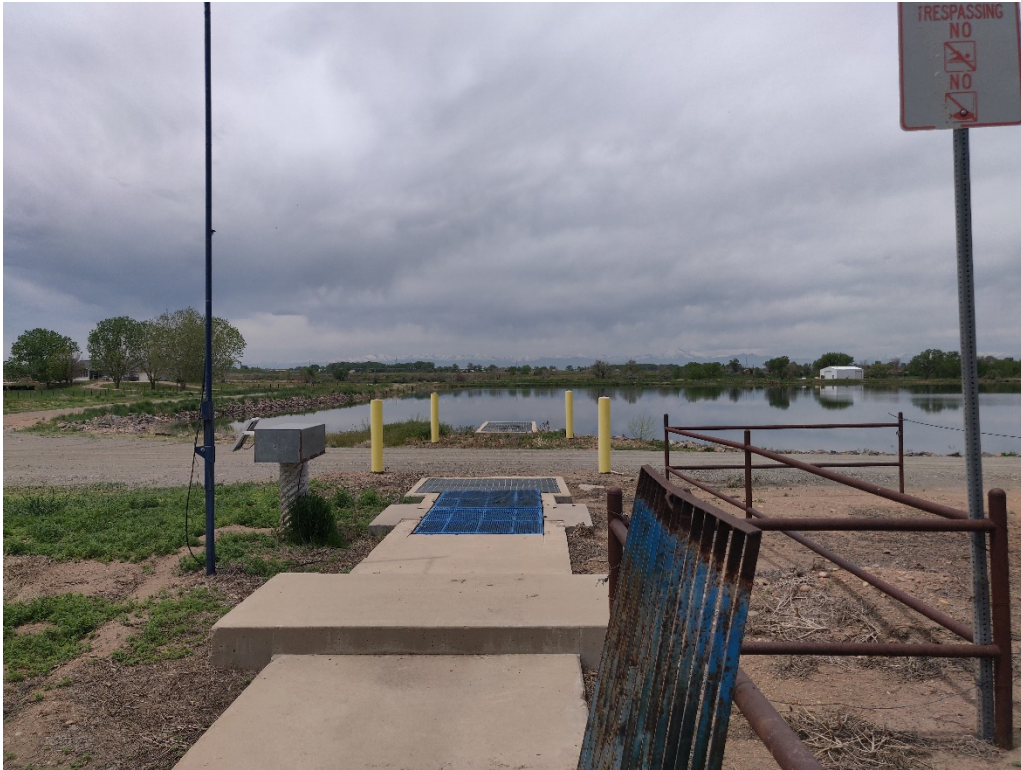
View of the inlet structure located in the southeast corner of the site

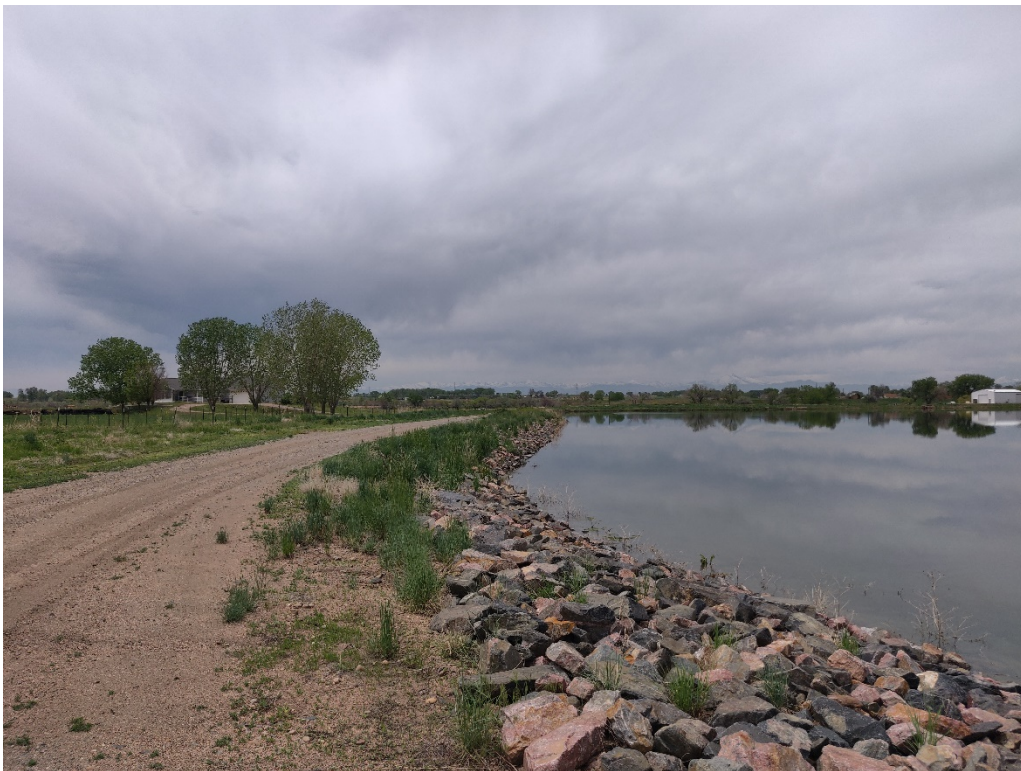
View of the southern shoreline from the southeast corner of the reservoir looking west

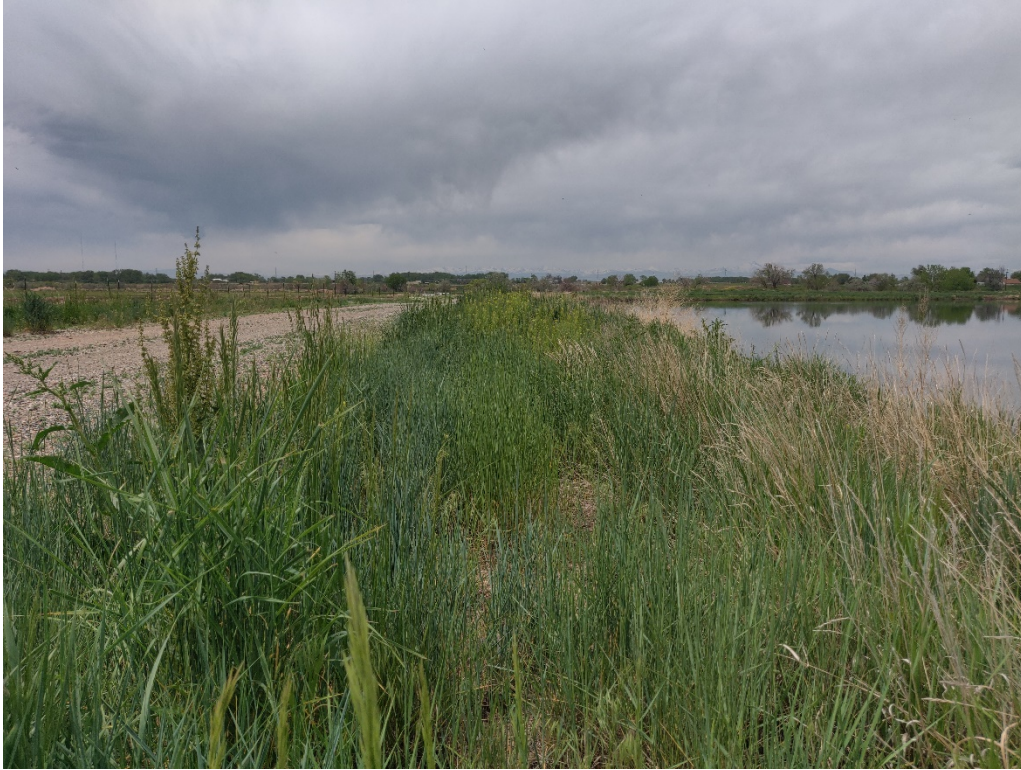
The approved post-mine land use for the site is developed water resource. The slurry wall is complete and was approved by the Division of Water Resources in a letter dated March 9, 2010. The non-riprapped shorelines and upland vegetation consisted of western wheatgrass, blue grama and other varieties of wheat grasses. Noxious and annual weeds including Scotch Thistle, downy brome (cheat grass), yellow sweet clover and hoary crest (white top) were observed during the inspection. Overall, the native grasses were well-established and appeared to be outcompeting the weeds. During the inspection, the Division recommended the weeds are chemically and mechanically controlled by the Operator. The Operator stated the County weed control team would be contacted to schedule the site for treatment. The Division recommends the Operator file for final release of the site following the weed treatments this year or next spring, based on the observations from this inspection.

View of the shoreline vegetation along the western portion of the southern shoreline

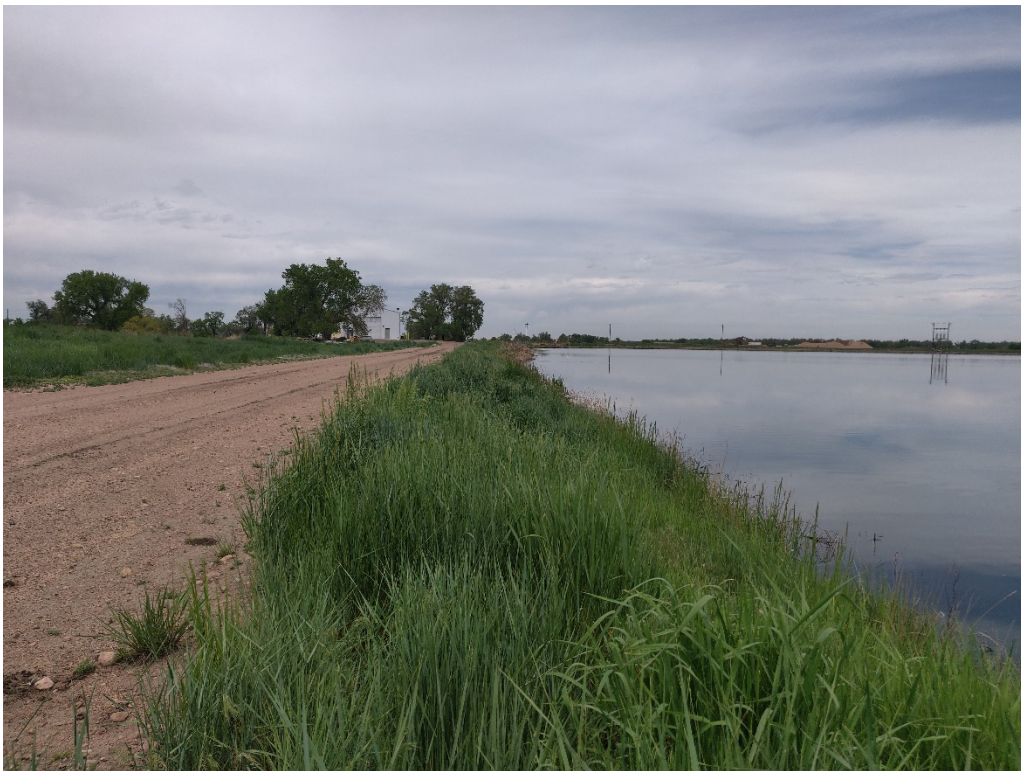
View of the eastern shoreline vegetation looking north

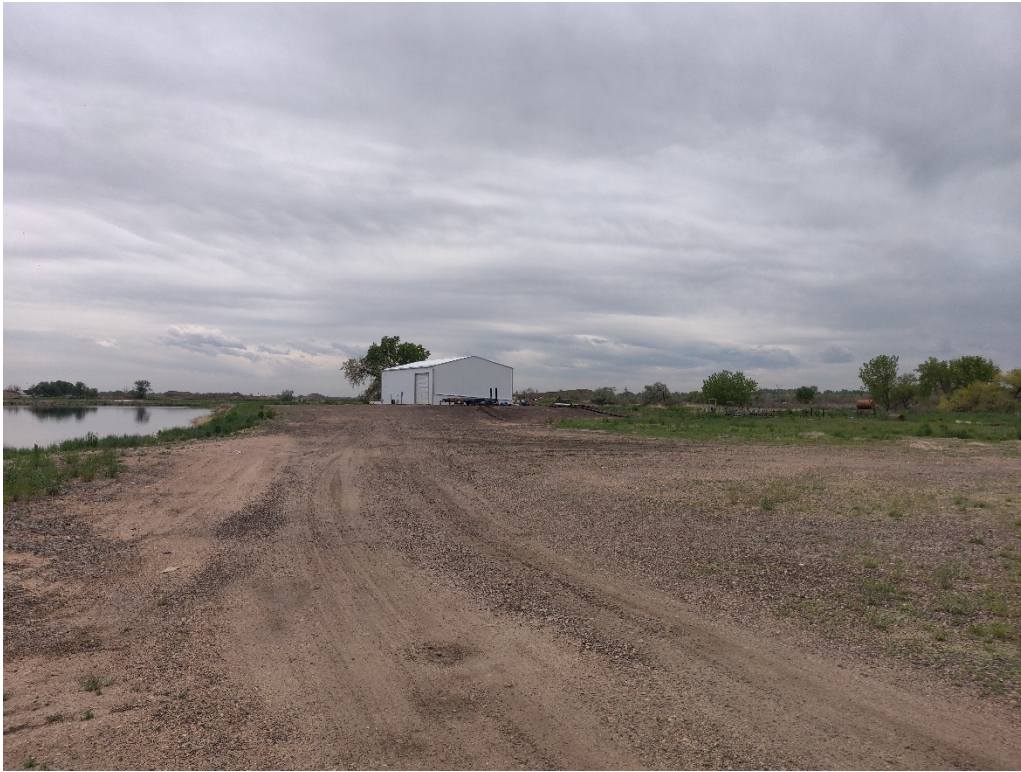
View of the maintenance/shop building and outdoor storage area located in the northwest corner of the site
