MINERALS PROGRAM INSPECTION REPORT
PHONE: (303) 866-3567

MINE NAME: Union Hill Gravel Pit	MINE/PROSPECTING ID#: M-2000-056	MINERAL: Gravel	COUNTY: Fremont
INSPECTION TYPE: Monitoring	INSPECTOR(S): Timothy Cazier, P.E.	INSP. DATE: March 30, 2021	INSP. TIME: 11:30
OPERATOR: Fremont County	OPERATOR REPRESENTATIVE: Sterling Rife	TYPE OF OPERATION: 112c - Construction Regular Operation	
REASON FOR INSPECTION: Normal I&E Program	BOND CALCULATION TYPE: None	BOND AMOUNT: \$0.00	
DATE OF COMPLAINT: NA	POST INSP. CONTACTS: None	JOINT INSP. AGENCY: None	
WEATHER: Cloudy	INSPECTOR'S SIGNATURE:

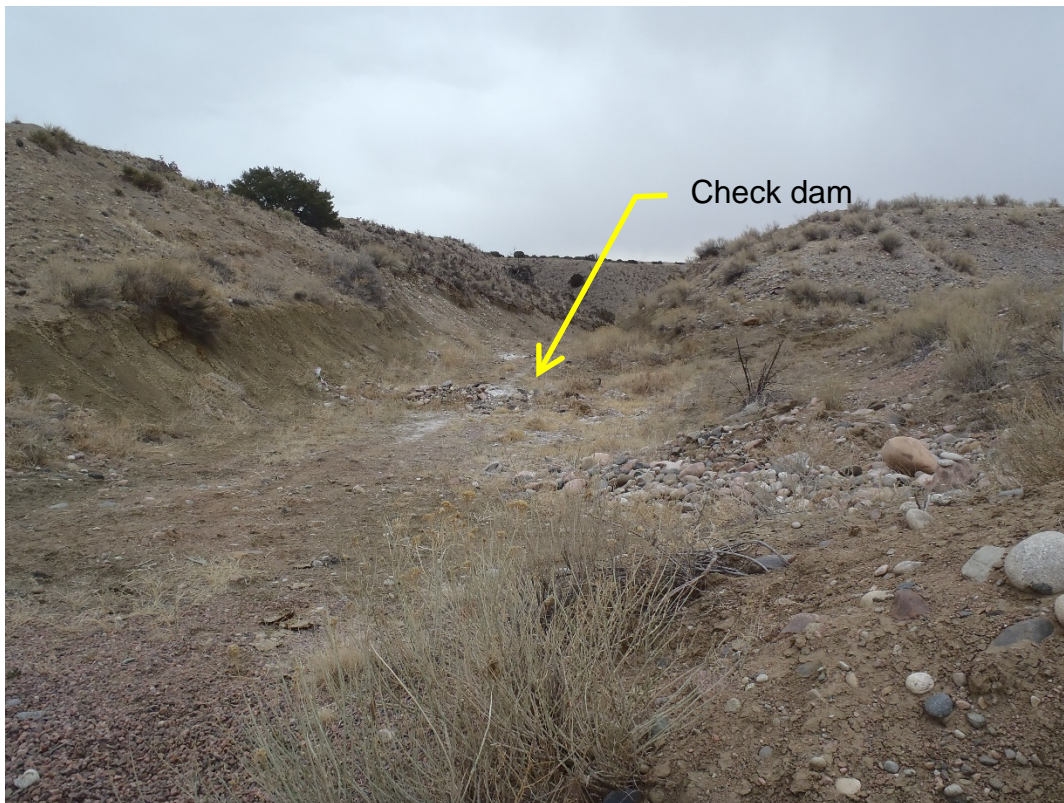
Gen. Compliance with Mine Plan: The operation appeared to be in compliance with the approved mine plan. The maximum allowed disturbed area is 79.7 acres. Google Earth was used to measure the disturbed area, which was estimated to be approximately one acre, based on 2018 imagery. The extent of disturbance is limited to what appears to be an access road cut (see **Photos 1 and 2**).

Storm Water MGT Plan: No oil or fuel spills observed. Stormwater is controlled using check dams (see **Photo 1**).

Photo 1. West end of access road cut and typical rock check dam (looking east from west end).

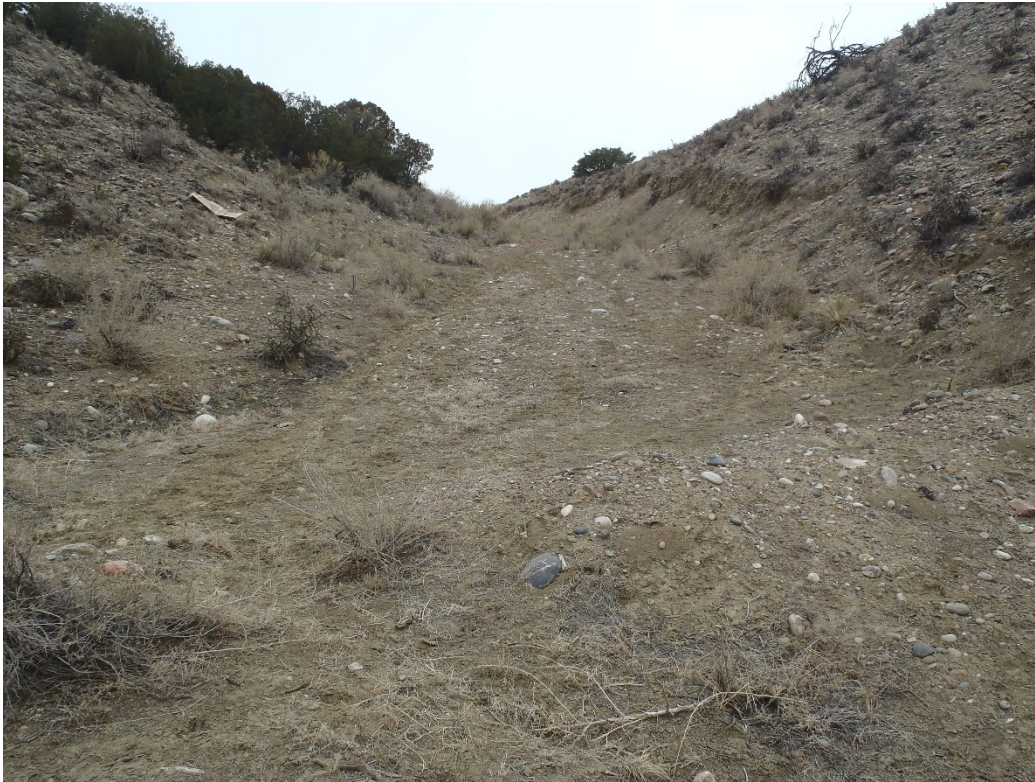
Photo 2. East end of access road cut (looking west from east end).

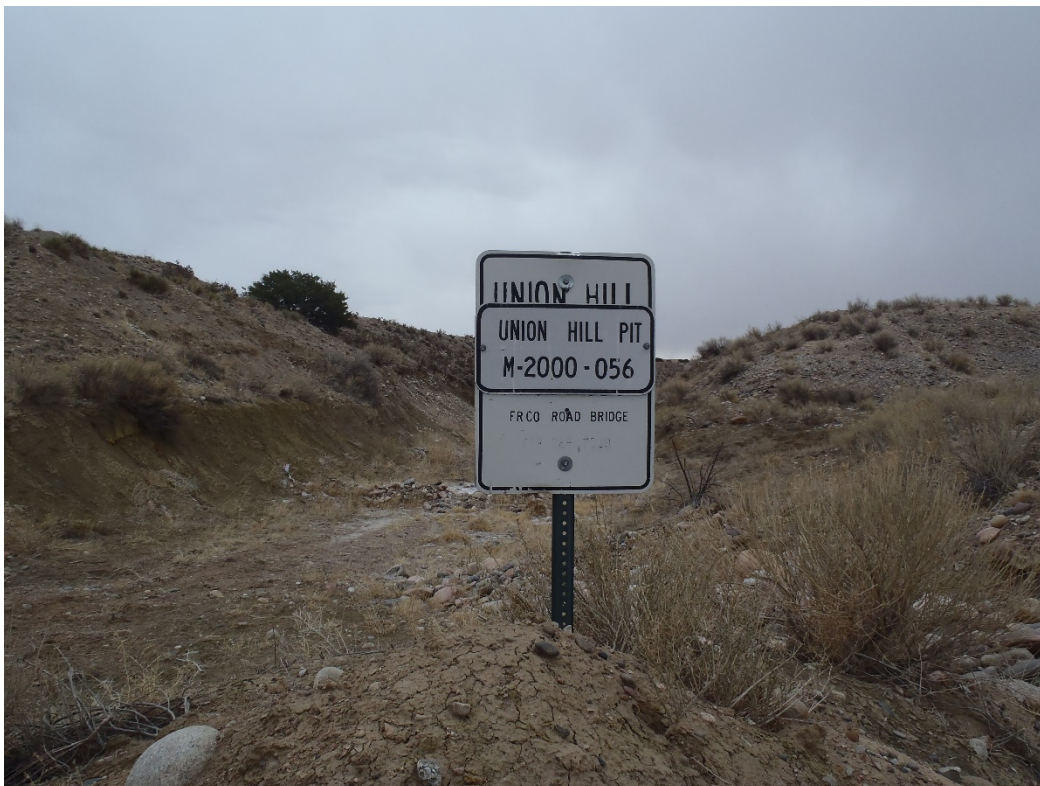
Signs and Markers: The permit sign was properly posted (see **Photo 3**). The access road cut is in the center of the west end of the pit. It does not extend anywhere near the permit boundary. It is unclear if any boundaries are marked other than that shared by the adjacent Dist No 2 Gravel Pit (M-1979-216).

Photo 3. Permit sign (at west entrance).
