MINERALS PROGRAM INSPECTION REPORT
PHONE: (303) 866-3567

MINE NAME: Franciscotti Pit #2	MINE/PROSPECTING ID#: M-2018-058	MINERAL: Sand and gravel	COUNTY: Huerfano
INSPECTION TYPE: Monitoring	INSPECTOR(S): Patrick Lennberg	INSP. DATE: May 26, 2021	INSP. TIME: 12:00
OPERATOR: APC Southern Construction Co., LLC	OPERATOR REPRESENTATIVE: None	TYPE OF OPERATION: 112c - Construction Regular Operation	
REASON FOR INSPECTION: Normal I&E Program	BOND CALCULATION TYPE: None	BOND AMOUNT: \$343,600.00	
DATE OF COMPLAINT: NA	POST INSP. CONTACTS: None	JOINT INSP. AGENCY: None	
WEATHER: Cloudy	INSPECTOR'S SIGNATURE:

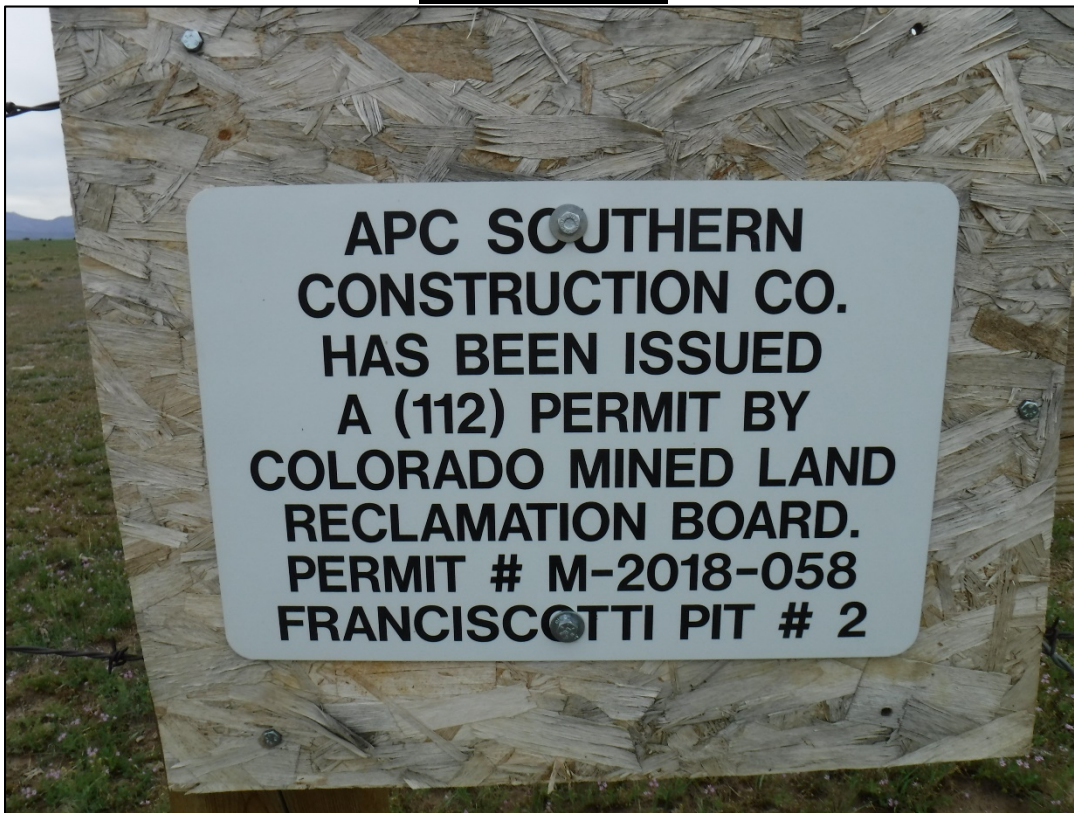
The entrance to the 112c 329.9 acre mine is from the eastside of the permit boundary via County Road 613 approximately 2 miles from the intersection of County Road 611 and State Highway 69 which is 7.5 miles from Farista just north of Walsenburg, CO. A mine sign has been posted at the mine entrance pursuant to Rule 3.1.12.

Photo 1: Mine sign at mine entrance location

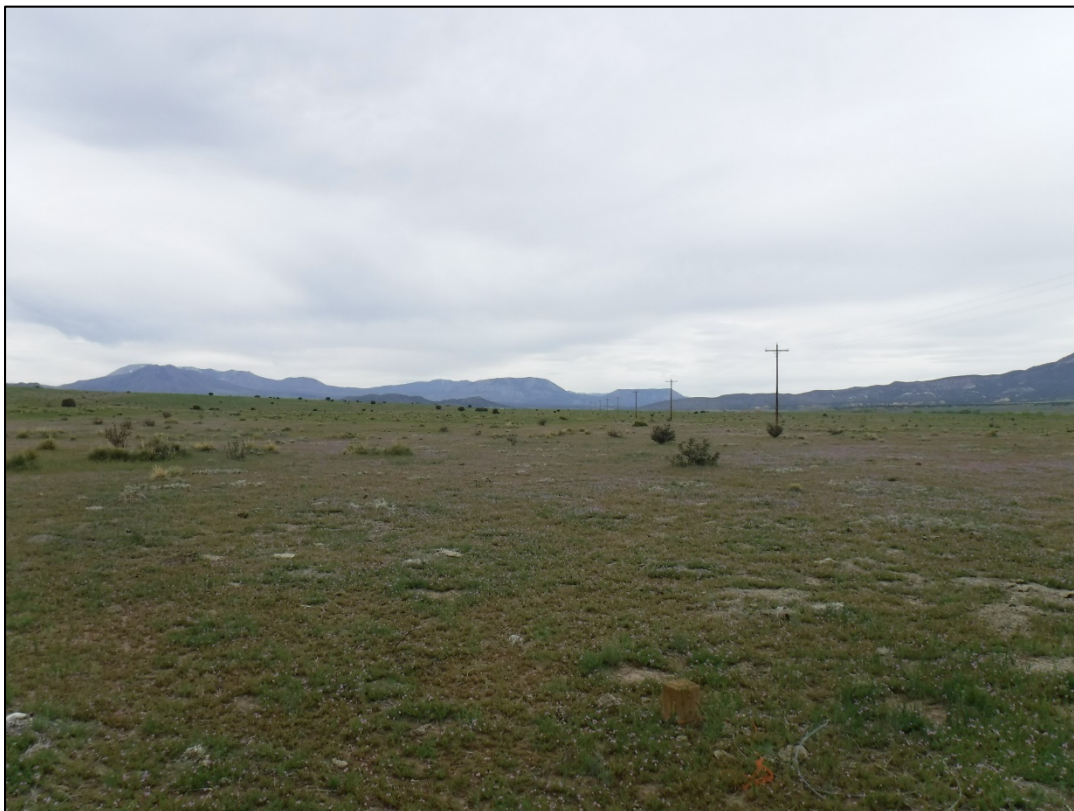
Photo 2: Looking west across permit area along the power line corridor

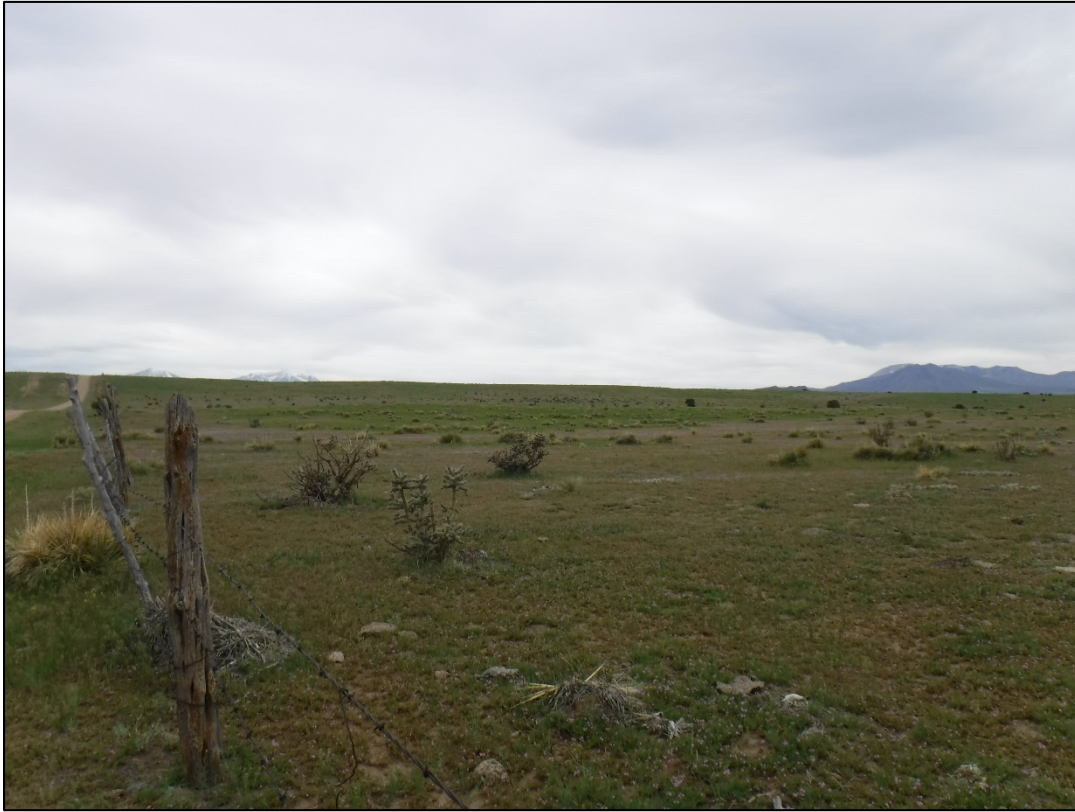
The mine has not begun operation yet. Some of permit boundary markers were visible from the road and the area is surrounded by a barbed wire fence.

Photo 3: Looking south along eastern permit boundary

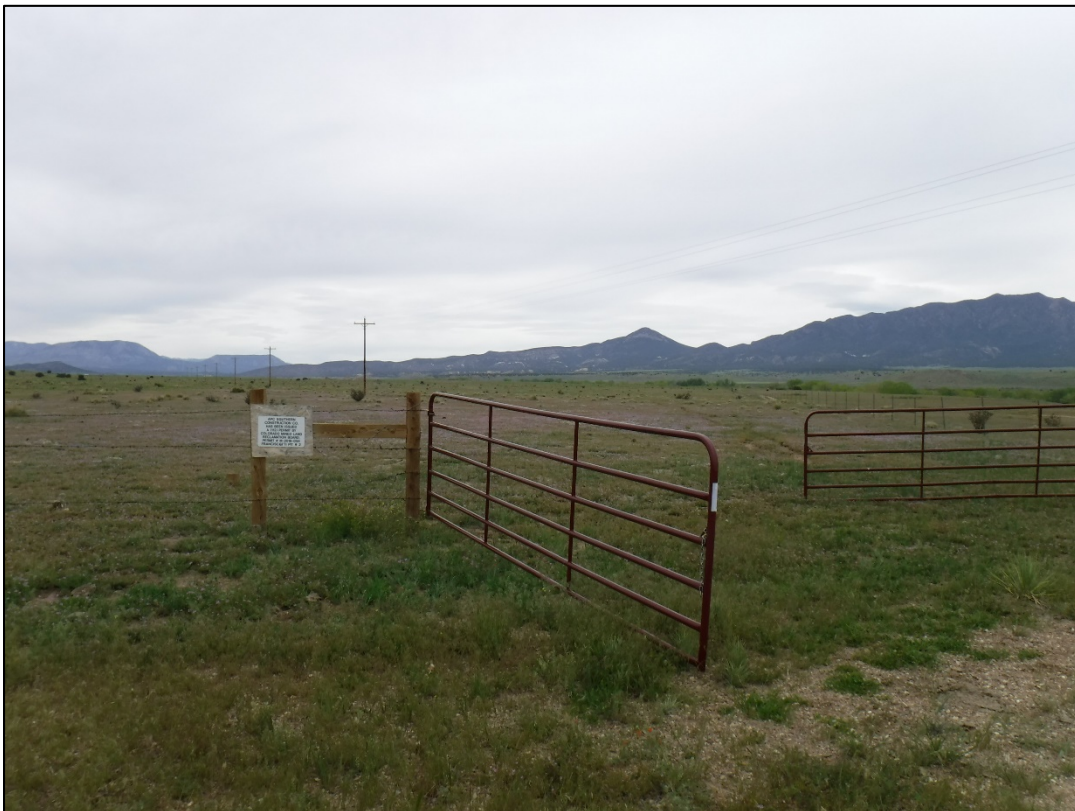
Photo 4: Mine entrance along County Road 613
