**MINERALS PROGRAM INSPECTION REPORT**  
**PHONE: (303) 866-3567**

| <b>MINE NAME:</b><br>Treiber Lakes | <b>MINE/PROSPECTING ID#:</b><br>M-2011-049 | <b>MINERAL:</b><br>Aggregate | <b>COUNTY:</b><br>Larimer |
| <b>INSPECTION TYPE:</b><br>Monitoring | <b>INSPECTOR(S):</b><br>Amy Eschberger | <b>INSP. DATE:</b><br>May 26, 2021 | <b>INSP. TIME:</b><br>14:00 |

# M-2011-049 / Treiber Lakes / City of Greeley (112c)

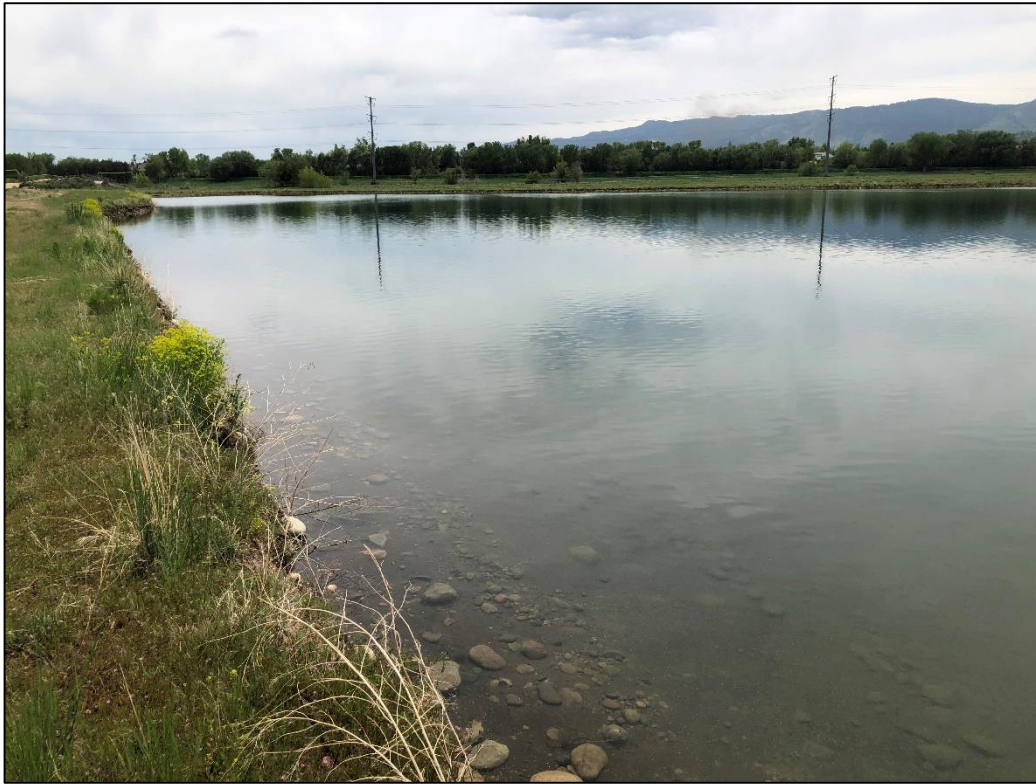
**Photo 1.** View looking south across eastern shoreline of South Reservoir, graded 3H:1V or flatter and stable with good vegetative cover. Operator will need to implement weed control plan in this area for state-listed noxious weed species.

**CORRECTIVE ACTIONS:** By the correction action due date, the operator shall implement the approved weed control plan for the site and provide proof to the Division this was done. Such proof should include a short description of the control measures utilized, photographic documentation, and a site map showing areas where weed control was conducted. If a weed control plan is not already in place, the operator must develop a weed control and management plan in accordance with Rule 3.1.10(6). This plan should be developed in consultation with the county extension agency or weed control district office, and should include specific control measures to be applied, a schedule for when control measures will be applied, and a post-treatment monitoring plan. If a new plan is developed for the site, it must be submitted to the Division as a Technical Revision, with the required \$216 revision fee, by the corrective action due date.

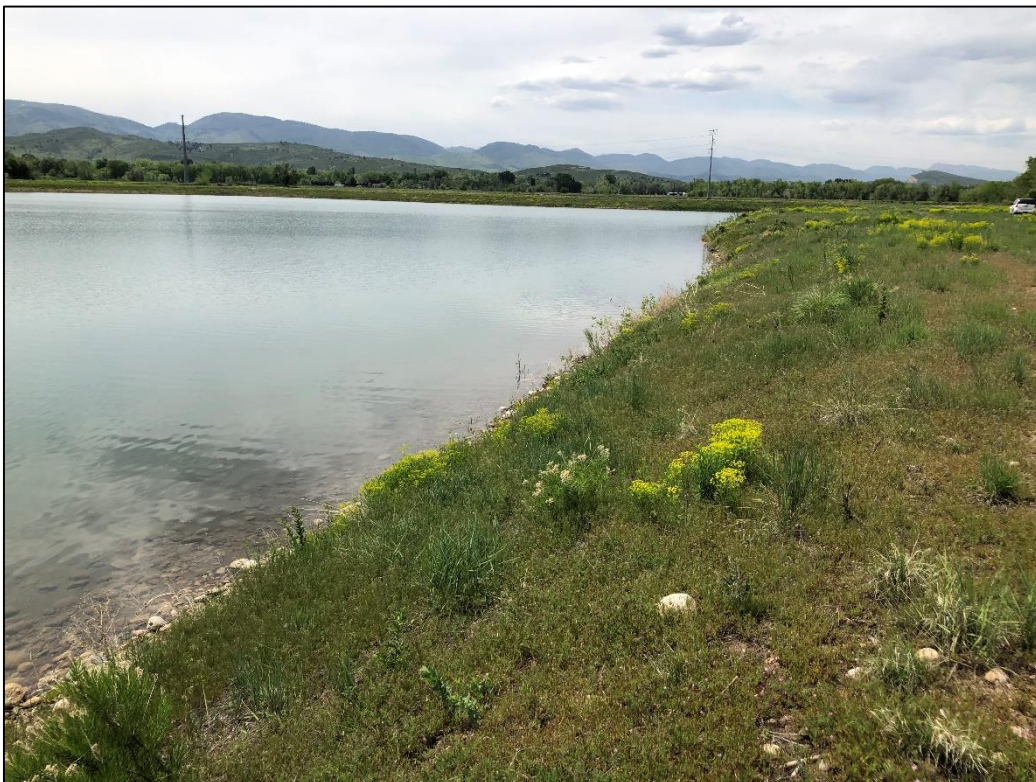
**Photo 2.** View looking northwest across northern shoreline of South Reservoir, graded 3H:1V or flatter and stable with good vegetative cover. Operator will need to implement weed control plan in this area for state-listed noxious weed species.

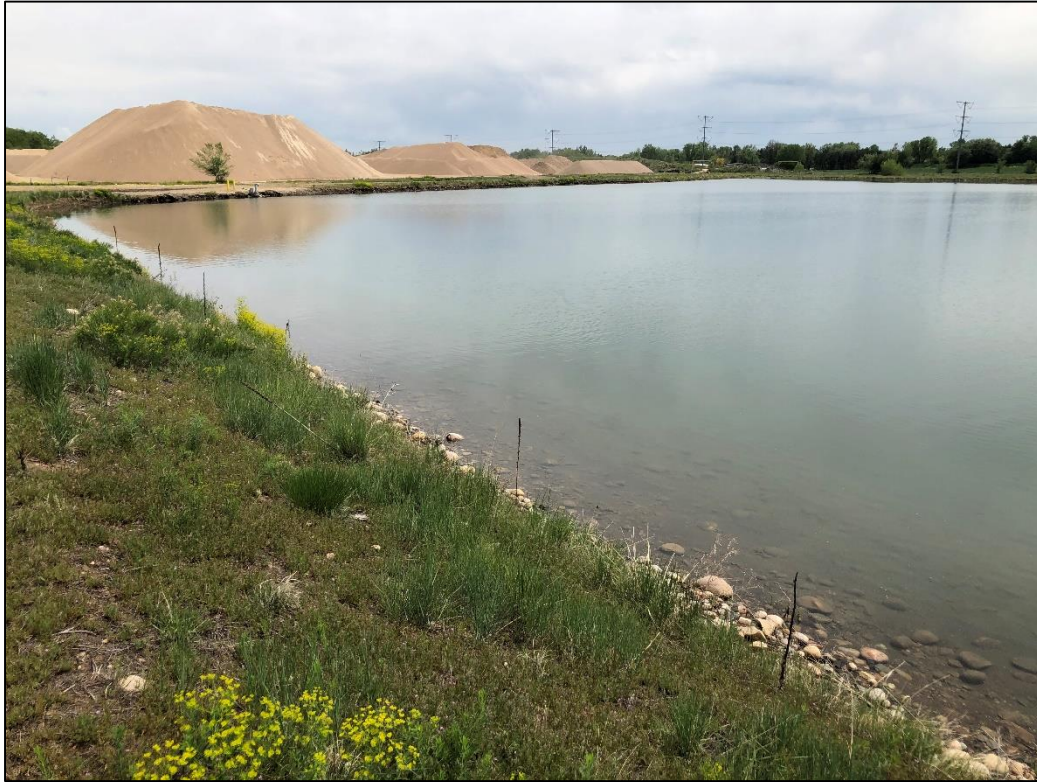
**Photo 3.** View looking southeast across northern shoreline of South Reservoir, graded 3H:1V or flatter and stable with good vegetative cover. Operator will need to implement weed control plan in this area for state-listed noxious weed species. Large material stockpiles visible in background are part of adjacent Home Office Mine permit.

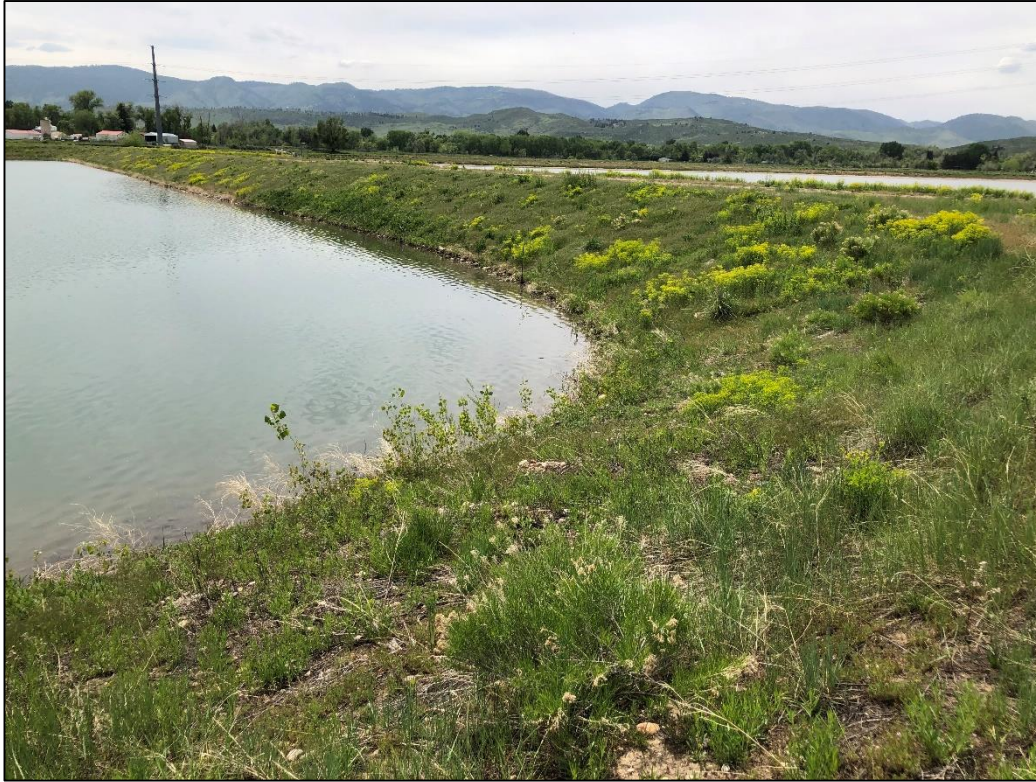
**Photo 5.** View looking west at western shoreline of South Reservoir, graded 3H:1V or flatter and stable with good vegetative cover. Operator will need to implement weed control plan in this area for state-listed noxious weed species.

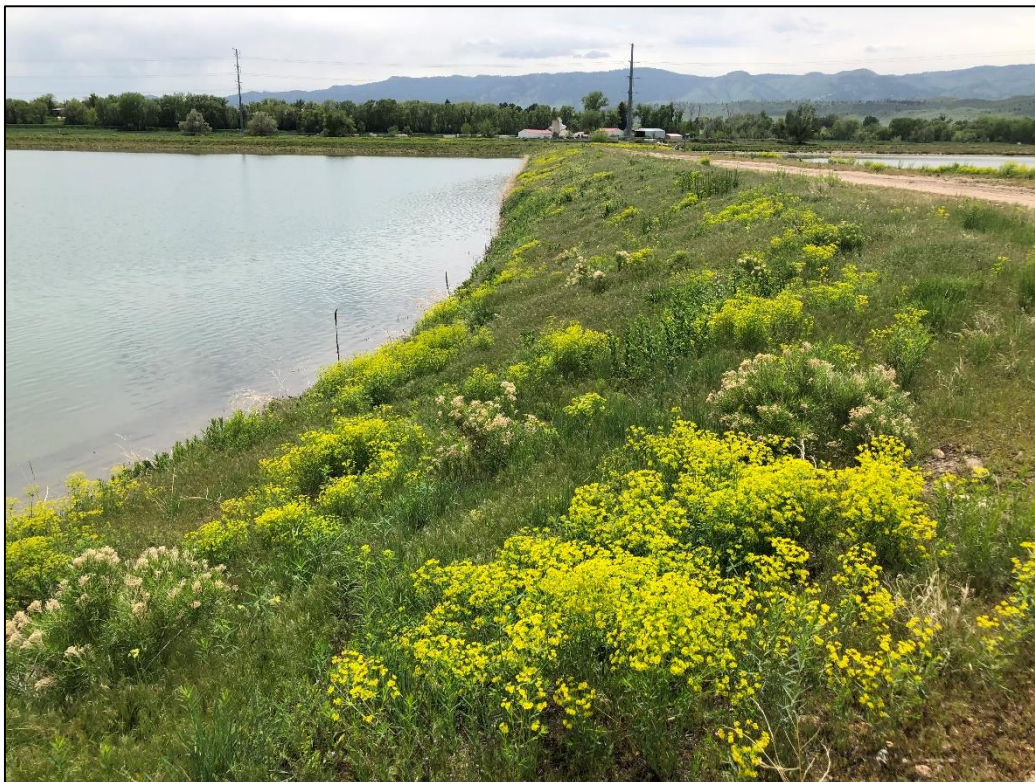
As mentioned above, there is good grass cover present across much of the affected lands. However, abundant weeds were also observed throughout the site, including state-listed noxious weed species such as leafy spurge, downy brome, and common mullein. Rule 3.1.10(6) requires methods of weed control to be employed for all prohibited noxious weed species, and whenever invasion of a reclaimed area by other weed species seriously threatens the continued development of the desired vegetation. **Therefore, a problem is cited in this report (see page 1; Problem #3) for the state-listed noxious weed species present at the site. The operator will need to either implement the approved weed control plan for the site and provide proof to the Division this was done, or develop a new weed control plan for the site in consultation with the county extension agency or weed control district office and submit this plan as a Technical Revision.** Mr. Dickmeyer indicated the City would most likely be on site in June to manage the weeds, as part of their annual weed control program. Given the proximity of the weeds to the reservoirs, mechanical methods are preferred.

**Photo 6.** View looking southwest across western shoreline of South reservoir, showing abundant leafy spurge (plant with yellow flowers) present in this area. Operator will need to implement weed control plan in this area for all state-listed noxious weed species.

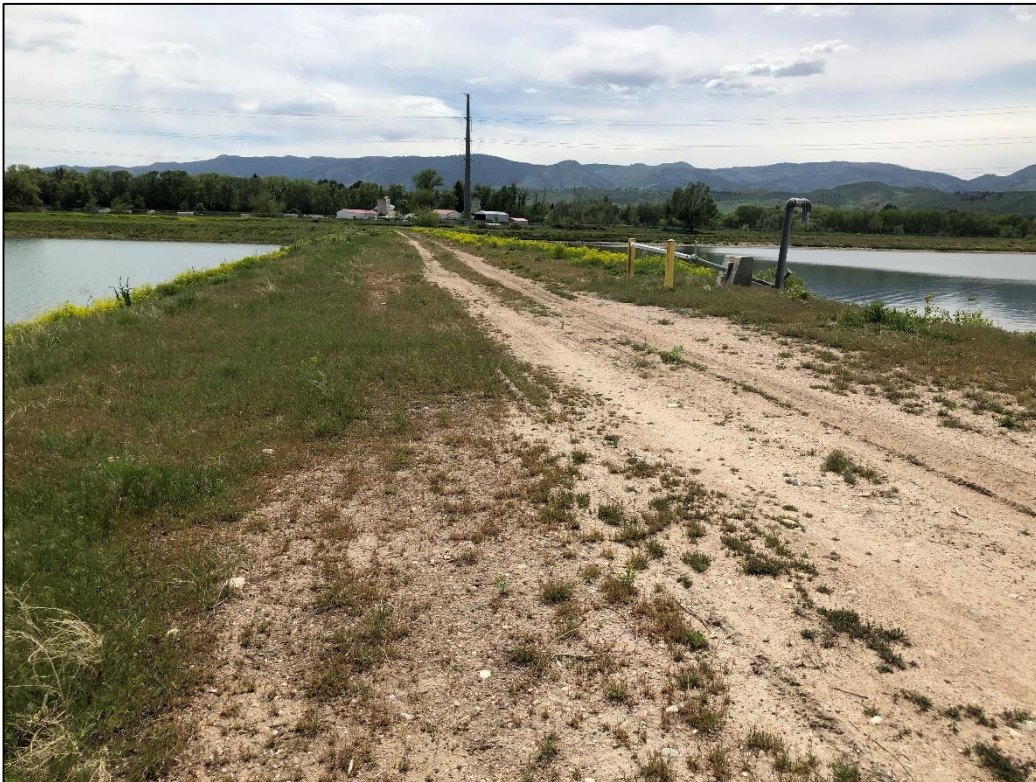
**PROBLEM #2:** Failure to follow approved reclamation plan, or current reclamation plan needs to be updated and clarified pursuant to C.R.S. 34-32.5-116(1). The operator must follow the approved reclamation plan or provide sufficient information to describe or identify how the operator intends to conduct reclamation. Specifically, the operator has installed water management structures for the reservoirs (e.g., outlet, interconnect pipelines) which are not part of the approved reclamation plan.

**Photo 8.** View looking southwest across land separating the two reservoirs. According to the operator, two interconnect pipelines are installed in this area. The reclamation plan and map need to be updated to address any permanent water management structures installed on the affected lands.

**CORRECTIVE ACTIONS:** By the correction action due date, the operator shall submit a Technical Revision,

with the required \$216 revision fee, to update and clarify the current approved reclamation plan and map to reflect existing and proposed activities. The revised reclamation plan and map must address any structures proposed to remain for final reclamation. Additionally, the revised reclamation plan map must show the final installed location of the slurry wall.

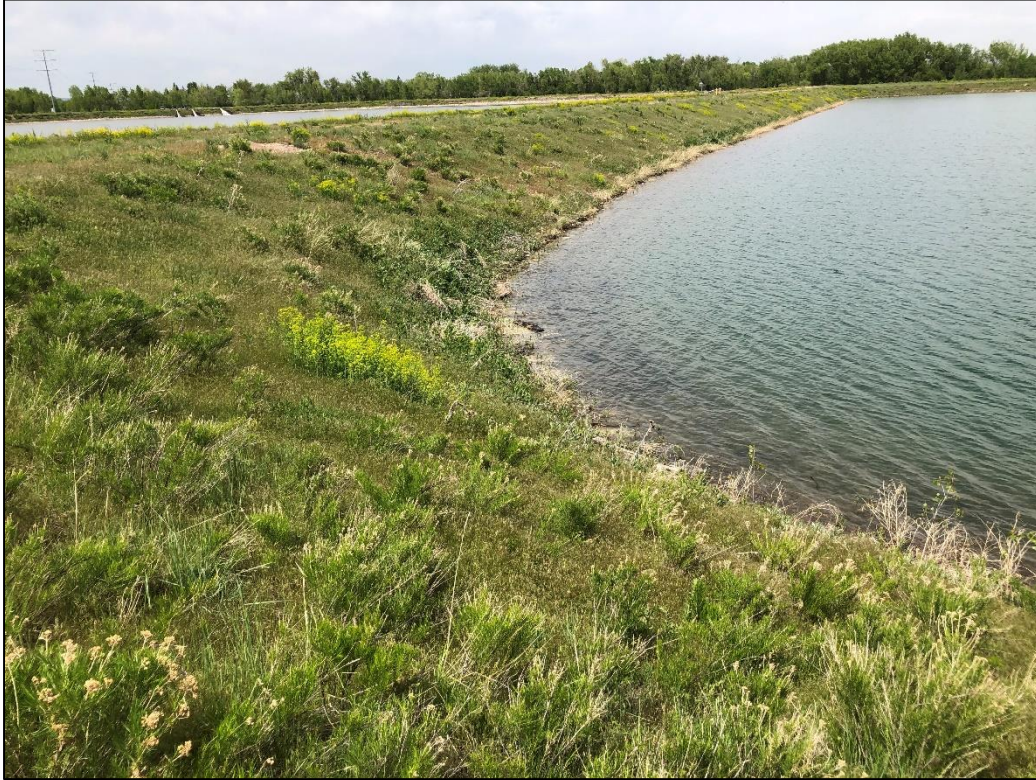
**Photo 9.** View looking northeast across western shoreline of South Reservoir, graded 3H:1V or flatter and stable with good vegetative cover. Operator will need to implement weed control plan in this area for state-listed noxious weed species.

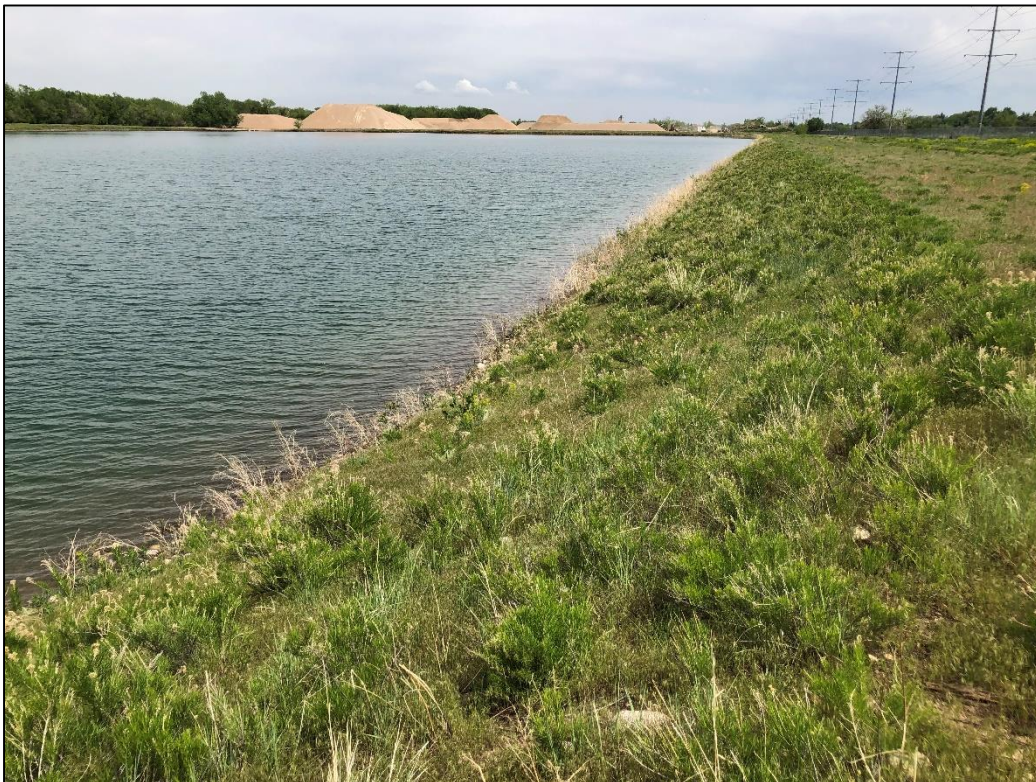
**Photo 10.** View looking southeast across southern shoreline of South Reservoir, graded 3H:1V or flatter and stable with good vegetative cover. Operator will need to implement weed control plan in this area for state-listed noxious weed species.

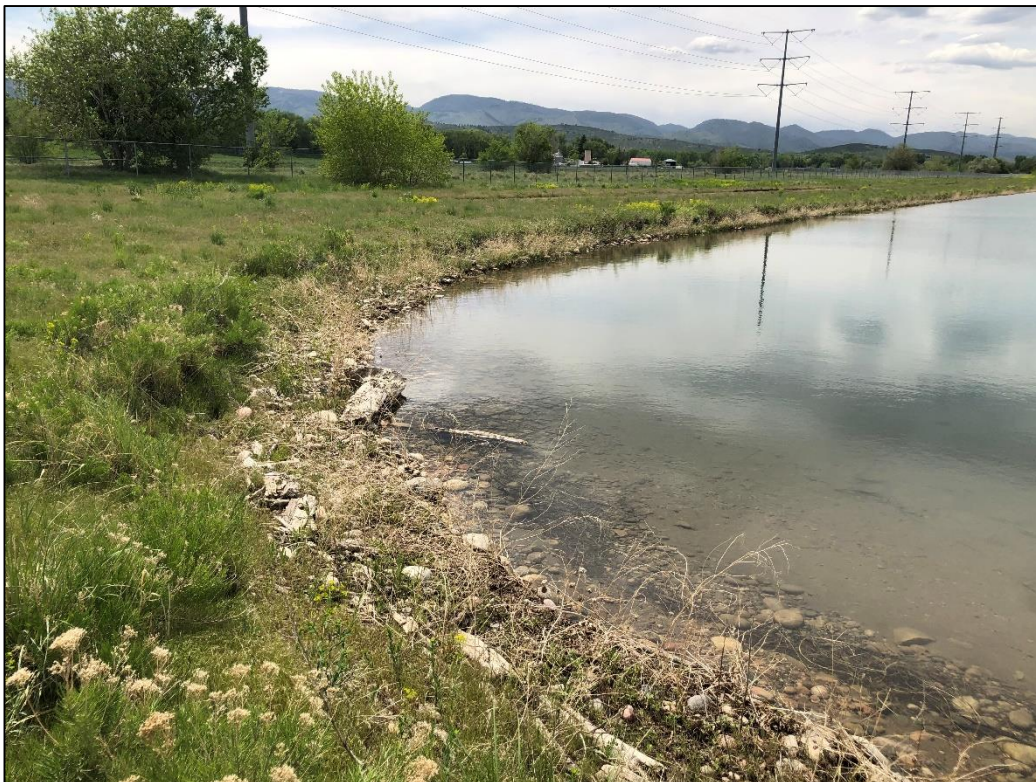
**Photo 12.** View looking west across southeastern shoreline of South Reservoir, graded 3H:1V or flatter and stable with good vegetative cover. Operator will need to implement weed control plan in this area for state-listed noxious weed species.

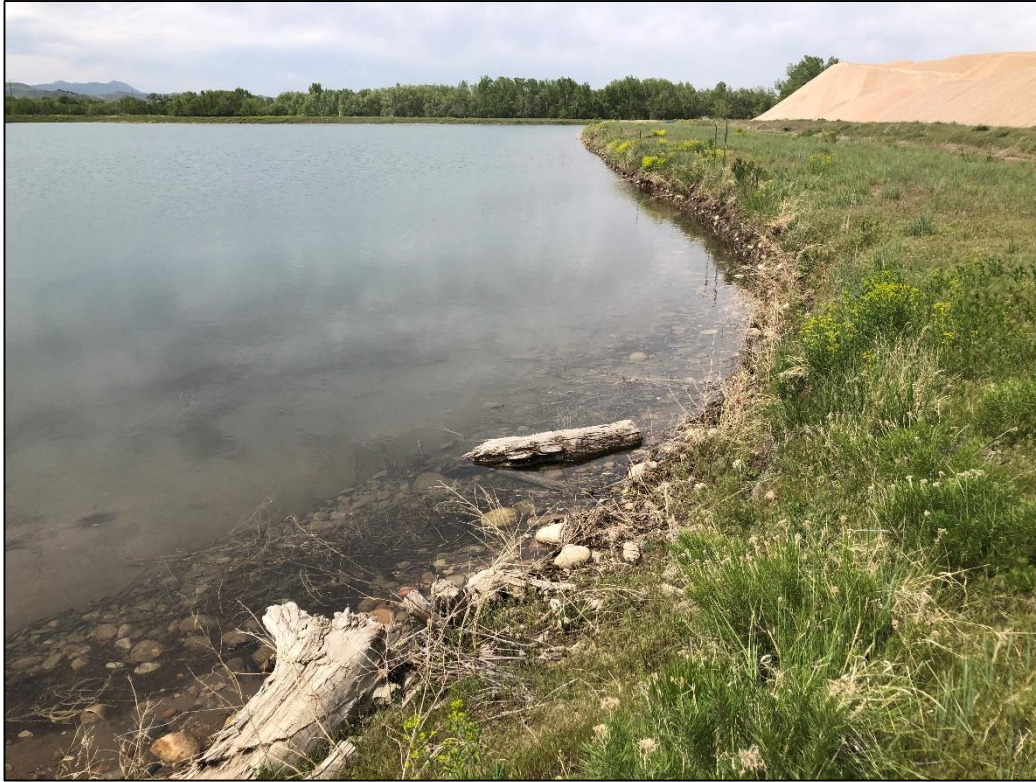
**Photo 13.** View looking north across eastern shoreline of South Reservoir, graded 3H:1V or flatter and stable with good vegetative cover. Operator will need to implement weed control plan in this area for state-listed noxious weed species.

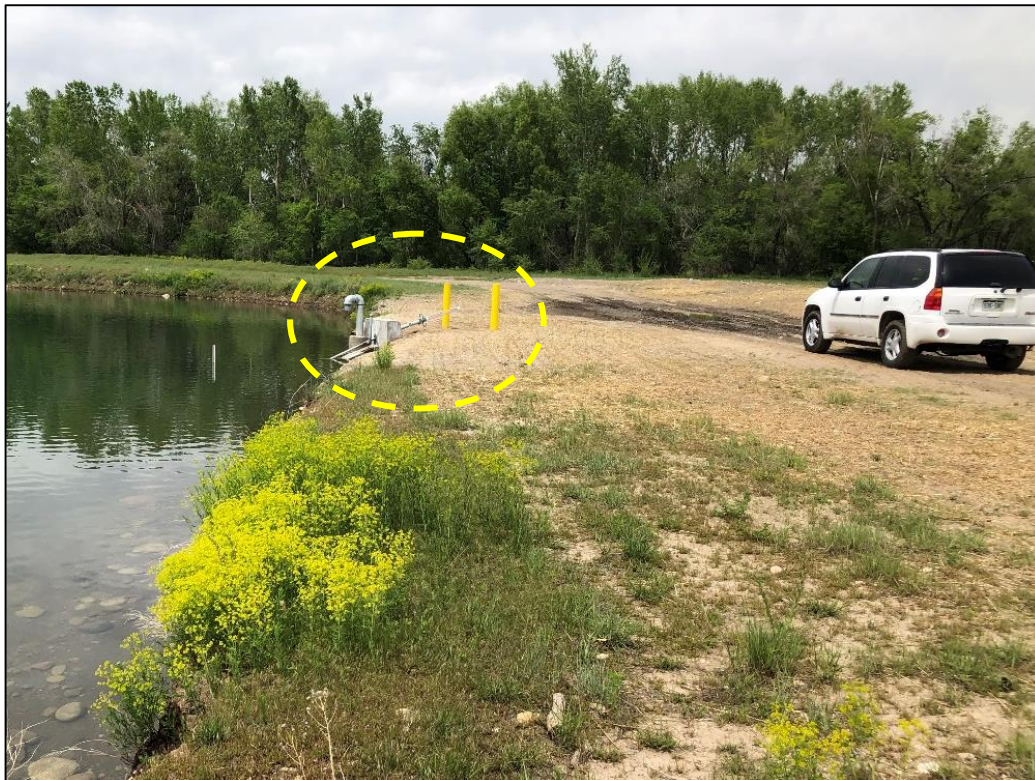
**Photo 14.** View looking north across eastern shoreline of South Reservoir, showing area (at right) re-disturbed by operation to install outlet structure (circled). Operator will need to implement weed control plan in this area for state-listed noxious weed species.

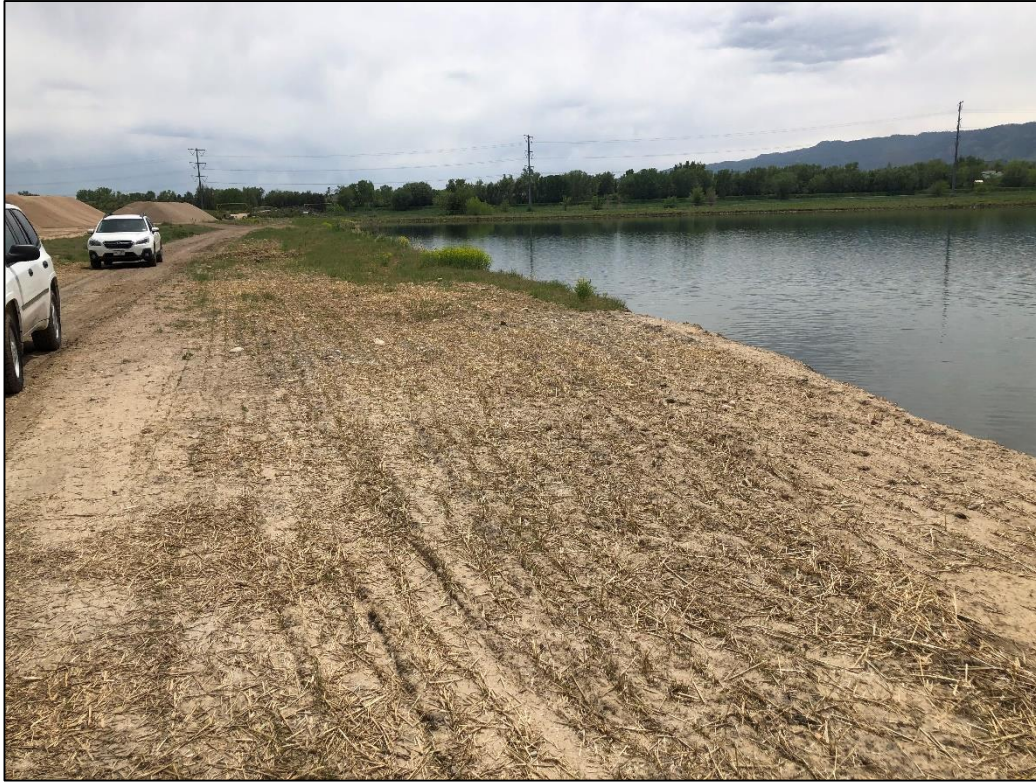
The Division observed an area at the northeastern corner of the South Reservoir where the operator has recently constructed an outlet structure. According to Mr. Dickmeyer, this structure was constructed in December 2020/January 2021, and the disturbed area was seeded and mulched in April of this year. Some grass seedlings were observed in the seeded area. While the revegetation of this re-disturbed area is off to a great start, the outlet structure constructed in this area is not part of the approved reclamation plan for the site. Additionally, Mr. Dickmeyer informed the Division that two interconnect pipelines were previously installed between the two reservoirs. These structures are also not part of the approved reclamation plan. **Therefore, a Problem is cited in this report (see page 1; Problem #2) for failure to follow the approved reclamation plan pursuant to C.R.S. 34-32.5-116(1). Specifically, the operator has installed water management structures for the reservoirs which are not part of the approved reclamation plan. The operator will need to submit a Technical Revision to update the approved reclamation plan and map to reflect existing and proposed activities. The revised reclamation plan and map must address any structures proposed to remain for final reclamation. Additionally, the revised reclamation plan map must show the final installed location**

**Photo 15.** View looking south across eastern shoreline of South Reservoir, showing area re-disturbed by operation to install outlet structure. This area was seeded and mulched this spring.

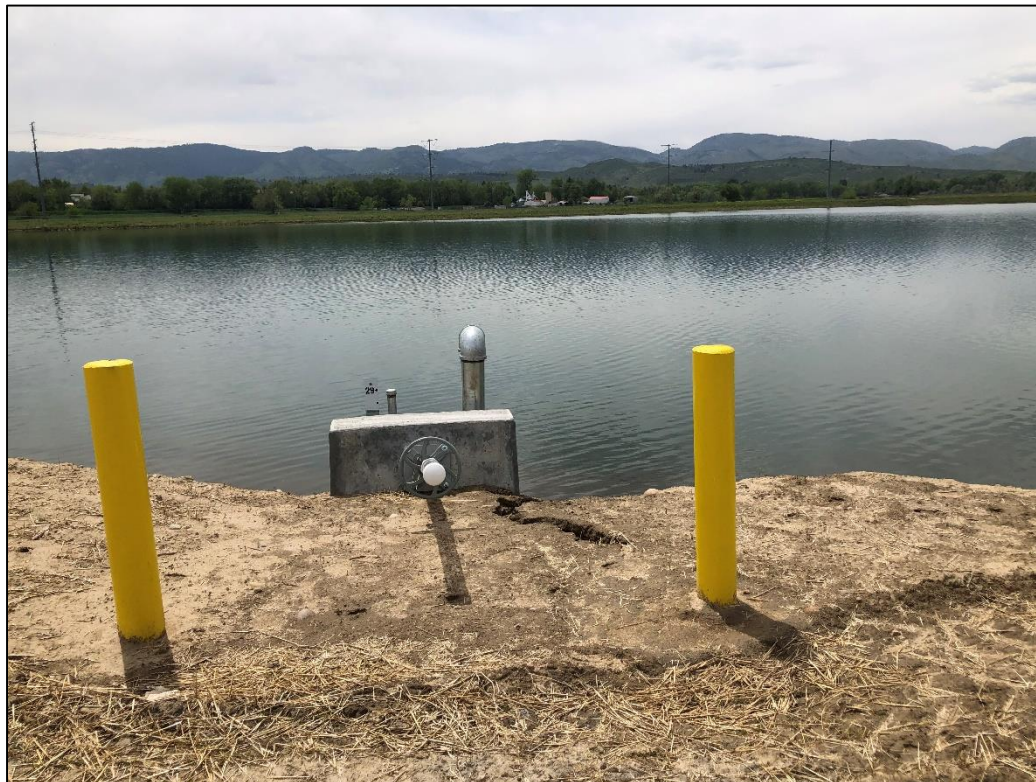
**Photo 16.** View looking west at outlet structure recently installed at northeastern edge of South Reservoir. The reclamation plan and map need to be updated to address any permanent water management structures installed on the affected lands.

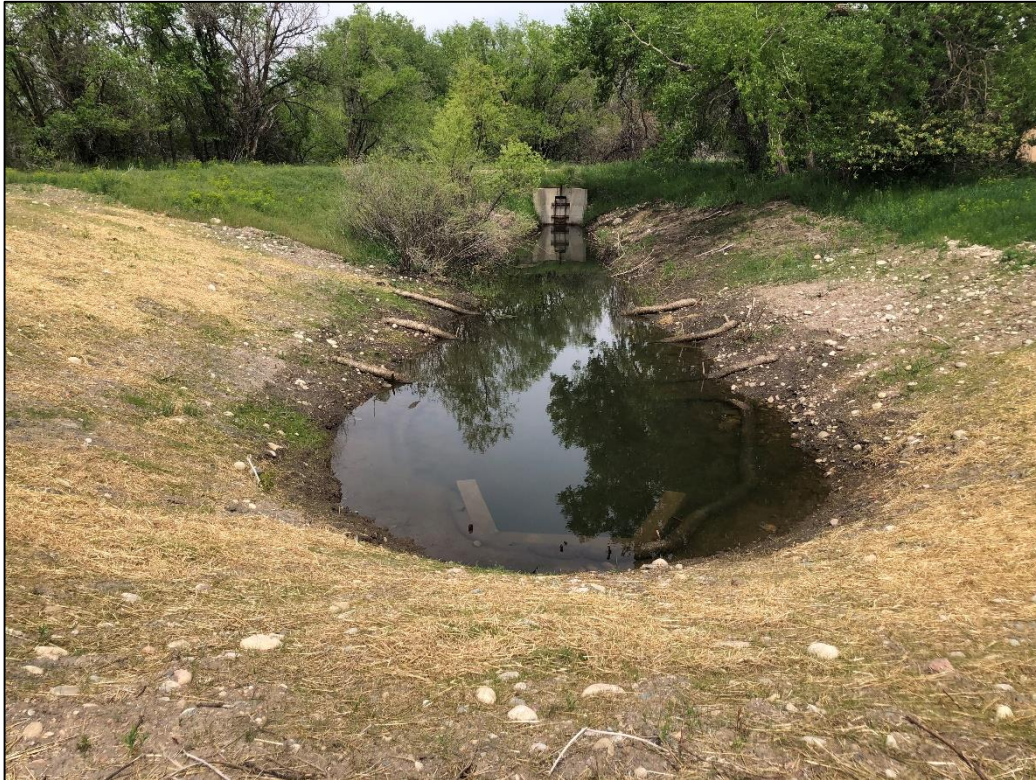
**Photo 17.** View looking northeast at outlet structure recently installed at northeastern edge of South Reservoir. The reclamation plan and map need to be updated to address any permanent water management structures installed on the affected lands.

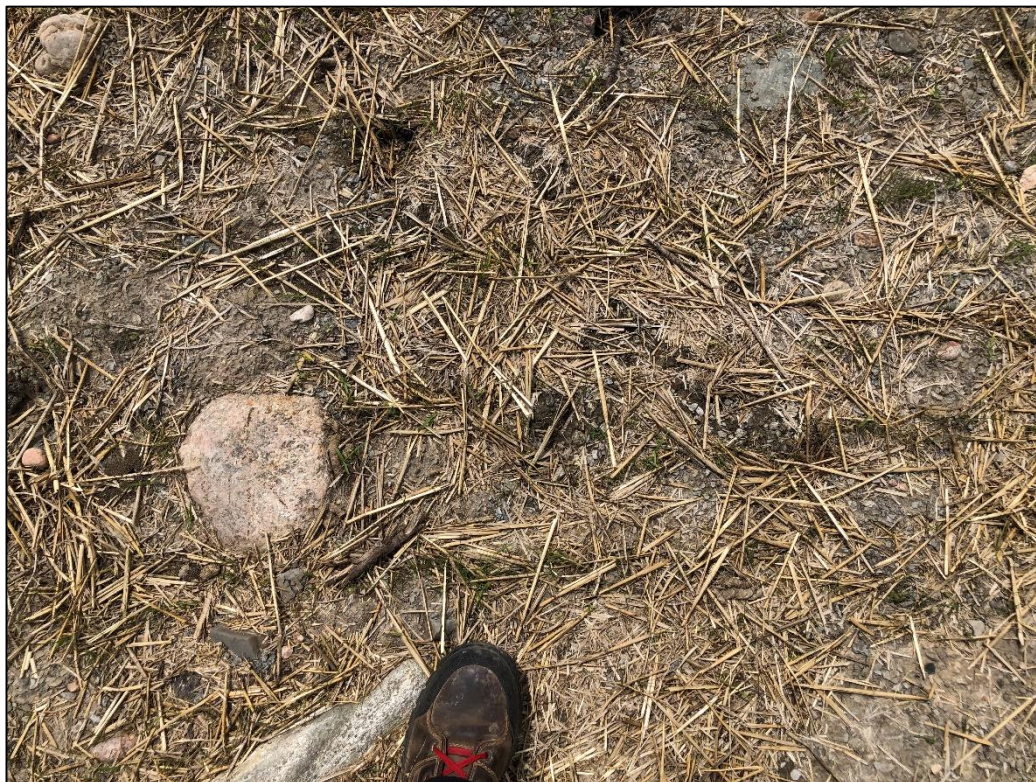
**Photo 18.** Ground view of area re-disturbed at southeastern edge of South Reservoir to install outlet structure, which was seeded and mulched this spring. Note grass seedlings present in this area.

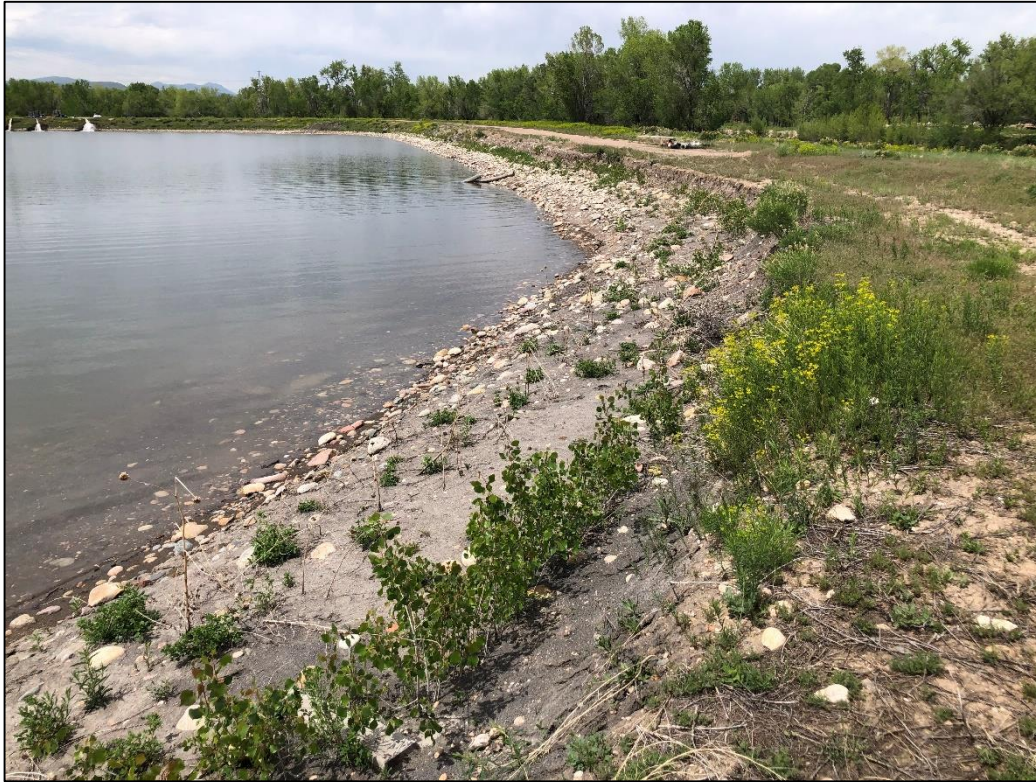
The Division observed numerous volunteer cottonwood trees (and some willow trees) growing along the reservoir shorelines, especially along the eastern and southern shorelines of the North Reservoir. Depending on the installed location of the slurry wall liner, the growth of these trees could potentially compromise the integrity of the liner. Until an updated reclamation plan map has been provided showing the location of the installed slurry wall, it is difficult to determine whether the barrier could be impacted by the trees growing along the reservoir shorelines. Regardless, the operator has an interest in removing these trees from the reservoir shorelines due to their future impacts to water storage. The Division strongly recommends the operator remove any trees and other woody vegetation from the reservoir shorelines, and to do so in a manner that protects the integrity of the shorelines as well as the slurry wall liner.

**Photo 19.** View looking north across eastern shoreline of North Reservoir, graded mostly 3H:1V or flatter with very sparse vegetative cover consisting primarily of volunteer cottonwood trees. Operator will need to remove trees, repair any erosion rilling, and reseed shoreline as needed. Weed control must also be implemented in this area for state-listed noxious weed species.

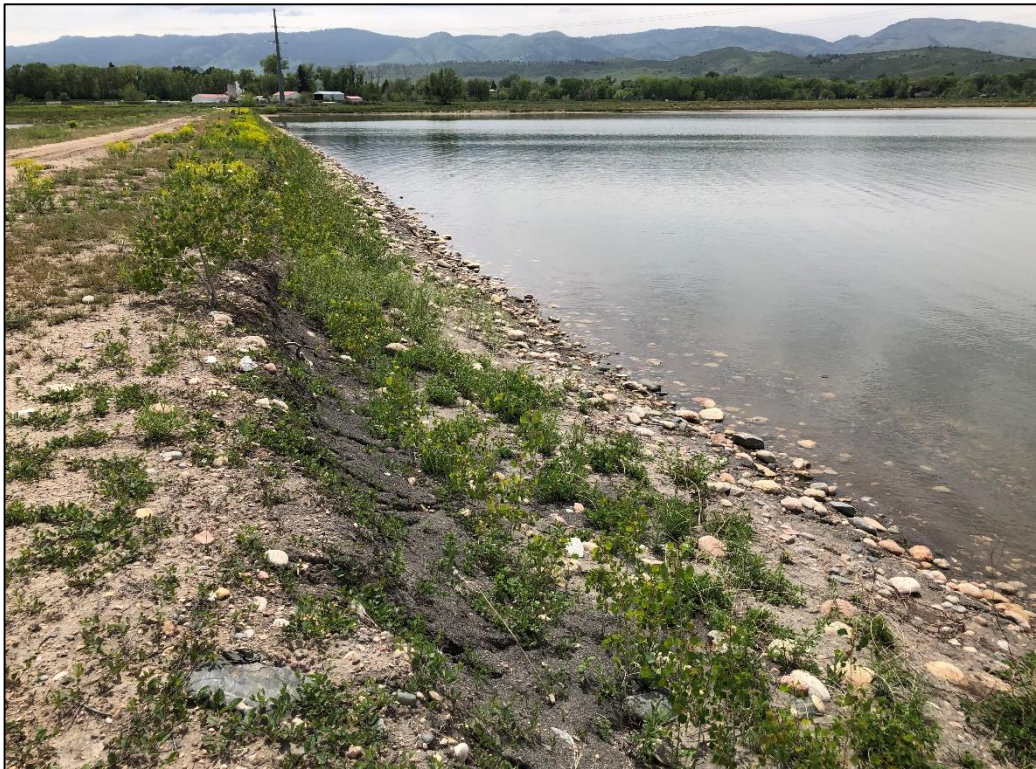
**Photo 20.** View looking southwest across southeastern shoreline of North Reservoir, graded mostly 3H:1V or flatter with very sparse vegetative cover consisting primarily of volunteer cottonwood trees. Operator will need to remove trees, repair any erosion rilling, and reseed shoreline as needed. Weed control must also be implemented in this area for state-listed noxious weed species.

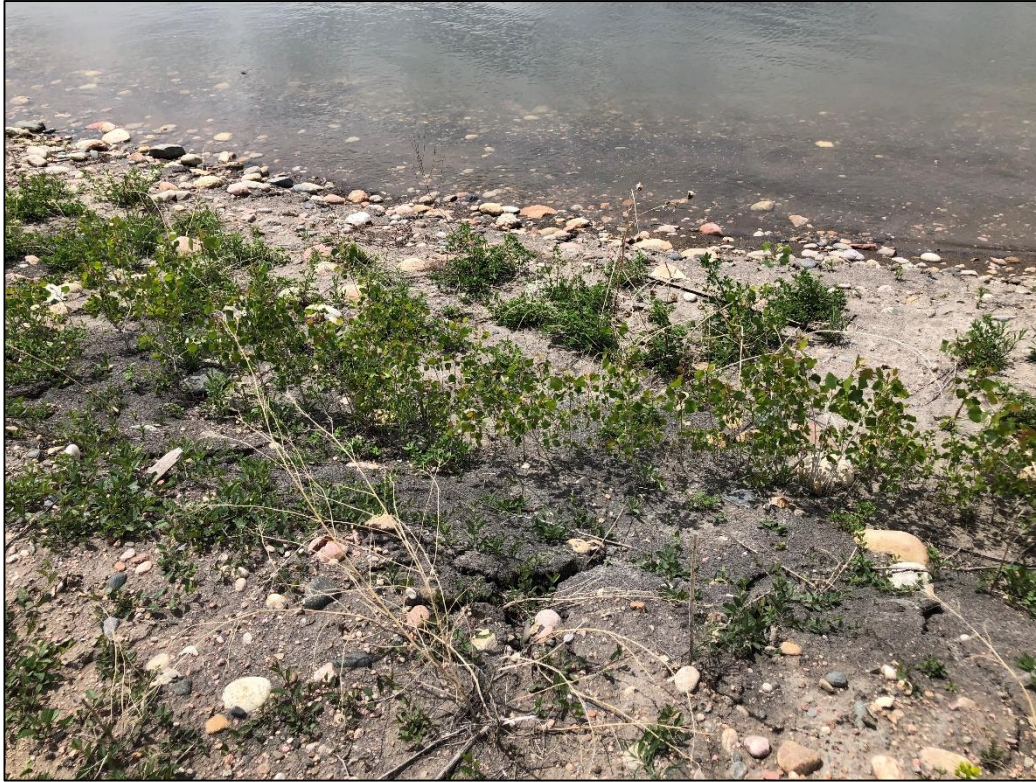
**Photo 21.** Closer view of southeastern shoreline of North Reservoir, graded mostly 3H:1V or flatter with very sparse vegetative cover consisting primarily of volunteer cottonwood trees. Operator will need to remove trees, repair any erosion rilling, and reseed shoreline as needed.

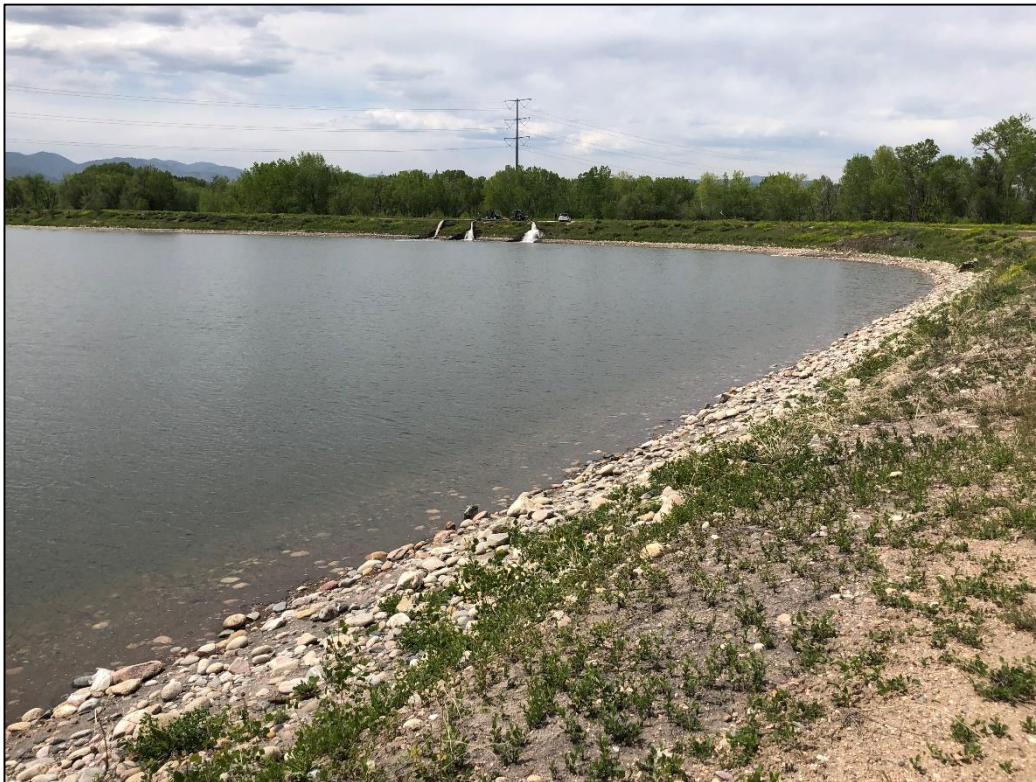
**Photo 22.** View looking northwest across eastern shoreline of North Reservoir, graded mostly 3H:1V or flatter with very sparse vegetative cover consisting primarily of volunteer cottonwood trees. Operator will need to remove trees, repair any erosion rilling, and reseed shoreline as needed. Weed control must also be implemented in this area for state-listed noxious weed species.

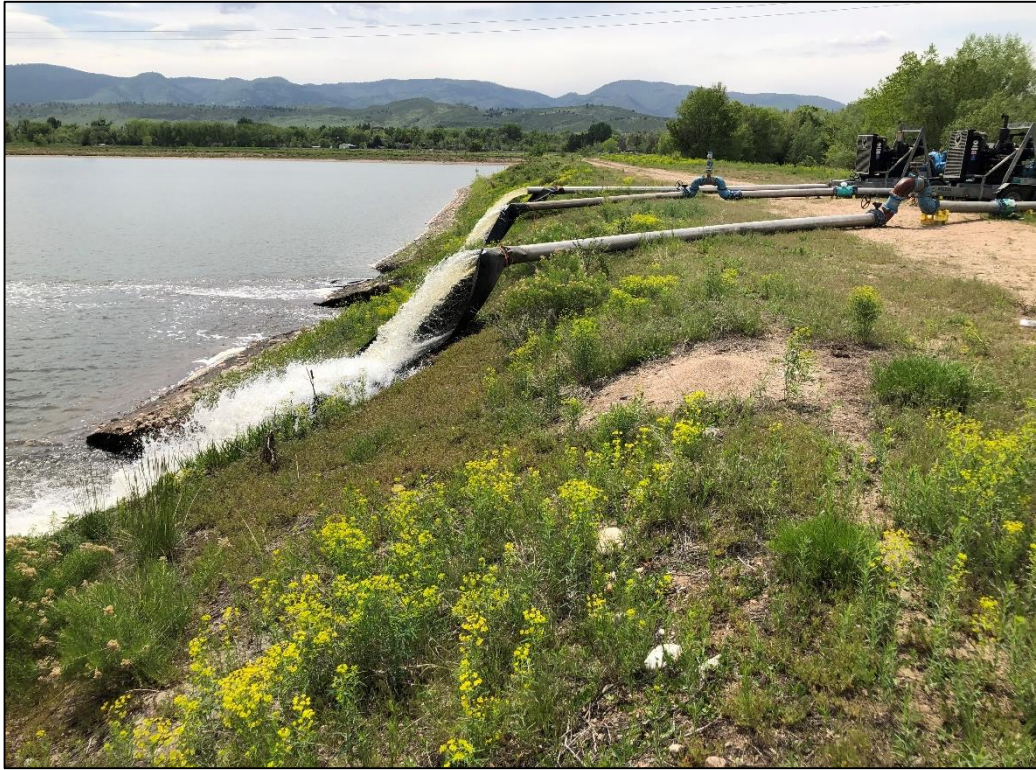
**PROBLEM #1:** Erosion gullies and ruts were observed on-site. Specifically, the three above-ground pipelines temporarily discharging water from the creek into the North Reservoir have created large erosion gullies along the northern shoreline of this reservoir. Erosion rilling was also observed along unvegetated portions of the shorelines. This is a problem at this time for failure to protect the affected land from erosion pursuant to C.R.S. 34-32.5-116(4)(j).

Along the northern shoreline of the North Reservoir, three portable pumps were in operation, pumping water from the river (located north of the site) and discharging this water into the South Reservoir via three above-ground pipelines. The ends of these pipelines terminated above the shoreline so that the water discharging from the pipelines was creating large erosion gullies (approximately 6 feet in depth) along the graded shoreline. Mr. Dickmeyer indicated once the operation completes filling the reservoir (in another 2-3 weeks), the pipelines will be removed and the erosion along the shoreline repaired. He believes the slurry wall was installed 10's of feet north of the crest of the shoreline, and therefore is not being impacted by the erosion damage. However, without having any record of the final constructed slurry wall alignment, the Division could not confirm whether the barrier is impacted by the erosion damage. **A Problem is cited in this report (see page 1; Problem #1) for failure to protect the affected land from erosion pursuant to C.R.S. 34-32.5-116(4)(j). The operator will need to repair the erosion damage present along reservoir shorelines and provide photographic evidence to the Division demonstrating this has been done.** This corrective action shall apply to all erosion damage present along the North Reservoir shorelines, including the large erosion gullies created along its northern shoreline from the discharge and the erosion rilling present along other portions of its shorelines. These repaired areas will most likely require additional seeding in order to achieve the required grass cover for reclamation.

**Photo 23.** View looking west across northern shoreline of North Reservoir, showing three above-ground pipelines discharging water pumped from river into the reservoir. Note large erosion gullies created along shoreline from this discharge. Operator will need to repair erosion damage and reseed shoreline as needed. Weed control must also be implemented in this area for state-listed noxious weed species.

**CORRECTIVE ACTIONS:** By the corrective action due date, the operator shall provide photo documentation to the Division verifying the erosion along reservoir shorelines has been repaired, and that the site has been reconstructed and stabilized to prevent continued erosion damage.

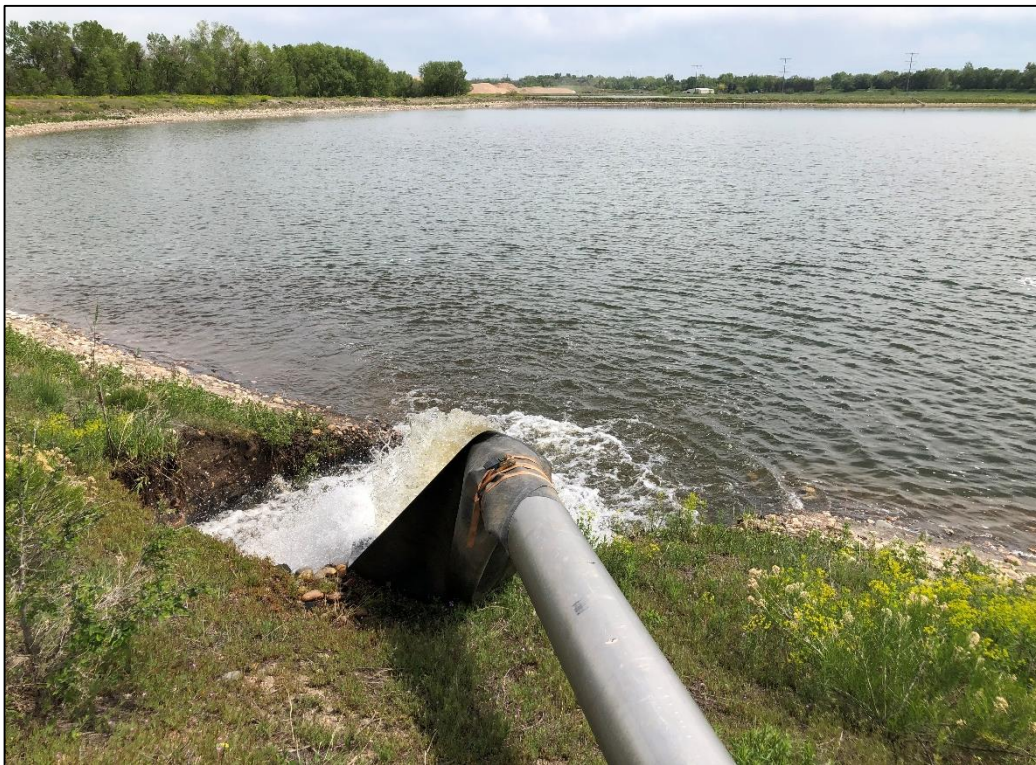
**Photo 24.** Closer view of pipeline discharging water into North Reservoir along its northern shoreline, showing large erosion gully (approximately 6 feet deep) created along shoreline. Operator will need to repair this erosion damage and reseed shoreline as needed.

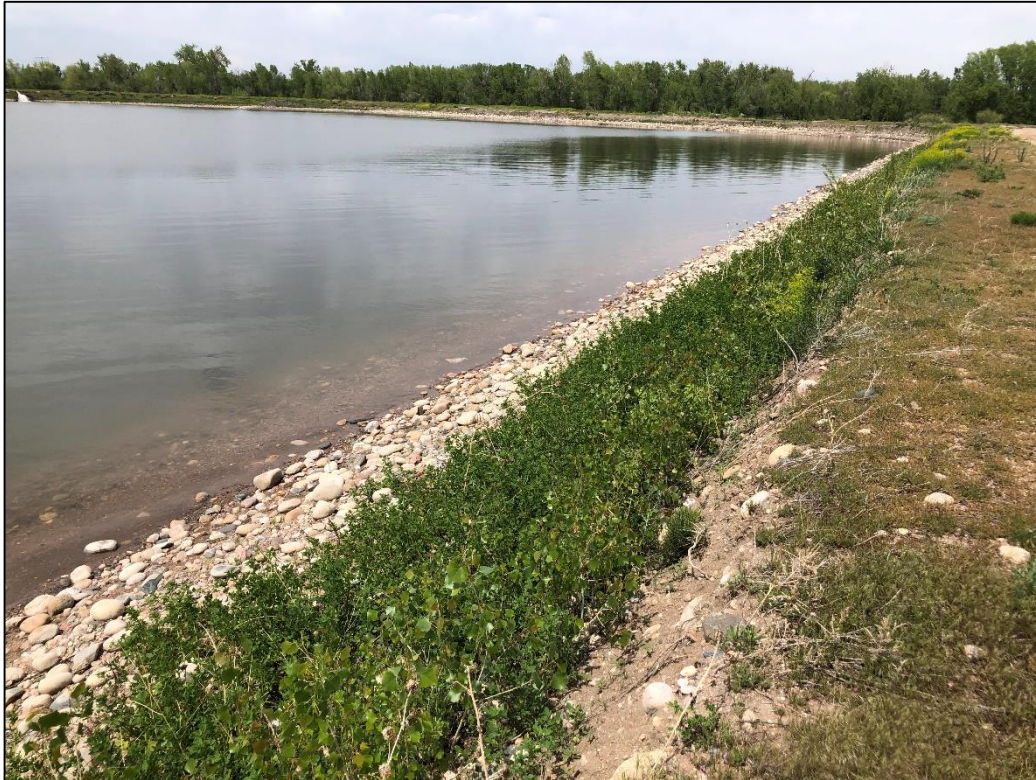
**Photo 25.** View looking northeast across southeastern shoreline of North Reservoir, graded mostly 3H:1V or flatter with dense cluster of volunteer cottonwood trees. Operator will need to remove trees, repair any erosion rilling, and reseed shoreline as needed. Weed control must also be implemented in this area for state-listed noxious weed species.

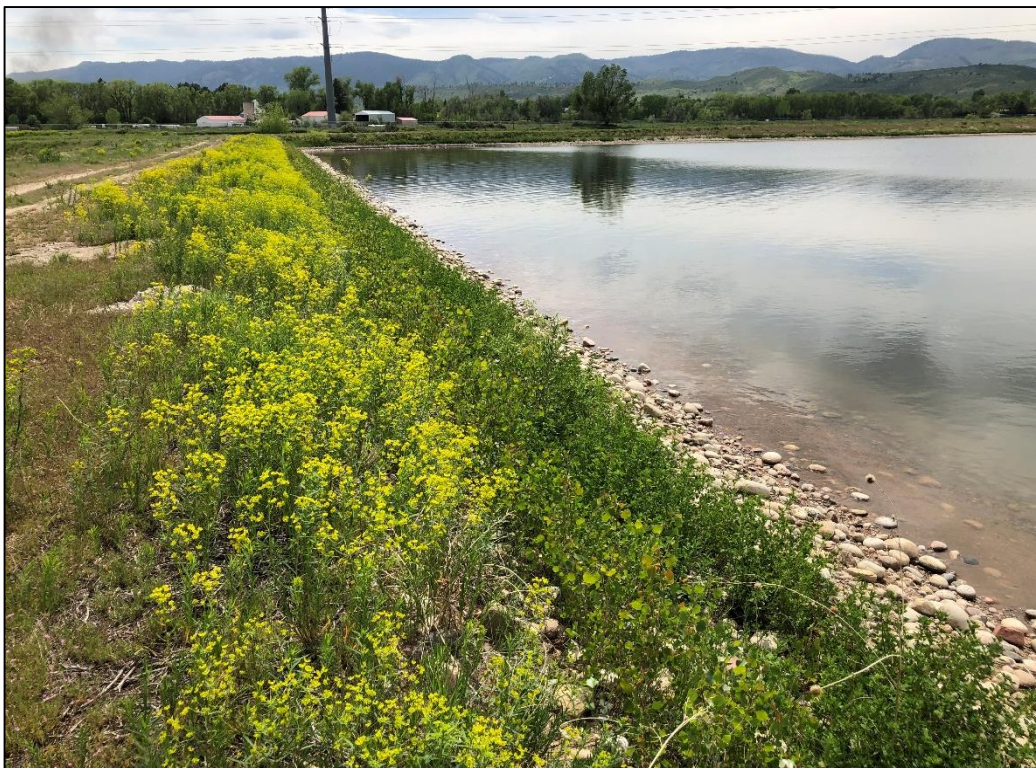
**Photo 26.** View looking southwest across southeastern shoreline of North Reservoir, graded mostly 3H:1V or flatter with dense cluster of volunteer cottonwood trees. Operator will need to remove trees, repair any erosion rilling, and reseed shoreline as needed. Weed control must also be implemented in this area for state-listed noxious weed species.
