**MINERALS PROGRAM INSPECTION REPORT**  
**PHONE: (303) 866-3567**

| <b>MINE NAME:</b><br>Treiber Lakes | <b>MINE/PROSPECTING ID#:</b><br>M-2011-049 | <b>MINERAL:</b><br>Aggregate | <b>COUNTY:</b><br>Larimer |
| <b>INSPECTION TYPE:</b><br>Monitoring | <b>INSPECTOR(S):</b><br>Amy Eschberger | <b>INSP. DATE:</b><br>May 26, 2021 | <b>INSP. TIME:</b><br>14:00 |

# M-2011-049 / Treiber Lakes / City of Greeley (112c)

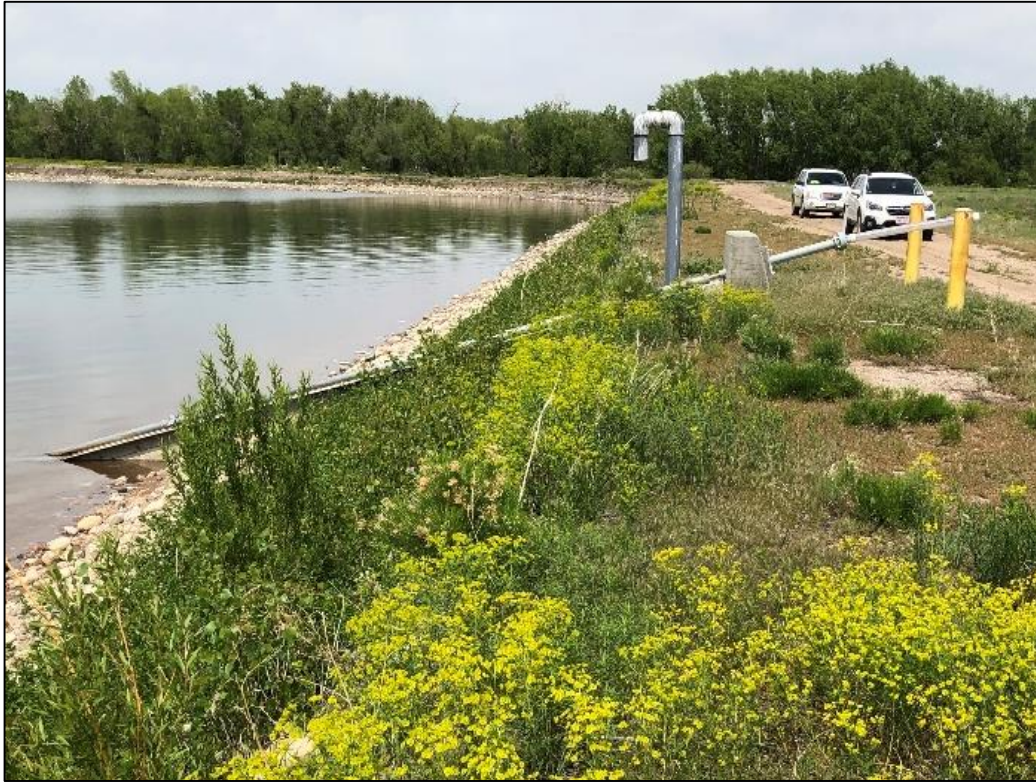
**Photo 27.** View looking northeast at control structure installed at southeastern edge of North Reservoir. The reclamation plan and map need to be updated to address any permanent water management structures installed on the affected lands. Operator will need to implement weed control plan in this area for state-listed noxious weed species

**CORRECTIVE ACTIONS:** By the correction action due date, the operator shall submit a Technical Revision,

with the required \$216 revision fee, to update and clarify the current approved reclamation plan and map to reflect existing and proposed activities. The revised reclamation plan and map must address any structures proposed to remain for final reclamation. Additionally, the revised reclamation plan map must show the final installed location of the slurry wall.

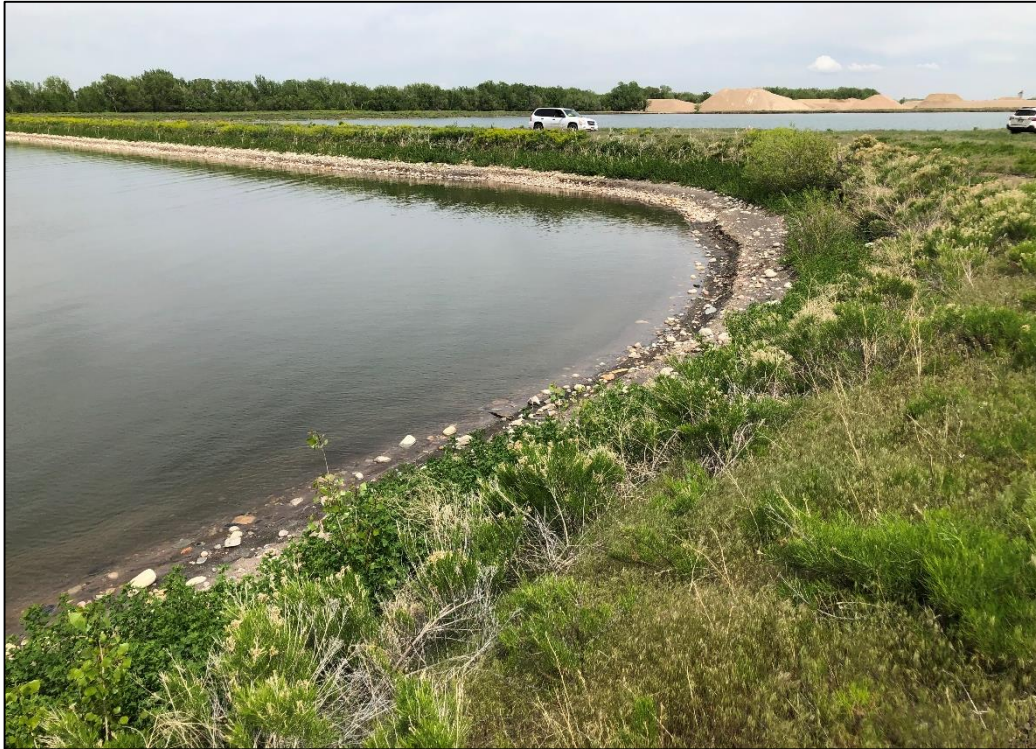
**Photo 29.** View looking southeast at southern shoreline of North Reservoir, graded mostly 3H:1V or flatter with dense cluster of volunteer cottonwood trees. Operator will need to remove trees, repair any erosion rilling, and reseed shoreline as needed. Weed control must also be implemented in this area for state-listed noxious weed species.

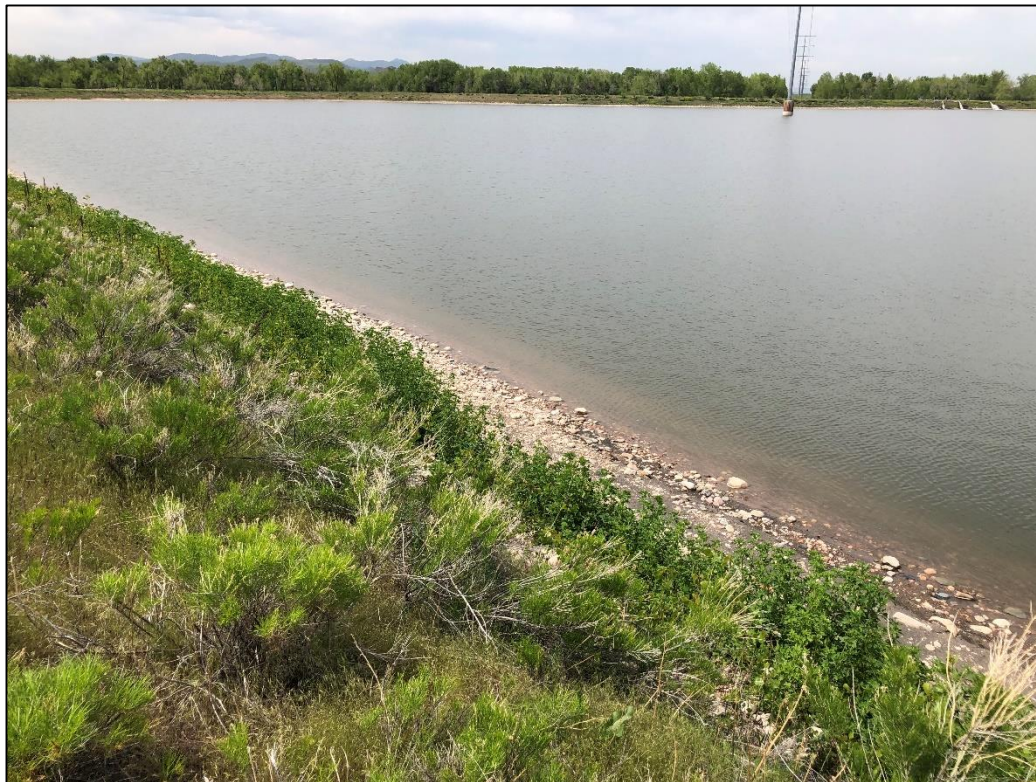
**Photo 30.** View looking northwest across southwestern shoreline of North Reservoir, graded mostly 3H:1V or flatter with dense cluster of volunteer cottonwood trees. Operator will need to remove trees, repair any erosion rilling, and reseed shoreline as needed. Weed control must also be implemented in this area for state-listed noxious weed species.

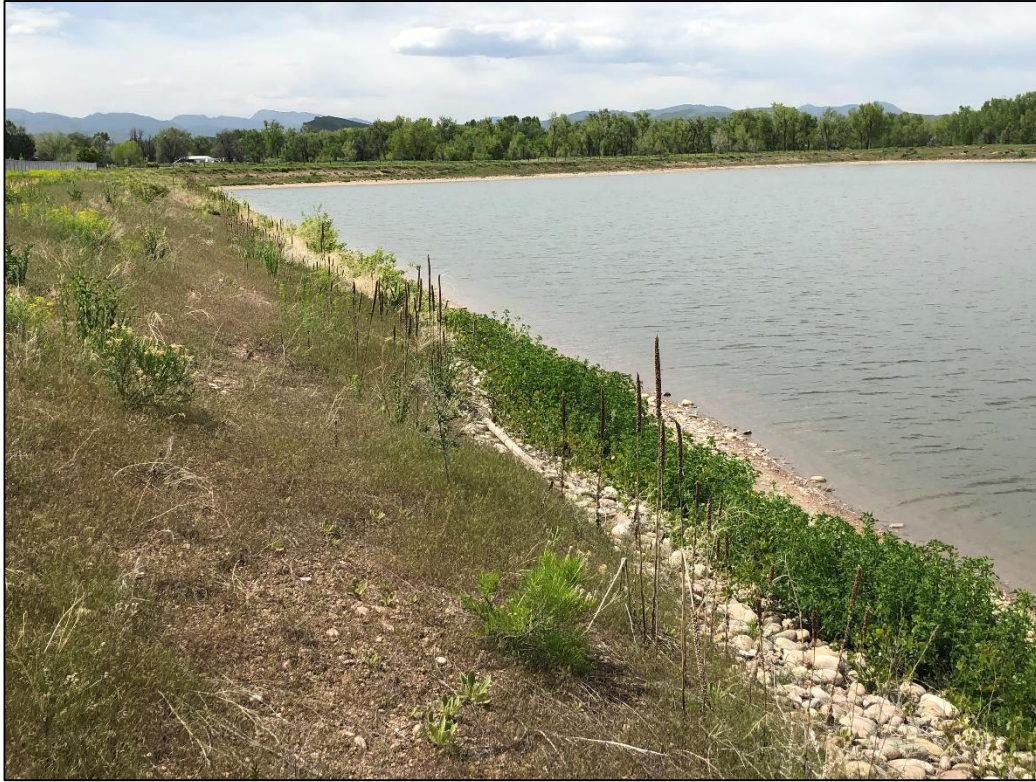
**Photo 31.** View looking northwest across southwestern shoreline of North Reservoir, graded mostly 3H:1V or flatter with dense cluster of volunteer cottonwood trees. Operator will need to remove trees, repair any erosion rilling, and reseed shoreline as needed. Weed control must also be implemented in this area for state-listed noxious weed species.

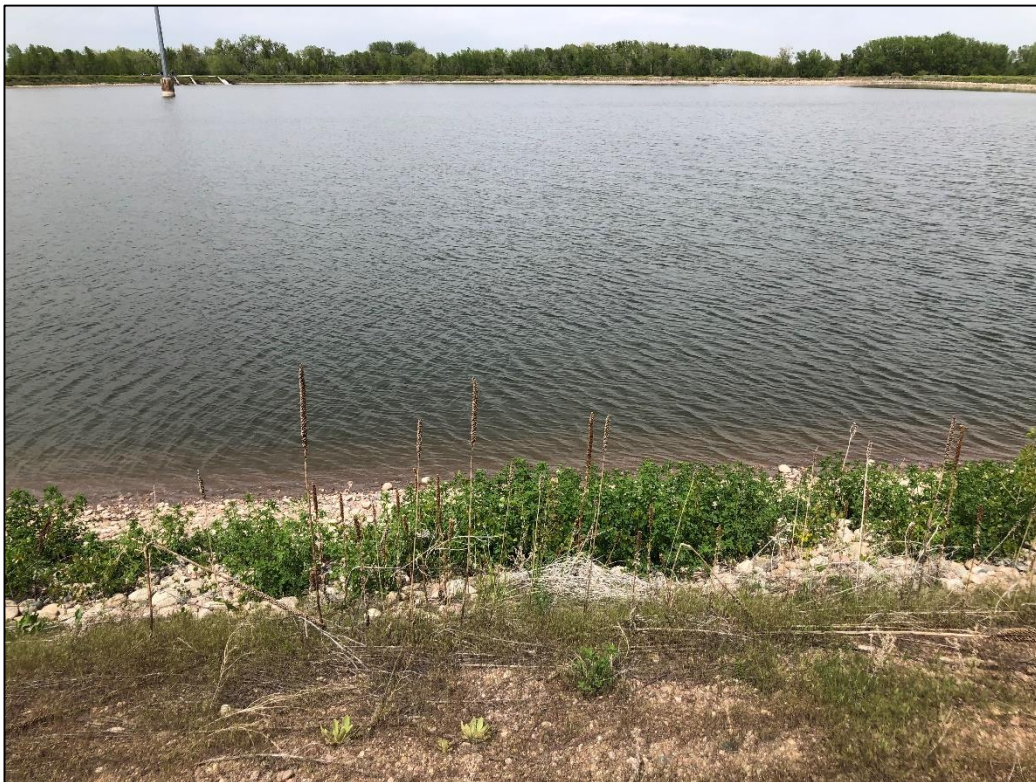
**Photo 32.** View looking northeast across North Reservoir from its southwestern shoreline. Operator will need to remove trees, repair any erosion rilling, and reseed shoreline as needed. Weed control must also be implemented in this area for state-listed noxious weed species.
