MINERALS PROGRAM INSPECTION REPORT
PHONE: (303) 866-3567

MINE NAME: Cresson Project	MINE/PROSPECTING ID#: M-1980-244	MINERAL: Gold	COUNTY: Teller
INSPECTION TYPE: Monitoring	INSPECTOR(S): Timothy Cazier, P.E.	INSP. DATE: April 29, 2021	INSP. TIME: 09:00
OPERATOR: Cripple Creek & Victor Gold Mining Company	OPERATOR REPRESENTATIVE: Katie Blake & Dylan Noble	TYPE OF OPERATION: 112d-3 - Designated Mining Operation	
REASON FOR INSPECTION: Normal I&E Program	BOND CALCULATION TYPE: None	BOND AMOUNT: \$159,491,188.00	
DATE OF COMPLAINT: NA	POST INSP. CONTACTS: None	JOINT INSP. AGENCY: None	
WEATHER: Clear	INSPECTOR'S SIGNATURE:

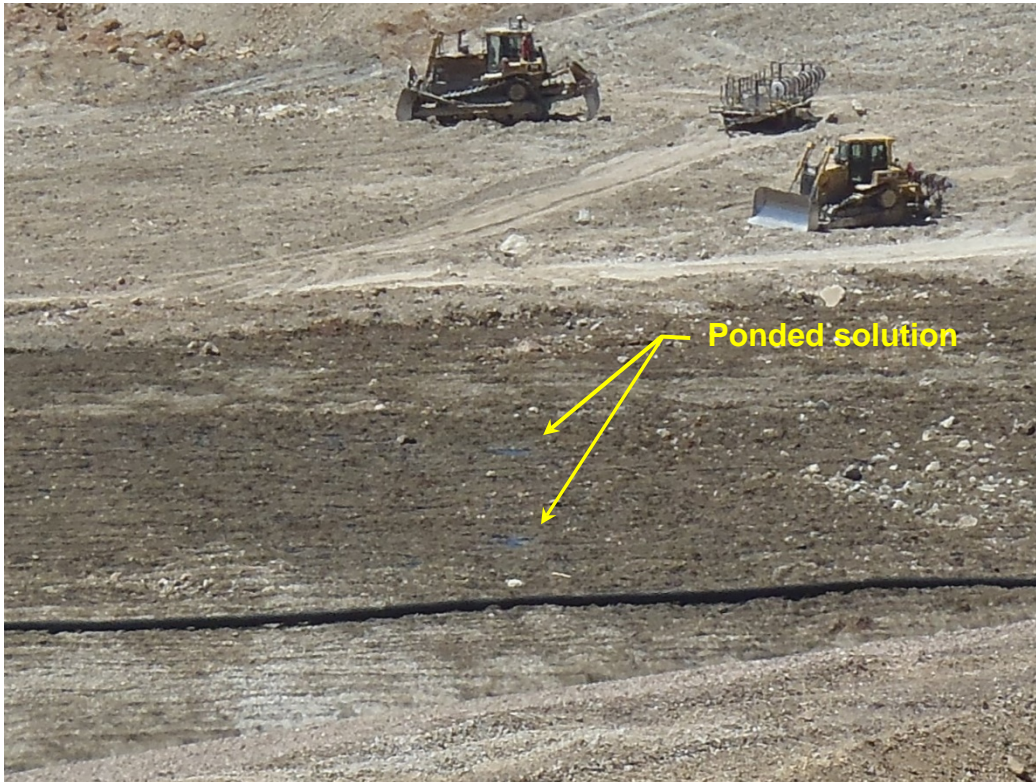
The surface of VLF2 was being actively leached with process solution at the time of the inspection. Two small areas with ponded solution were observed using binoculars (see **Photo 1**). These two areas appeared to be close to the 3-ft by 3-ft limit in the approved wildlife protection plan. CC&V representatives stated they would remedy the situation.

Photo 1. VLF 2: Smaller areas of ponded solution (looking SW from Brahma Building overlook).

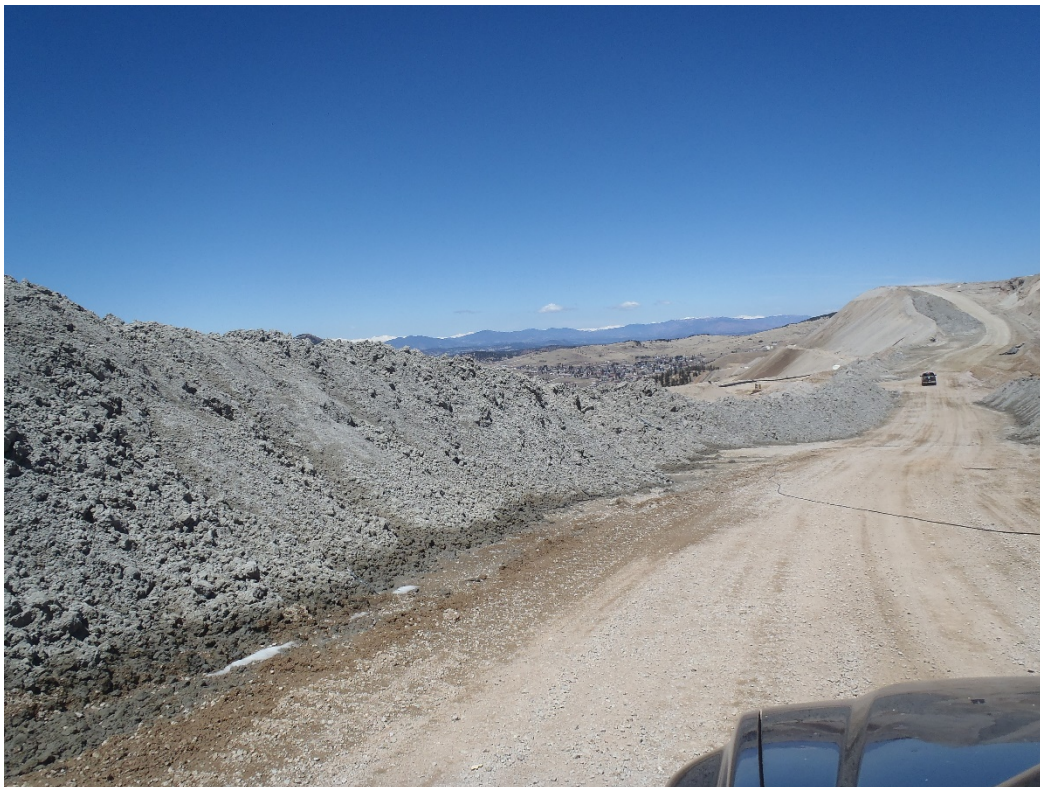
VLF 1 was checked for solution ponding limits based on the approved wildlife protection plan limiting ponding to areas less than 3 feet by 3 feet. No ponding was observed on the 10,200, 10,300, and 10,400 levels. High Grade Mill tailings were observed stacked along the access road (see **Photo 2**).

Photo 2. HGM tailings stockpiled along VLF1 haul road (looking north).

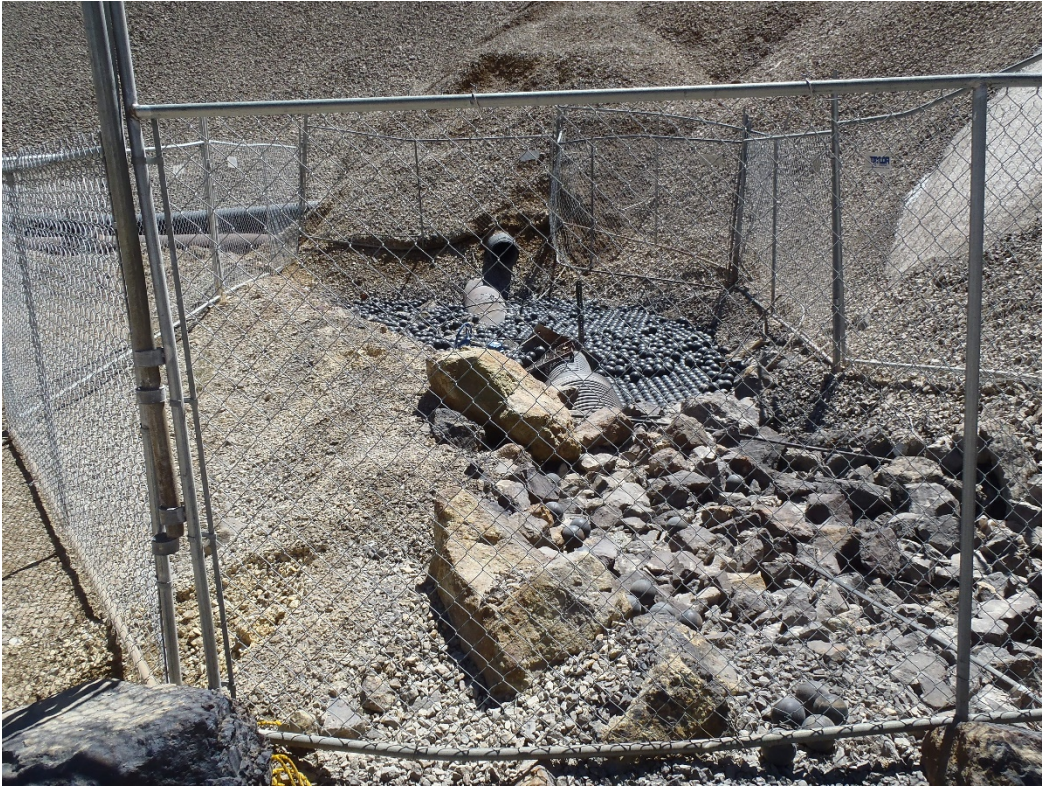
DRMS aerial inspection images have highlighted ponds on the crusher side of Phase V. Site representatives explained these surge ponds were constructed in this area to accommodate collected Phase V leachate in an area where the collection pipes are on a flatter grade, thereby reducing their flow capacity. These surge ponds were inspected for compliance with the approved wildlife protection plan. Both ponds were dry at the time of the inspection but were surrounded by six-foot chain link fence and filled with bird balls (see **Photos 3 and 4**). The configuration appeared to meet the intent of the wildlife protection plan. The DRMS will continue to monitor these protections to ensure the fence is maintained and the sufficient bird balls are in place.

Photo 3. VLF 1: East Phase V surge pond (looking east).

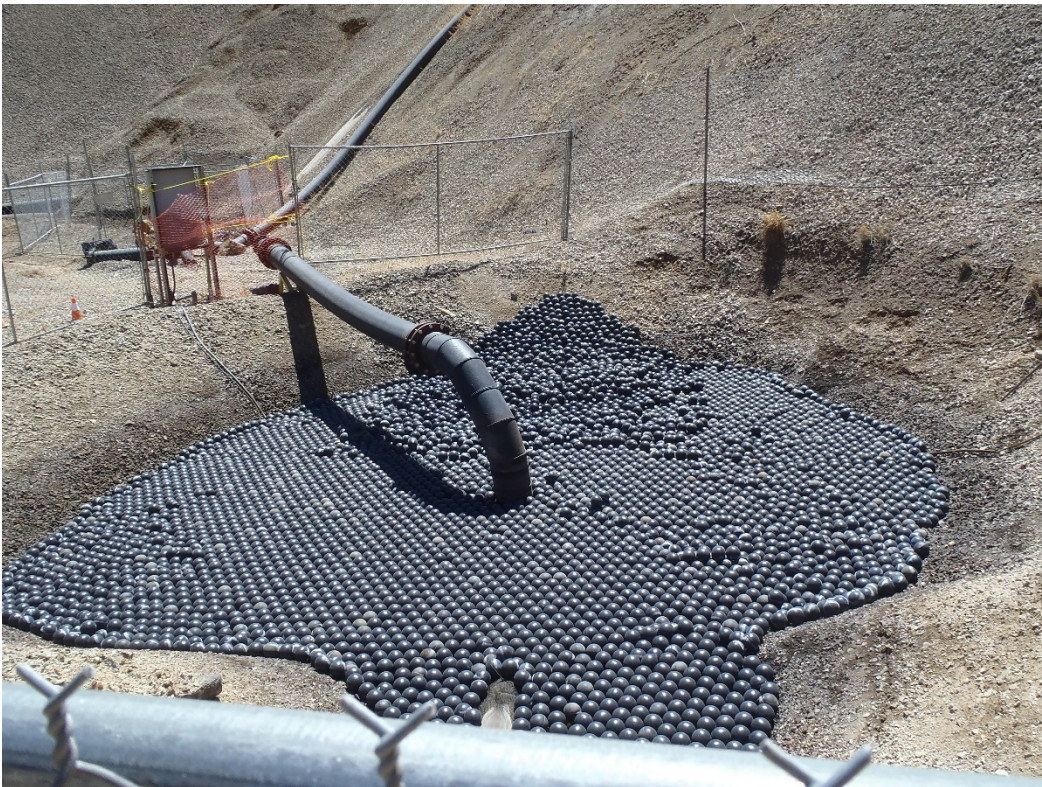
Photo 4. VLF 1: West Phase V surge pond (looking east, east surge pond in background).

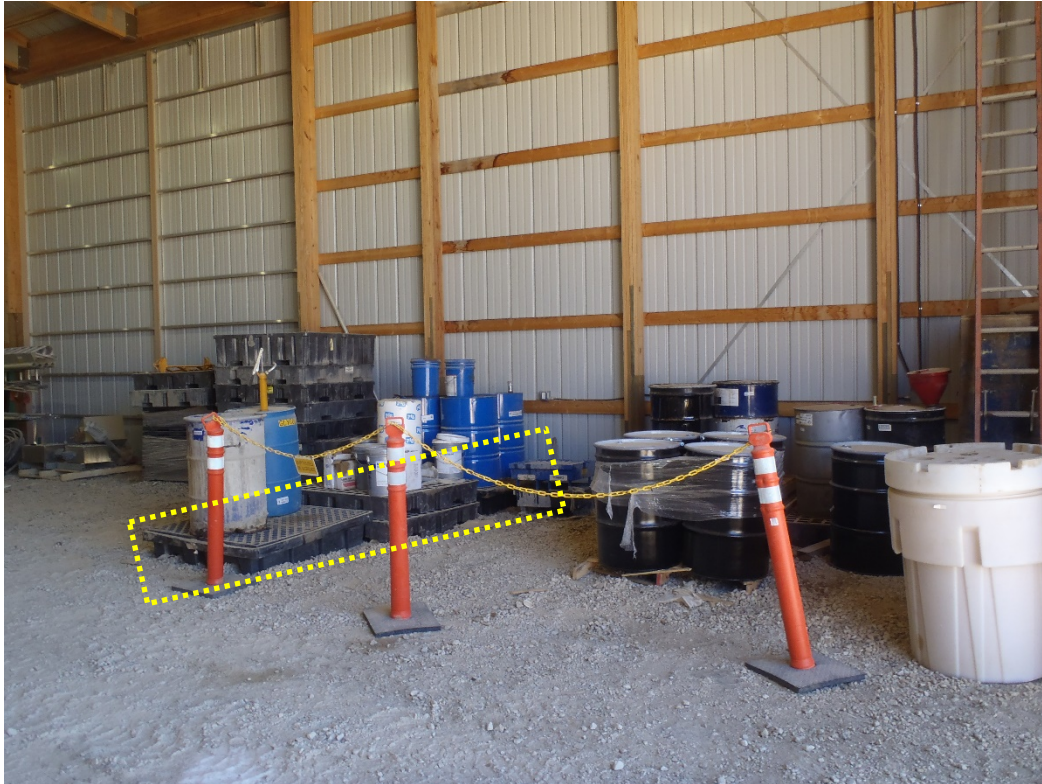
and west sides of the mill exterior were inspected, as well as the area around the concentrate storage facility (Con Barn). Both sides appeared well maintained and no measurable secondary containment storage volume was observed. The maintenance storage shed north of the HGM was also inspected. Containers not factory sealed and stored inside appeared to have adequate secondary containment (see **Photo 5**).

Photo 5. Secondary containment under drums and buckets being filled with waste liquids (HGM Maintenance Shed).

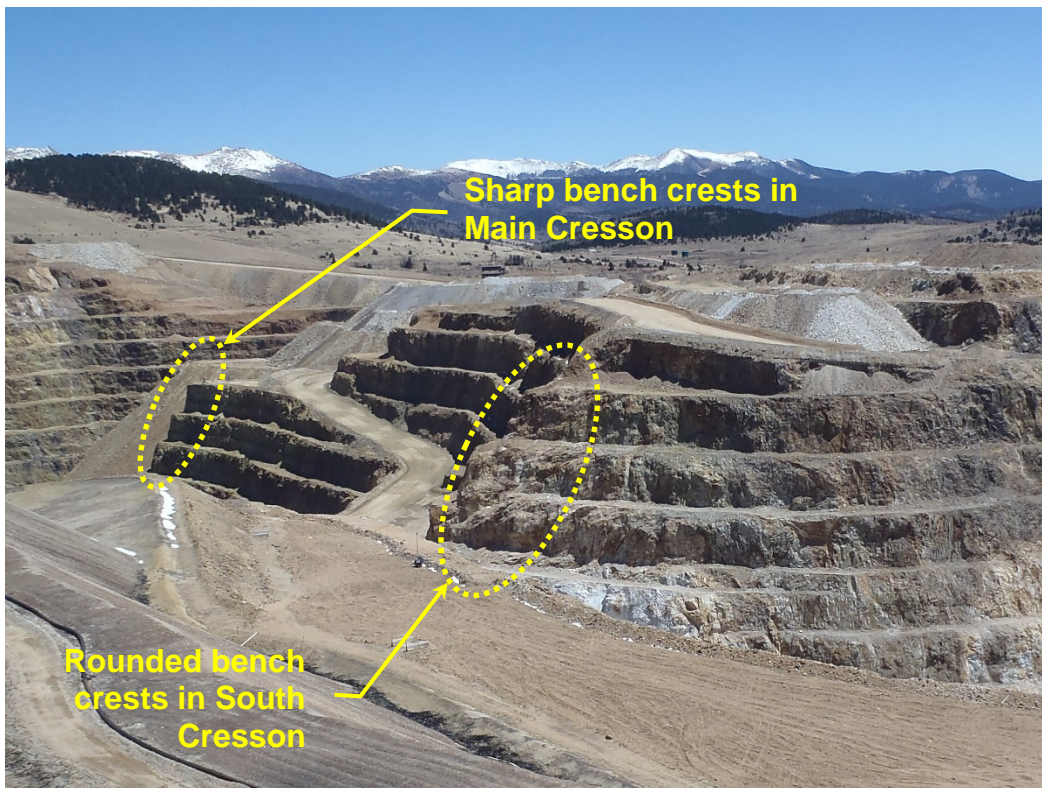
South Cresson Highwall: The South Cresson highwalls were inspected to observe bench configurations. Benches were more defined than what appeared in DRMS aerial images. Although bench crests appeared more rounded than in the adjacent Main Cresson pit (see **Photo 6**). An image taken of the east South Cresson highwall indicates the overall slope is $\sim 58^\circ$ (see **Photo 7**). The East Cresson west highwall bench crests are also somewhat rounded, limiting rockfall catchment capacity (see **Photo 8**). Site representatives were asked if the highwalls were scaled to limit rockfall. They indicated it was likely not common, but would check with Mine Operations to get a more definitive answer.

Photo 6. Main Cresson and South Cresson Bench comparison (looking ENE from VLF1 10,400 level)

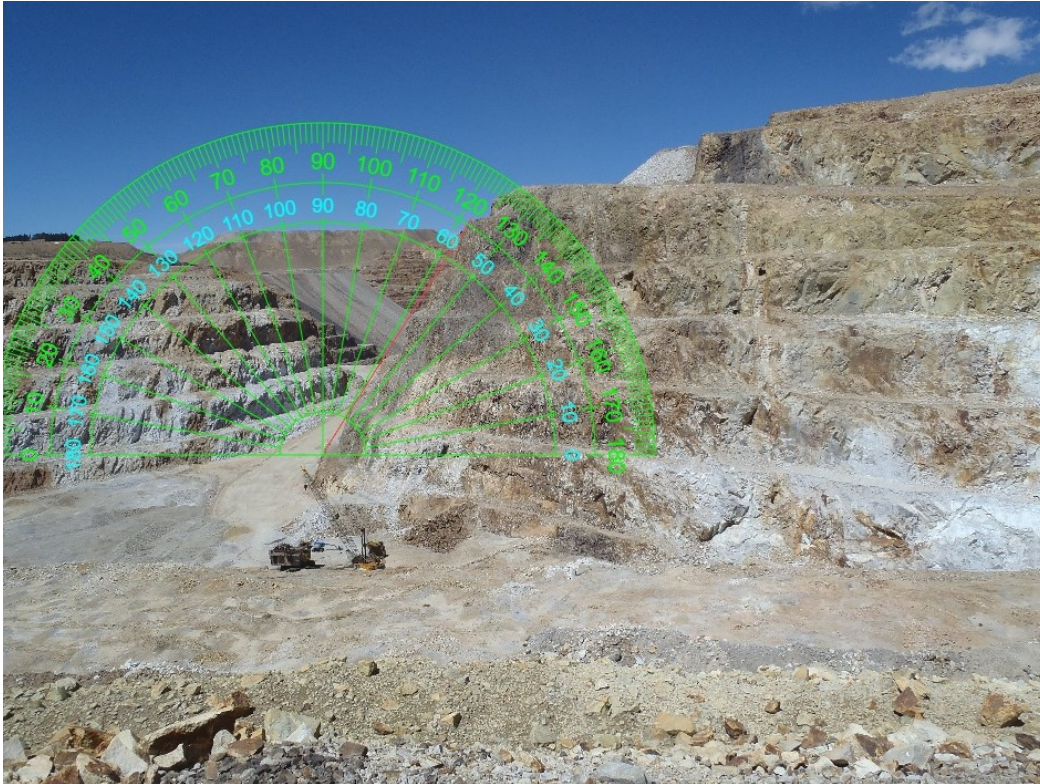
Photo 7. South Cresson, east highwall angle at $\sim 58^\circ$ (looking north).

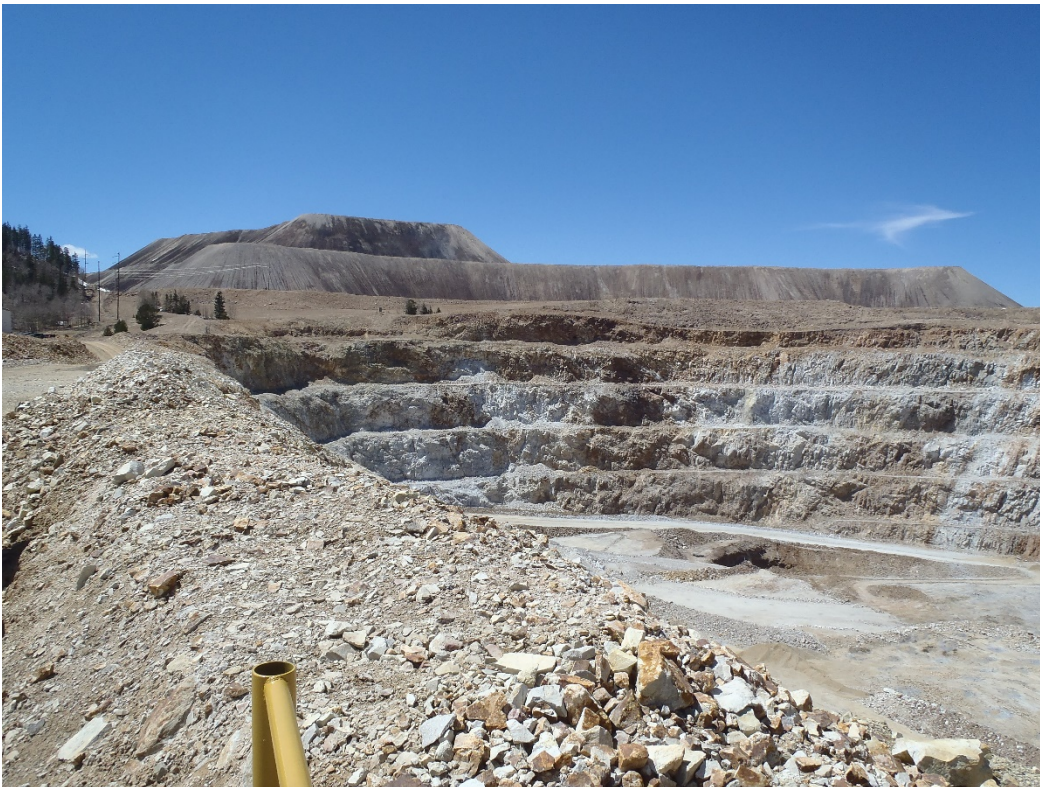
Photo 8. South Cresson, west highwall (looking NW).

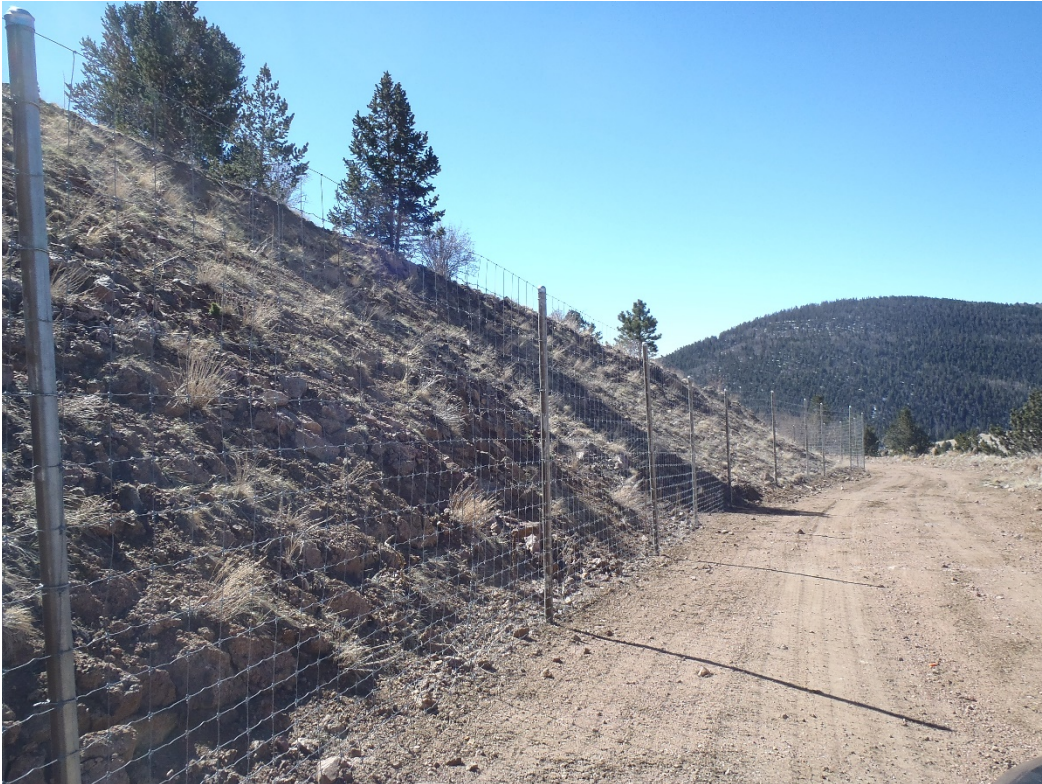
- New wildlife fencing was observed along the road between the VLF1 Phase V pumps and Hwy 67 just west of the city of Victor (see **Photo 9**).
- The widening of the berm/embankment for the holding pond west of the PSES (cited as having potential containment concerns in our June 30, 2020 inspection) was observed (see **Photo 10**). This embankment is still the low point where if capacity is exceeded, potentially impacted water would flow off the lined area. However, the widening of the embankment crest will reduce the potential for it to breach from overtopping erosion.

Photo 9. New wildlife fencing along Phase V pump access road (looking SSE).

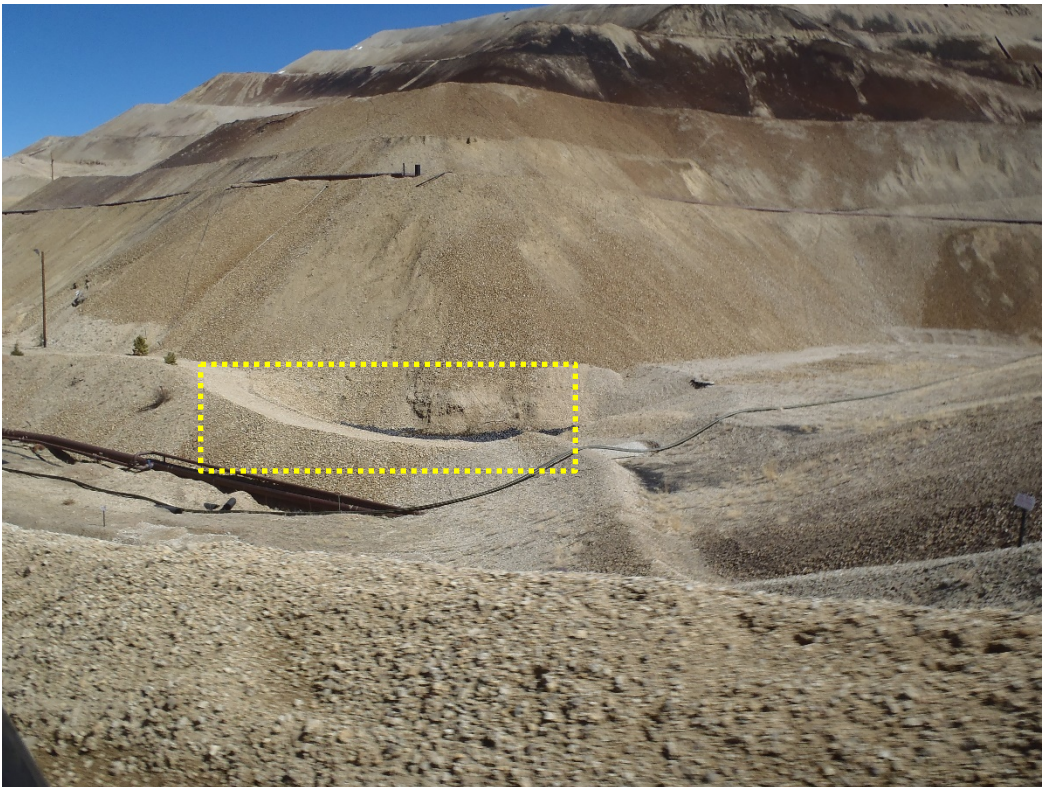
Photo 10. Widened embankment on SW side of PSES holding pond (note low point directs overflow off liner).

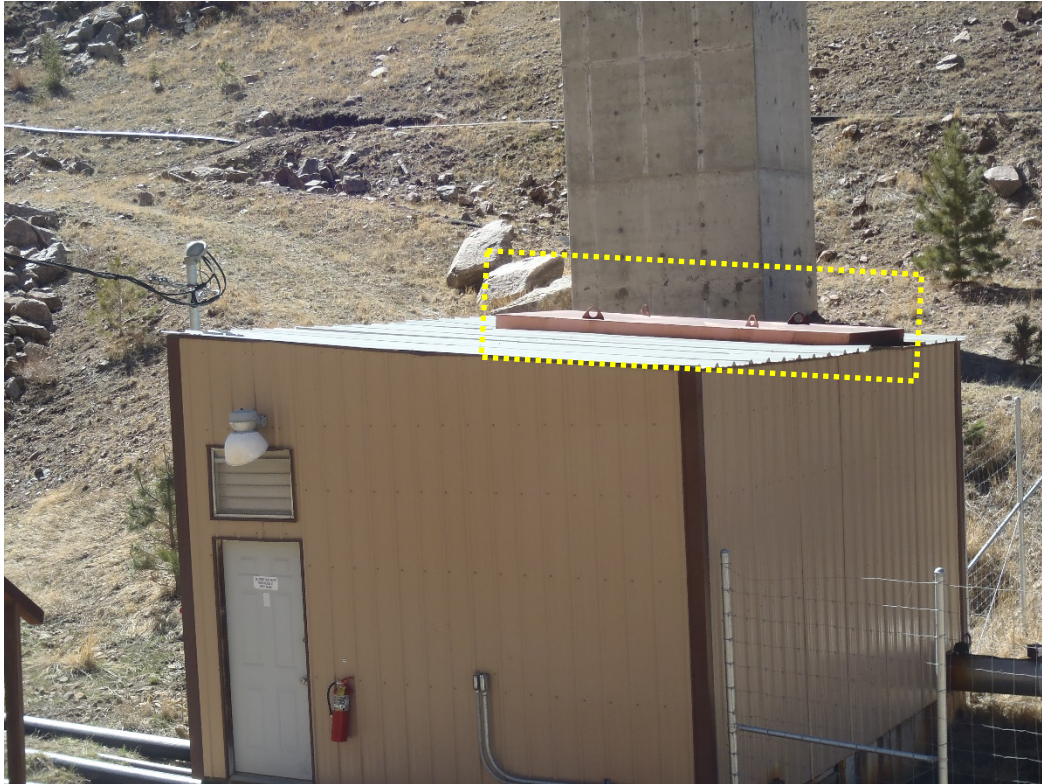
- The Arequa Gulch pumpback system was visited. A steel plate has been placed on the roof (see **Photo 11**) of the pumpback building to cover the hole in the roof and provide some protection from ice fall originating from the overhead Hwy 67 bridge. Site representatives were asked about the bird nest fouling the CRMW-3 series monitoring well. **Photo 12** shows how the cap on CRMW-3B was cut to accommodate several hoses. **Photo 13** shows how the cap on CRMW-3A was patched with duct tape to curtail bird entry.

Photo 11. Steel plate on Arequa Gulch pumpback shed.

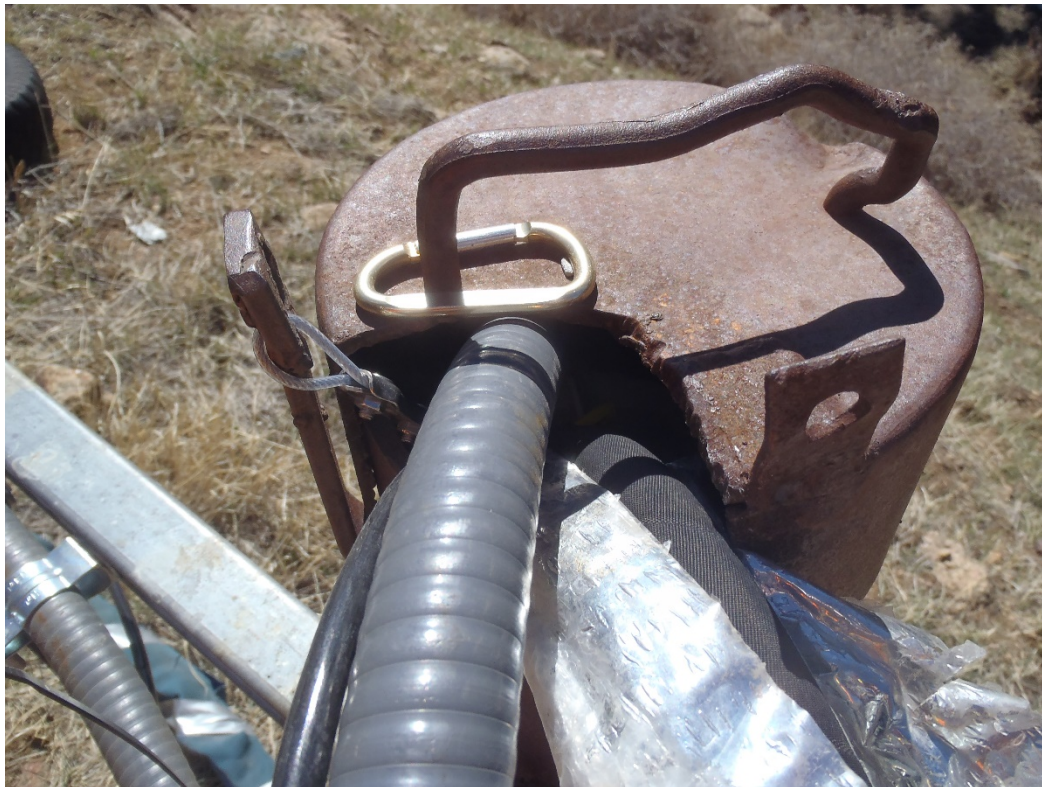
Photo 12. CRMW-3B monitoring well cap (showing cut for hose access).

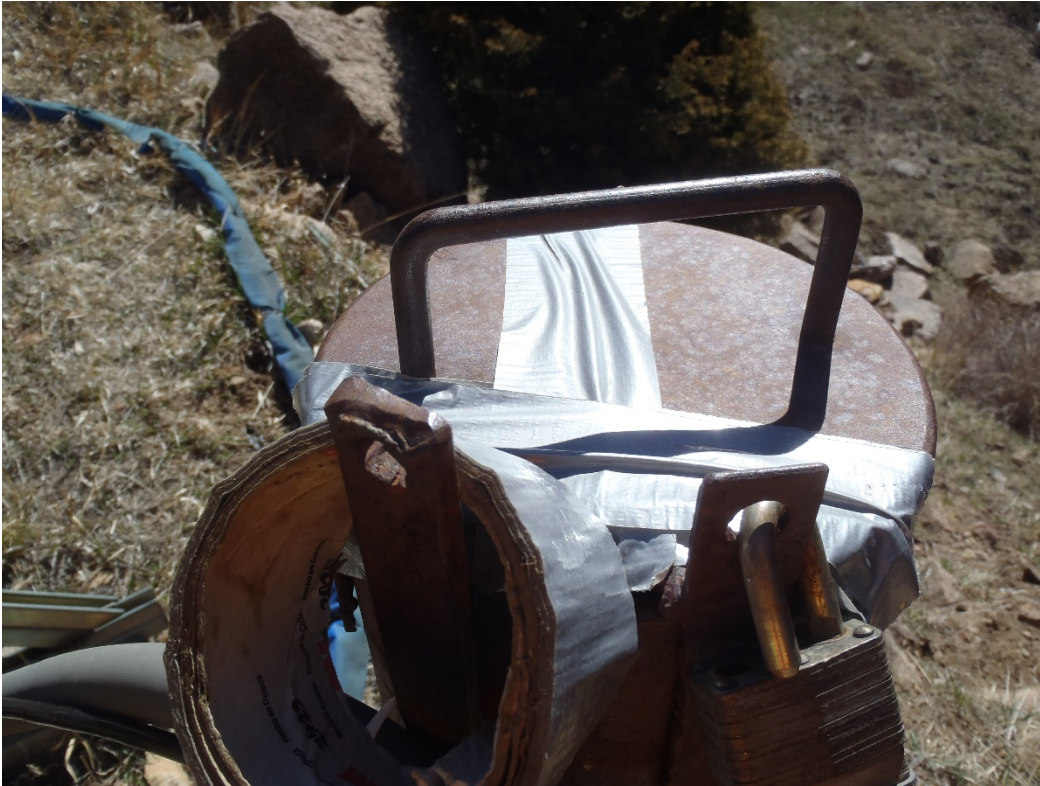
Photo 13. CRMW-3A monitoring well cap (showing duct-taped seal around hole for hoses).
