MINERALS PROGRAM INSPECTION REPORT
PHONE: (303) 866-3567

MINE NAME: Henderson Mine	MINE/PROSPECTING ID#: M-1977-342	MINERAL: Molybdenum	COUNTY: Clear Creek, Grand
INSPECTION TYPE: Monitoring	INSPECTOR(S): Peter Hays	INSP. DATE: May 20, 2021	INSP. TIME: 10:00
OPERATOR: Climax Molybdenum Company	OPERATOR REPRESENTATIVE: Geoff Niggeler	TYPE OF OPERATION: 112d-3 - Designated Mining Operation	
REASON FOR INSPECTION: Normal I&E Program	BOND CALCULATION TYPE: None	BOND AMOUNT: \$134,155,028.00	
DATE OF COMPLAINT: NA	POST INSP. CONTACTS: None	JOINT INSP. AGENCY: None	
WEATHER: Clear	INSPECTOR'S SIGNATURE:

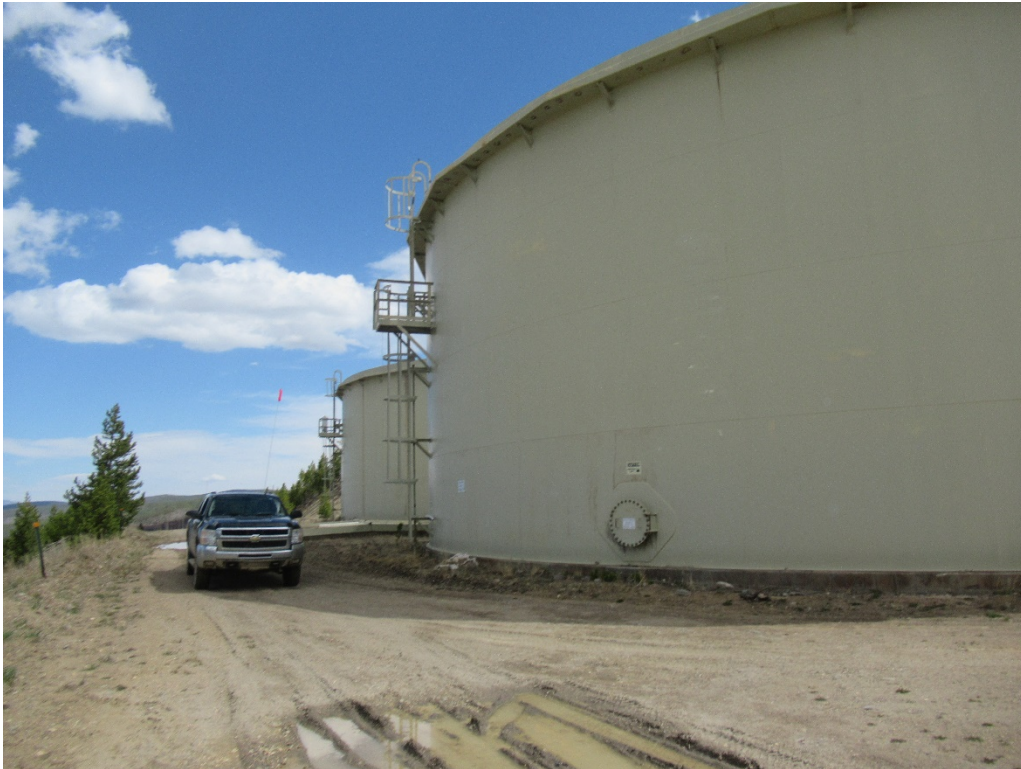
View of the Mill Process Water Storage Tanks

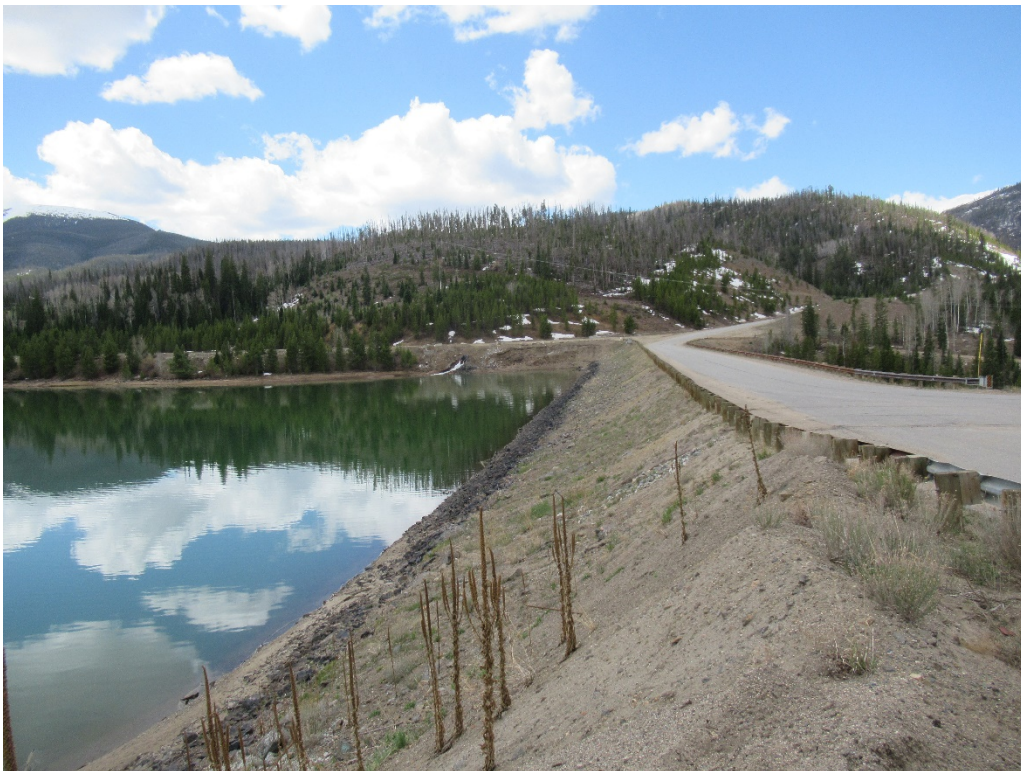
View of East Branch dam and reservoir from the east side looking west

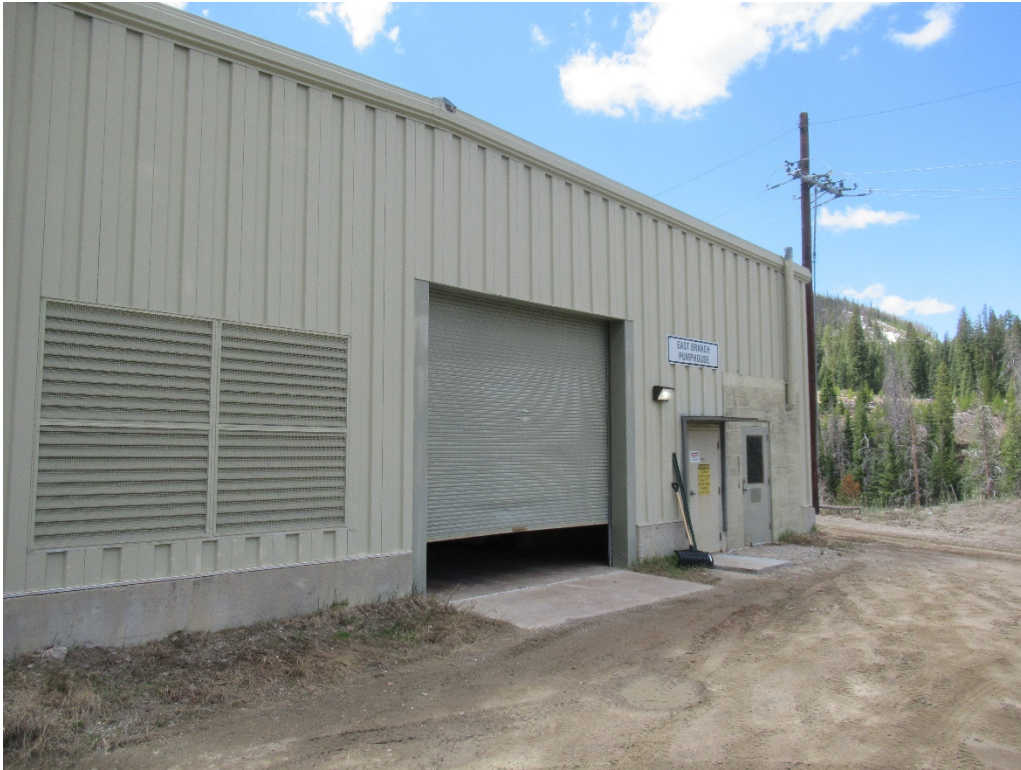
View of the East Branch Pump Station

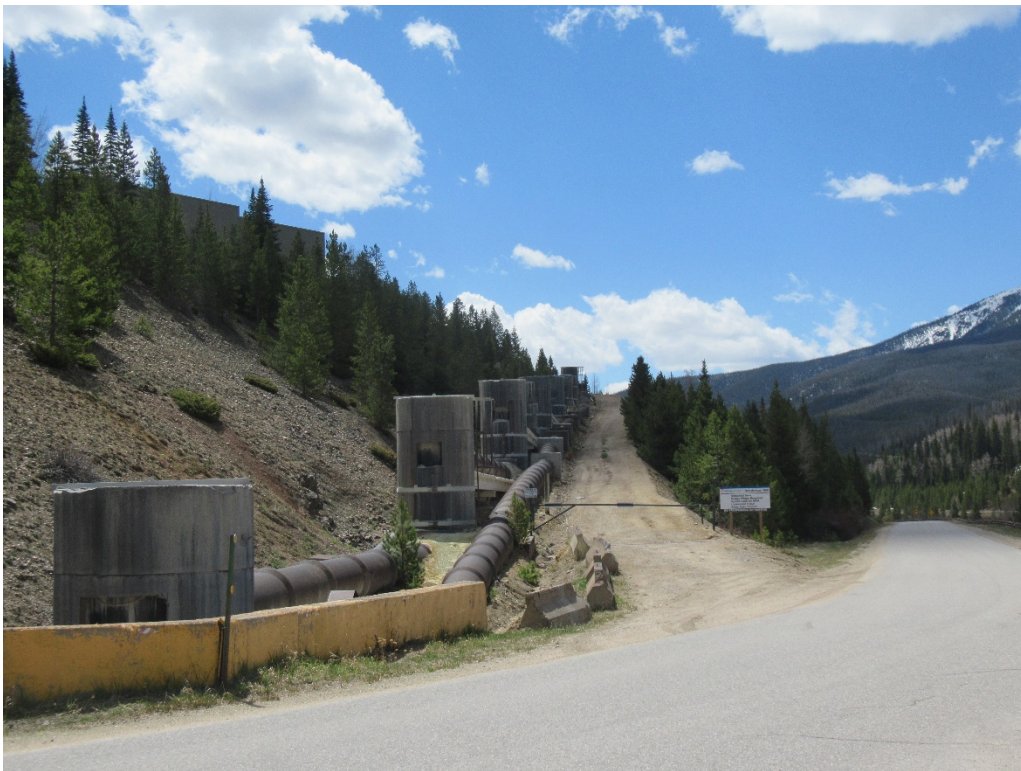
View of a section of the upper TDL

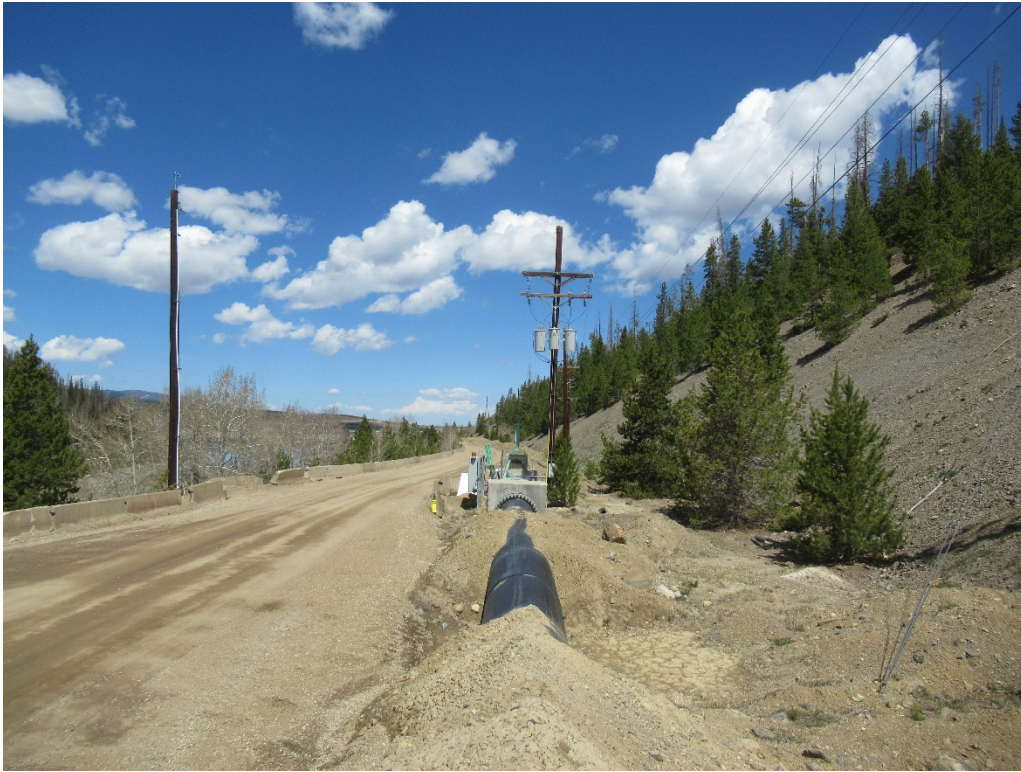
View of a section of the lower TDL

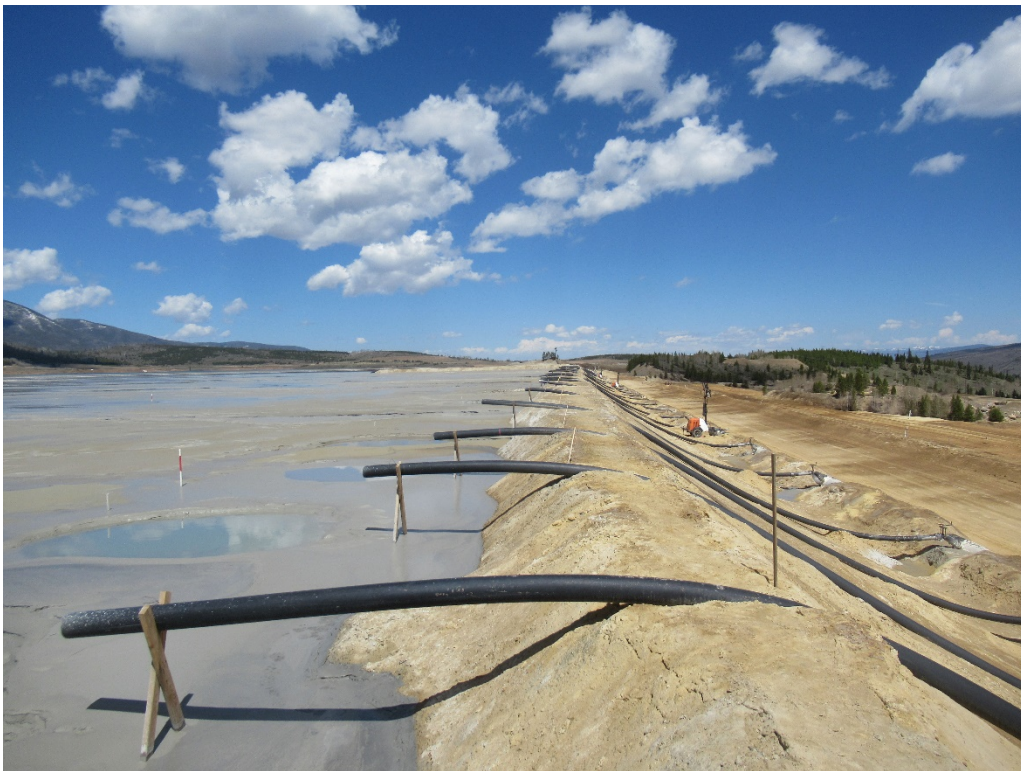
View of the TSF from the south end of 3-Dam looking north

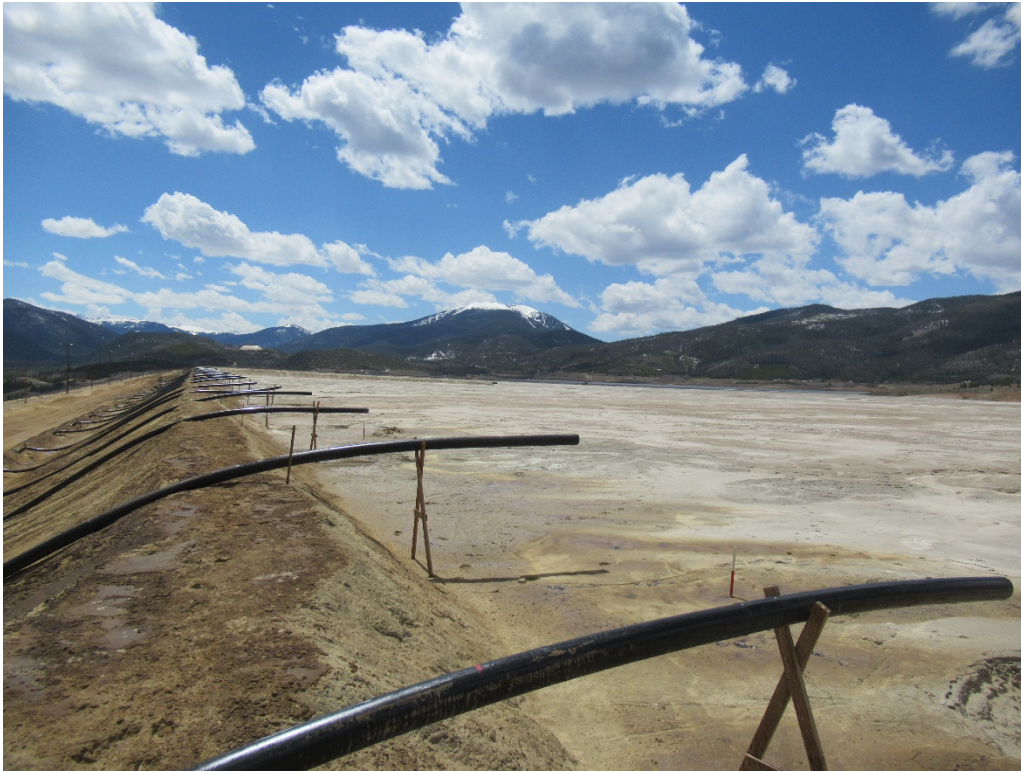
View of the TSF from the north end of 1-Dam looking south

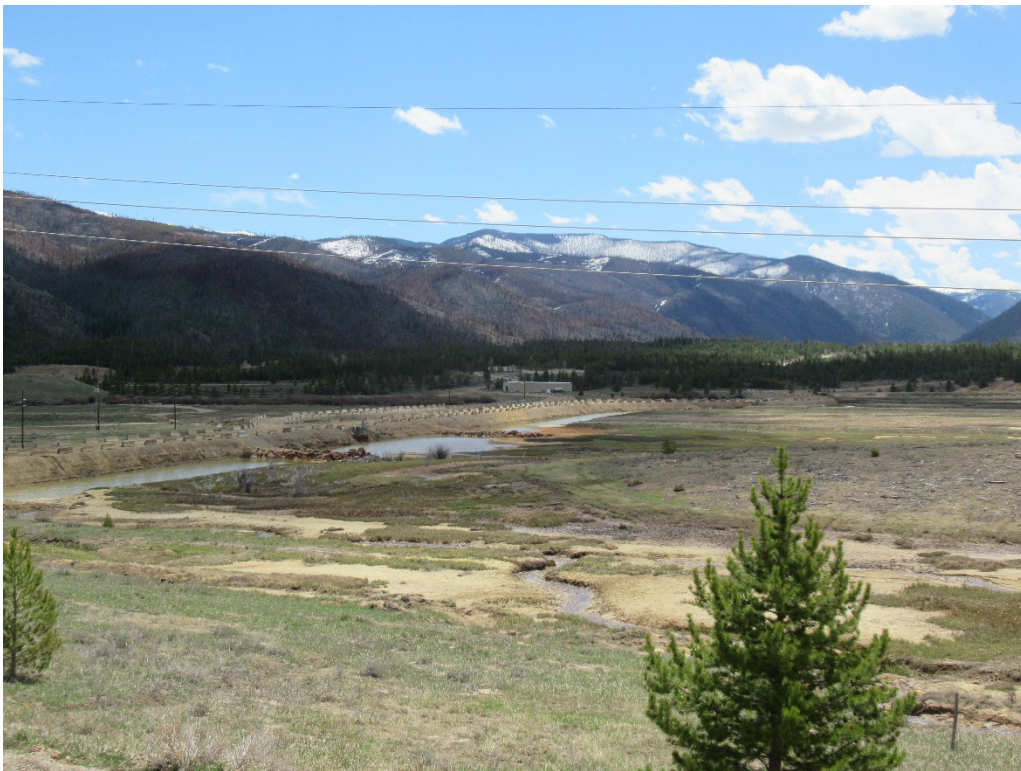
View of the Seep Water Collection below 1-Dam and Ute Park pump station

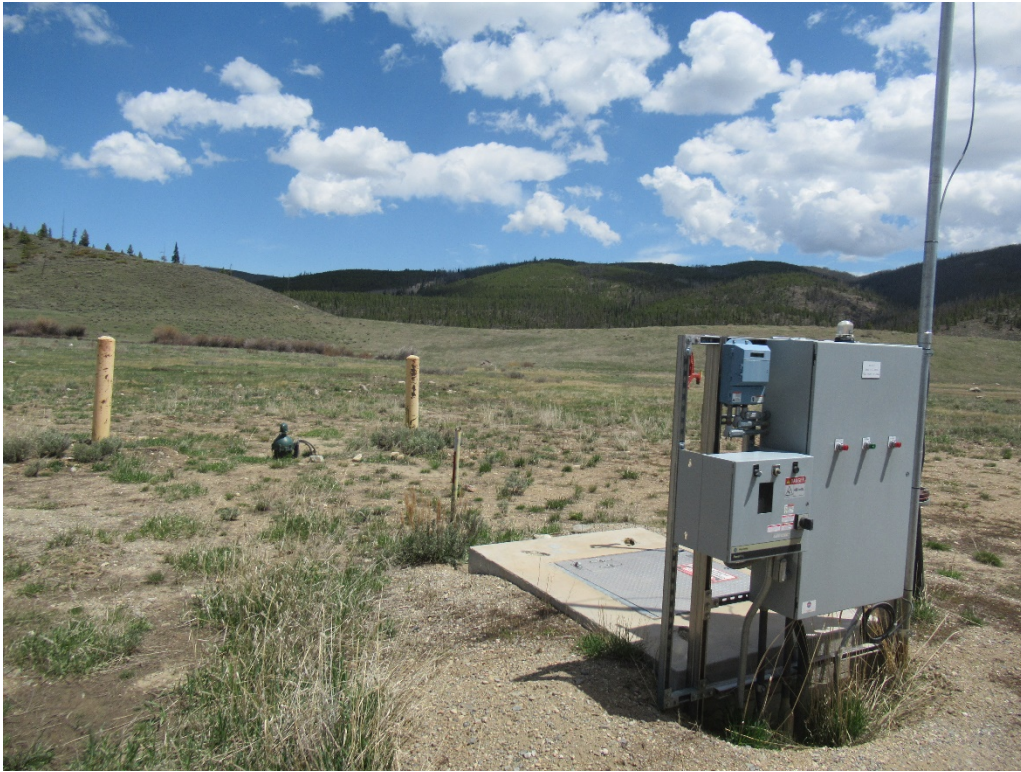
View of MLEX-1 extraction well

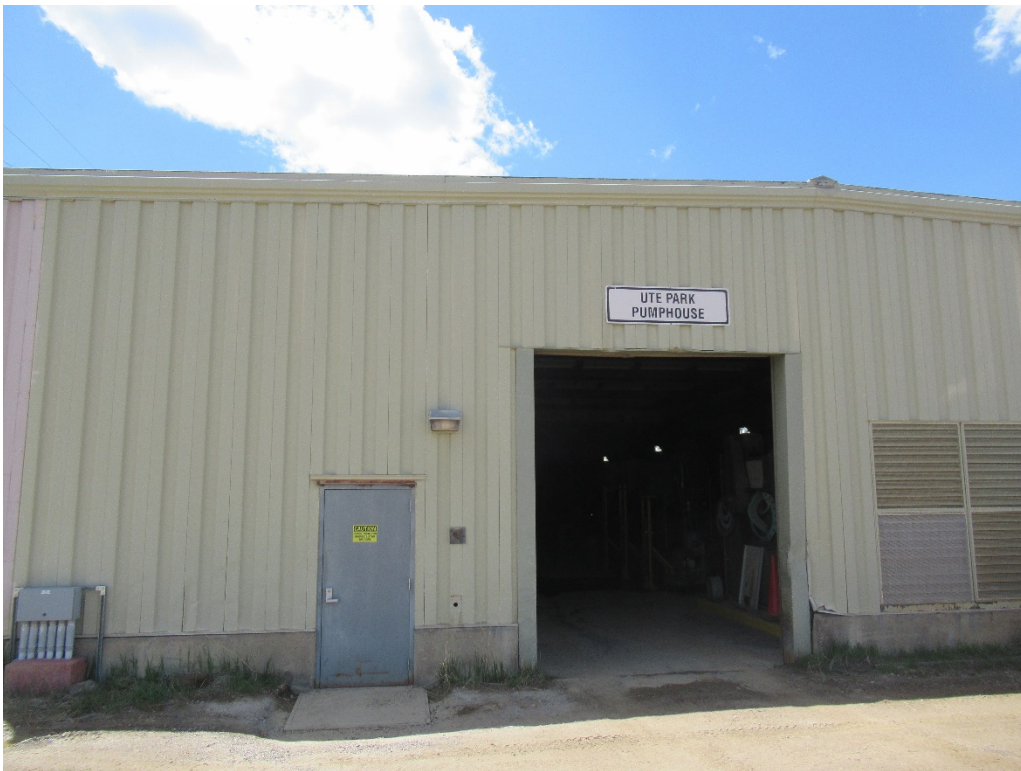
View of Ute Park Pump Station

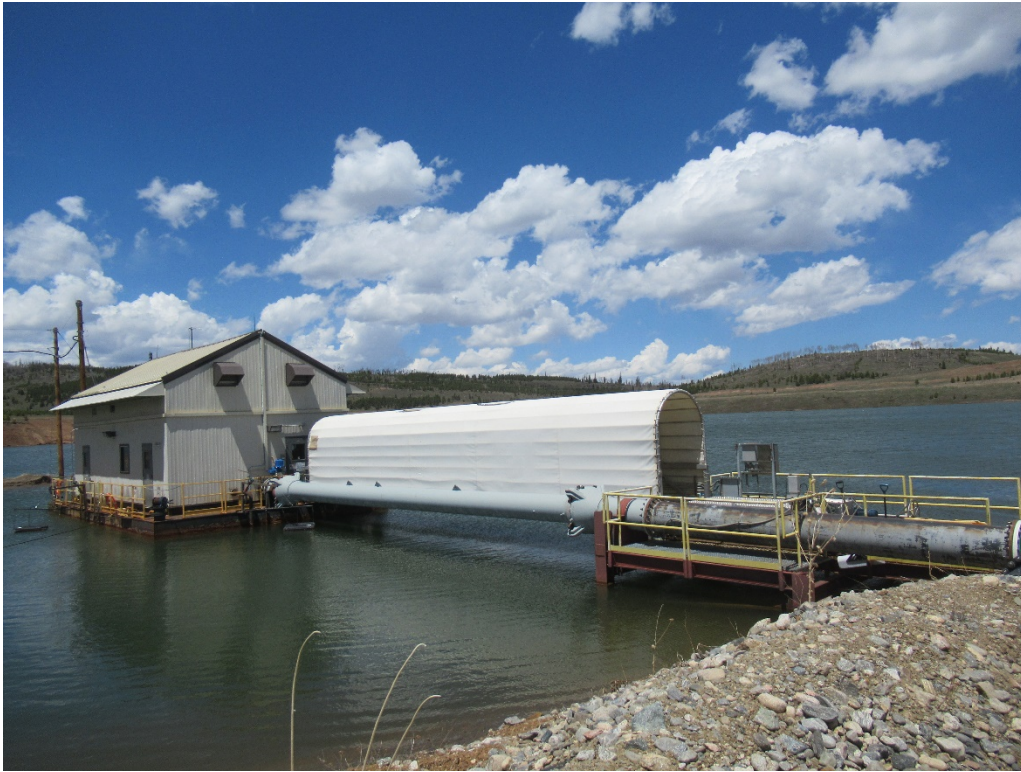
View of the Barge Pump House

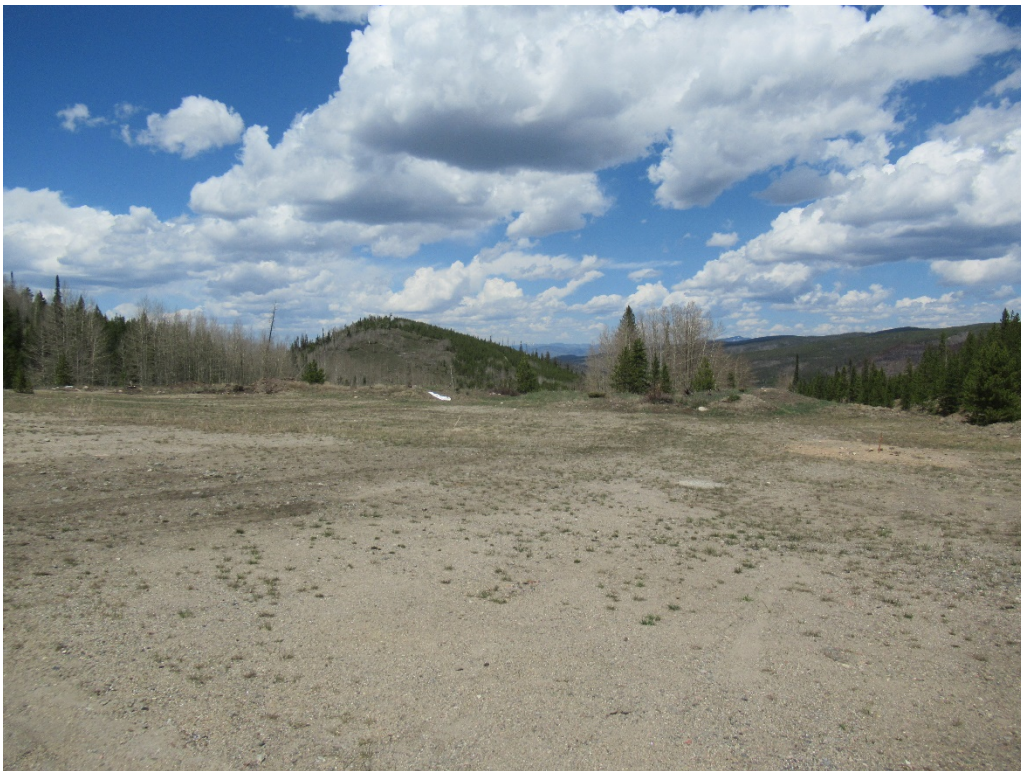
View of the proposed location of the Mill WTP
