MINERALS PROGRAM INSPECTION REPORT
PHONE: (303) 866-3567

MINE NAME: Vagneur Site	MINE/PROSPECTING ID#: M-1980-085	MINERAL: Sand and gravel	COUNTY: Pitkin
INSPECTION TYPE: Monitoring	INSPECTOR(S): Amy Yeldell	INSP. DATE: May 24, 2021	INSP. TIME: 12:00
OPERATOR: Elam Construction, Inc.	OPERATOR REPRESENTATIVE: Jim Doody	TYPE OF OPERATION: 112c - Construction Regular Operation	
REASON FOR INSPECTION: High Priority	BOND CALCULATION TYPE: None	BOND AMOUNT: \$804,529.00	
DATE OF COMPLAINT: NA	POST INSP. CONTACTS: DRMS	JOINT INSP. AGENCY: None	
WEATHER: Clear	INSPECTOR'S SIGNATURE:

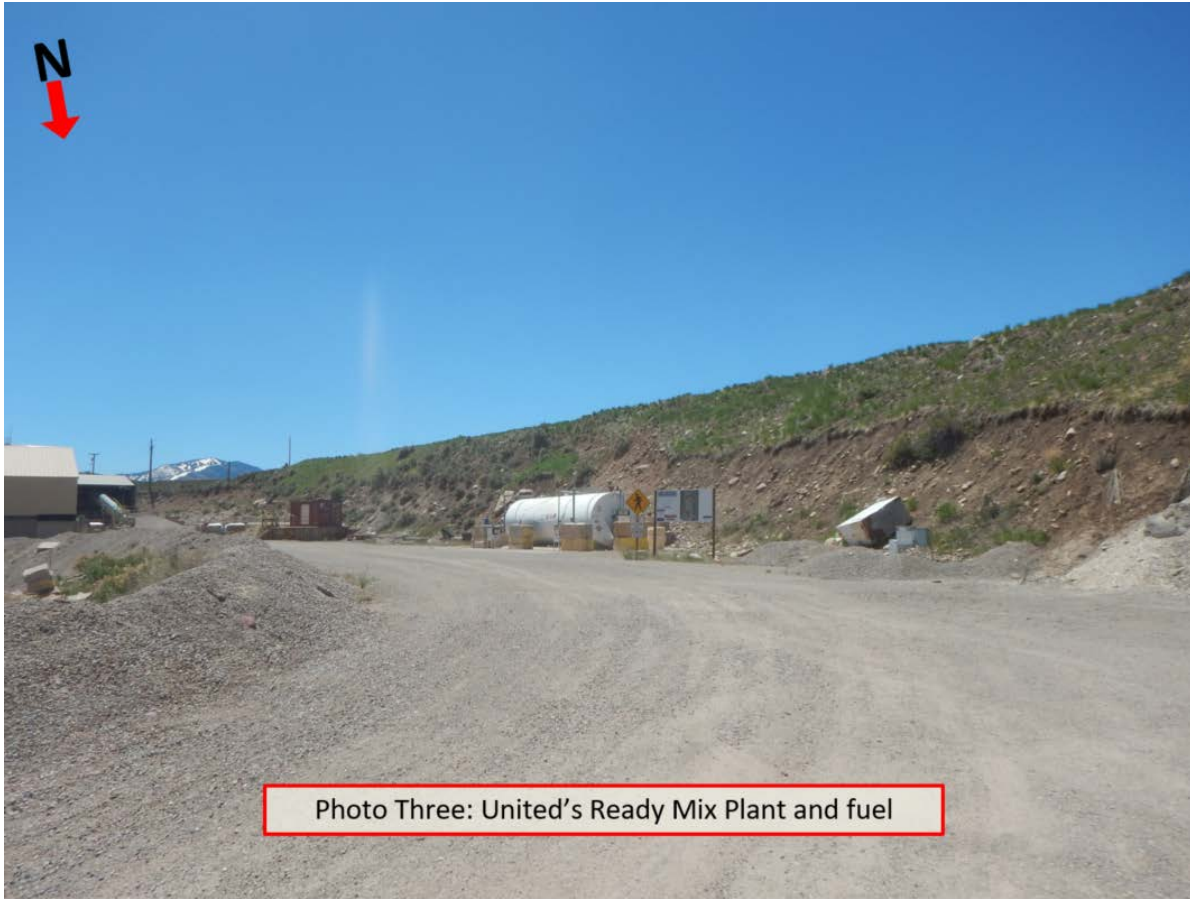
Photo Three: United's Ready Mix Plant and fuel

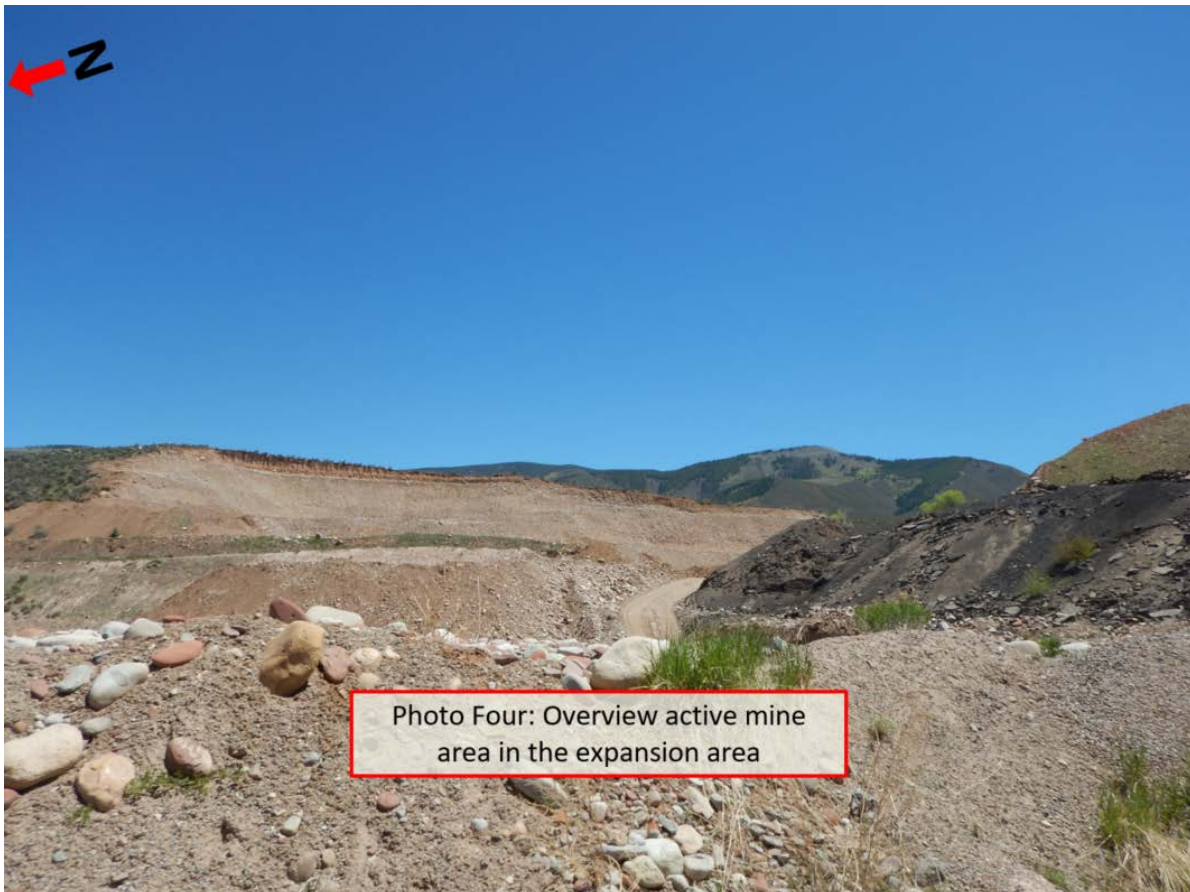
Mining is progressing to the east in the expansion area. The processing plant is located just to the east of where the accident occurred. The plant remains in place but was not operational. The northern portion of the mine has been mined out and is in the process of being backfilled. Trucks were observed importing material throughout the inspection.

Photo Four: Overview active mine area in the expansion area

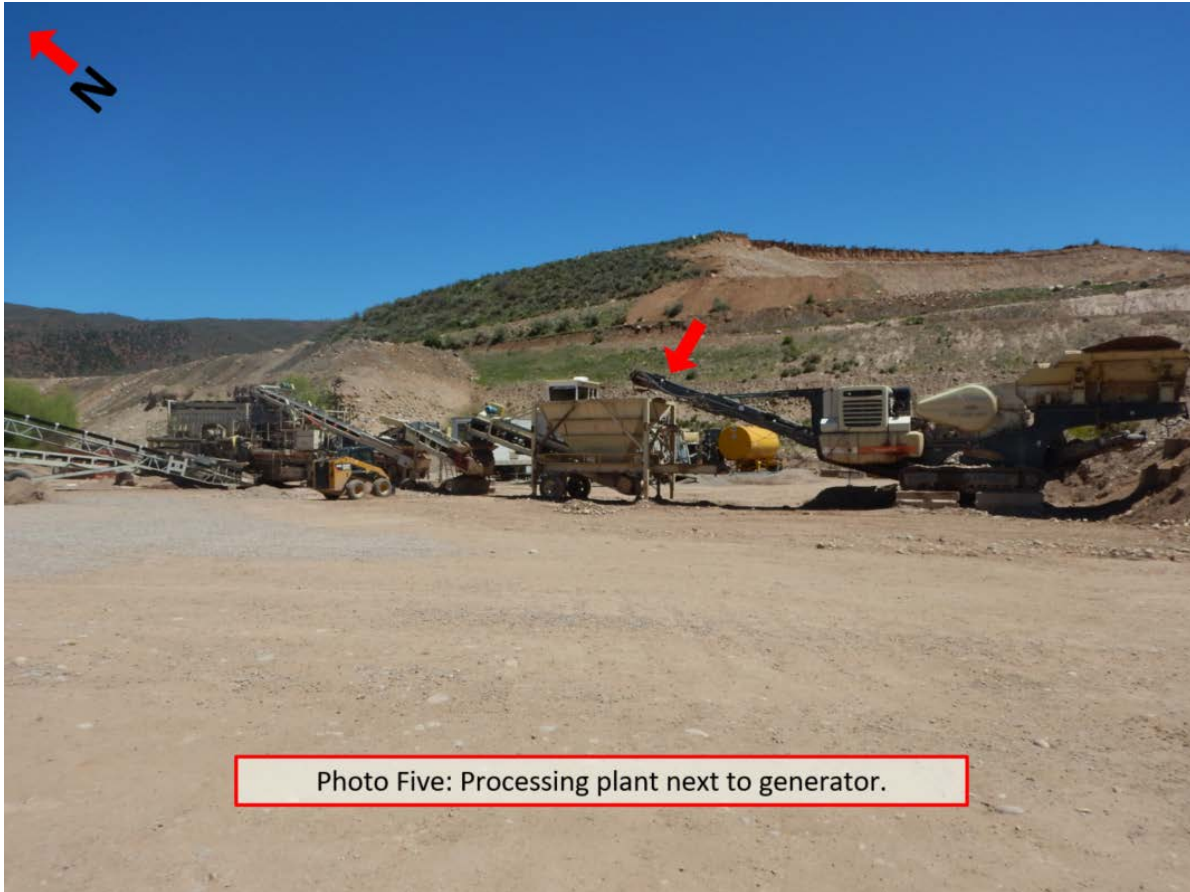
Photo Five: Processing plant next to generator.

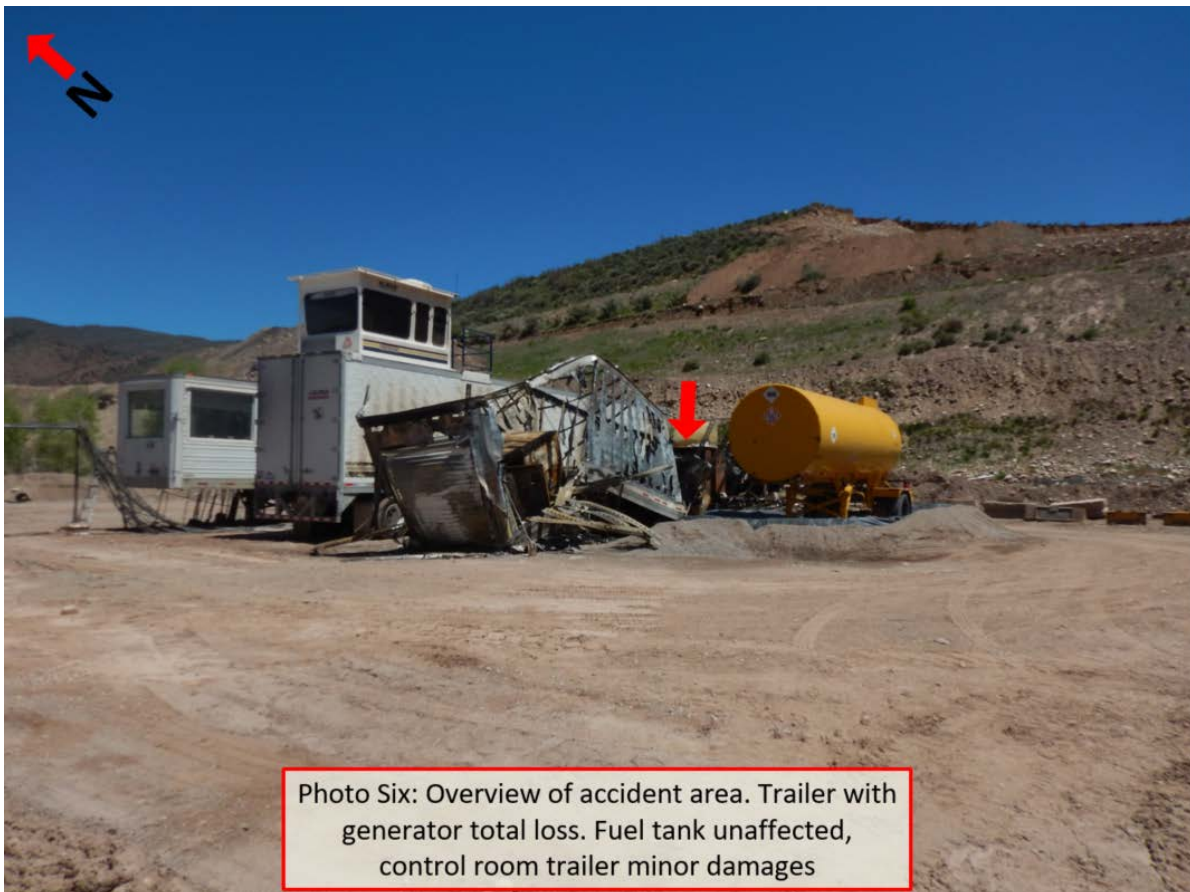
Based on fuel tank measurements it is estimated that approximately 100 gallons of diesel escaped, the majority of which was consumed in the fire. Additional oils and other lubricants contained within the generator engine were also consumed. A sheen was observed in water running off of the extinguished fire/equipment. All run-off water was contained on site in close proximity to the plant area. The mobile 2,500 gallon diesel fuel tank located to the south of the trailer was not damaged. The control room trailer for the crusher located to the north sustained minor damages.

Photo Six: Overview of accident area. Trailer with generator total loss. Fuel tank unaffected, control room trailer minor damages

CORRECTIVE ACTIONS: The operator shall immediately remediate the spill and submit a final report to the Division containing at least the following information:

- 1.) A description of how the spill was cleaned up containing at a minimum - the appropriate maps, volumes removed, sample locations, analytical data, and photo documentation.
- 2.) Evidence in the form of a receipt that the contaminated soil was disposed of by an approved method (such as sent to an approved landfill, land farming, recycling center, etc.).
- 3) Copy of the CDPHE Spill Report.
