**MINERALS PROGRAM INSPECTION REPORT**  
**PHONE: (303) 866-3567**

<b>MINE NAME:</b> Climax Mine	<b>MINE/PROSPECTING ID#:</b> M-1977-493	<b>MINERAL:</b> Molybdenum	<b>COUNTY:</b> Lake, Summit
<b>INSPECTION TYPE:</b> Multi Person Inspection	<b>INSPECTOR(S):</b> Lucas West, Amy Yeldell	<b>INSP. DATE:</b> June 1, 2021	<b>INSP. TIME:</b> 09:00
<b>OPERATOR:</b> Climax Molybdenum Company	<b>OPERATOR REPRESENTATIVE:</b> Diana Kelts, Alex Ungers	<b>TYPE OF OPERATION:</b> 112d-3 - Designated Mining Operation	
<b>REASON FOR INSPECTION:</b> Normal I&E Program	<b>BOND CALCULATION TYPE:</b> None	<b>BOND AMOUNT:</b> \$91,011,850.00	
<b>DATE OF COMPLAINT:</b> NA	<b>POST INSP. CONTACTS:</b> None	<b>JOINT INSP. AGENCY:</b> None	
<b>WEATHER:</b> Clear	<b>INSPECTOR'S SIGNATURE:</b>

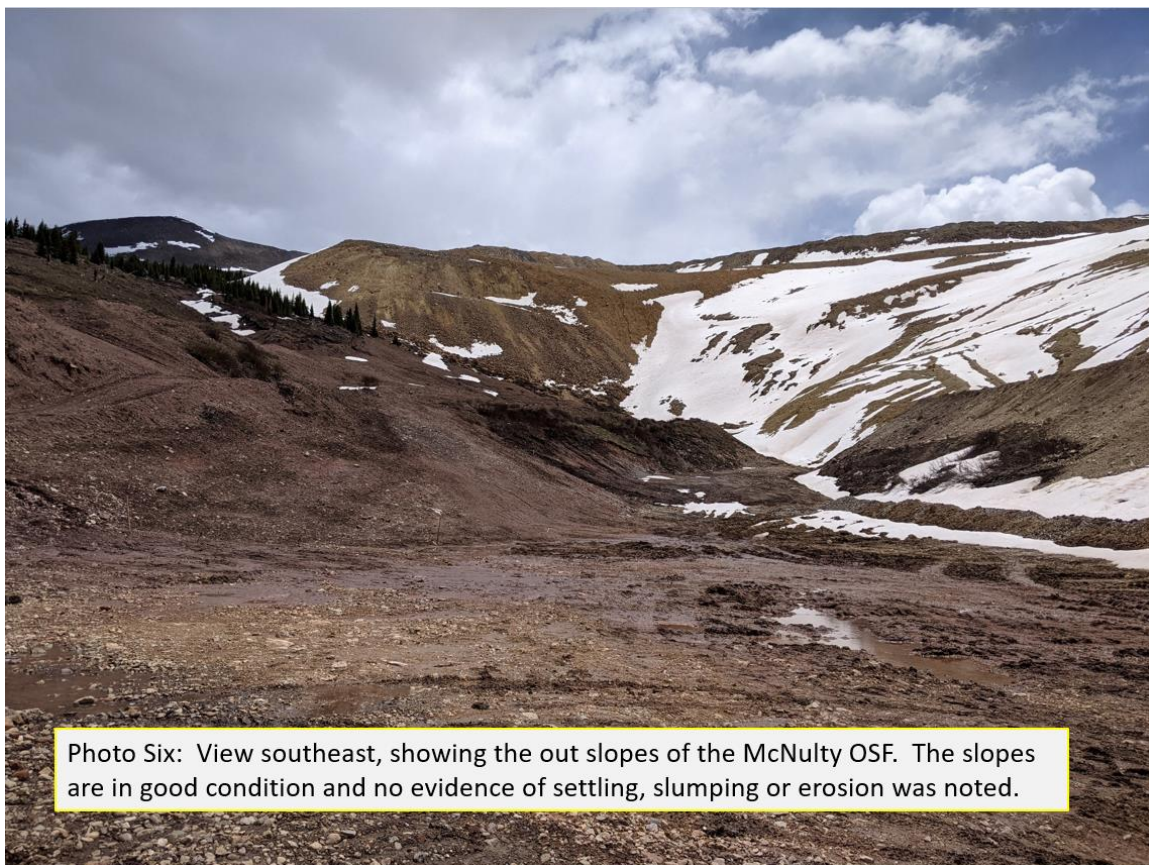
A Red Level Alert for lightning was experienced during the inspection of the McNulty OSF which resulted in vehicle born observations. The storage facility was in excellent condition. All existing out slopes of the storage material appeared to be stable. The storage material can be seen in Photo Six. The water control systems installed during the previous summer were functioning as designed and delivering flows from the OSF into the ditch reporting to the Tailings storage facility. The water collection discharge point can be seen in Photo Seven. Some vegetation clearing has taken place along the southwestern slope of the facility in preparation for summer depositing of overburden. On site discussions with the Operator indicate the vegetation and soil salvage operations are being conducted by in house crews moving forward. No signs of significant erosion, settling or slumping was noted in the greater footprint of the OSF or the already deposited material.

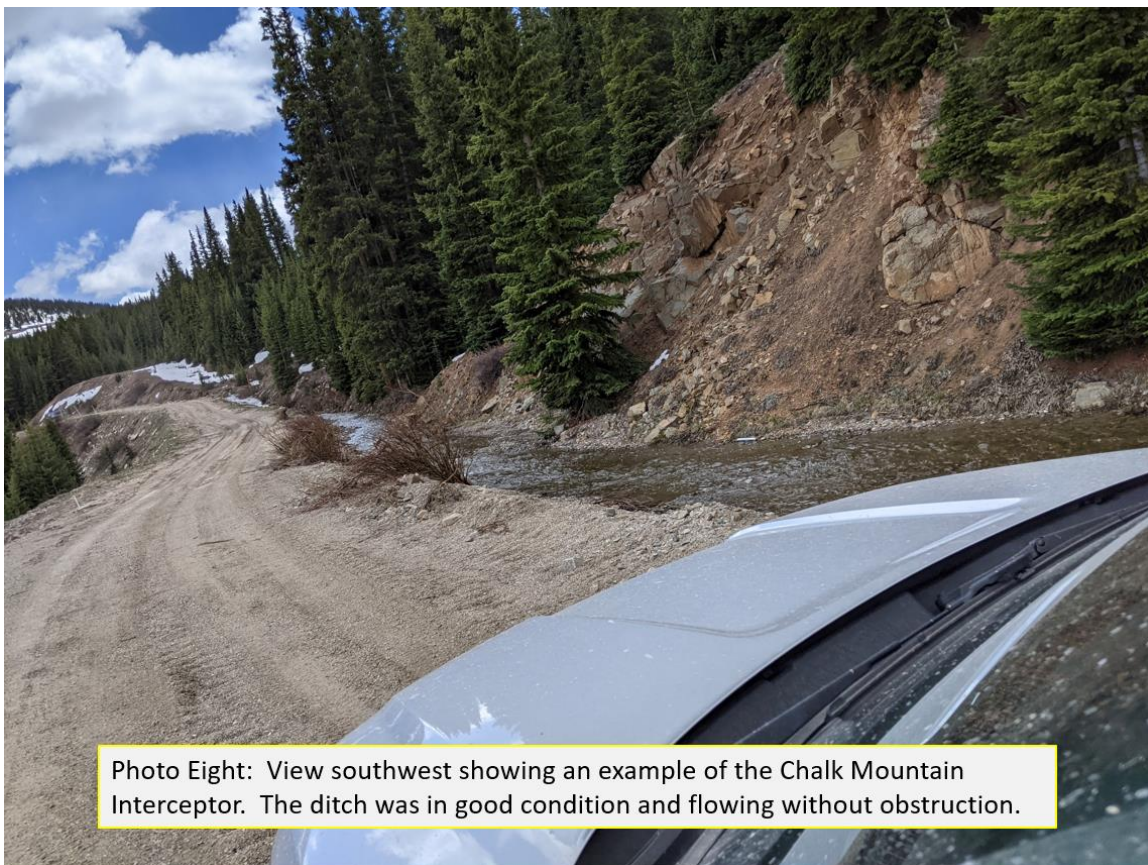
During the inspection the Chalk Mountain, West and East Interceptors were observed. The function of the interceptor is to prevent run on from snow melt or storm water sheet flows to become impacted and require treatment. The Chalk Mountain Interceptor is an open top ditch running generally along the southwest portion of the site. The Interceptor was flowing in response to snowmelt and recent precipitation events. The entire length of the Interceptor that was observed was flowing unimpeded and was in good condition. An example of the Chalk Mountain Interceptor can be seen in Photo Eight.

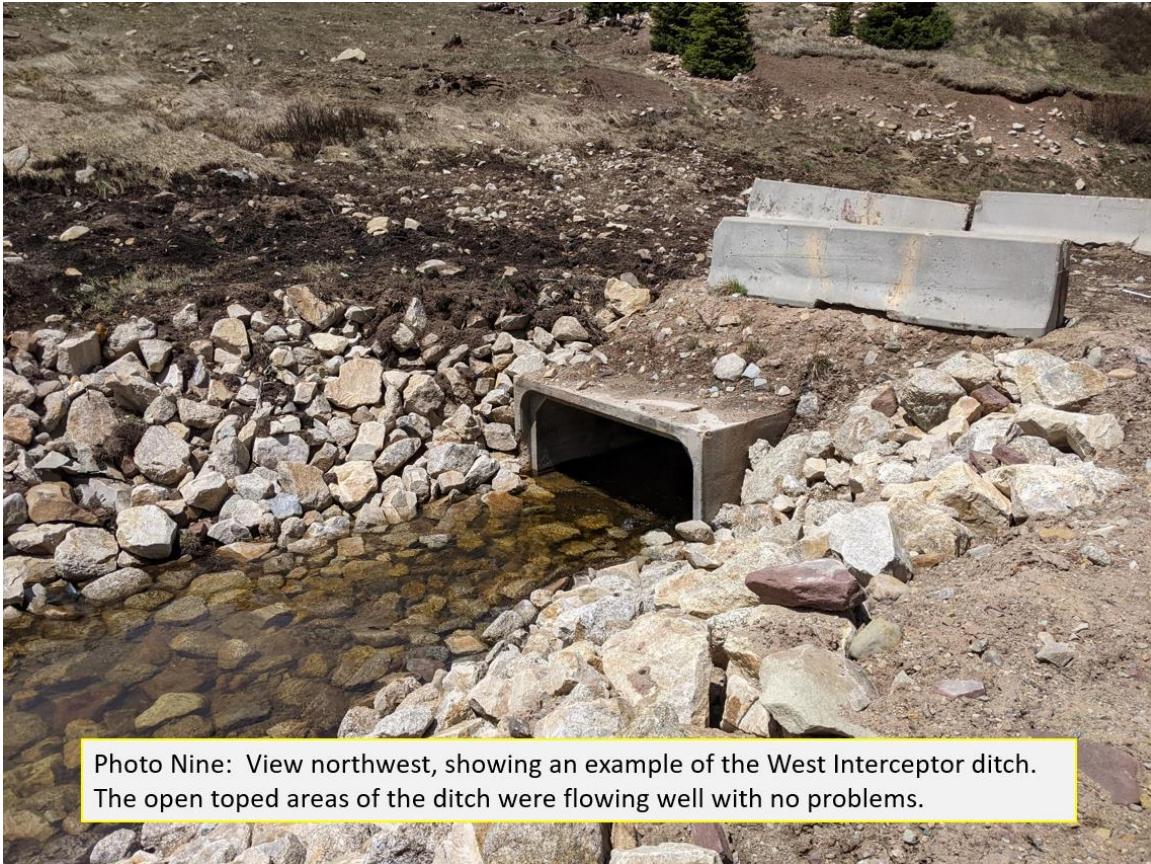
The West Interceptor is in the ongoing process of being converted from an open top ditch to a subsurface HDPE piped ditch with periodic inlet points. The open topped portion of the Interceptor was observed and was flowing with no obstructions. An Example of the open topped portion can be seen in Photo Nine. The areas that are piped, contain various inlet points, where flow is directed to a grated opening to allow the water to enter the piped system. The inlet structures that were observed were free from obstruction and appeared to be functioning as designed.

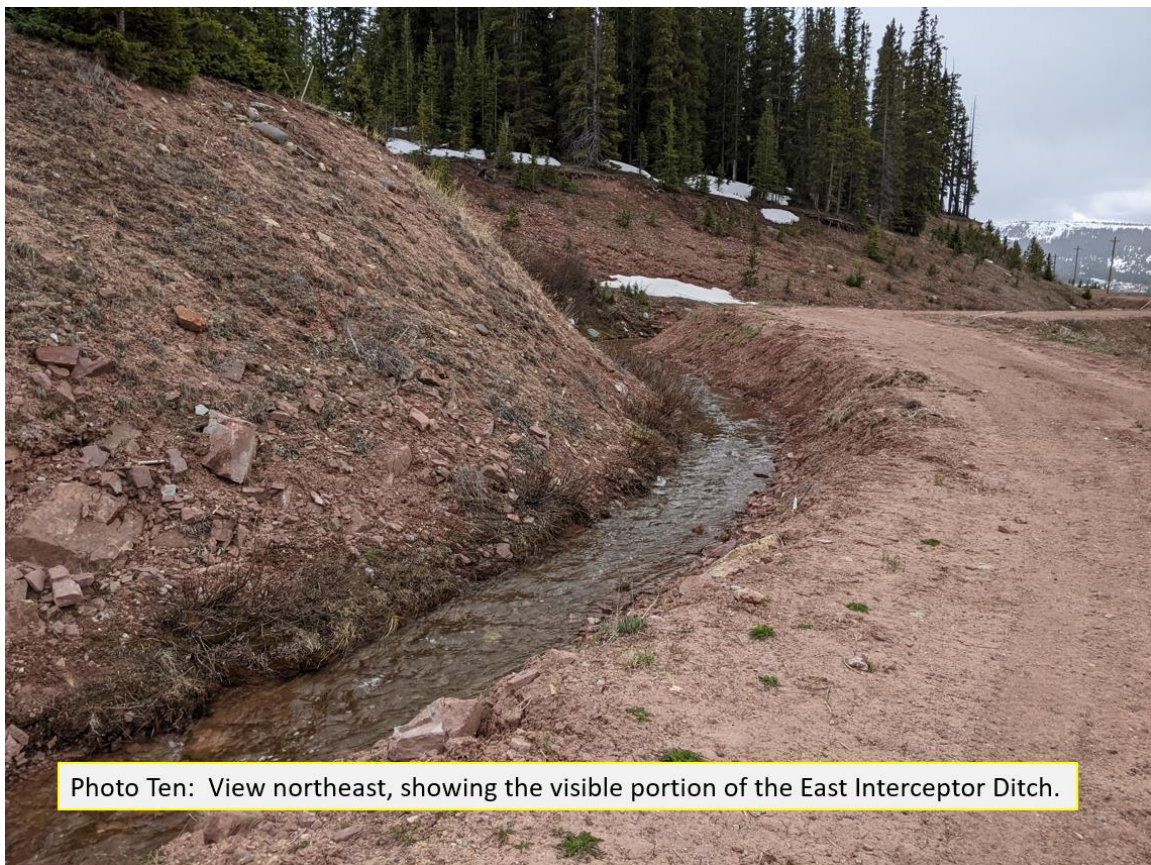
A majority of the East Interceptor exists in densely forested areas along the eastern boundary of the site. A portion of the Interceptor runs along the access road and was observed during the inspection. Similar to the other ditches, it was flowing without obstruction and the channel was in good condition. An example of the observed portion can be seen in Photo Ten.
