**MINERALS PROGRAM INSPECTION REPORT**  
**PHONE: (303) 866-3567**

<b>MINE NAME:</b> Berry Pit	<b>MINE/PROSPECTING ID#:</b> M-1977-132	<b>MINERAL:</b> Sand and gravel	<b>COUNTY:</b> Rio Blanco
<b>INSPECTION TYPE:</b> Monitoring	<b>INSPECTOR(S):</b> Amy Yeldell	<b>INSP. DATE:</b> May 25, 2021	<b>INSP. TIME:</b> 11:00
<b>OPERATOR:</b> Oldcastle SW Group, Inc. dba United Com Mesa County	<b>OPERATOR REPRESENTATIVE:</b> Jason Burkey	<b>TYPE OF OPERATION:</b> 112c - Construction Regular Operation	
<b>REASON FOR INSPECTION:</b> Normal I&E Program	<b>BOND CALCULATION TYPE:</b> Complete Bond	<b>BOND AMOUNT:</b> \$186,149.53	
<b>DATE OF COMPLAINT:</b> NA	<b>POST INSP. CONTACTS:</b> None	<b>JOINT INSP. AGENCY:</b> None	
<b>WEATHER:</b> Clear	<b>INSPECTOR'S SIGNATURE:</b>

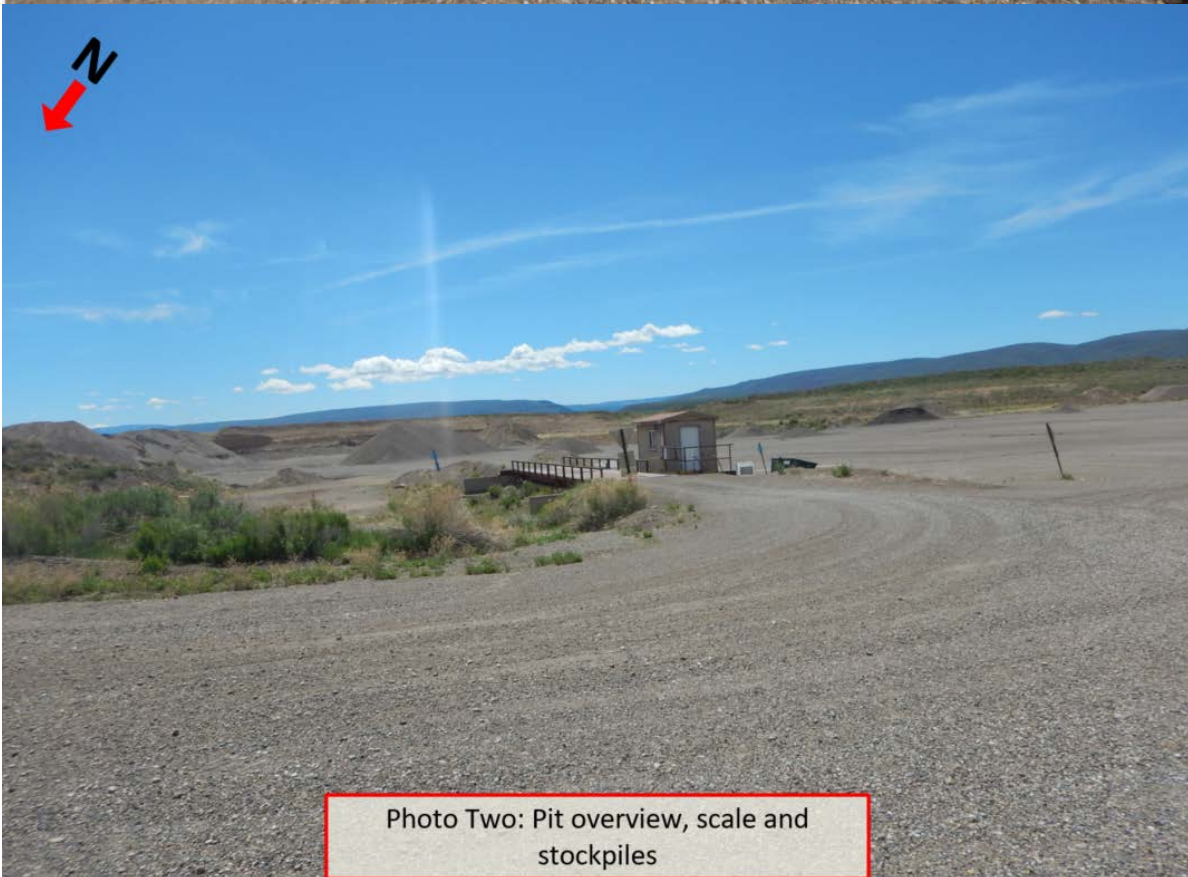
Photo Two: Pit overview, scale and stockpiles

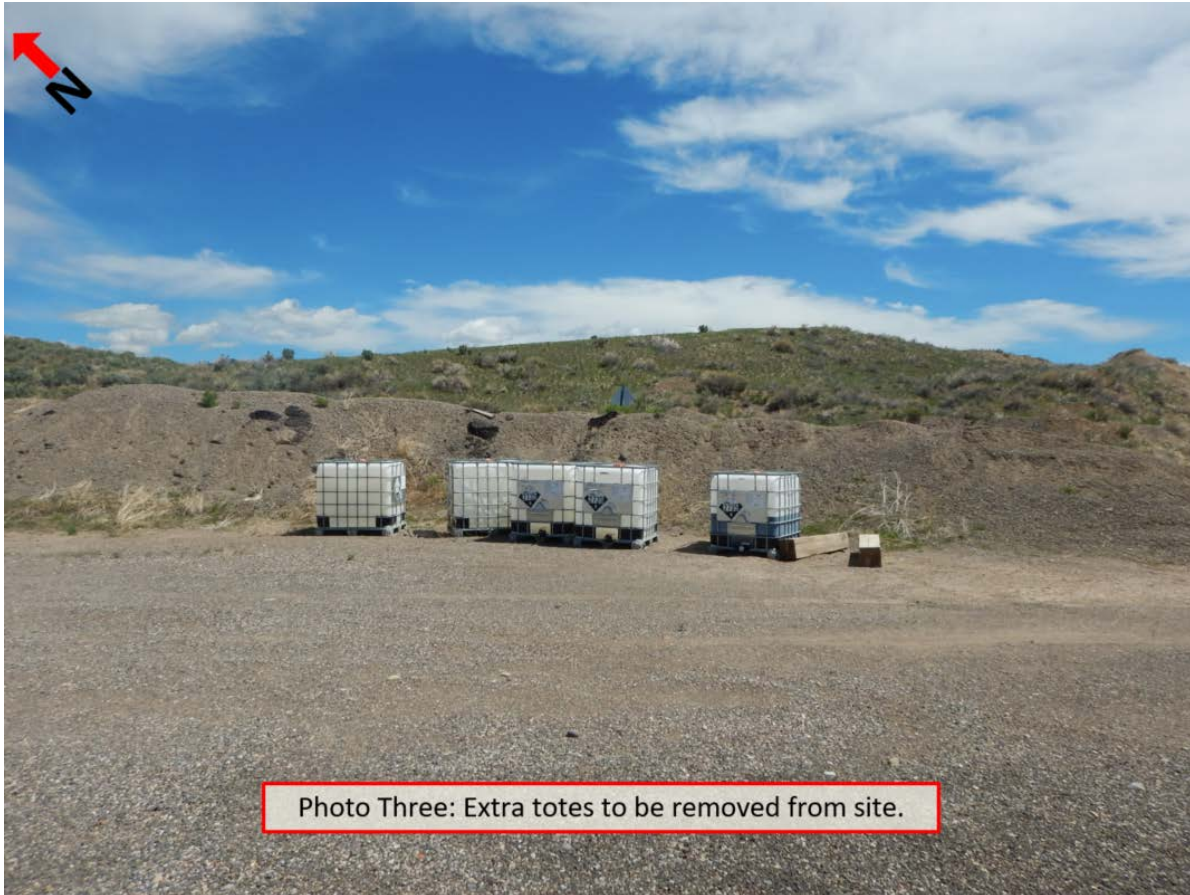
The site was inactive at the time of the inspection. No equipment was present on site. The scale and scale house remain on site. Fuel remains on site in a mobile tank with secondary containment. Several empty totes were located throughout the site. If the totes are no longer needed they should be removed from the site. The hot plant has since been removed from the site.

Photo Three: Extra totes to be removed from site.

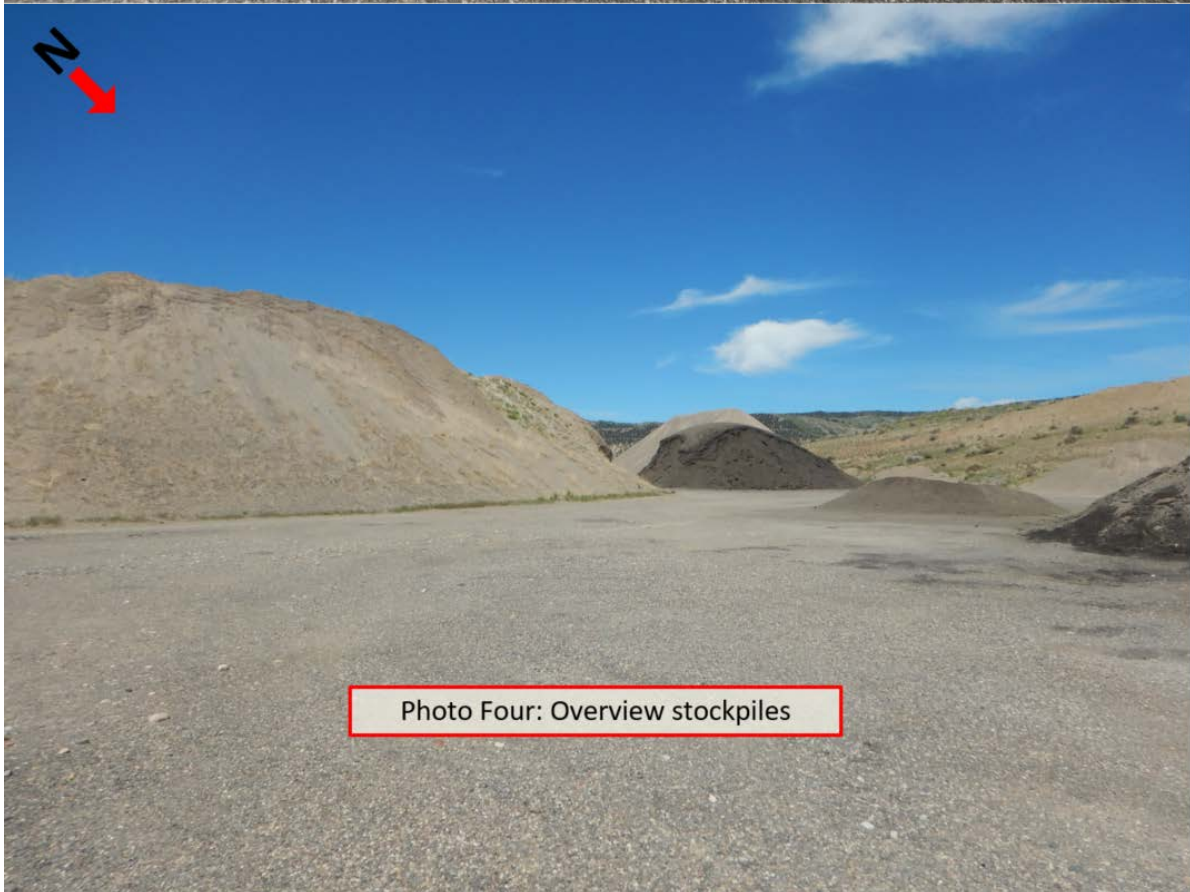
The eastern portion of the permit area remains undisturbed. Mining is progressing to the east with some reclaimed areas along the southwestern highwall. Stockpiles of asphalt millings remain on site. Several large stockpiles of various processed materials are located throughout the pit floor.

Photo Four: Overview stockpiles

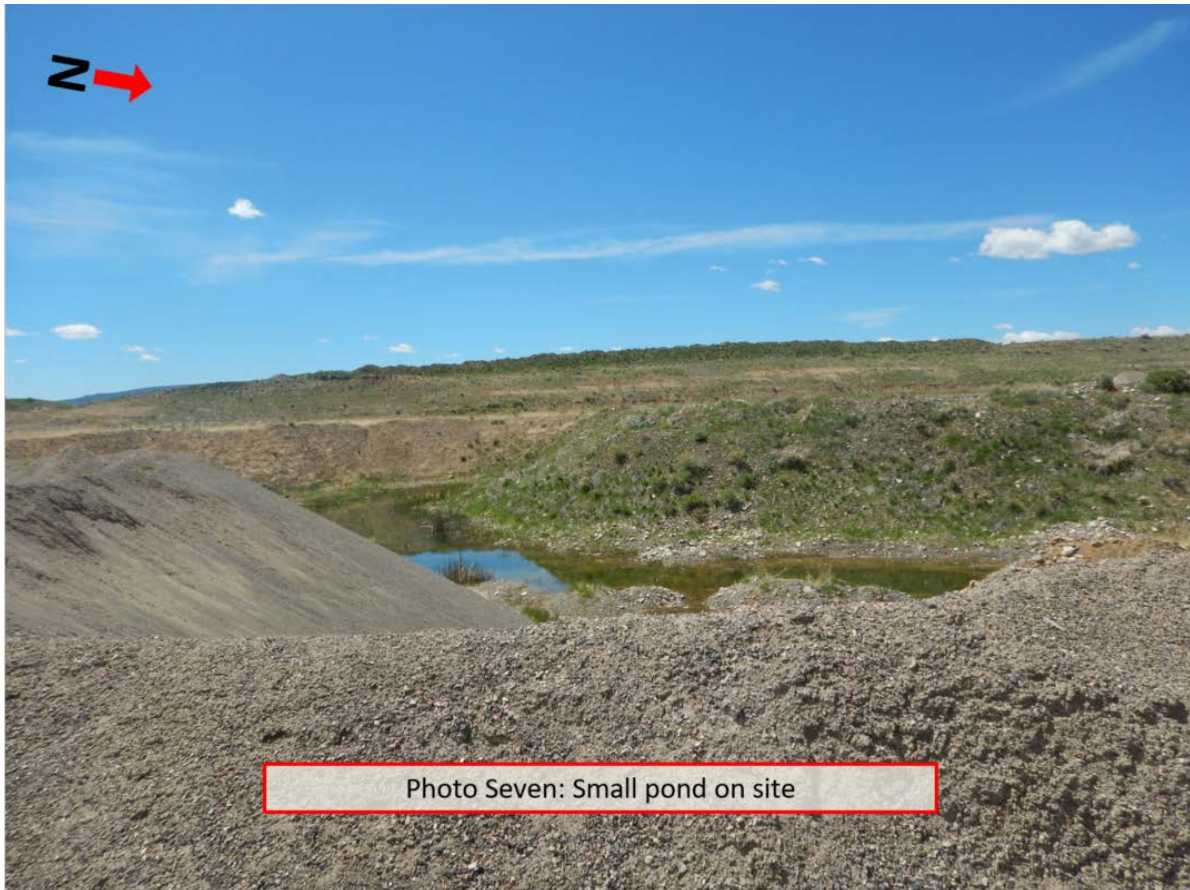
The pit is mined to approximately 40 feet deep. The active highwall is along the eastern side and is approximately 1000 linear feet and near vertical. The majority of the other highwalls in the pit are approximately a 2H: 1V. Most are a continual slope but some have an interstitial bench. Approximately half of the slopes have some sort of vegetation. The approved reclamation plan calls for slopes no greater than 2.5H: 1V so some additional grading may be needed. The pit floor is stabilized with gravel. A small pond was located along the southeast site of the permit boundary.

Photo Seven: Small pond on site

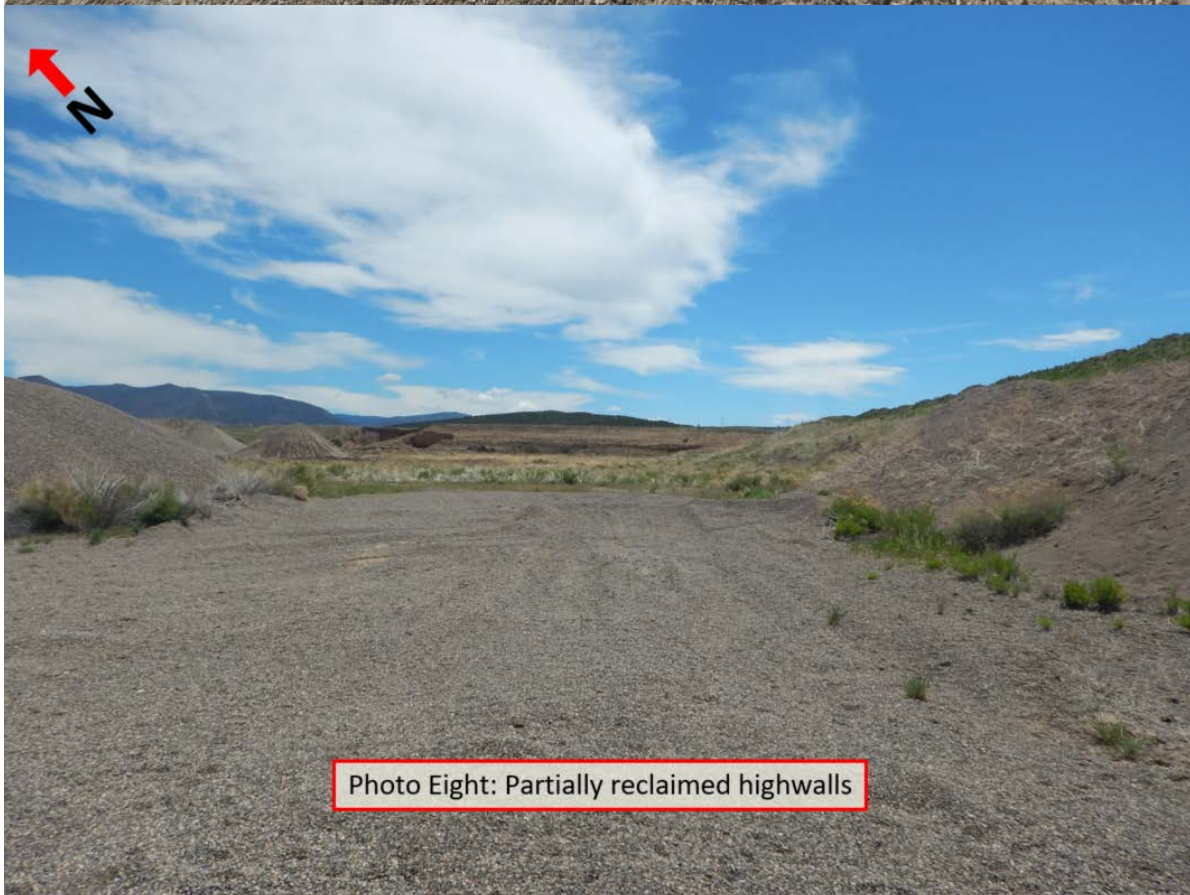
Photo Eight: Partially reclaimed highwalls
