MINERALS PROGRAM INSPECTION REPORT

MINE NAME: White River City Pit	MINE/PROSPECTING ID#: M-2006-084	MINERAL: Gravel and sand	COUNTY: Rio Blanco
INSPECTION TYPE: Monitoring	INSPECTOR(S): Amy Yeldell	INSP. DATE: May 25, 2021	INSP. TIME: 13:00
OPERATOR: Oldcastle SW Group, Inc. dba United Con	OPERATOR REPRESENTATIVE: Jason Burkey	TYPE OF OPERATION: 112c - Construction Regular Operation	
REASON FOR INSPECTION: Normal I&E Program	BOND CALCULATION TYPE: Complete Bond	BOND AMOUNT: \$447,245.79	
DATE OF COMPLAINT: NA	POST INSP. CONTACTS: DRMS	JOINT INSP. AGENCY: None	
WEATHER: Clear	INSPECTOR'S SIGNATURE:

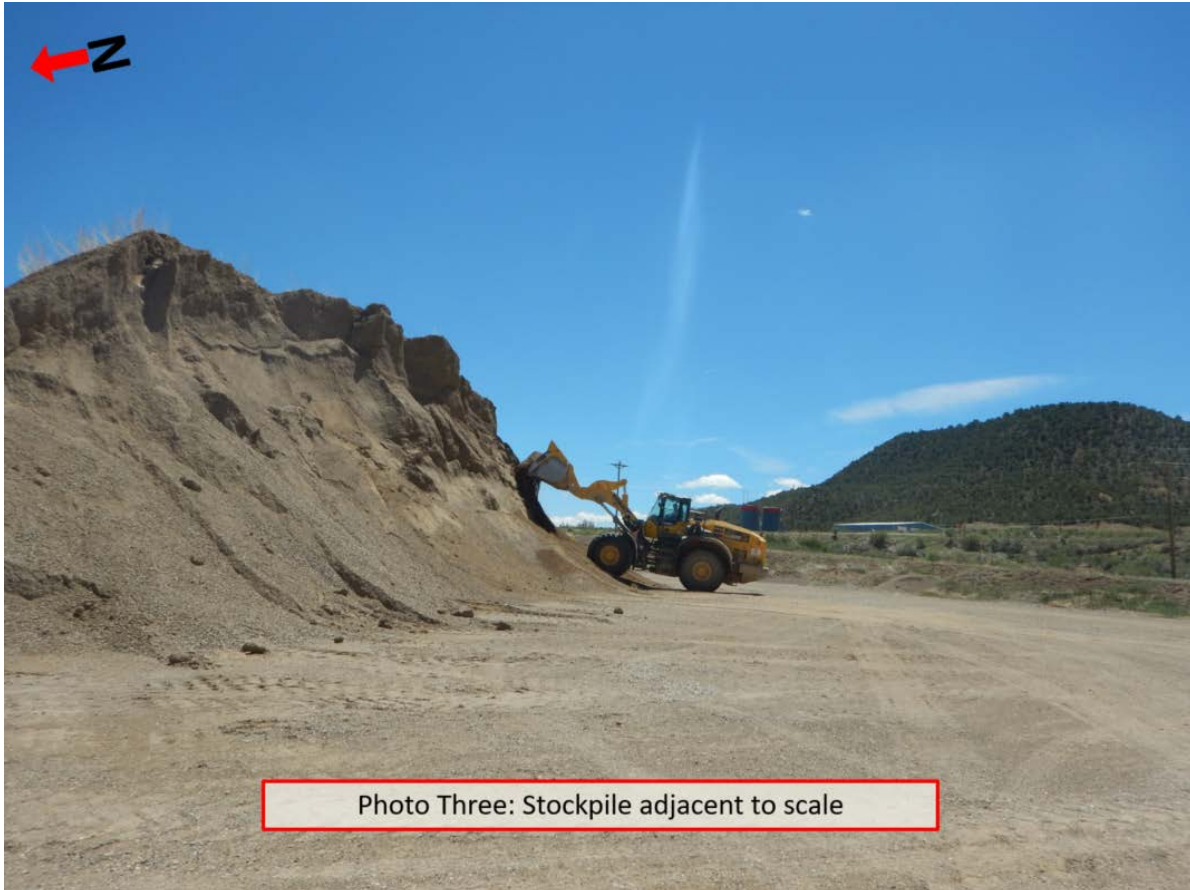
Photo Three: Stockpile adjacent to scale

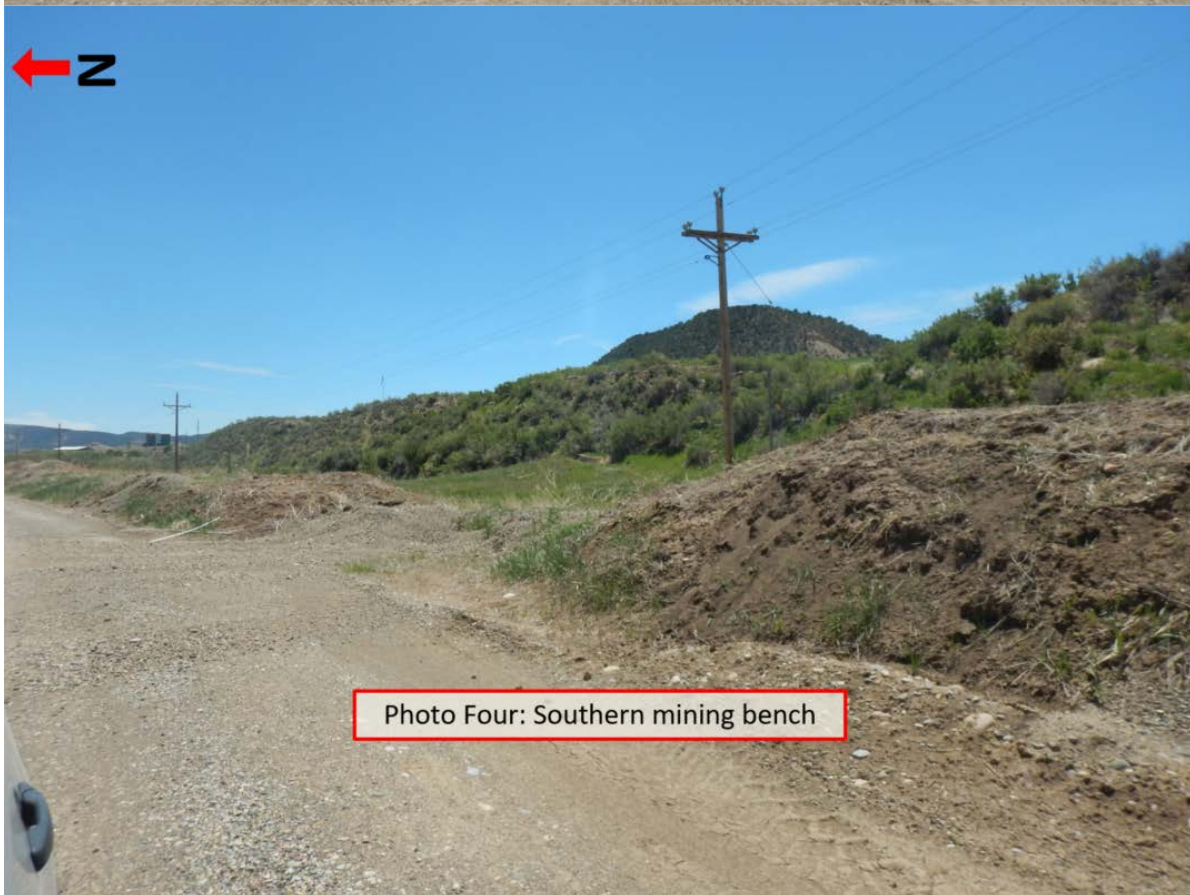
Mining is taking place in the northeast corner of the pit. The active highwall is approximately 20 feet high. There are two extremely large stockpiles in the bottom of the pit adjacent to the crusher. A ramp is needed to continue stockpiling as a conveyor is not tall enough. Along the south side of the pit is a mine bench where material was previous stockpiled. The bench is approximately 15 feet above the rest of the pit floor.

Photo Four: Southern mining bench

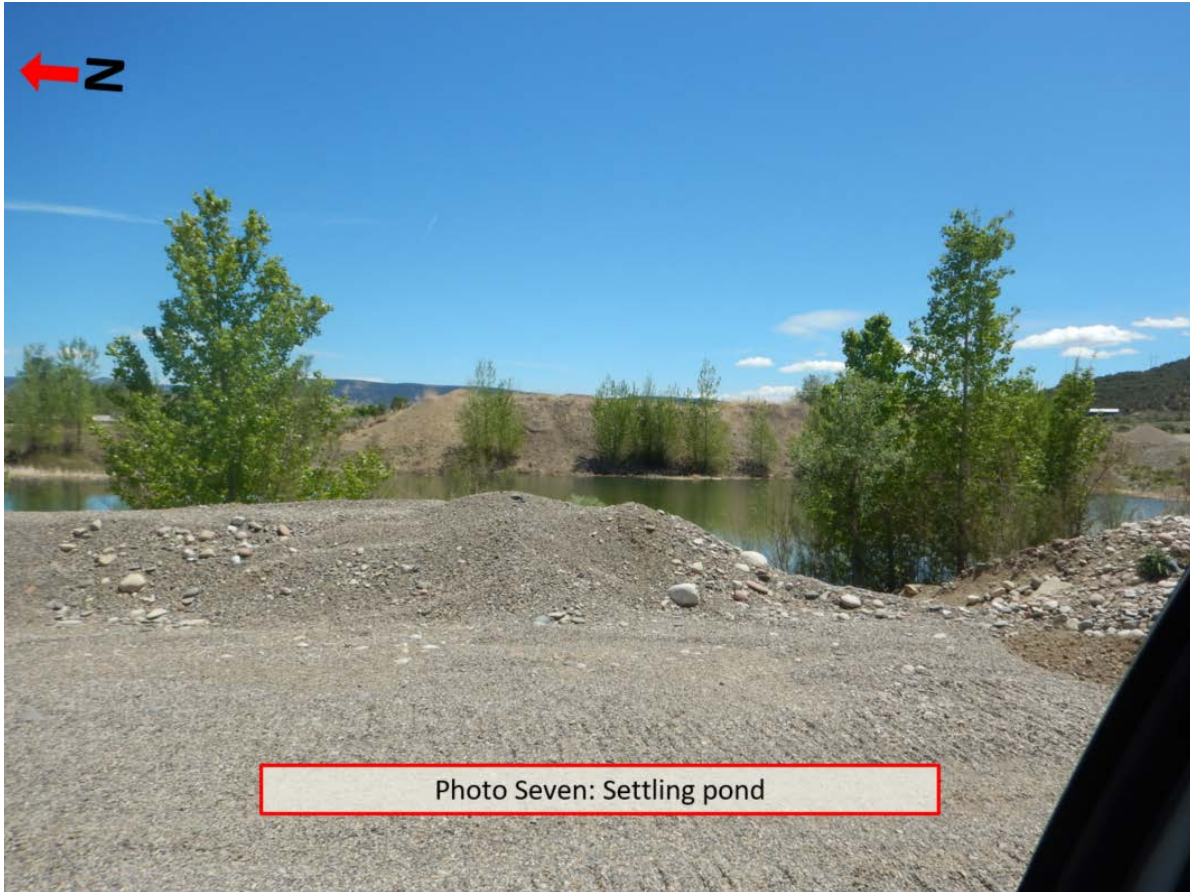
The wetland areas in the bottom of the pit appear to be properly avoided. Several undisturbed patches were evident. The settling pond is located in the middle of the pit along the east side.

Photo Seven: Settling pond

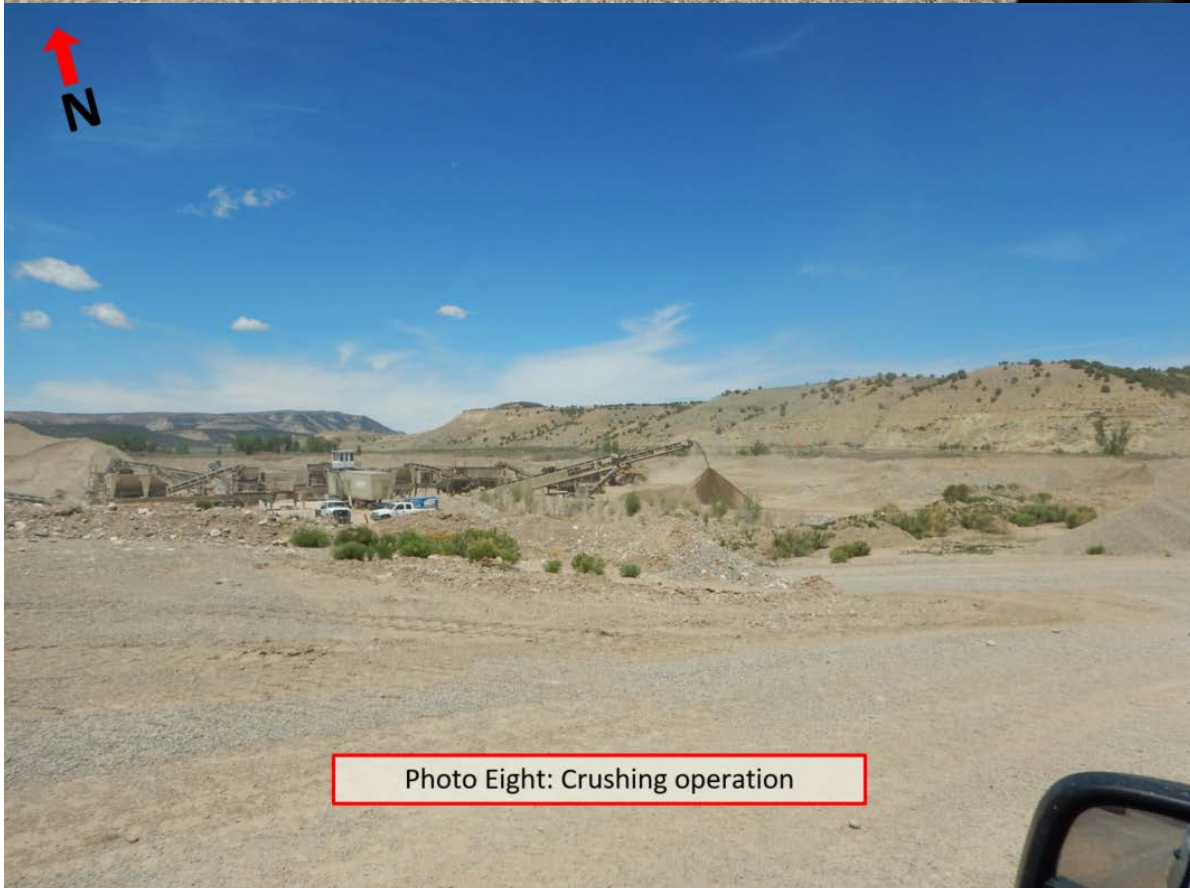
The site was active at the time of the inspection. The crusher was operational. Trucks were observed hauling material off site. A scale and scale house is located near the permit entrance. Fuel is on site in a mobile tank with secondary containment.

Photo Eight: Crushing operation
