MINERALS PROGRAM INSPECTION REPORT
PHONE: (303) 866-3567

MINE NAME: North Taft Hill Expansion Site	MINE/PROSPECTING ID#: M-2001-051	MINERAL: Sand and gravel	COUNTY: Larimer
INSPECTION TYPE: Monitoring	INSPECTOR(S): Amy Eschberger	INSP. DATE: May 26, 2021	INSP. TIME: 12:30
OPERATOR: Martin Marietta Materials, Inc.	OPERATOR REPRESENTATIVE: Julie Mikulas	TYPE OF OPERATION: 112c - Construction Regular Operation

M-2001-051 / North Taft Hill Expansion Site / Martin Marietta Materials, Inc. (112c)

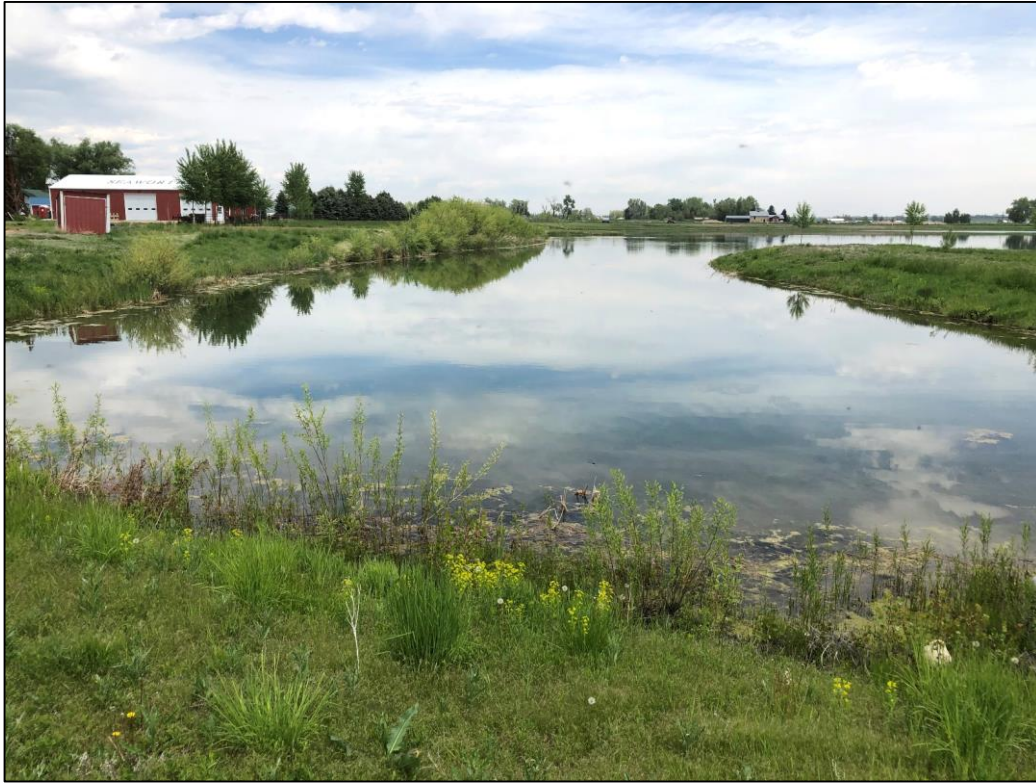
Photo 1. View looking north across southwestern edge of large pond, showing slopes graded to 3H:1V or flatter and stable with good vegetative cover. Some weed control is needed in this area.

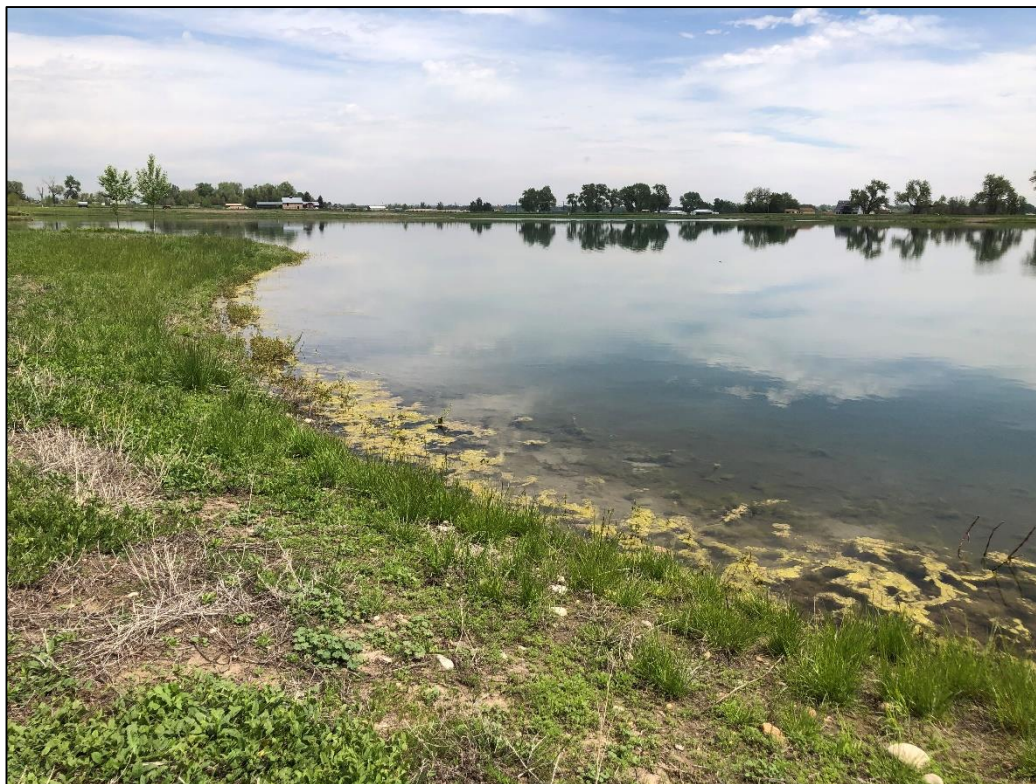
Photo 2. View looking north across southwestern shoreline of large pond, showing slopes graded to 3H:1V or flatter and stable with good vegetative cover. Some weed control is needed in this area.

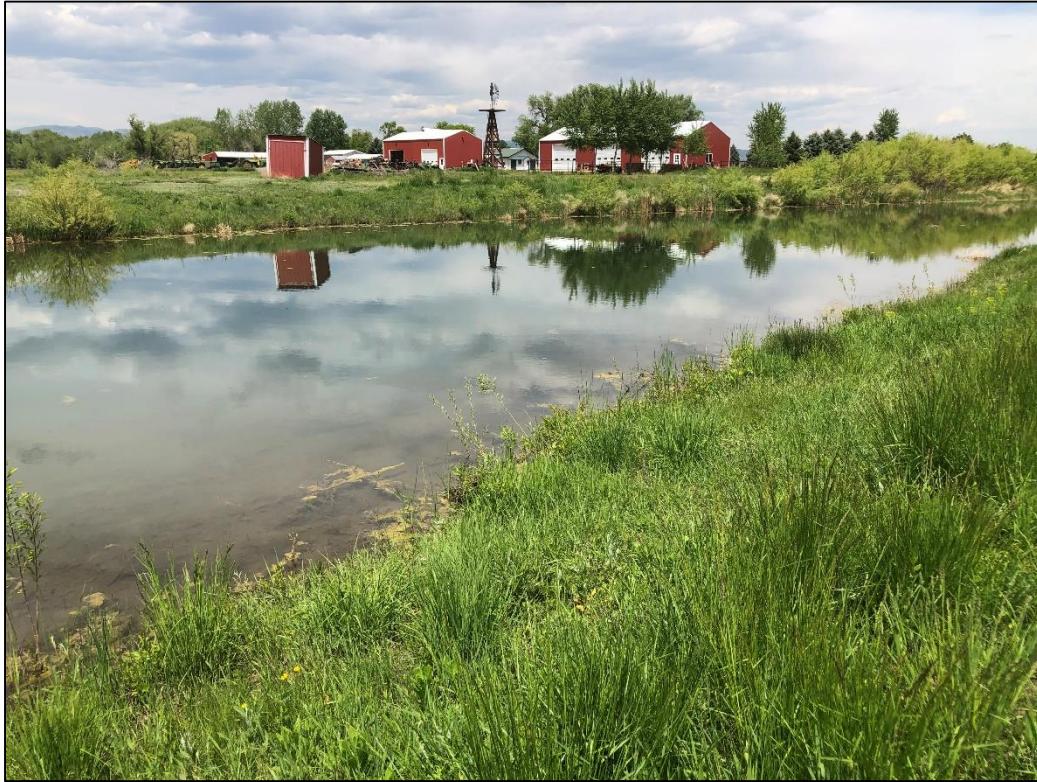
Photo 3. View looking west across southwestern portion of large pond, showing slopes graded to 3H:1V or flatter and stable with good vegetative cover.

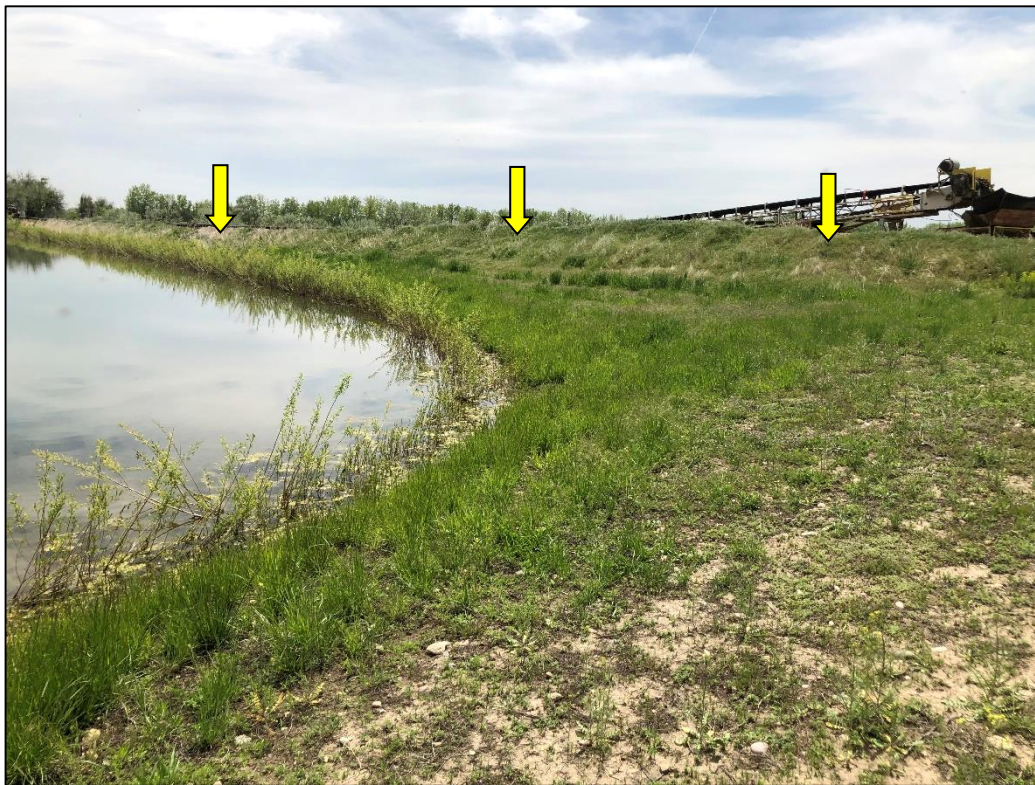
Photo 4. View looking southeast across southern shoreline of large pond, showing slopes graded to 3H:1V or flatter and stable with good vegetative cover. Some weed control is needed in this area. Note approx. 5 foot tall berm (indicated) constructed along northern edge of conveyor.

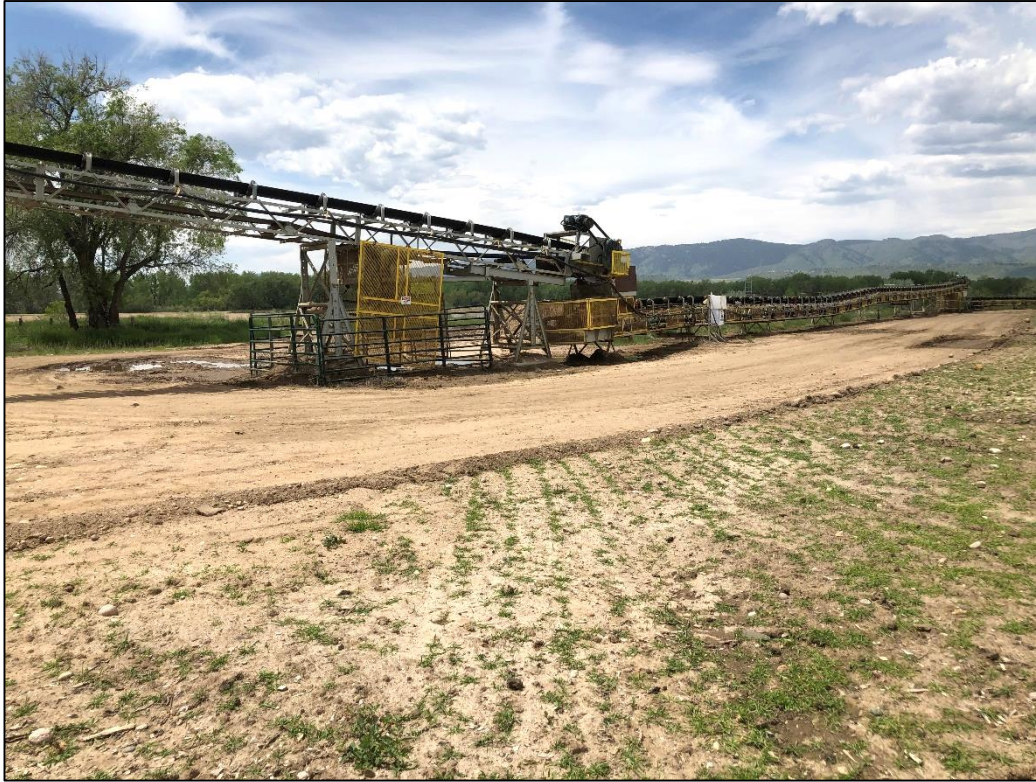
Photo 5. View looking west at conveyor system installed along southern edge of permit area, which supports Home Office Mine permit.

Given that mining is complete at this site and current activities include operating a conveyor system which supports another mine operation (Home Office Mine), the Division strongly recommends the operator either incorporate this entire permit into the Home Office Mine permit then request a release of this permit, or incorporate the conveyor disturbance into the Home Office Mine permit then request a release of this permit once the eastern portion has been successfully revegetated.

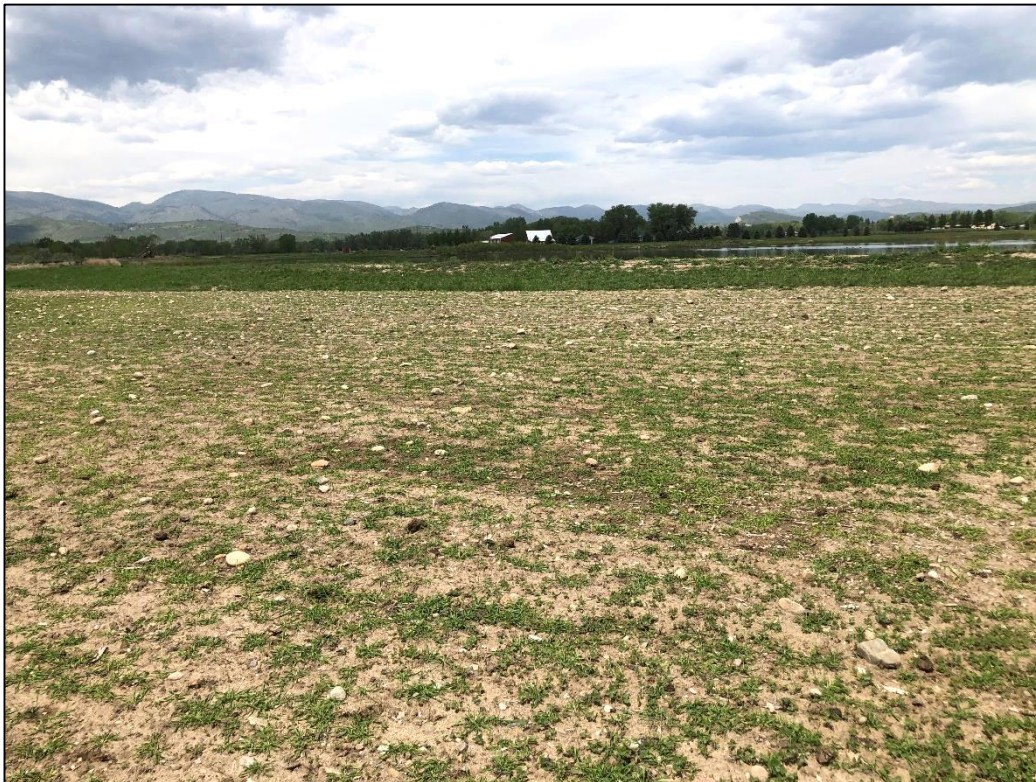
Photo 6. View looking west across area located southeast of large pond which requires additional revegetation efforts and some weed control.

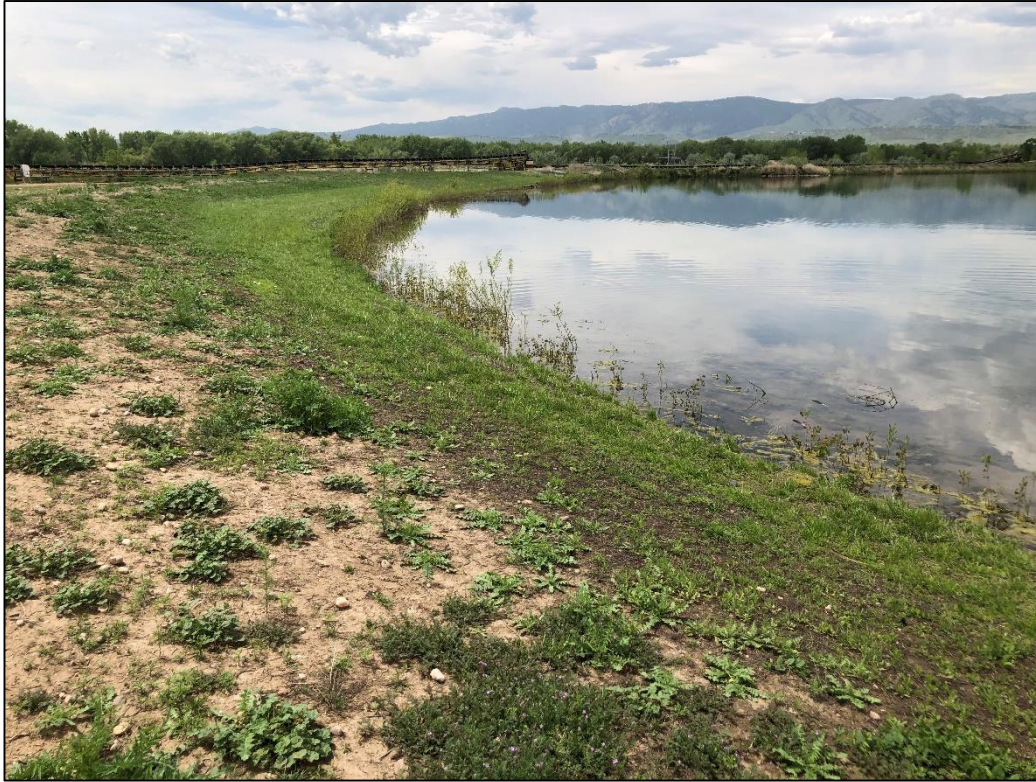
Photo 7. View looking southwest across southeastern shoreline of large pond, showing slopes graded to 3H:1V or flatter and stable with good vegetative cover. Area located just east of shoreline (in foreground) requires additional revegetation efforts and some weed control.

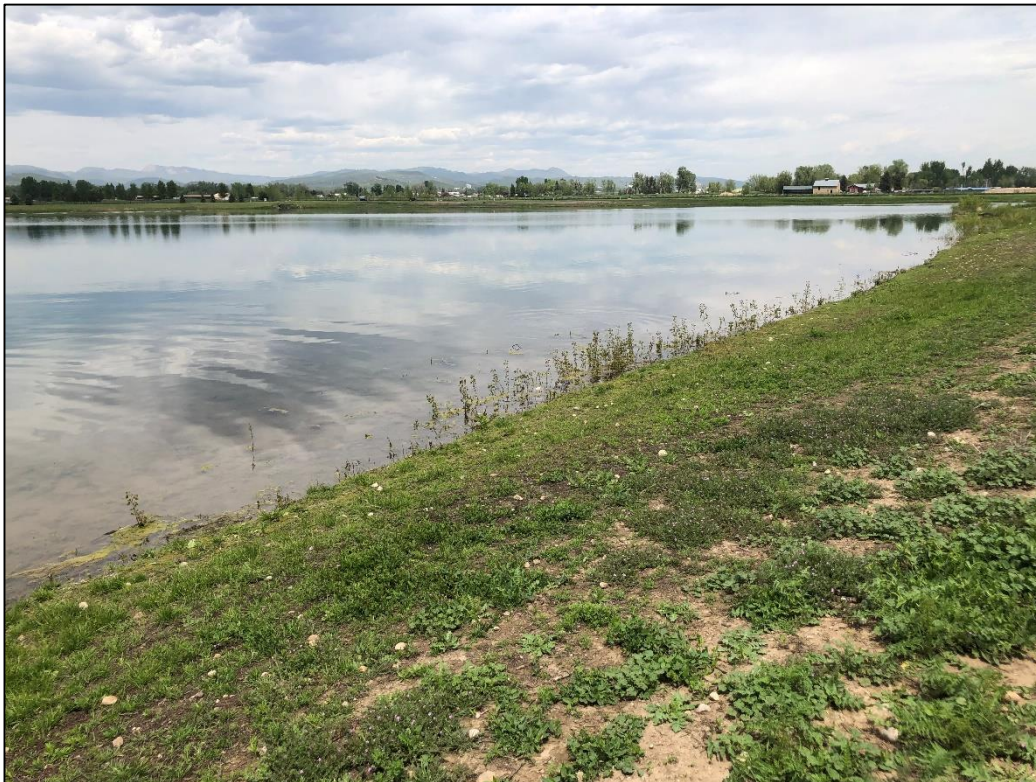
Photo 8. View looking north across eastern shoreline of large pond, showing slopes graded to 3H:1V or flatter and stable with good vegetative cover. Area located just east of shoreline (in foreground) requires additional revegetation efforts and some weed control.

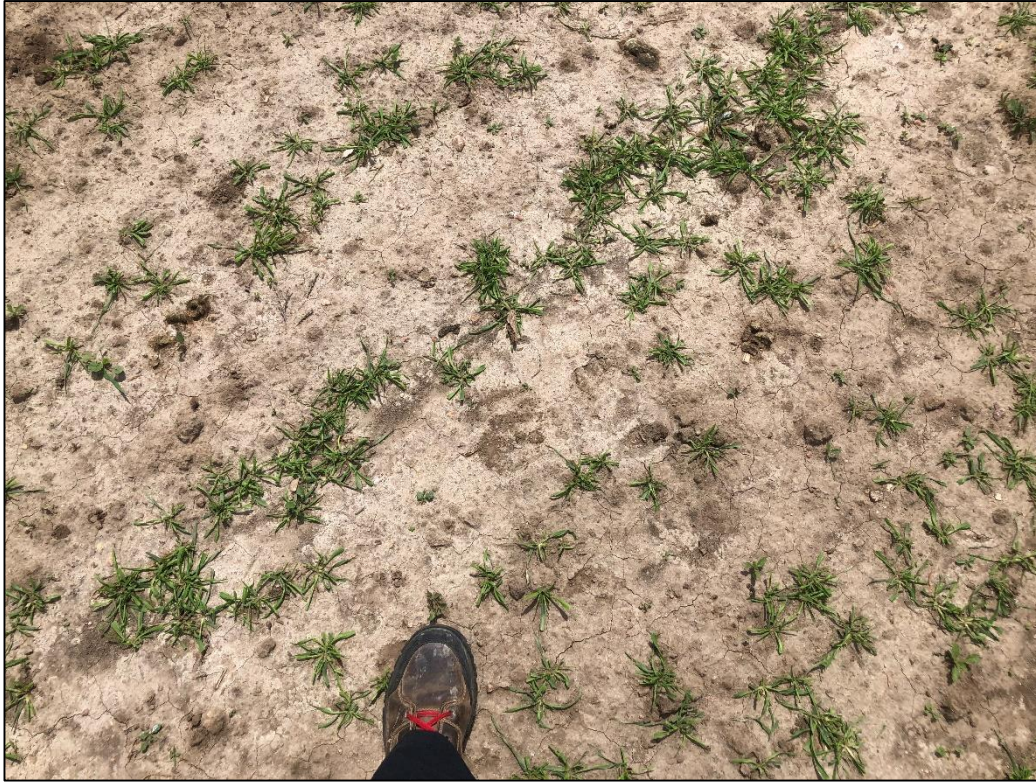
Photo 9. Ground view in area located east of large pond, showing sparse vegetative cover present in this area.

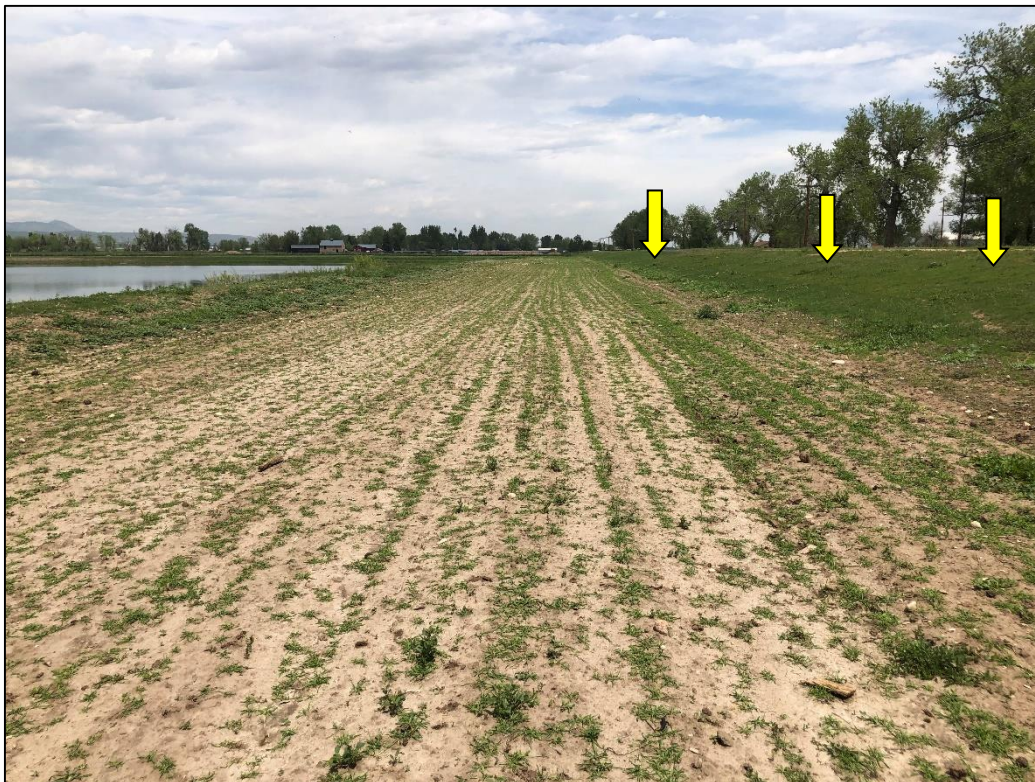
Photo 10. View looking north across area located east of large pond which requires additional revegetation efforts and some weed control. Note berm left along eastern edge of permit area (indicated) where remaining overburden stockpiles were graded to 3H:1V or flatter.

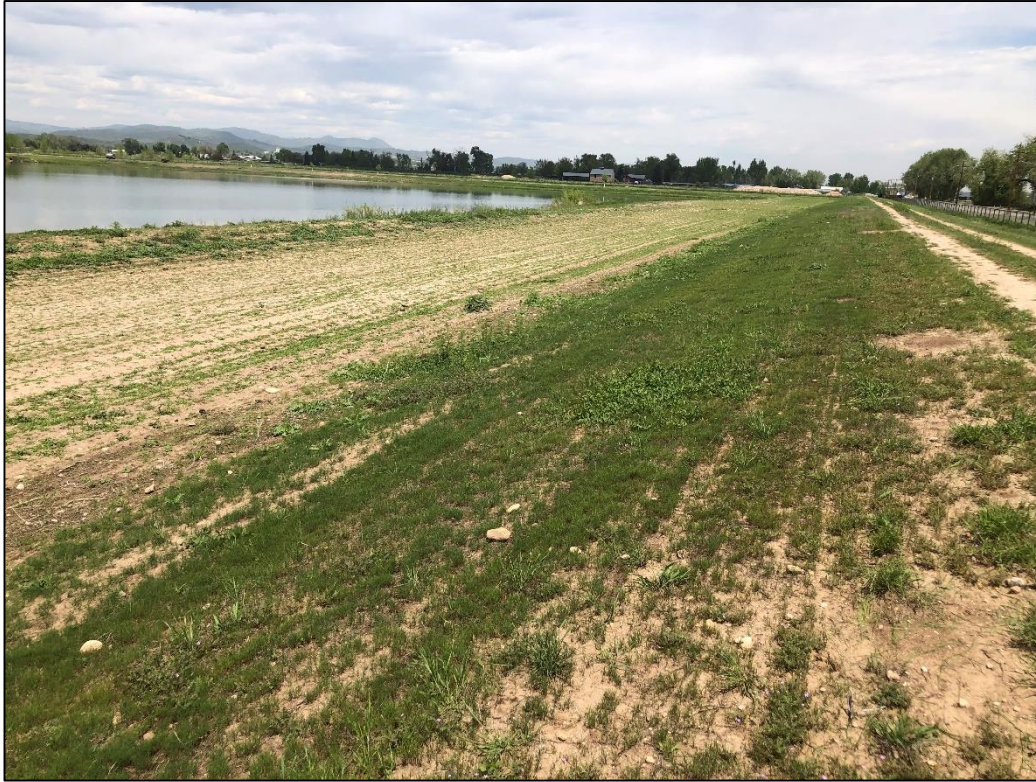
Photo 11. View looking north from eastern permit boundary across area located east of large pond which requires additional revegetation efforts and some weed control. Note slopes graded to 3H:1V or flatter.

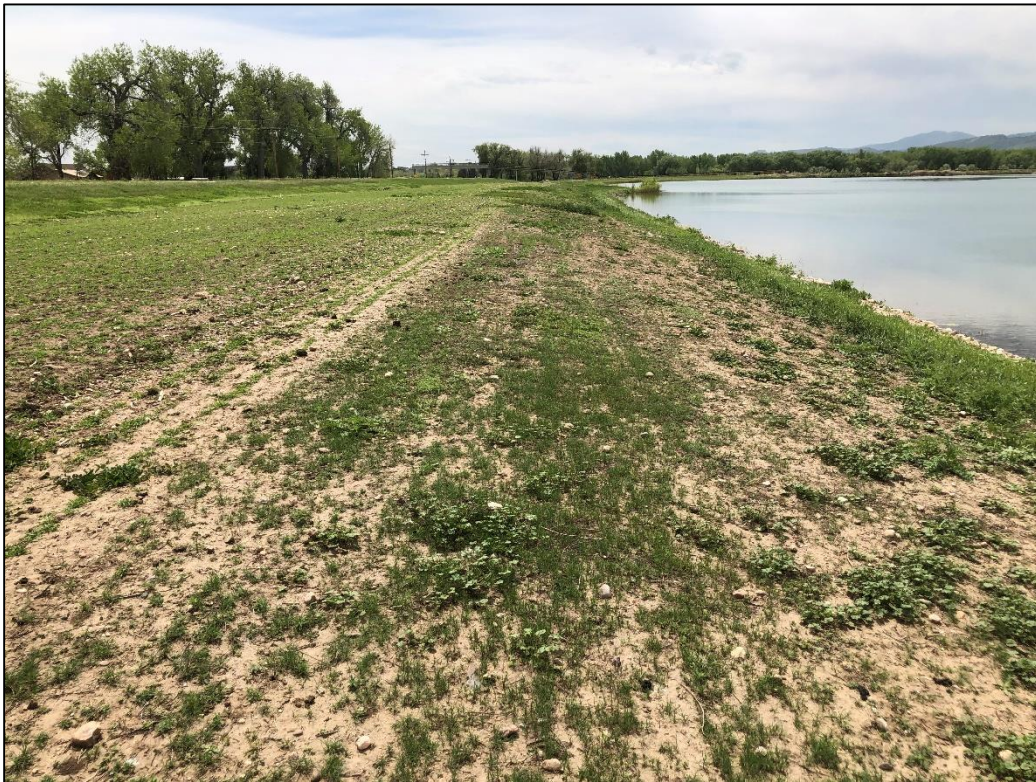
Photo 12. View looking south across area located northeast of large pond which requires additional revegetation efforts and some weed control.

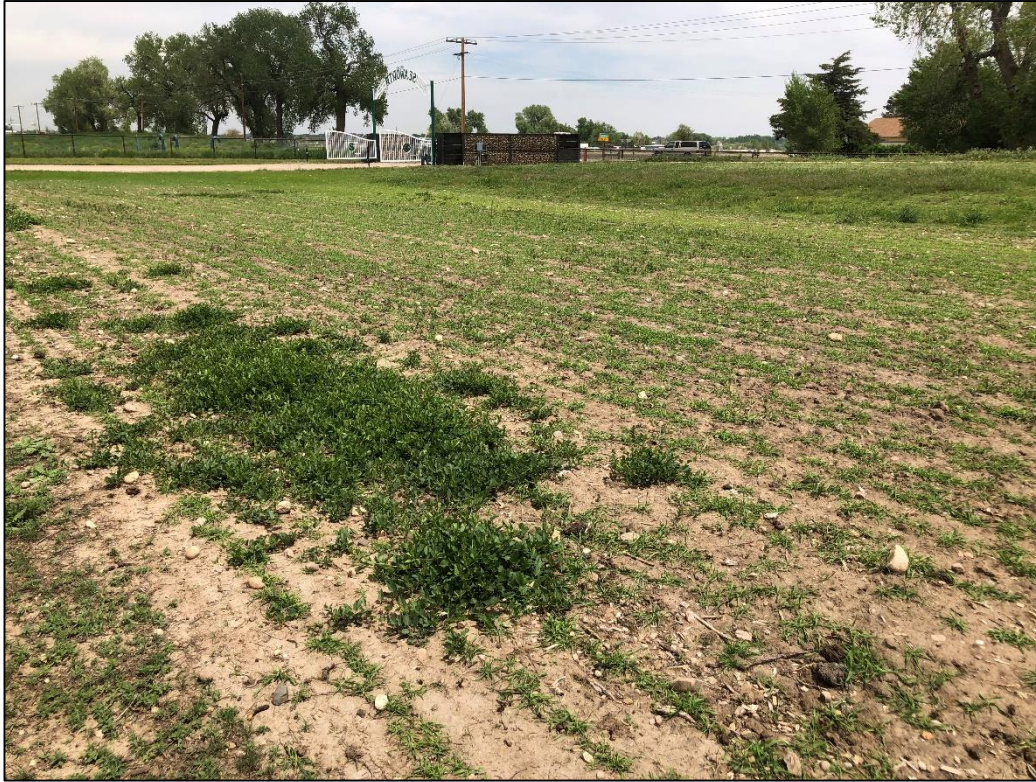
Photo 13. View looking northeast across area located northeast of large pond which requires additional revegetation efforts and some weed control.

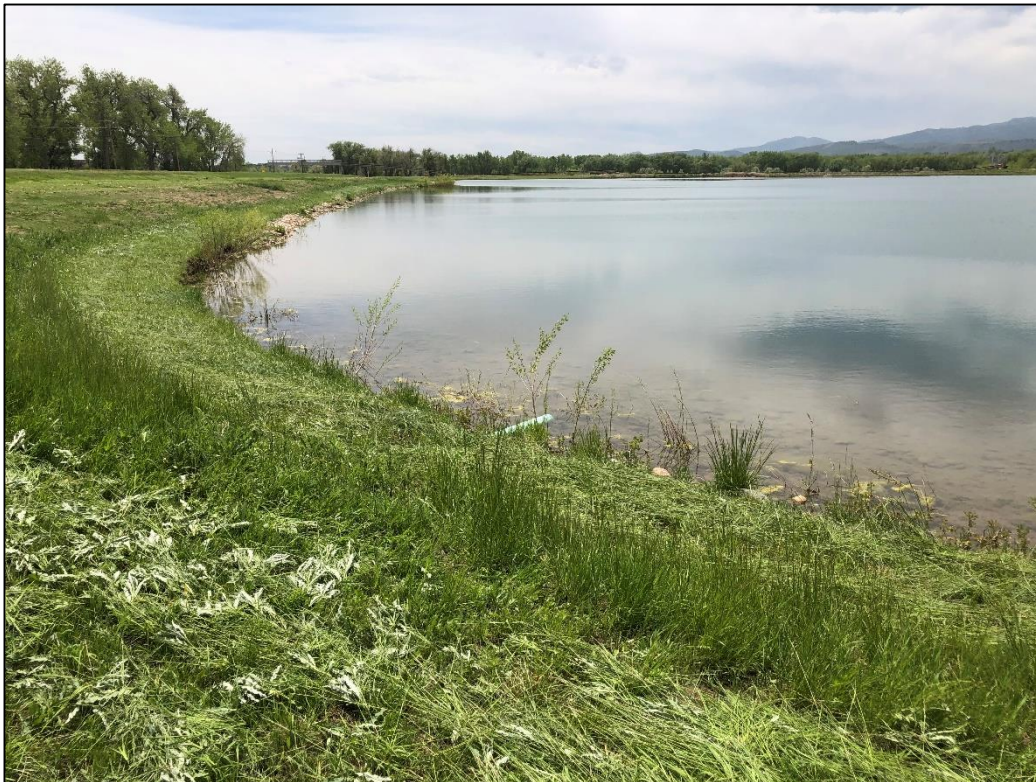
Photo 14. View looking southeast across northeastern shoreline of large pond, showing slopes graded to 3H:1V or flatter and stable with good vegetative cover.

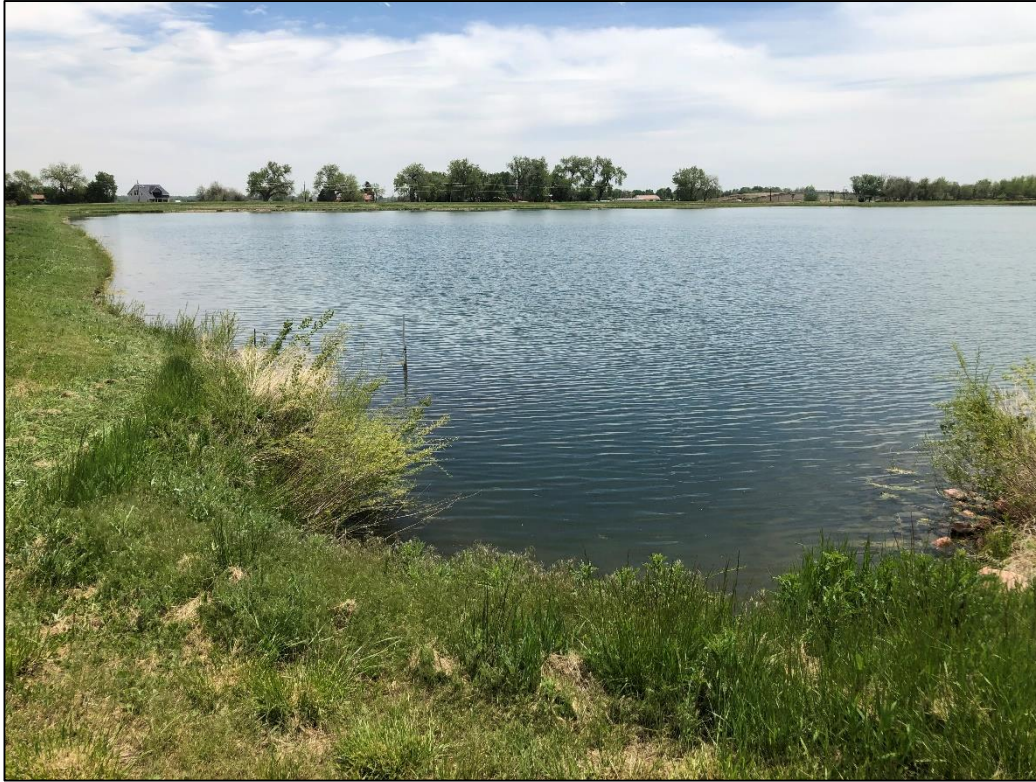
Photo 15. View looking east across northern shoreline of large pond, showing slopes graded to 3H:1V or flatter and stable with good vegetative cover.

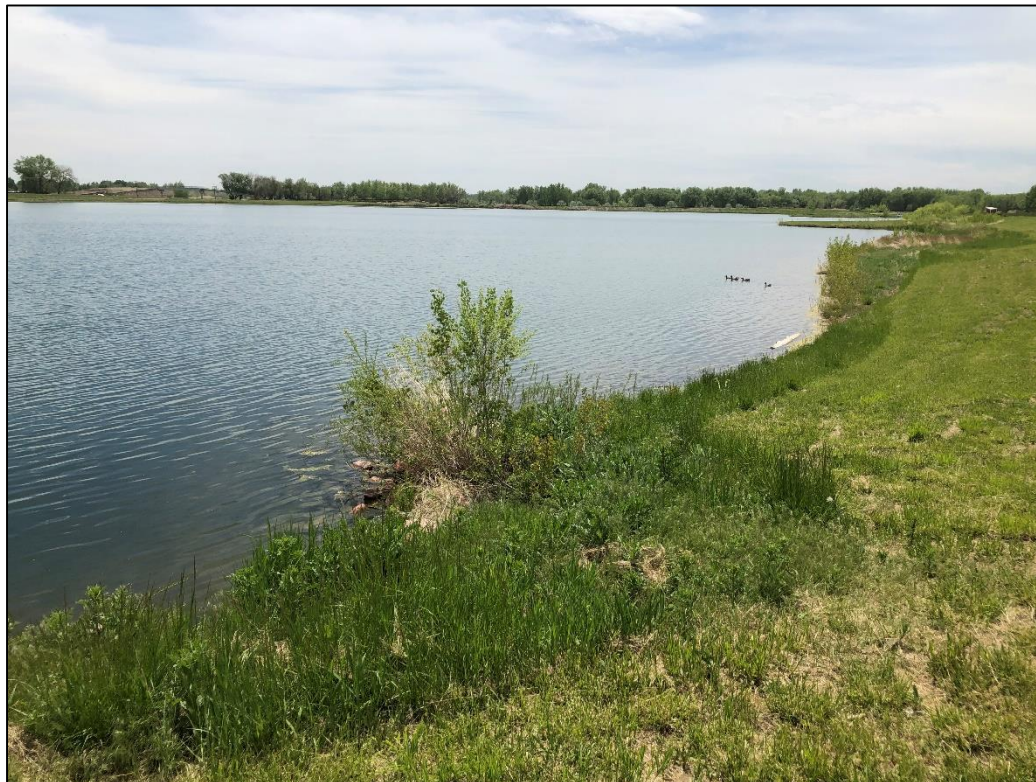
Photo 16. View looking south across western shoreline of large pond, showing slopes graded to 3H:1V or flatter and stable with good vegetative cover.

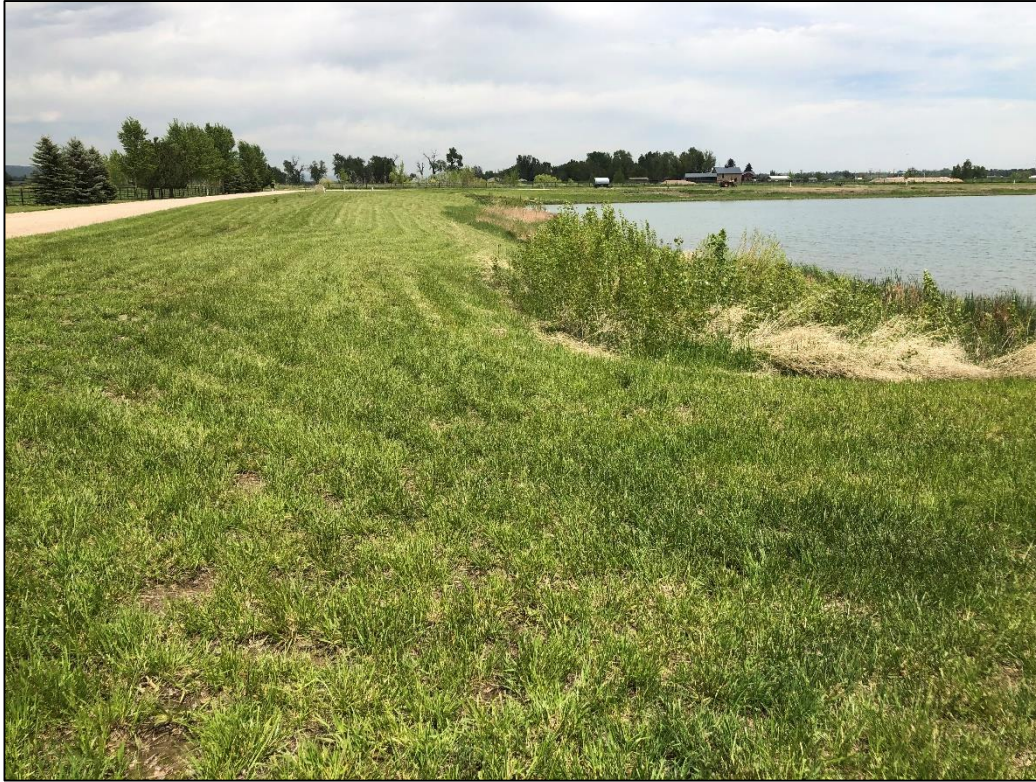
Photo 17. View looking north across area located west of large pond, showing well established grasses in this area.

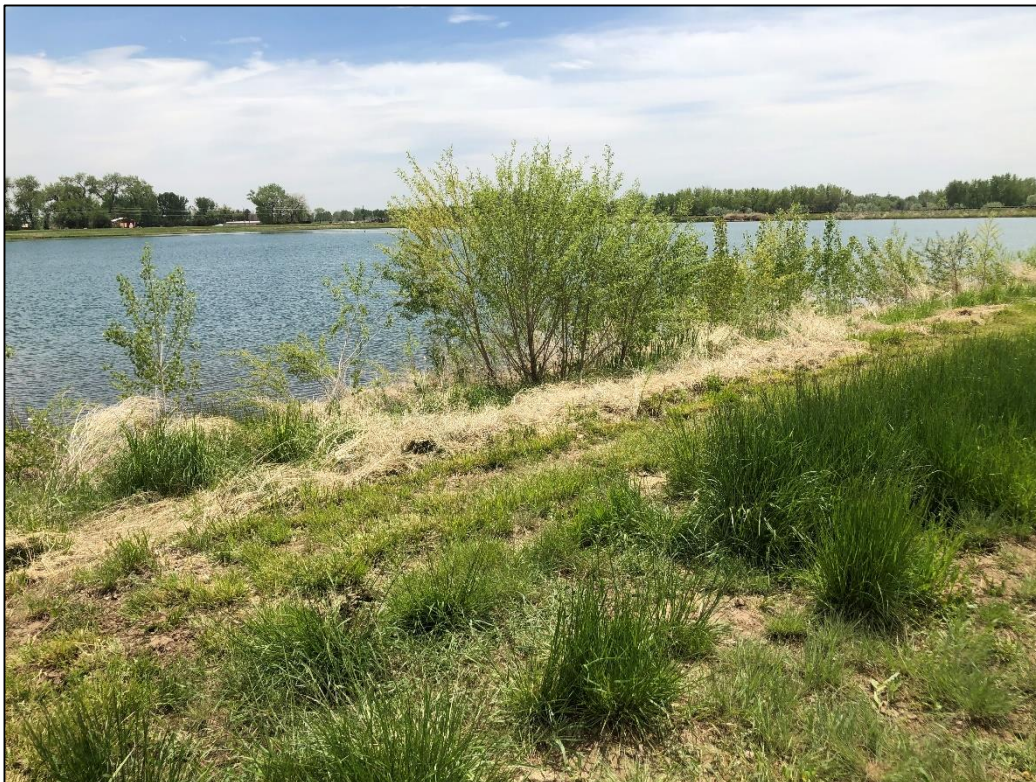
Photo 18. View looking southeast at western shoreline of large pond, showing slopes graded to 3H:1V or flatter and stable with good vegetative cover.

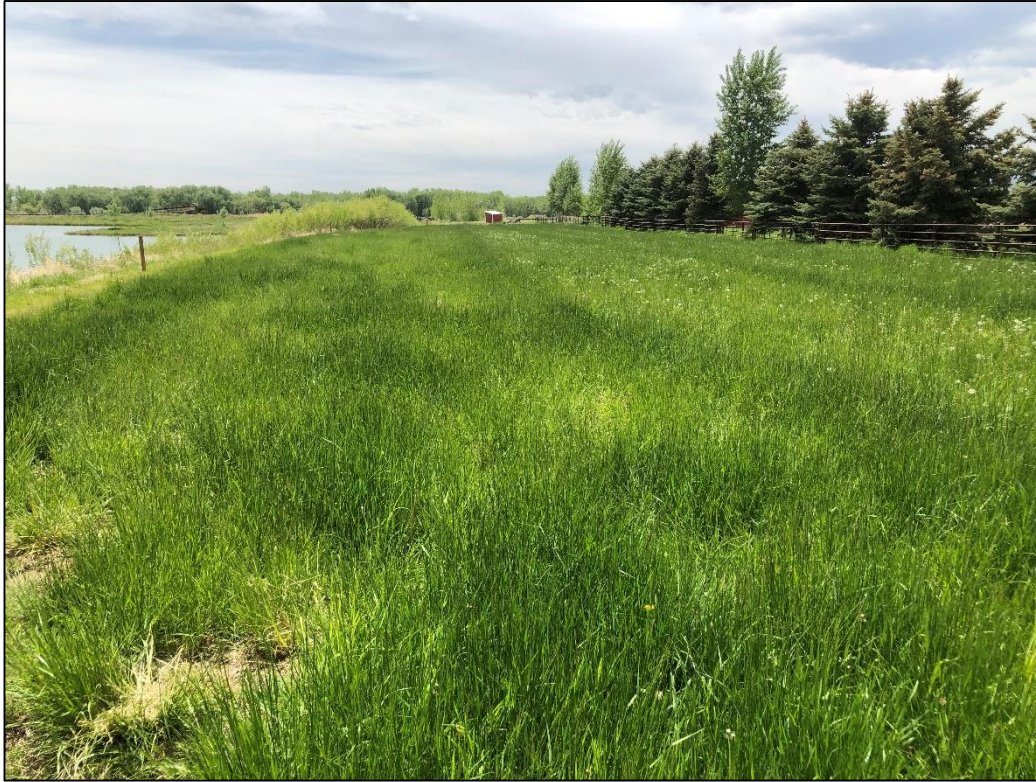
Photo 19. View looking south across area located west of large pond, showing well-established grasses in this area.

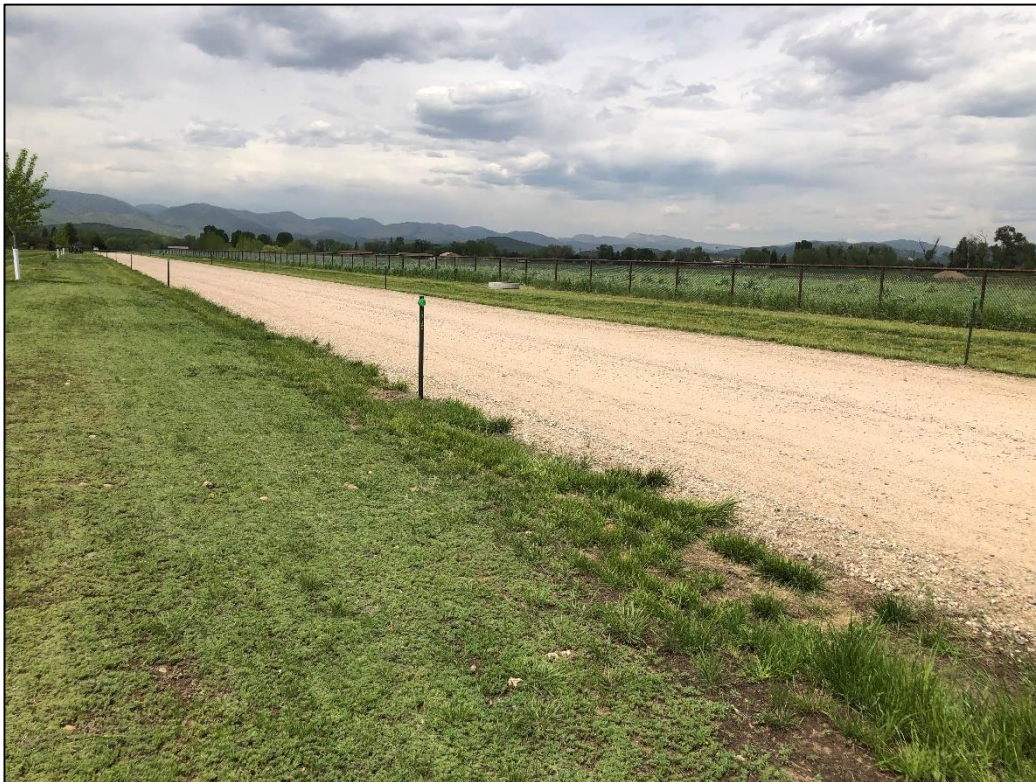
Photo 20. View looking northwest at residential access road which was relocated to northern edge of permit area per the approved reclamation plan. Note fence (in background) which delineates northern permit boundary.
