MINERALS PROGRAM INSPECTION REPORT
PHONE: (303) 866-3567

MINE NAME: The Mountain Mining Claim	MINE/PROSPECTING ID#: M-2004-008	MINERAL: Gold	COUNTY: Clear Creek
INSPECTION TYPE: Monitoring	INSPECTOR(S): Michael A. Cunningham	INSP. DATE: November 28, 2017	INSP. TIME: 11:00
OPERATOR: Joseph Curtis Harden	OPERATOR REPRESENTATIVE: Joseph Curtis Harden	TYPE OF OPERATION: 110(2) - Hard Rock Limited Impact	
REASON FOR INSPECTION: Normal I&E Program	BOND CALCULATION TYPE: Complete Bond	BOND AMOUNT: \$1,100.00	
DATE OF COMPLAINT: NA	POST INSP. CONTACTS: None	JOINT INSP. AGENCY: None	
WEATHER: Clear	INSPECTOR'S SIGNATURE:

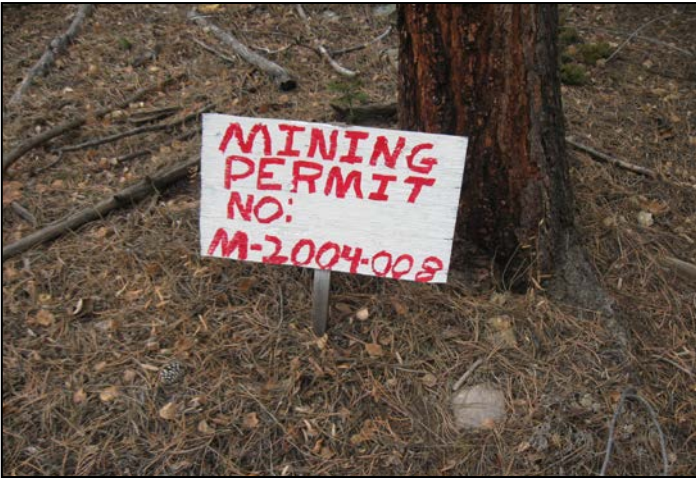
The permit sign was posted at the site entrance and the boundary of the affected area was clearly delineated.

1. Permit sign.

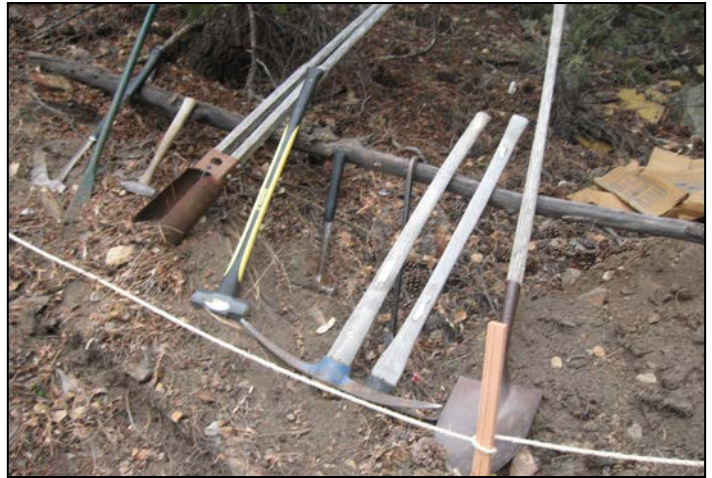
2. Hand tools.

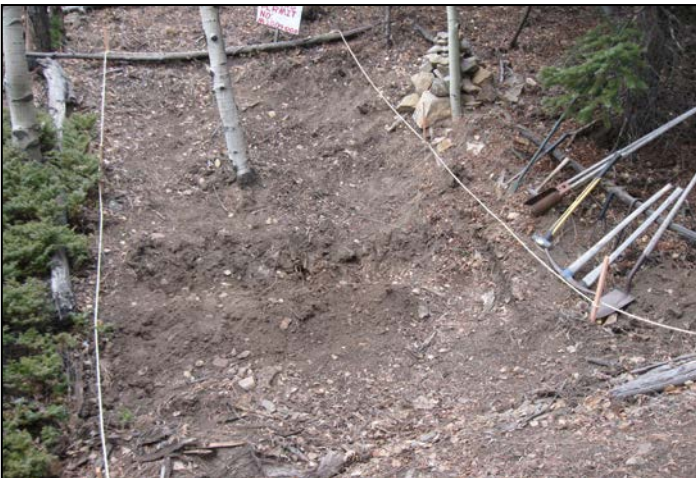
The approved Mining Plan allows the Operator to excavate within a 15 ft. x 7 ft. area up to 7 ft. in depth. The Operator is conducting mining with hand tools, no heavy equipment was observed on site. The excavation area is located immediately north and uphill of the trailer in which Mr. Harden resides. The Operator has backfilled the previous excavations created within the affected area and topsoil has been replaced. No stockpiles were present at the site. In addition, no revegetation of the affected area has been conducted as the Operator plans to continue excavating within the previously affected area.

3. Excavation area.
