**MINERALS PROGRAM INSPECTION REPORT**  
**PHONE: (303) 866-3567**

<b>MINE NAME:</b> 15 Road Gravel Pit	<b>MINE/PROSPECTING ID#:</b> M-2002-114	<b>MINERAL:</b> Sand and gravel	<b>COUNTY:</b> Mesa
<b>INSPECTION TYPE:</b> Monitoring	<b>INSPECTOR(S):</b> Amy Yeldell	<b>INSP. DATE:</b> May 26, 2021	<b>INSP. TIME:</b> 10:15
<b>OPERATOR:</b> Oldcastle SW Group, Inc. dba United Con Mesa County	<b>OPERATOR REPRESENTATIVE:</b> Tyra Bartuska	<b>TYPE OF OPERATION:</b> 112c - Construction Regular Operation	
<b>REASON FOR INSPECTION:</b> Normal I&E Program	<b>BOND CALCULATION TYPE:</b> Complete Bond	<b>BOND AMOUNT:</b> \$854,778.00	
<b>DATE OF COMPLAINT:</b> NA	<b>POST INSP. CONTACTS:</b> DRMS	<b>JOINT INSP. AGENCY:</b> None	
<b>WEATHER:</b> Clear	<b>INSPECTOR'S SIGNATURE:</b>

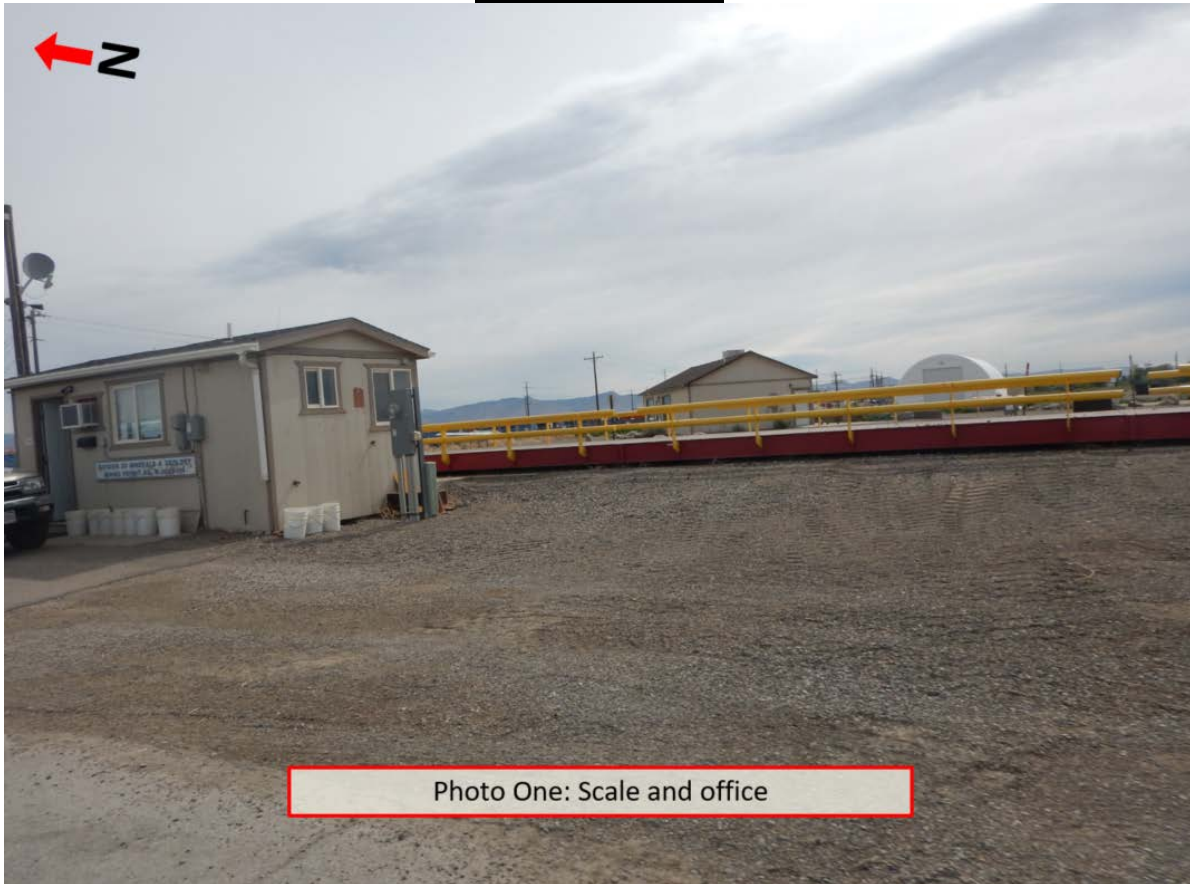
The scale and scale house are located near the permit entrance on the western side of the permit. Fuel tanks were observed throughout the site, all which were stored properly within secondary containments. The pit was active at the time of the inspections. The active mining is within pit 3 pit through approximately phase 3-4. Pit 3 is sloped at a 1H: 1V to near vertical slopes approximately 25 feet deep. Lots of stockpiles are on the pit floor. An inactive asphalt plant was located in the northern section of pit 3 next to the scale. Asphalt millings were on site and stored above the water table. Two settling ponds were located in the southern corner of pit 3 near the ramp to access pit 4. A crusher was operational as well as trucks hauling material off site. The crusher is located on the southern end between pits 3 and 4.

Photo One: Scale and office

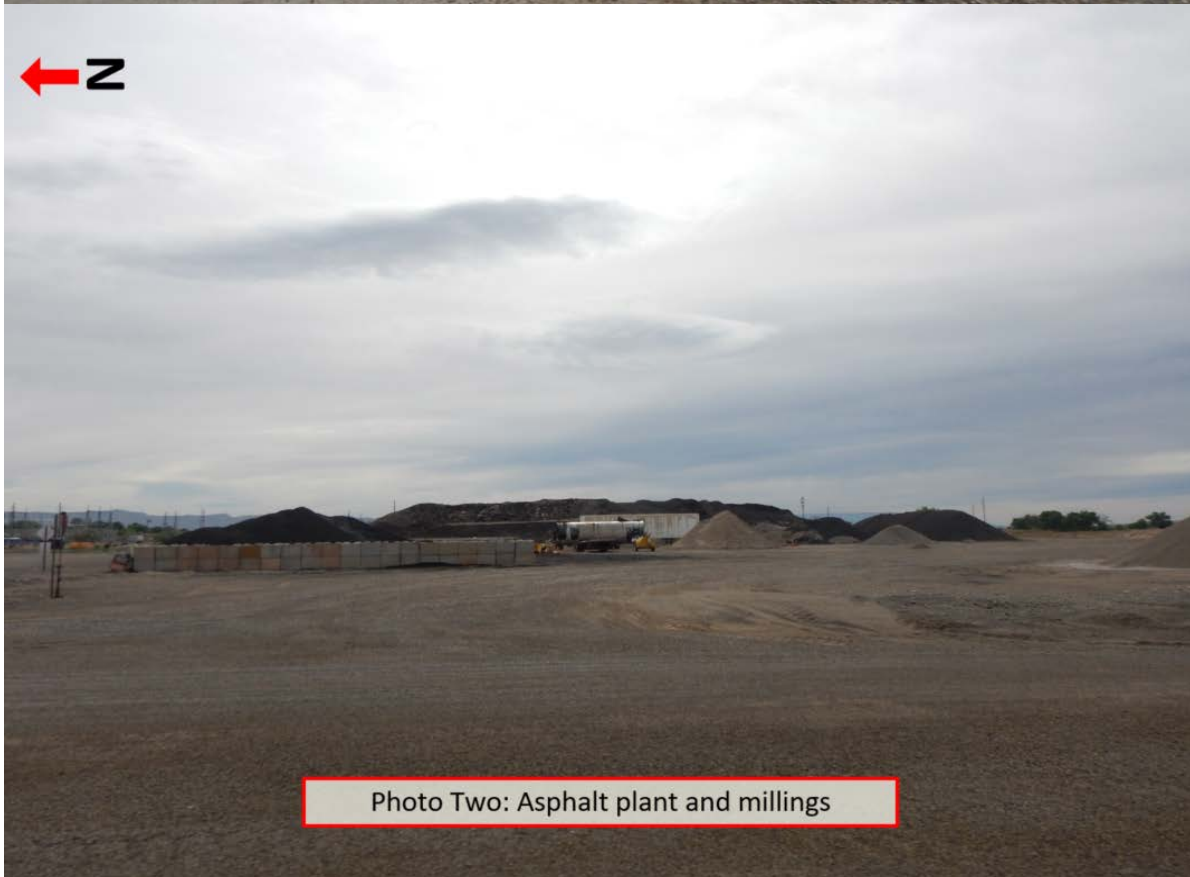
Photo Two: Asphalt plant and millings

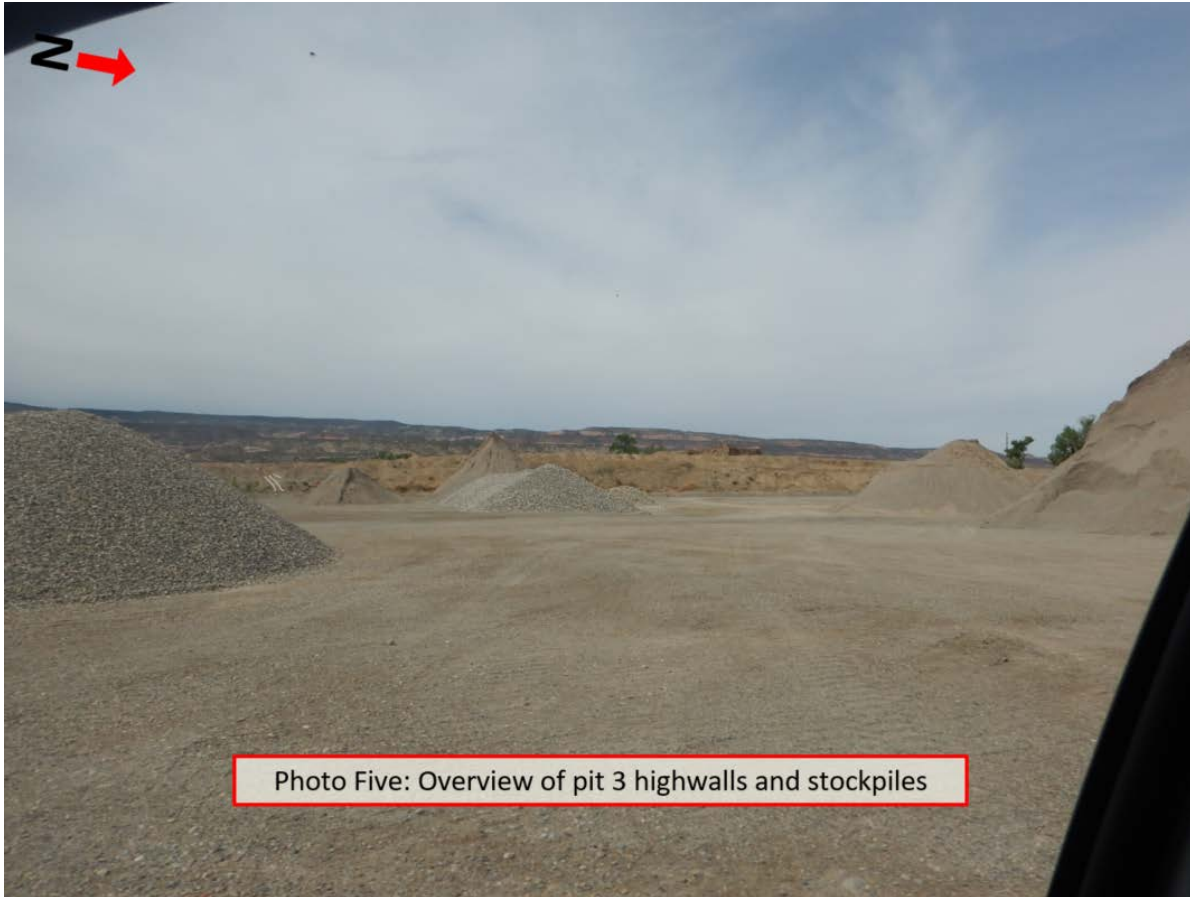
Photo Five: Overview of pit 3 highwalls and stockpiles

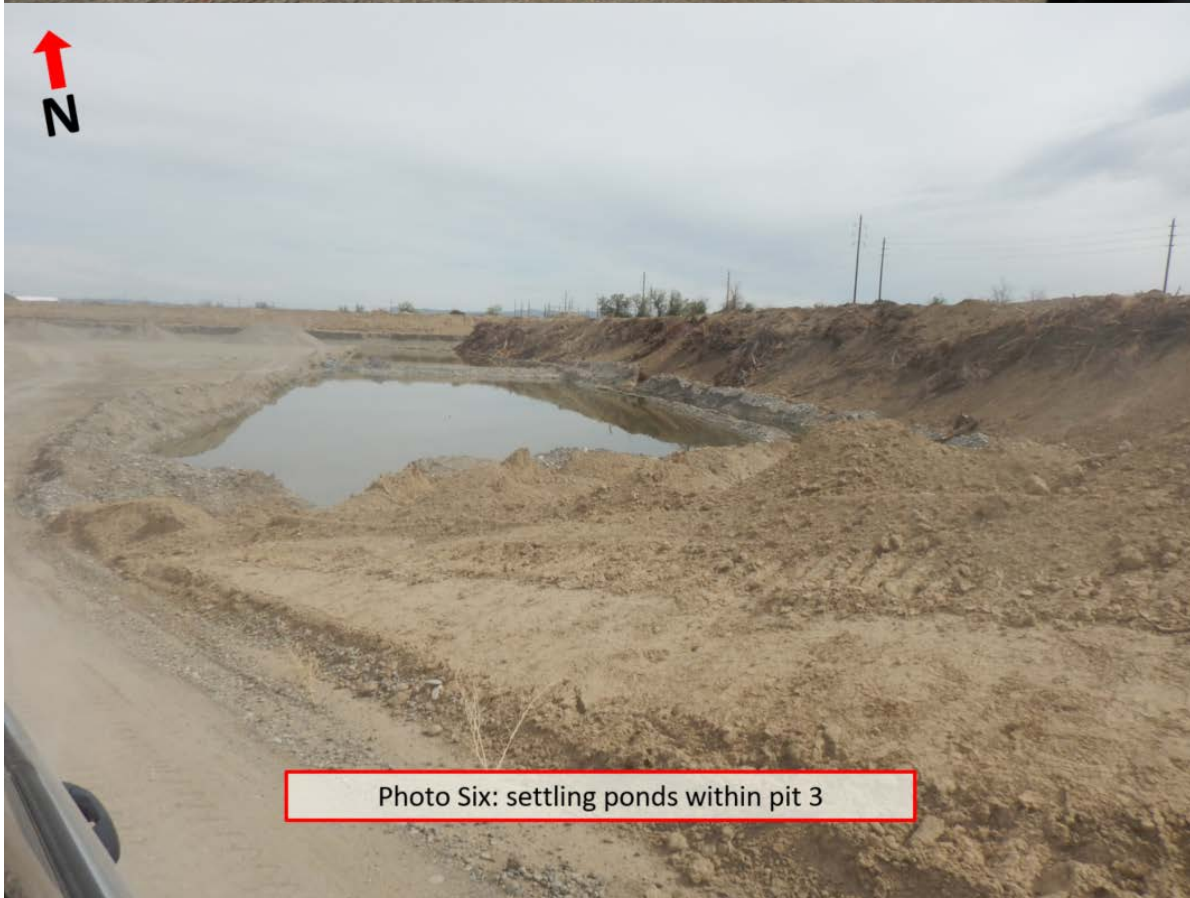
Photo Six: settling ponds within pit 3

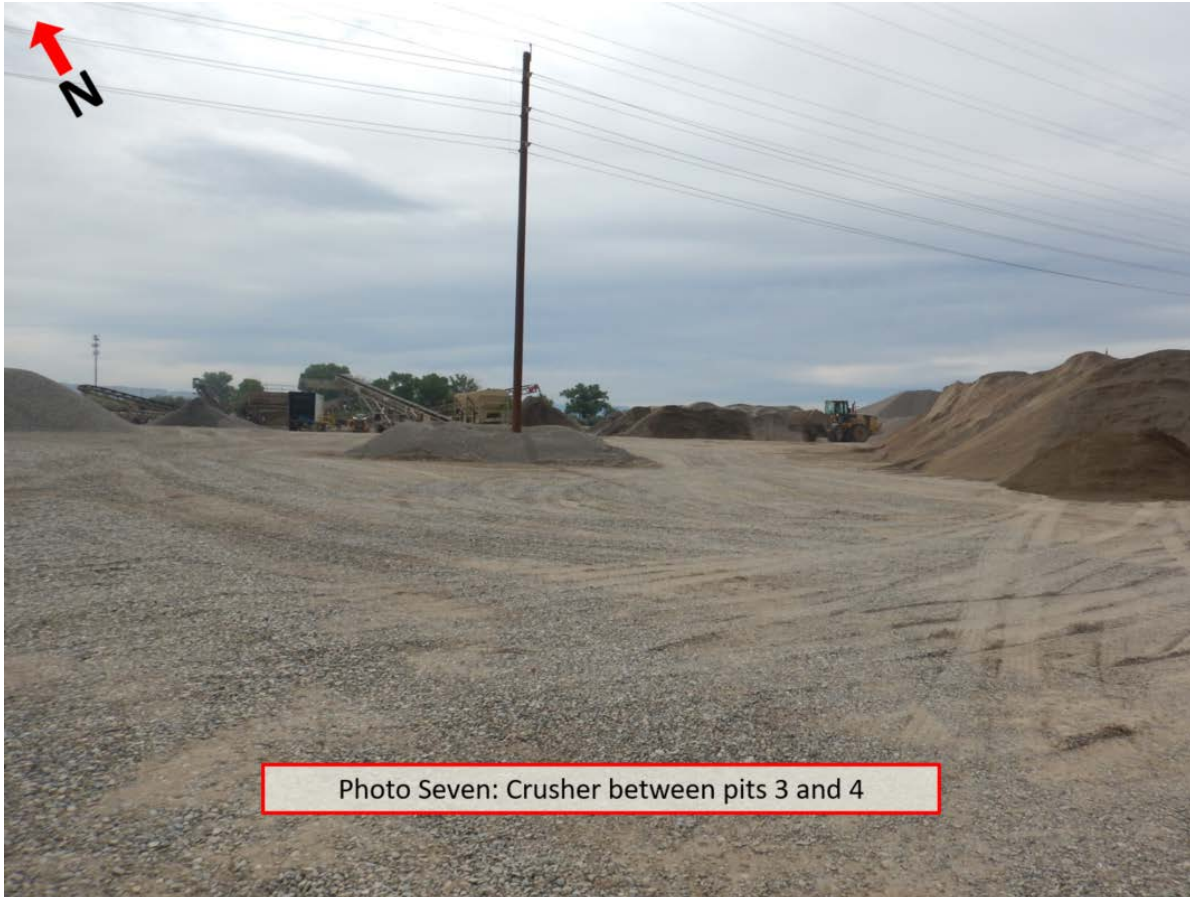
Photo Seven: Crusher between pits 3 and 4

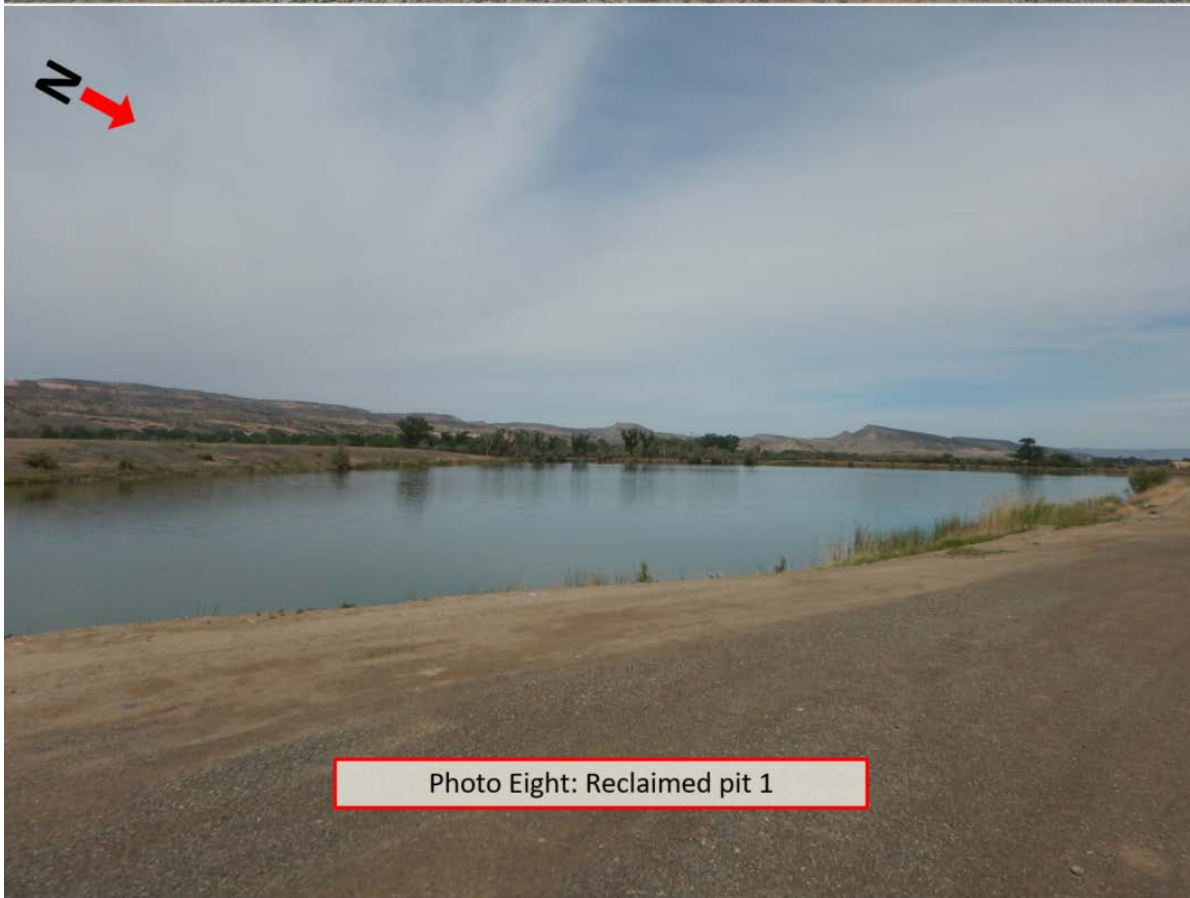
Phase 1 mining has been completed. The slopes have all been graded and the lake is completely filled with water. Vegetation appeared to be lacking. It was unclear if the area has been seeded or if weeds have invaded. Pit 4 is partially mined out through approximately phase 4. The pit is inundated (approx. 24 acres) so dewatering would be necessary prior to continuing to move north.

Photo Eight: Reclaimed pit 1
