MINERALS PROGRAM INSPECTION REPORT
PHONE: (303) 866-3567

MINE NAME: Gilsonite Gravel Pit	MINE/PROSPECTING ID#: M-2002-111	MINERAL: Sand and gravel	COUNTY: Mesa
INSPECTION TYPE: Monitoring	INSPECTOR(S): Amy C. Yeldell	INSP. DATE: June 3, 2019	INSP. TIME: 09:00
OPERATOR: Fruita Development LLC	OPERATOR REPRESENTATIVE: Gary Murphy	TYPE OF OPERATION: 112c - Construction Regular Operation	
REASON FOR INSPECTION: Normal I&E Program	BOND CALCULATION TYPE: None	BOND AMOUNT: \$500.00	
DATE OF COMPLAINT: NA	POST INSP. CONTACTS: None	JOINT INSP. AGENCY: None	
WEATHER: Clear	INSPECTOR'S SIGNATURE:

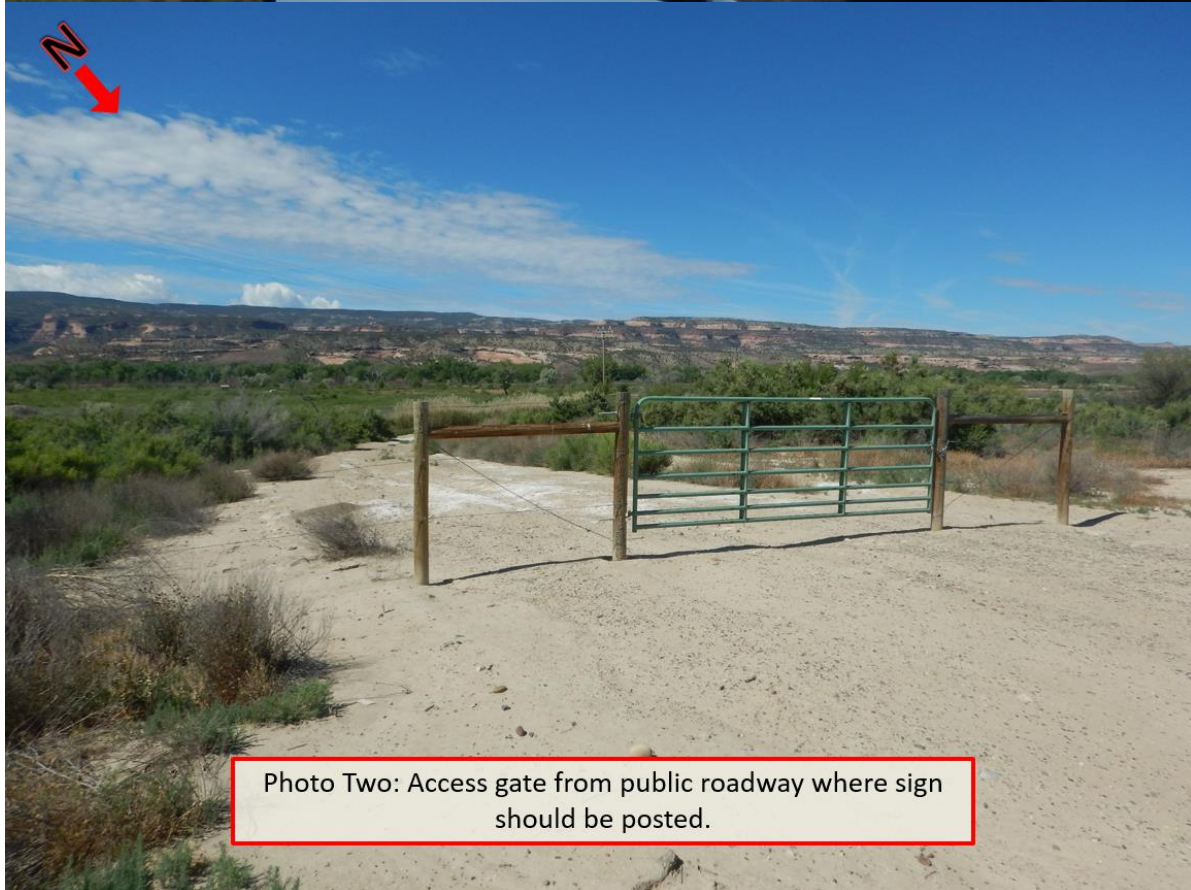
Photo Two: Access gate from public roadway where sign should be posted.

A mine sign was located on site. The Division would like to note that it was posted on an internal access road facing the river rather than at the mine entrance. The Operator should move this mine sign to the permit entrance/ gate off of the public access road. The permit boundary is delineated by a t-post wire and wire fence.

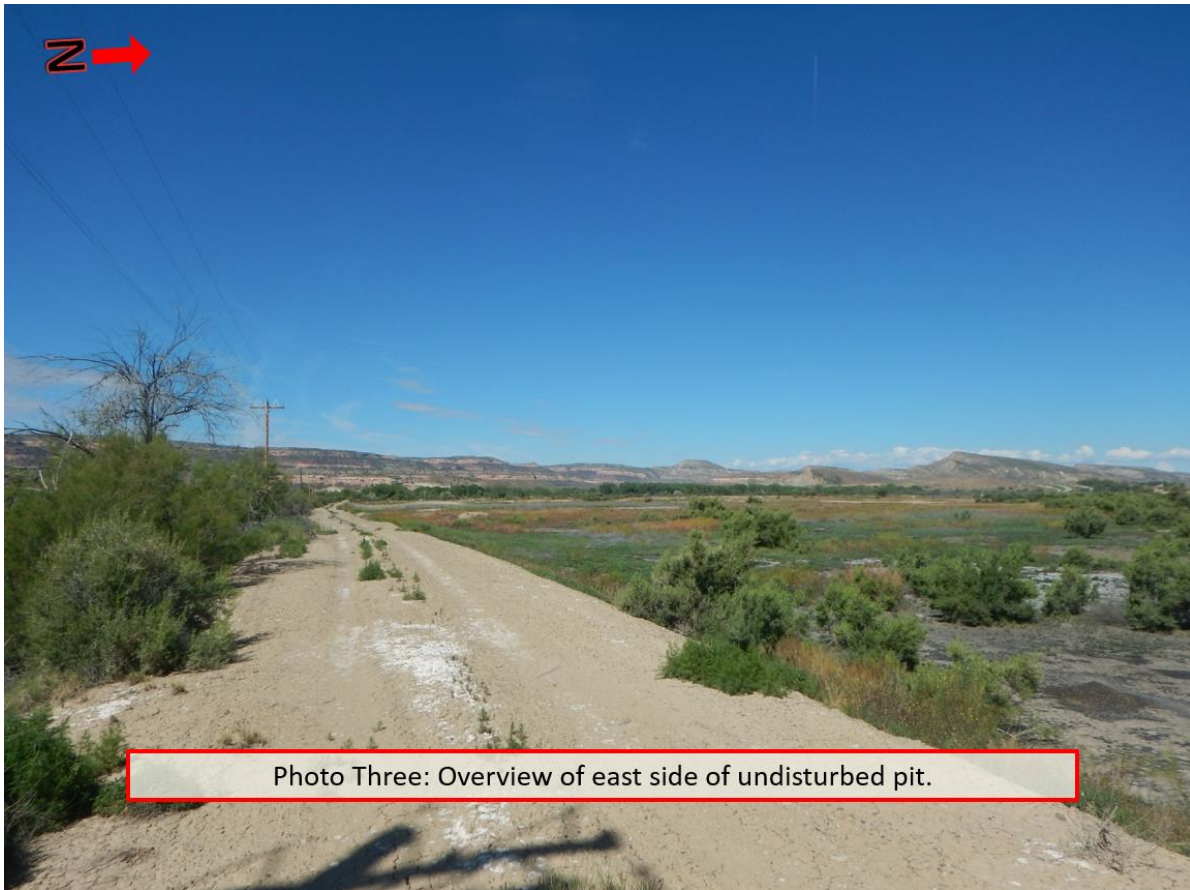
Photo Three: Overview of east side of undisturbed pit.

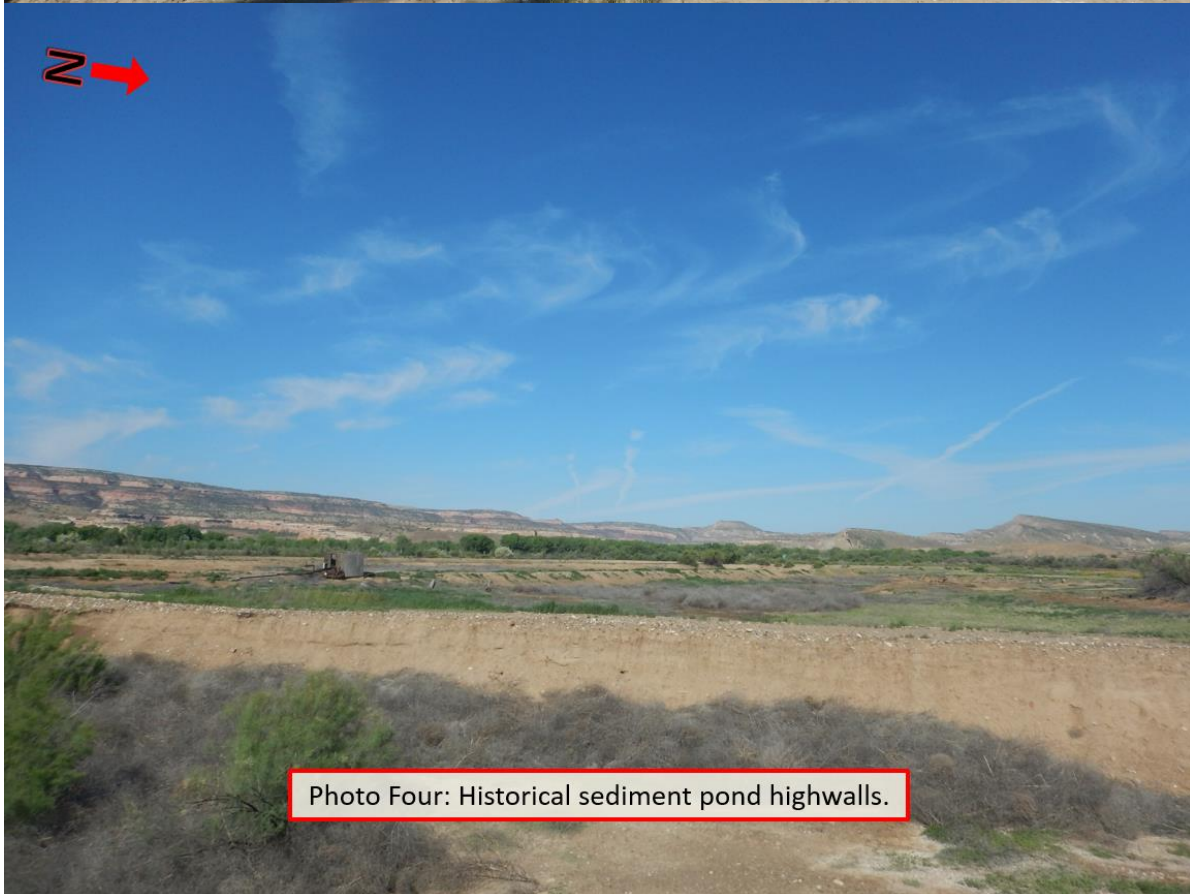
Photo Four: Historical sediment pond highwalls.
