COLORADO
Division of Reclamation,
Mining and Safety
Department of Natural Resources

Permit Number: C-1981-018 Mine Name: Deserado Mine Operator: Blue Mountain Energy, Inc. Operator Address: Mr. Kurtis Blunt 3607 County Road 65 Rangely, CO, 81648	County: Moffat, Rio Blanco Operation Type: Underground Permit Status: Active Ownership: Private
	Operator Representative Present: Kurt Blunt
Operator Representative Signature: (Field Issuance Only)

Inspection Start Date: June 3, 2021 Inspection Start Time: 10:30 Inspection End Date: June 3, 2021 Inspection End Time: 13:45		Inspection Type: Coal Complete Inspection Inspection Reason: Normal I&E Program Weather: Clear	
Joint Inspection Agency: None		Joint Inspection Contacts: None	
Post Inspection Agency: None		Post Inspection Contacts: None	
Inspector(s): Clayton Wein	Inspector's Signature: <i>Clayton Wein</i>		Signature Date: 6/9/2021

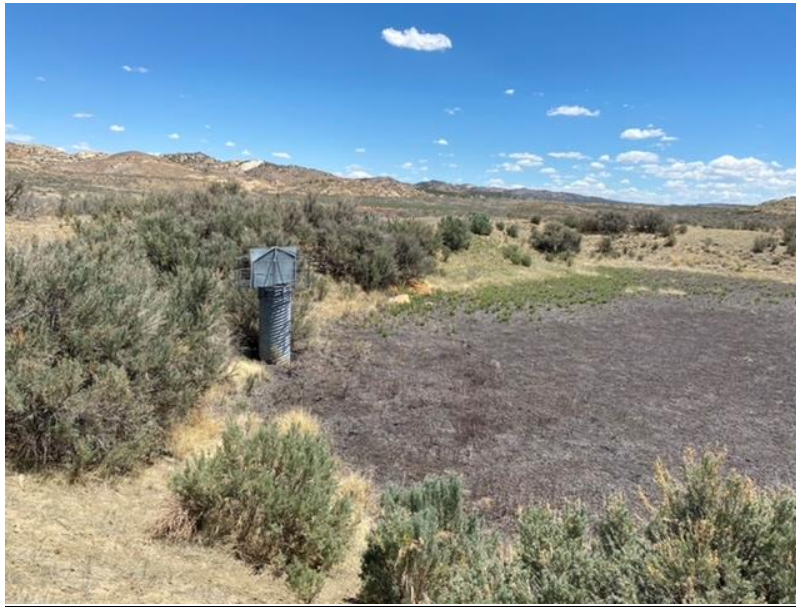
The RP-1 Pond is located at the northern base of the RP-1 Refuse Pile (Photo 1). The pond was dry. The trash rack over the spillway was clear of debris. The embankment was stable with vegetative cover. No erosional features were identified.

Photo 1: The embankment and outlet of the RP-1 Pond.

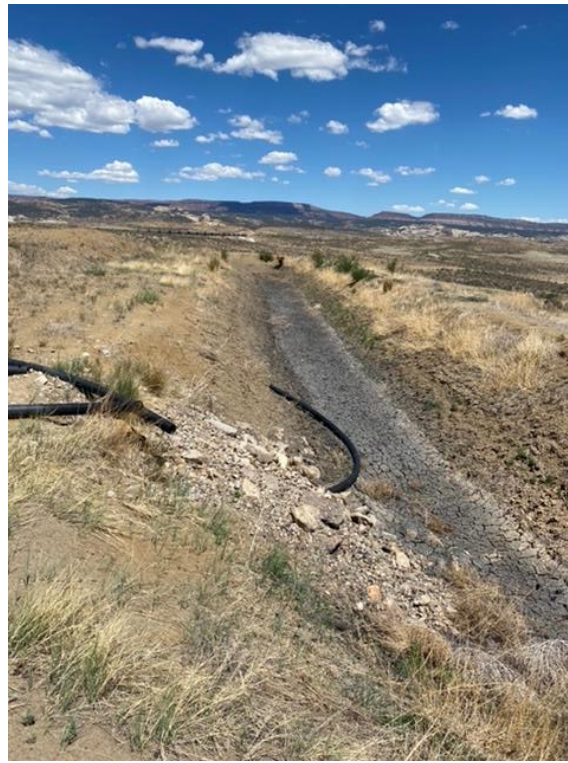
The B Seam No. 2 Dewatering System was inactive during the inspection (Photo 2). The system utilizes the first two cells, the third cell is not used when the system is active. All cells were dry. The outlet of the second cell was clear of debris. The embankments for the cells were stable and vegetated. No erosional features were observed.

Photo 2: The inlet of the first cell of the B Seam No. 2 Dewatering System.

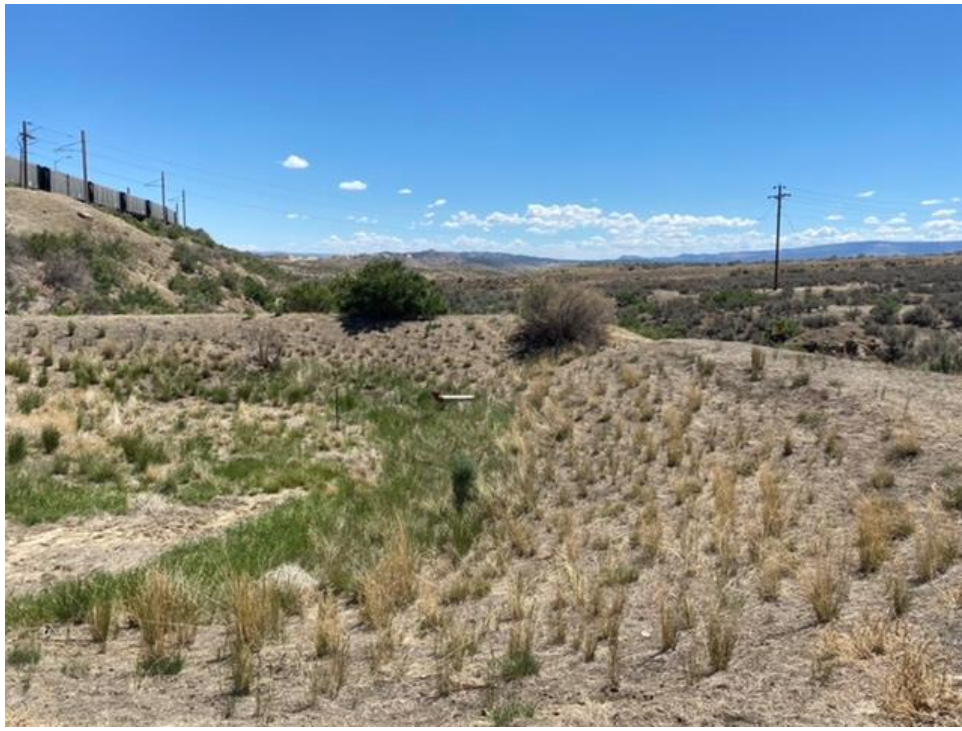
One pond and one sump are located on the south side of the coal loadout. The RS-1 sump is located on the northwest side of the loadout. The sump was dry during the inspection. The outlet was clear of debris. The embankment was vegetated and stable. There were no erosional features identified. The RR-1 pond is located to the northeast side of the loadout. The pond was dry (Photo 3). The outlet for the pond was unobstructed. The embankment was stable with vegetative cover. No erosional features were observed.

Photo 3: The embankment and outlet of the RR-1 Pond.

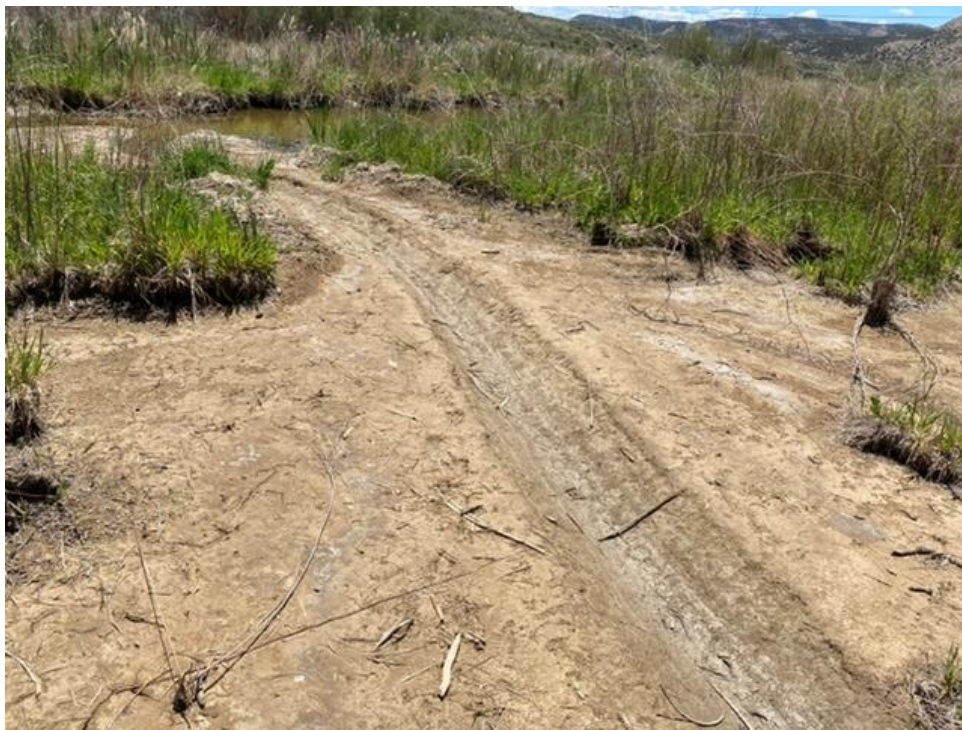
The Raw Water Lagoon, located at the southern edge of the permit area, was impounding water during the inspection. The embankment was vegetated and stable. No erosional concerns were identified. A feature noted in the Division's May 2021 aerial inspection report was located near the pond's embankment. This feature was

visited during this inspection and was identified as a feature made by wildlife, likely a beaver (Photo 4). The feature was not up against the pond's embankment and was not affecting the stability of the embankment.

Photo 4: The feature created by wildlife just south of the Raw Water Lagoon. Photo was taken looking to the south from a short distance from the pond's embankment.

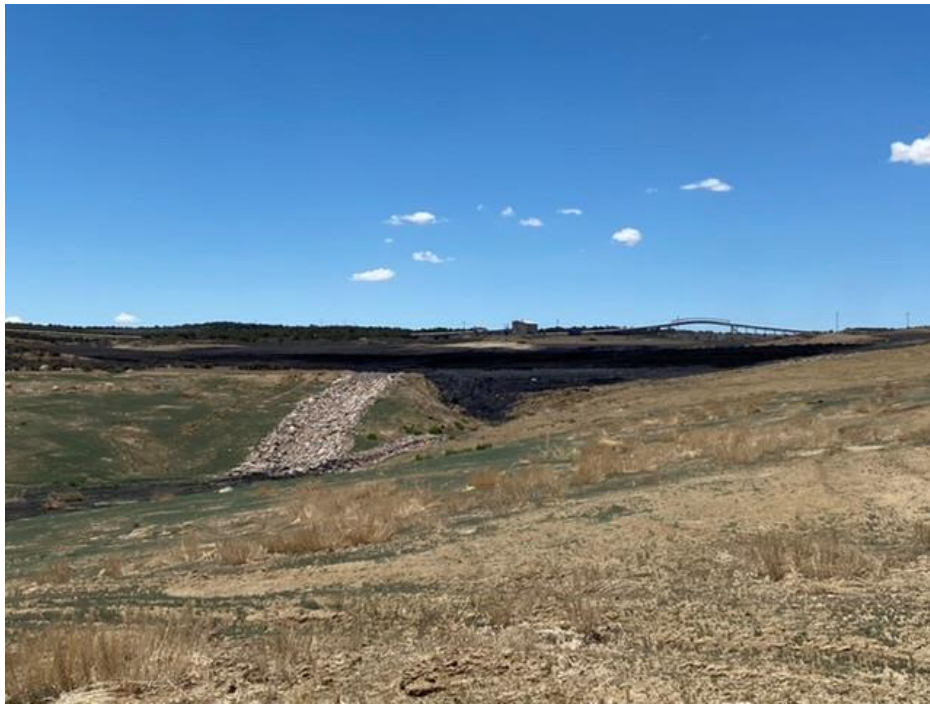
The RP-A refuse pile is the newest refuse disposal area at the Deserado Mine. During the inspection, refuse material was being spread out. The base of the pile is still being constructed (Photo 5). There were no indications of erosional features or signs of instability. No off site impacts were observed.

Photo 5: The RP-A Refuse Pile. The photo was taken at the base of the pile looking west.

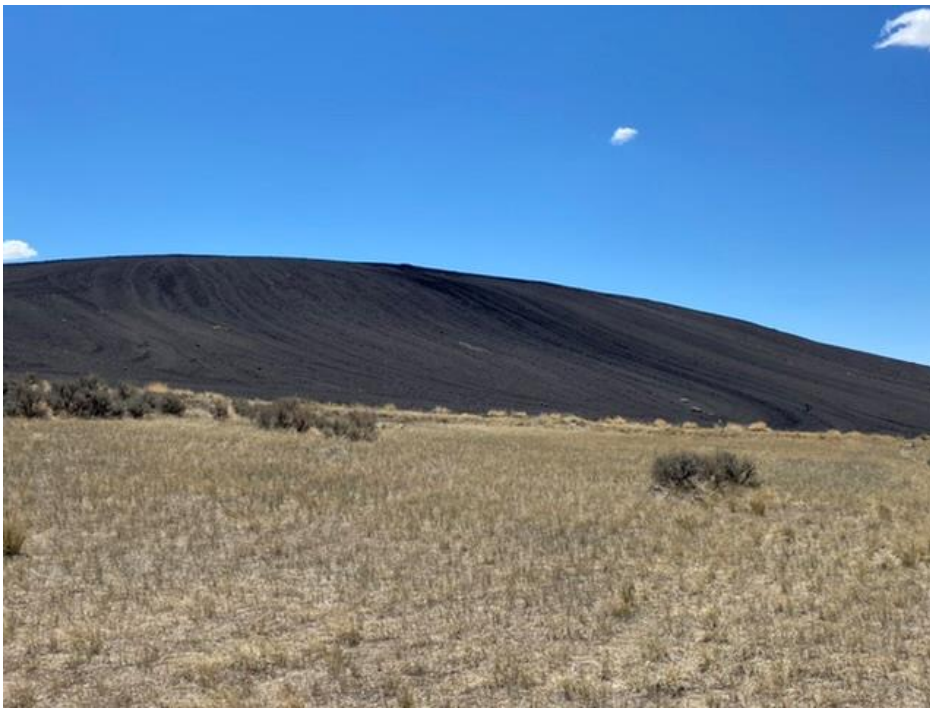
Refuse material was actively being placed on top of the RP-5a refuse pile. The slopes of the pile had been recently regarded (Photo 6). The slopes were stable and there were no indications of erosional features. No off site impacts were observed.

Photo 6: The slopes of the RP-5a Refuse Pile.

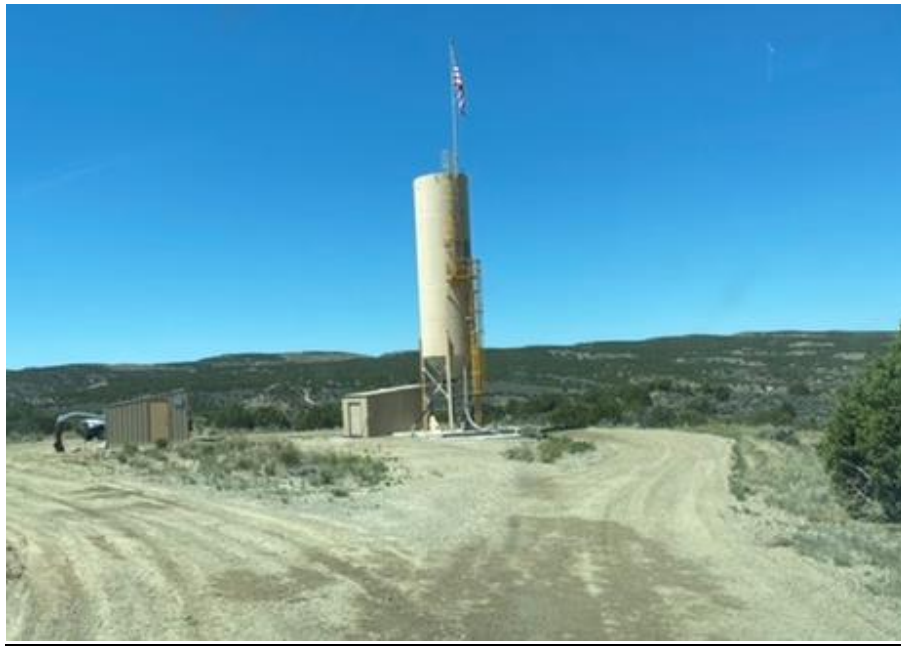
Support Facilities inspected included: Portals/Main Facilities Area, Fuel Storage Area, B Vent Shaft No. 1, RDH-2 (Photo 7), 13L Return Shaft (Photo 8), RDH-4, Nitrogen Plant No. 2, Slot Storage, and the Conveyor Corridor. Pads for the support facilities were stable with no erosional features noted. Berms on the pads were stable with vegetative cover. No off site impacts were observed. The pad for the 13L return shaft was beginning to undergo reclamation. The bulk of the facility structure has been removed. Only the concrete footings remain with the return shaft. Reclamation activities at the site will continue.

Photo 7: The RDH-2 Support facility and pad.

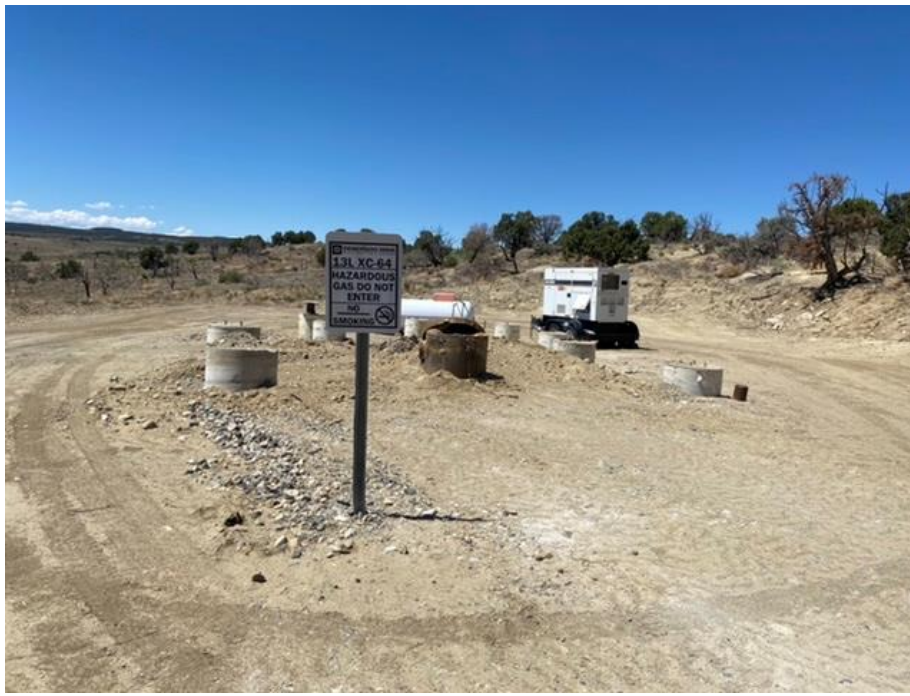
Photo 8: The 13L Return Shaft Pad.
