MINERALS PROGRAM INSPECTION REPORT
PHONE: (303) 866-3567

MINE NAME: Rifle Quarry	MINE/PROSPECTING ID#: M-1985-038	MINERAL: Limestone (general)	COUNTY: Garfield
INSPECTION TYPE: Surety Release Inspection	INSPECTOR(S): Amy Yeldell	INSP. DATE: June 2, 2021	INSP. TIME: 03:00
OPERATOR: Pete Lien & Sons, Inc.	OPERATOR REPRESENTATIVE: None	TYPE OF OPERATION: 112c - Construction Regular Operation	
REASON FOR INSPECTION: Surety Release Requested	BOND CALCULATION TYPE: None	BOND AMOUNT: \$10,752.72	
DATE OF COMPLAINT: NA	POST INSP. CONTACTS: DRMS	JOINT INSP. AGENCY: U.S.BLM	
WEATHER: Clear	INSPECTOR'S SIGNATURE:

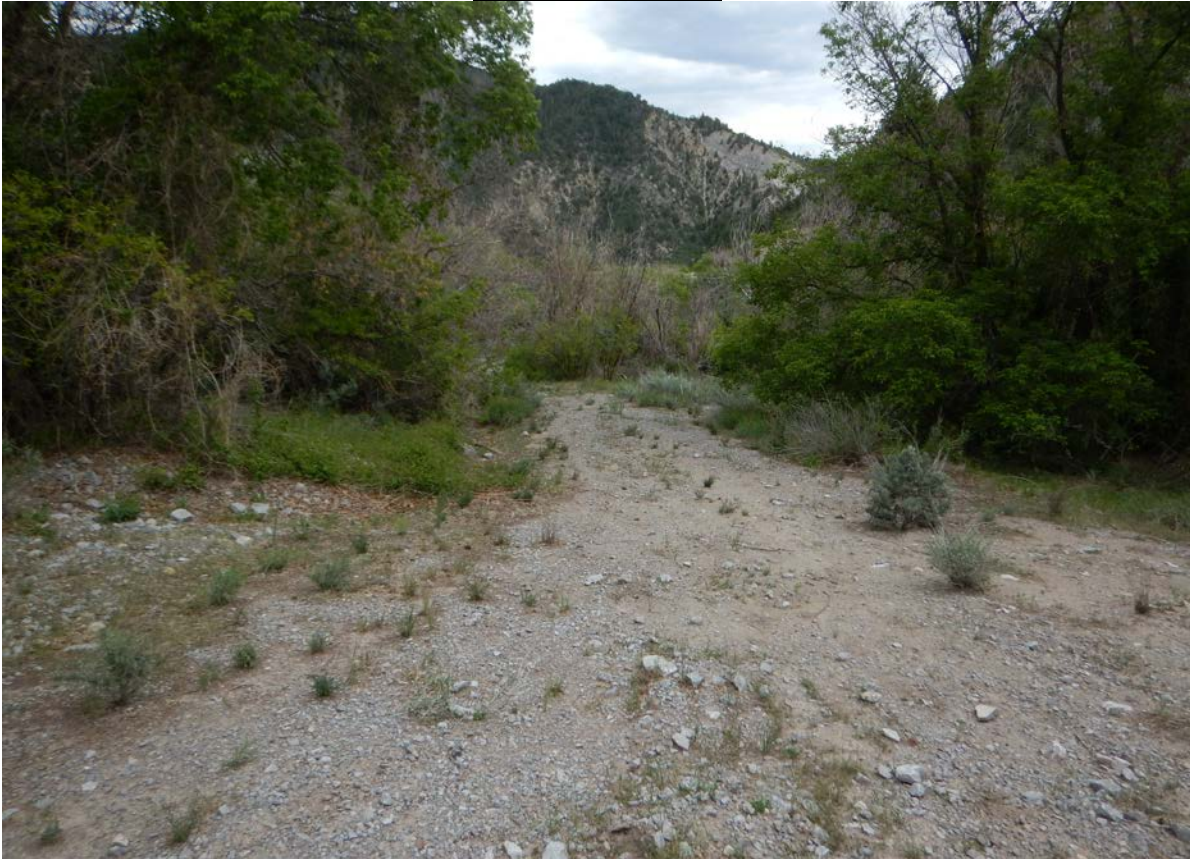
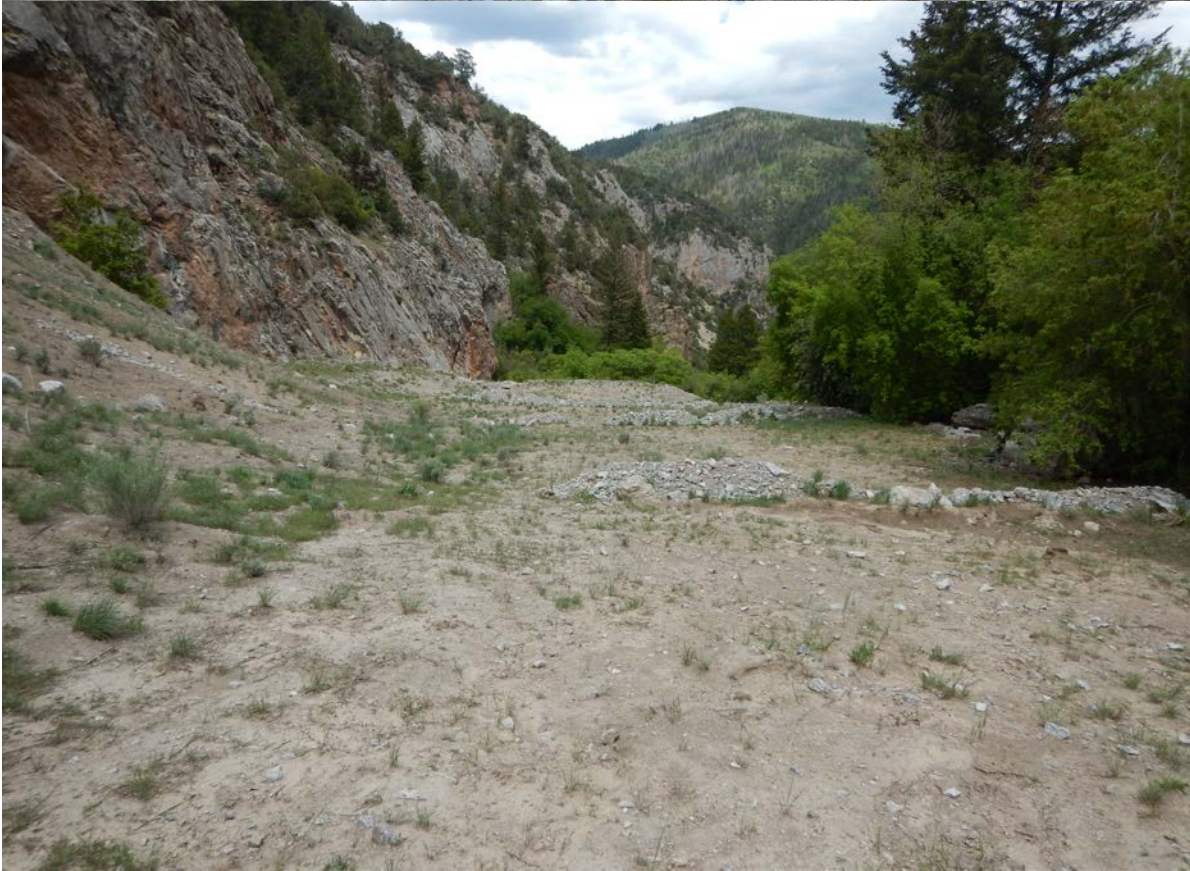
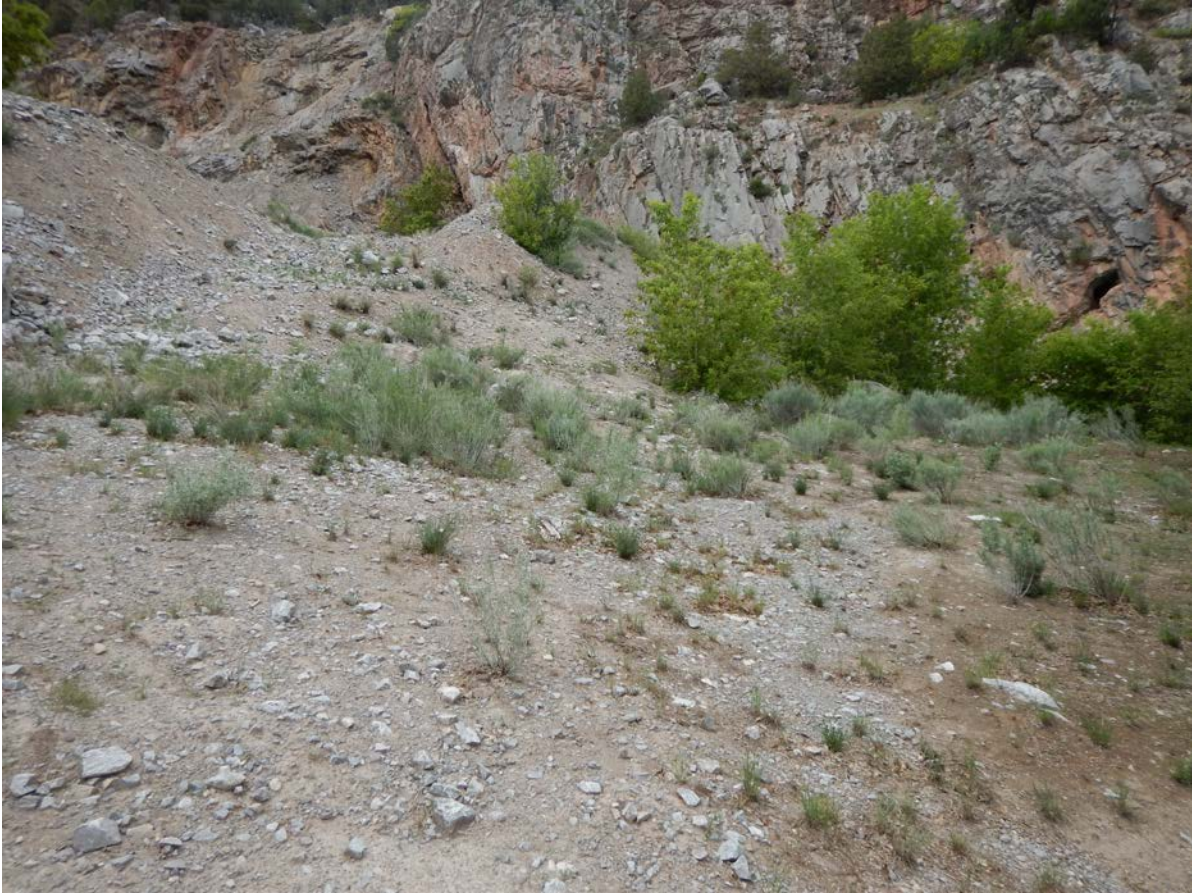
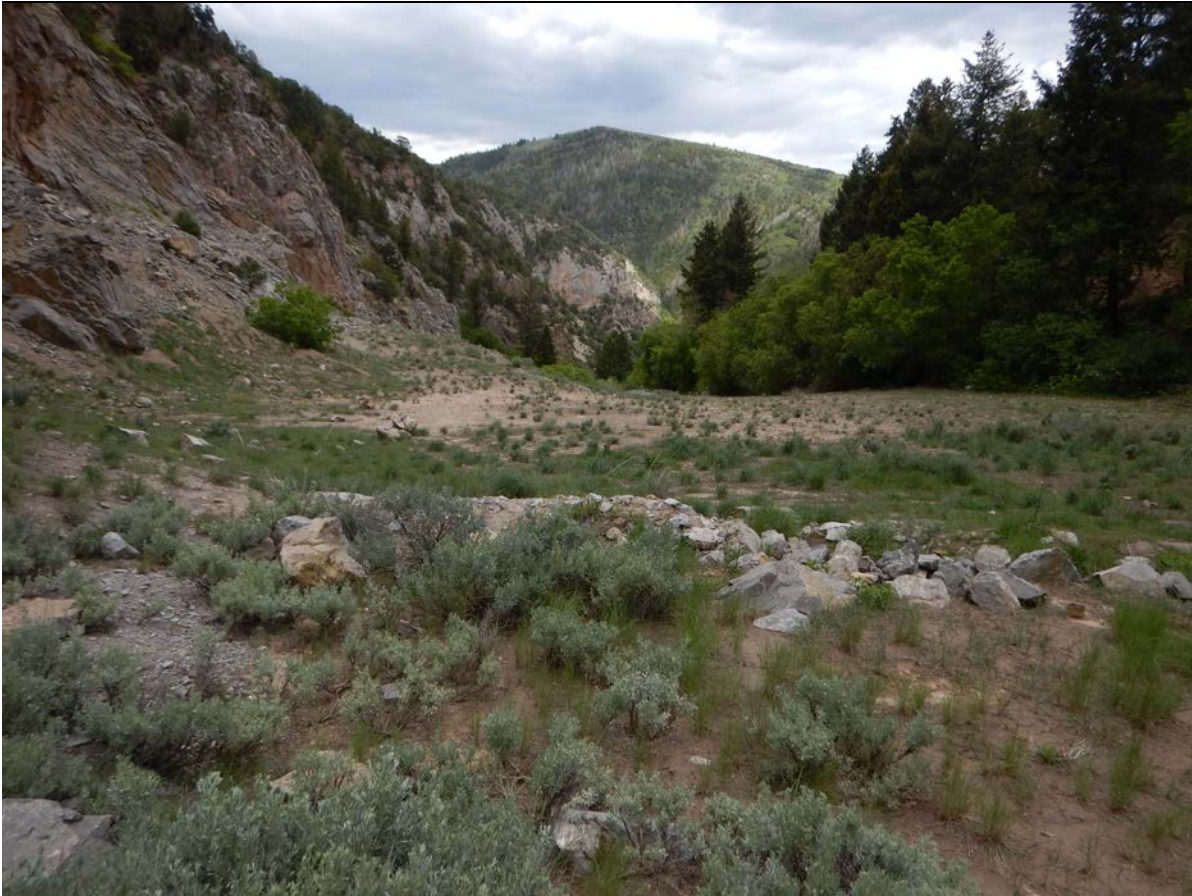
The mine identification sign and affected area boundary markers remain in place and in compliance with Rule 3.1.12. The mine identification sign is on the left side of the access road as you enter the site. The seeded access road remains a two track but is revegetated well considering the public vehicle traffic. The rocks which block access to the road remain in place and have helped greatly in detouring traffic.

Overall vegetation on the site is sufficient. Some areas are patchy but that is to be expected given the lack of available topsoil. In general the site has made significant progress towards final reclamation and establishment of vegetation. Overall the site is stable with minimal erosion and weeds. If given enough time the site will eventually blend in with its surroundings.
