**MINERALS PROGRAM INSPECTION REPORT**  
**PHONE: (303) 866-3567**

<b>MINE NAME:</b> Climax Mine	<b>MINE/PROSPECTING ID#:</b> M-1977-493	<b>MINERAL:</b> Molybdenum	<b>COUNTY:</b> Lake, Summit
<b>INSPECTION TYPE:</b> Monitoring	<b>INSPECTOR(S):</b> Dustin Czaplá	<b>INSP. DATE:</b> May 20, 2021	<b>INSP. TIME:</b> 13:00
<b>OPERATOR:</b> Climax Molybdenum Company	<b>OPERATOR REPRESENTATIVE:</b> Diana Kelts	<b>TYPE OF OPERATION:</b> 112d-3 - Designated Mining Operation	
<b>REASON FOR INSPECTION:</b> Normal I&E Program	<b>BOND CALCULATION TYPE:</b> None	<b>BOND AMOUNT:</b> \$91,011,850.00	
<b>DATE OF COMPLAINT:</b> NA	<b>POST INSP. CONTACTS:</b> None	<b>JOINT INSP. AGENCY:</b> None	
<b>WEATHER:</b> Clear	<b>INSPECTOR'S SIGNATURE:</b>

## **OBSERVATIONS**

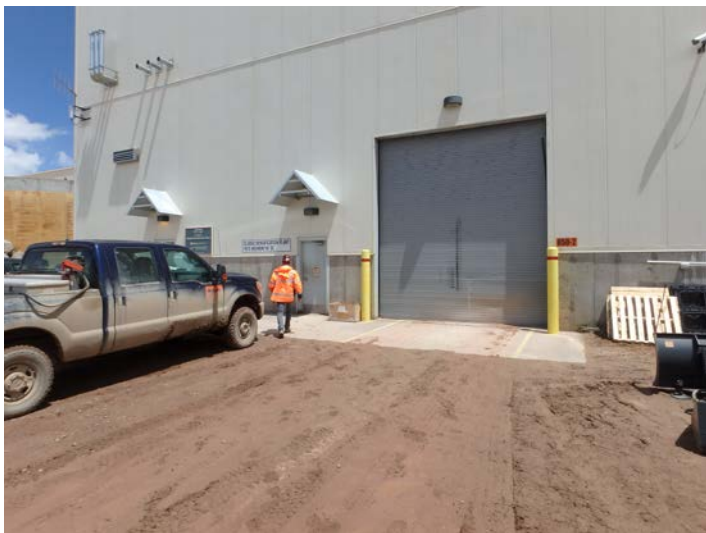
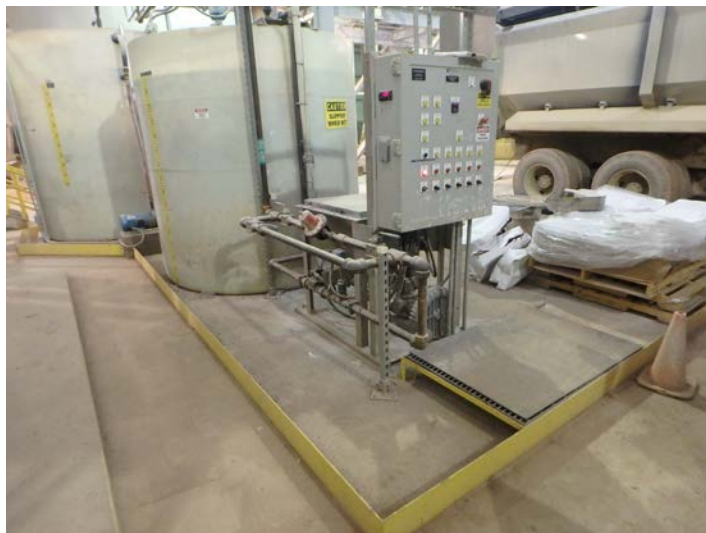
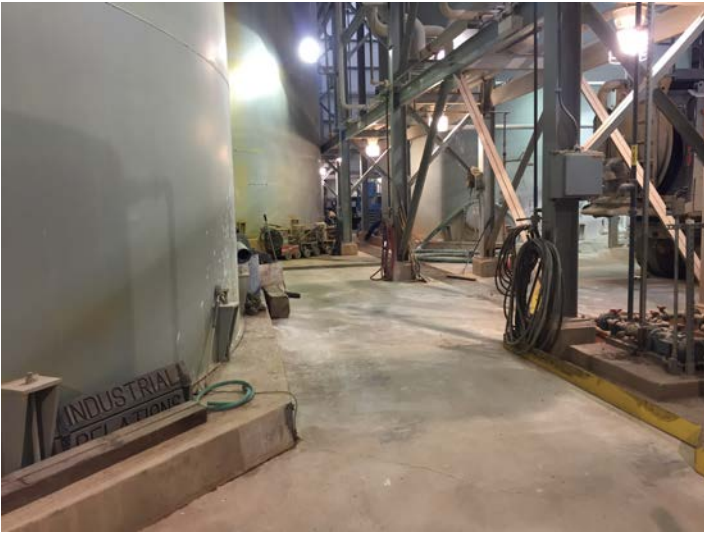
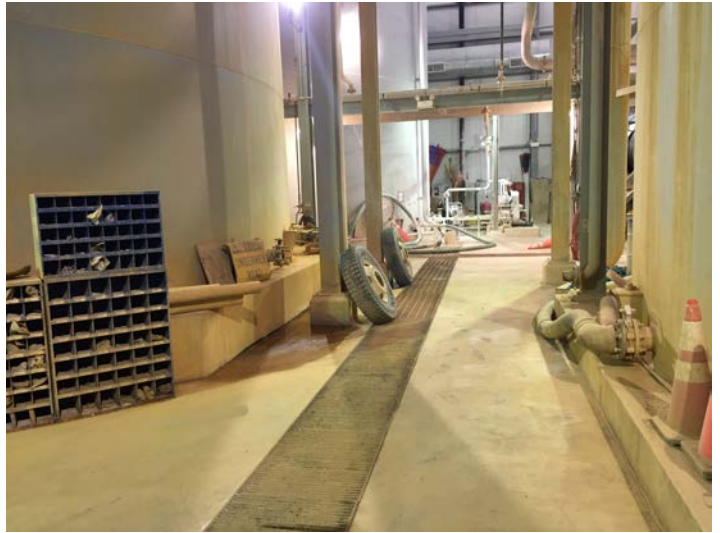
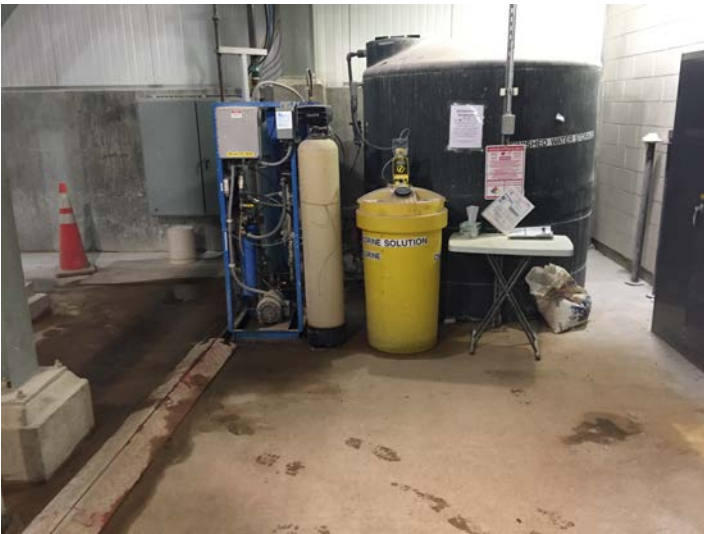
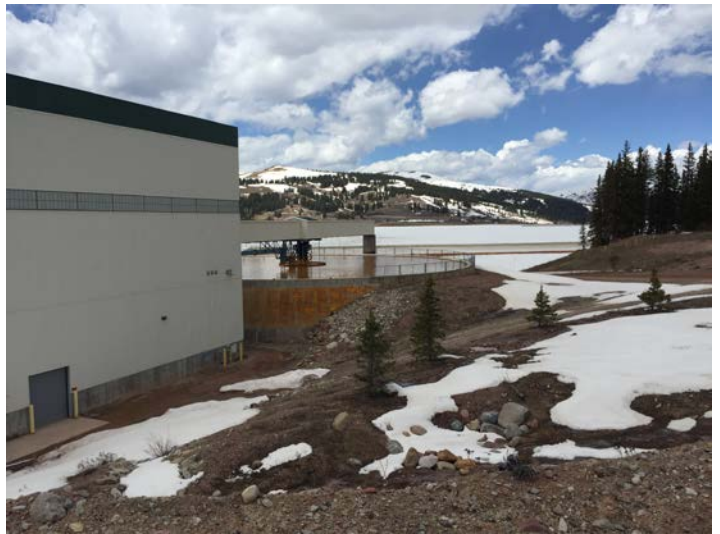
The SDP is located on the east side of Tenmile Pond. The SDP provides first stage metals treatment for a significant portion of the mines affected waters and creates sludge for deposition in tailings storage facilities. When possible, water is recycled through Robinson Lake for use in the mill facility. The plant has been constructed with adequate secondary containment, in the form of concrete sumps, to contain spills that could occur within the plant. Spills were not noted during this inspection. Operation of the SDP is automated and emergency generators are in place in case of power outages. Reagents utilized in the SDP include lime and flocculant. All chemicals and reagents observed in the SDP area were properly stored with adequate secondary containment protections. Containers were clearly labeled.

The SDP facility appeared to be well maintained and functioning as designed. No problems were noted.

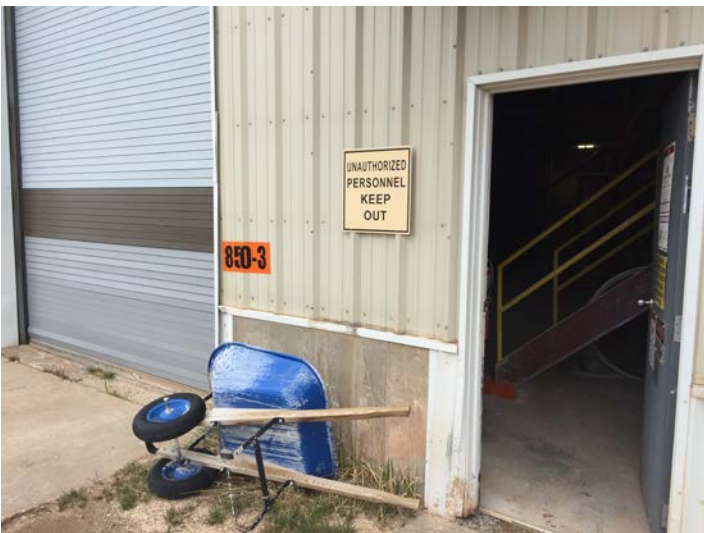
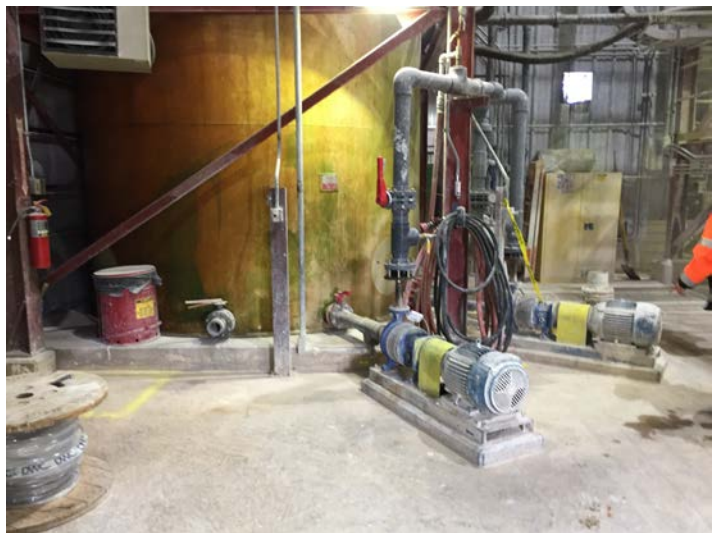
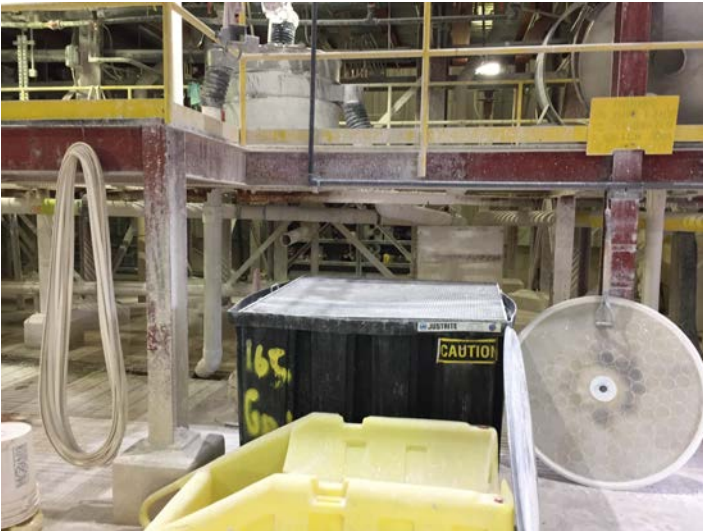
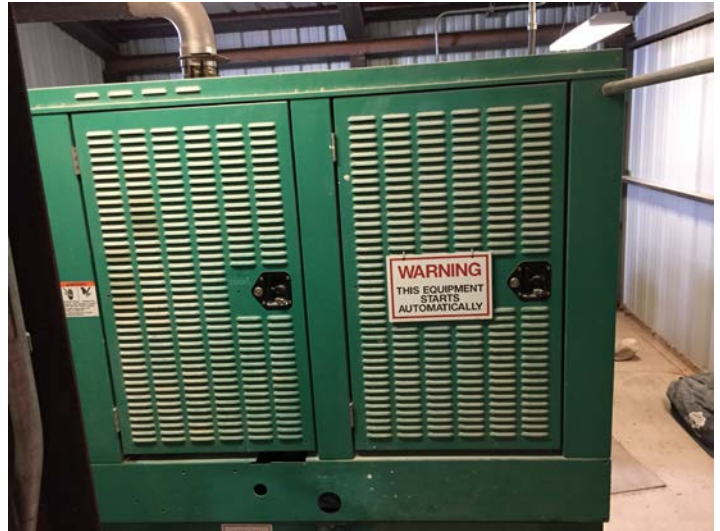
The SDP Lime Station is located approximately 800 feet south of the SDP. The lime station includes conventional silos for storage of lime and lime slakers. Slaked lime is produced by mixing lime from the silos with fresh water. No problems were noted in the lime station.

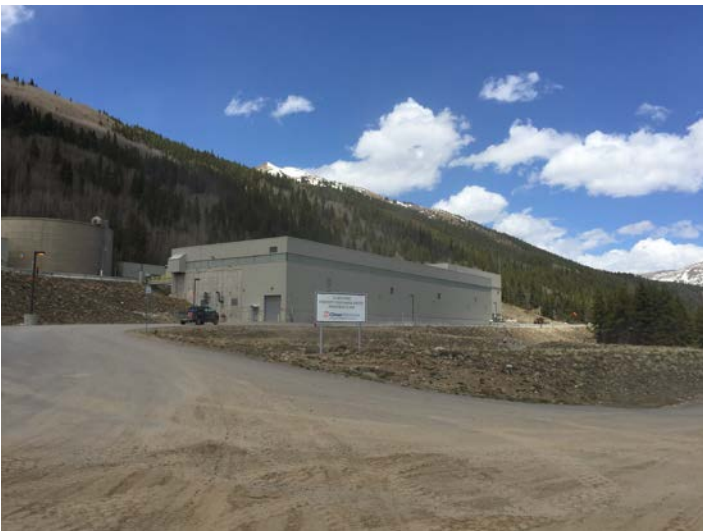
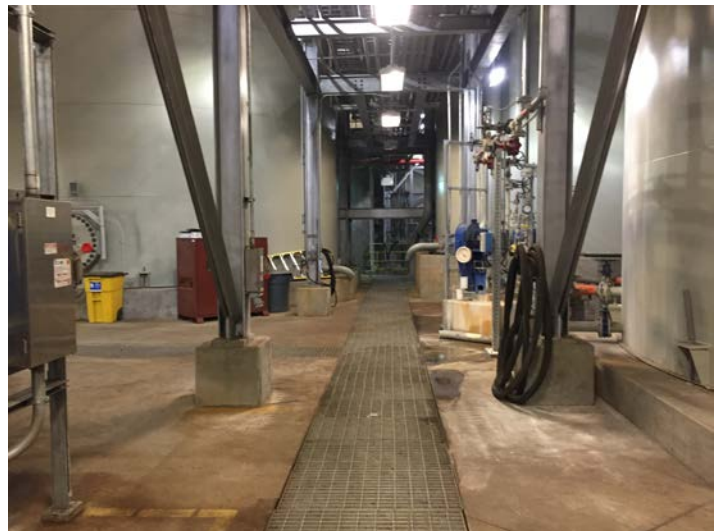
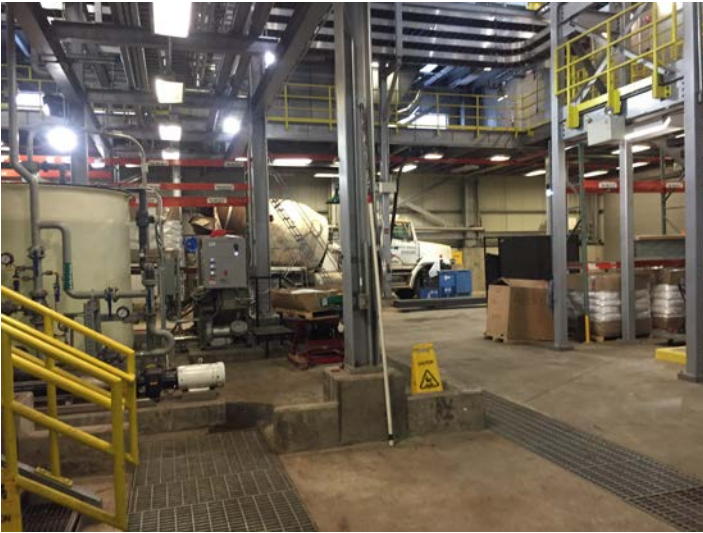
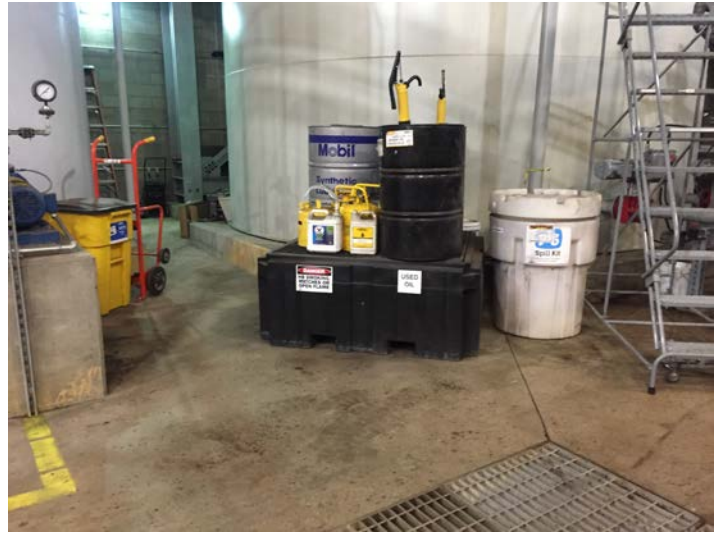
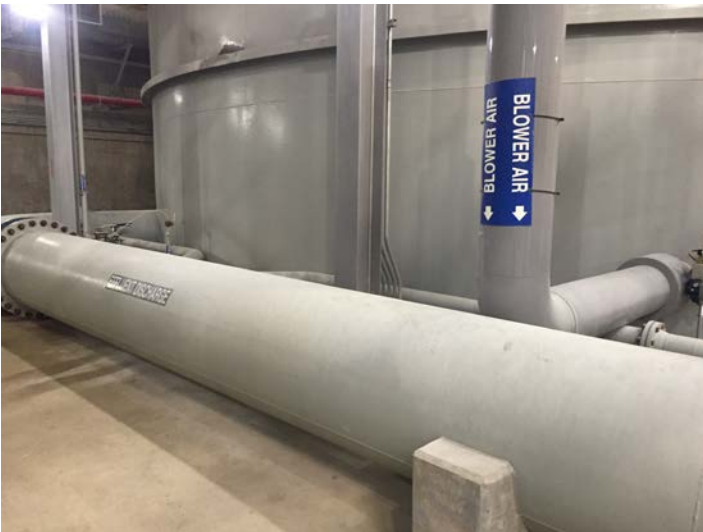
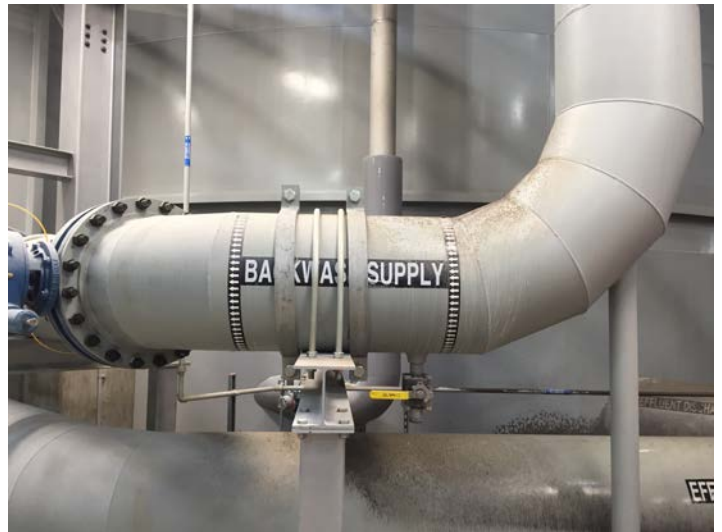
The PDWTP is located below 5 Dam and is intended to remove second stage metals, such as manganese, iron, copper and zinc, prior to discharging excess water into Tenmile Creek. It provides final treatment before affected water leaves the property. The plant has been constructed with adequate secondary containment, in the form of concrete sumps, to contain spills that could occur within the plant. Spills were not noted within the PDWTP during this inspection. Operation of the PDWTP is automated, but also manned around the clock. Emergency generators are in place in case of power outages. Reagents utilized in the PDWTP include lime, flocculant and sulfuric acid. All chemicals and reagents observed in the PDWTP area were properly stored with adequate secondary containment protections. Containers were clearly labeled. The sulfuric acid is stored in an isolated room in a phenolic lined carbon steel tank, located within an epoxy coated concrete containment area, which is isolated from the rest of the plants containment area. The sulfuric acid truck unloading area has adequate secondary containment in the form of a concrete sump. The PDWTP facility appeared to be well maintained and functioning as designed. No problems were noted with the PDWTP.

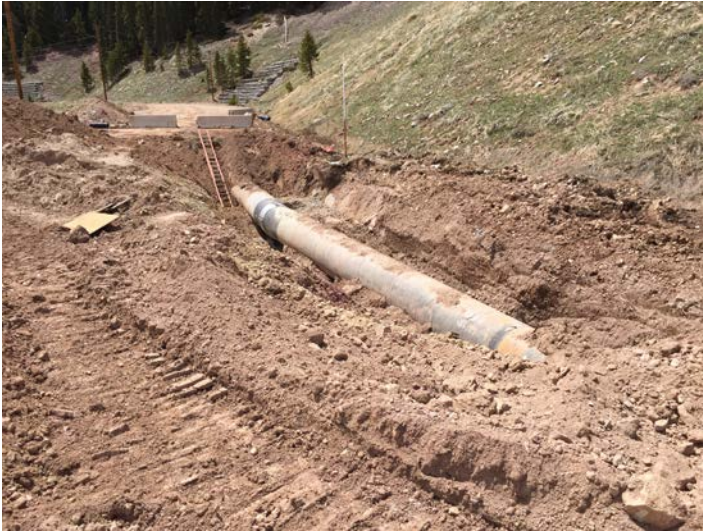
On April 27, 2021 Climax notified the Division of a small leak discovered in one of the PDWTP influent pipes. The incident occurred on April 27, 2021. The leak resulted from a crack in the pipe at a welded joint. The leak location was observed during this inspection. The pipe at the leak location was exposed. The pipe had been patched and banded. No leakage was observed during this inspection.
