MINERALS PROGRAM INSPECTION REPORT
PHONE: (303) 866-3567

MINE NAME: Birdseye Pit	MINE/PROSPECTING ID#: M-2019-034	MINERAL: Sand and gravel	COUNTY: Lake
INSPECTION TYPE: Monitoring	INSPECTOR(S): Dustin Czapla	INSP. DATE: May 20, 2021	INSP. TIME: 15:00
OPERATOR: Schofield Excavation, Inc.	OPERATOR REPRESENTATIVE:	TYPE OF OPERATION: 112c - Construction Regular Operation	
REASON FOR INSPECTION: Normal I&E Program	BOND CALCULATION TYPE: Complete Bond	BOND AMOUNT: \$115,746.00	
DATE OF COMPLAINT: NA	POST INSP. CONTACTS: None	JOINT INSP. AGENCY: None	
WEATHER: Clear	INSPECTOR'S SIGNATURE:

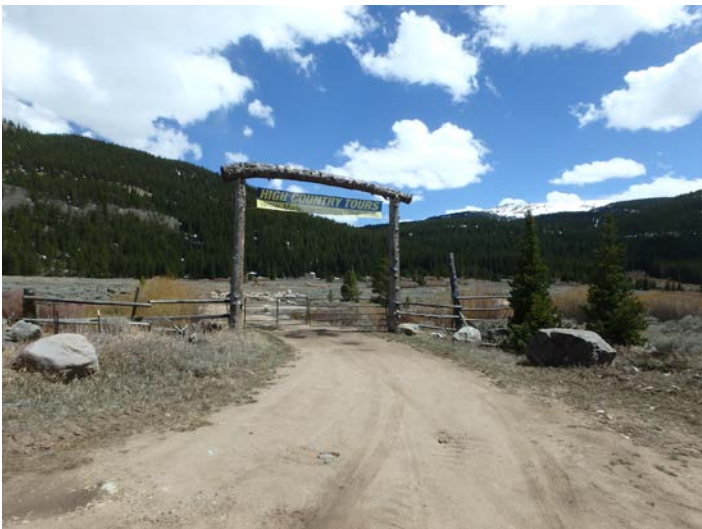
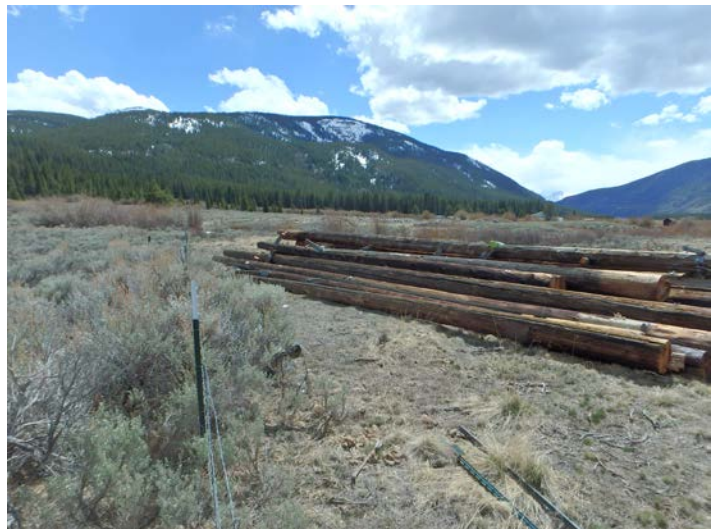
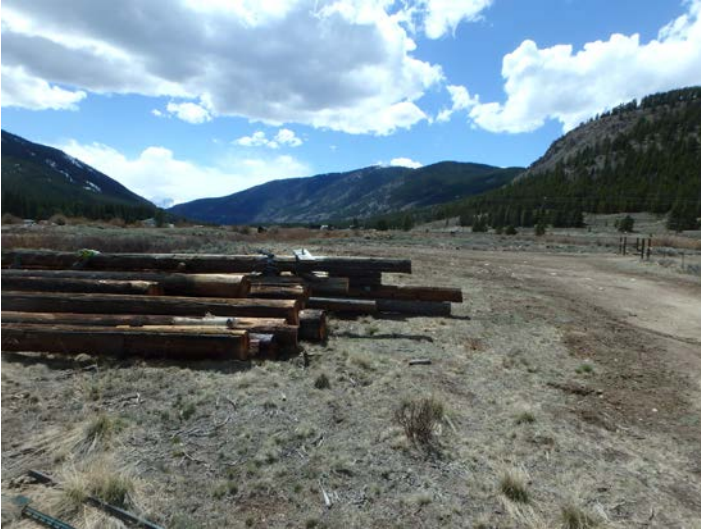
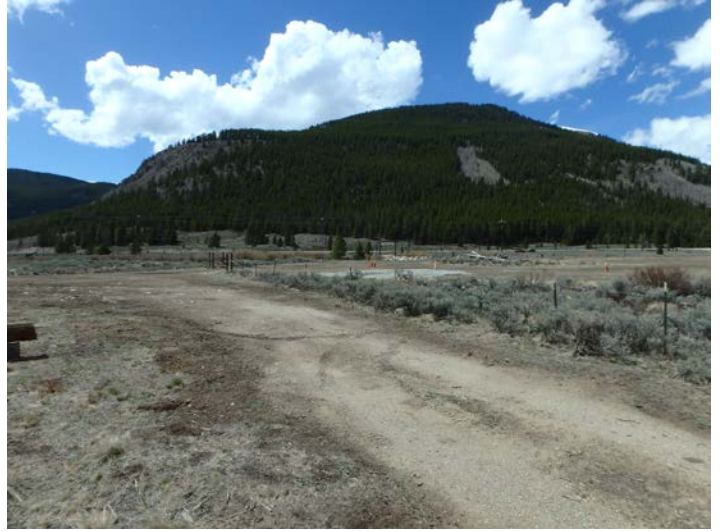
It did not appear that mining had yet commenced at the site. Mining is to occur on the south side of the permit area. No disturbance was observed.
