MINERALS PROGRAM INSPECTION REPORT
PHONE: (303) 866-3567

MINE NAME: Miami Road Properties	File #: M-2021-038	MINERAL: Sand and Gravel	COUNTY: Montrose
INSPECTION TYPE: Unpermitted Operation	INSPECTOR(S): Dustin Czapla	INSP. DATE: May 24, 2021	INSP. TIME: 10:00
OPERATOR: Matt Miles, Leadership Circle, LLC	OPERATOR REPRESENTATIVE:	TYPE OF OPERATION: IM - Is it Mining	
REASON FOR INSPECTION: Citizen Complaint	BOND CALCULATION TYPE: None	BOND AMOUNT: No Bond Held	
DATE OF COMPLAINT: NA	POST INSP. CONTACTS: None	JOINT INSP. AGENCY: None	
WEATHER: Clear	INSPECTOR'S SIGNATURE:

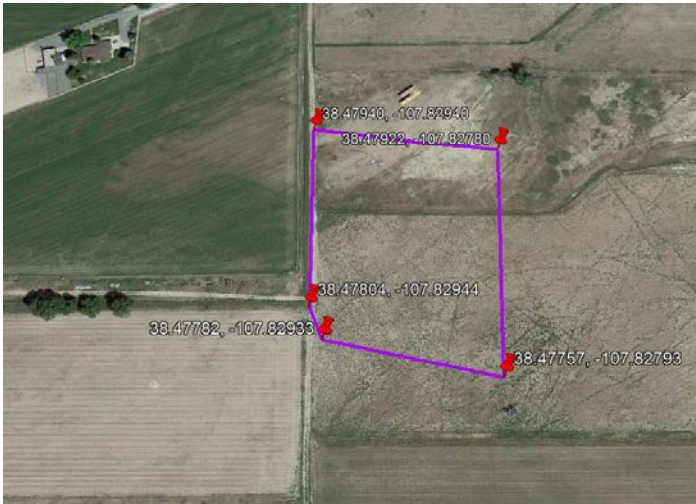
The site is located on the east side of Montrose and accessed from 6750 Road at location 38.481010°, -107.829361°. Approximately six acres were disturbed by the operation at the time of this inspection. The disturbed area observed is shown in the first photograph on the following page. The disturbance area was measured by GPS.

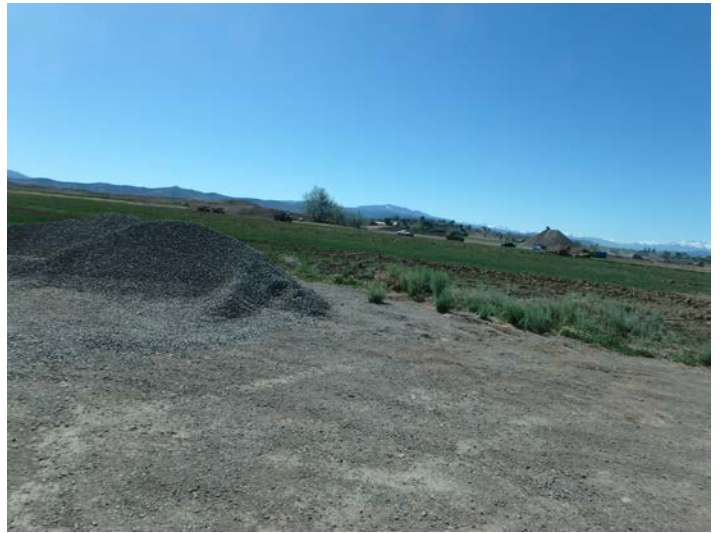
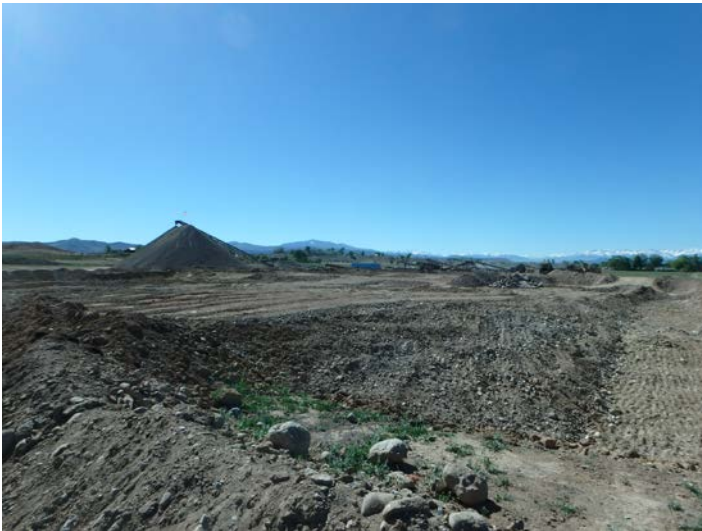
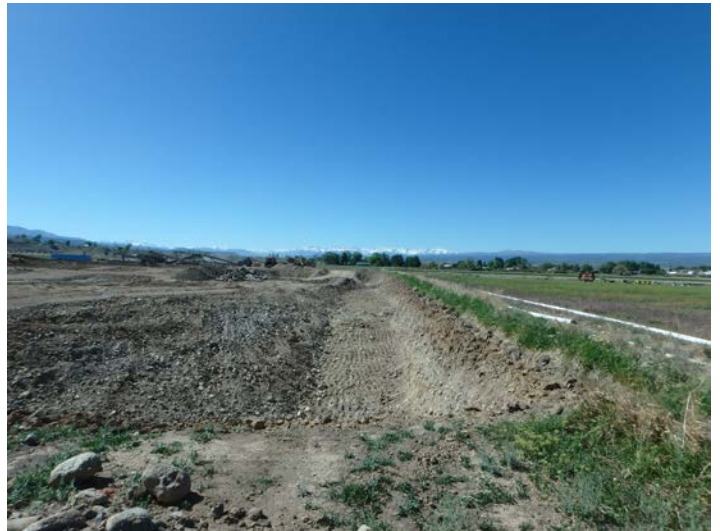
Extraction of construction materials was occurring at the site. Topsoil has been stripped from the six acre disturbed area and stockpiled on the northeast side of the operation, and in berms around the pit area. A pit is being excavated on the west side of the operation. The pit was approximately 10 feet deep at the time of this inspection. Crushing equipment was positioned on the east side of the pit. Crushed gravel stockpiles were located in the vicinity of the crushing area. The pit and processing area are shown in photos on the following page.
