MINERALS PROGRAM INSPECTION REPORT
PHONE: (303) 866-3567

MINE NAME: Butala Gravel Pit	MINE/PROSPECTING ID#: M-1977-170	MINERAL: Sand and gravel	COUNTY: Chaffee
INSPECTION TYPE: Monitoring	INSPECTOR(S): Dustin Czapla	INSP. DATE: May 25, 2021	INSP. TIME: 08:30
OPERATOR: Butala Construction Company	OPERATOR REPRESENTATIVE:	TYPE OF OPERATION: 112c - Construction Regular Operation	
REASON FOR INSPECTION: Normal I&E Program	BOND CALCULATION TYPE: Complete Bond	BOND AMOUNT: \$143,158.00	
DATE OF COMPLAINT: NA	POST INSP. CONTACTS: None	JOINT INSP. AGENCY: None	
WEATHER: Clear	INSPECTOR'S SIGNATURE:

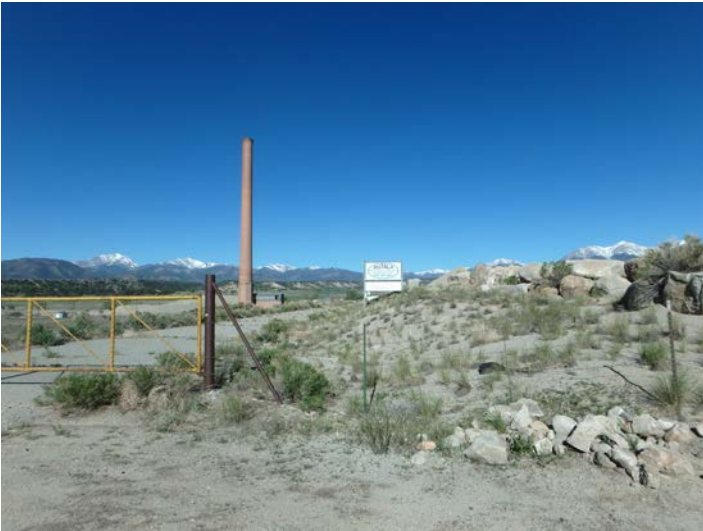
Adequate mine identification signage was noted at the entrance to the site.

ID sign at site entrance

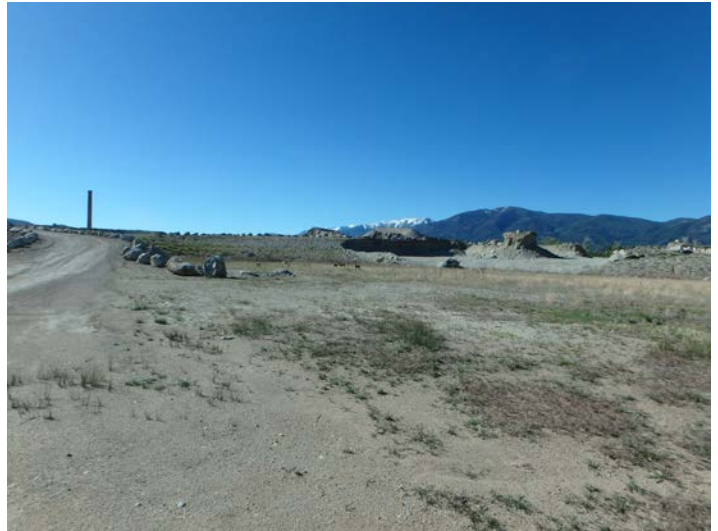
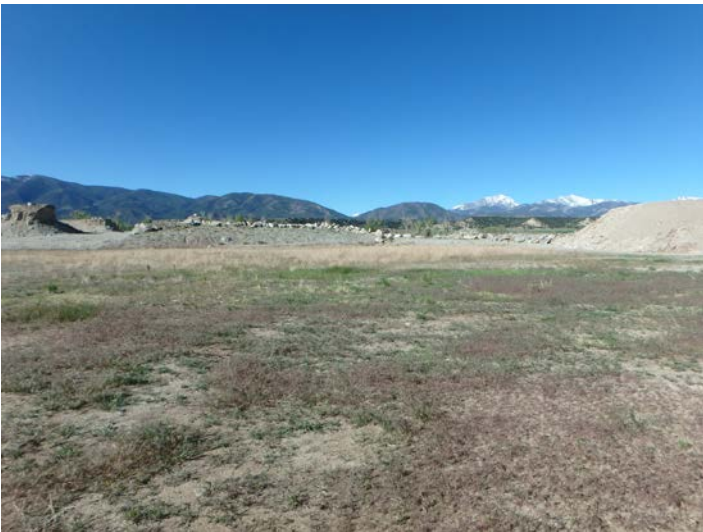
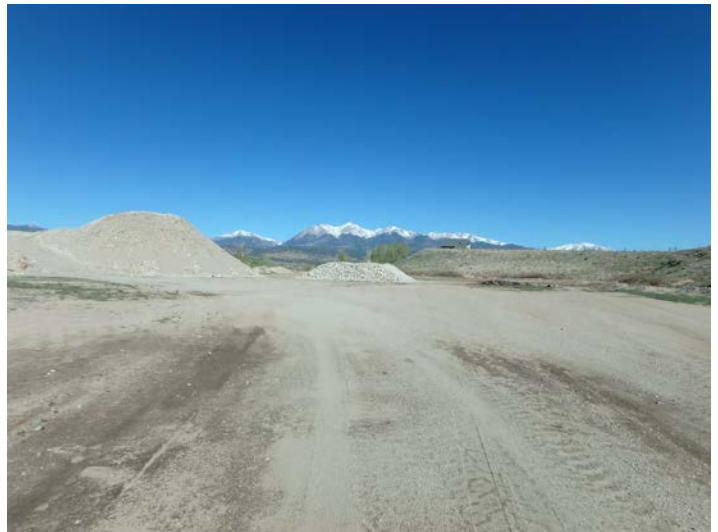
The Phase 1 area has been mined out and partial reclamation has occurred. The perimeter slopes on the north and west have been graded to 3H:1V and the pit floor is graded flat. Materials stockpiles are located on the pit floor in this area. Mining of the east slope has occurred, progressing toward the Phase 2 area.

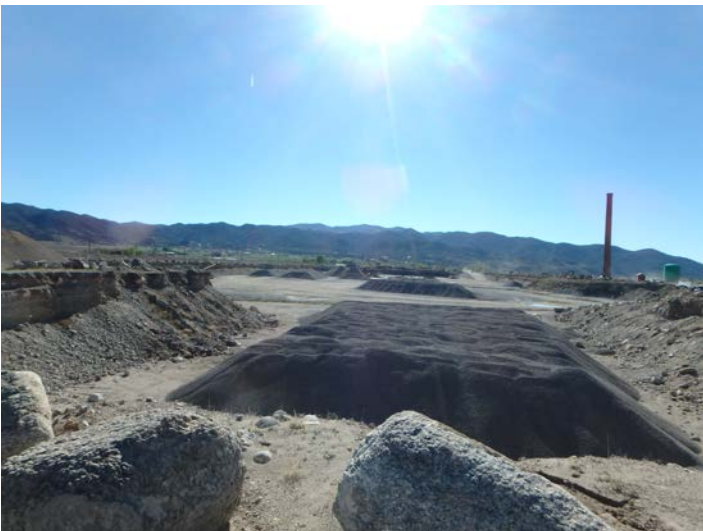
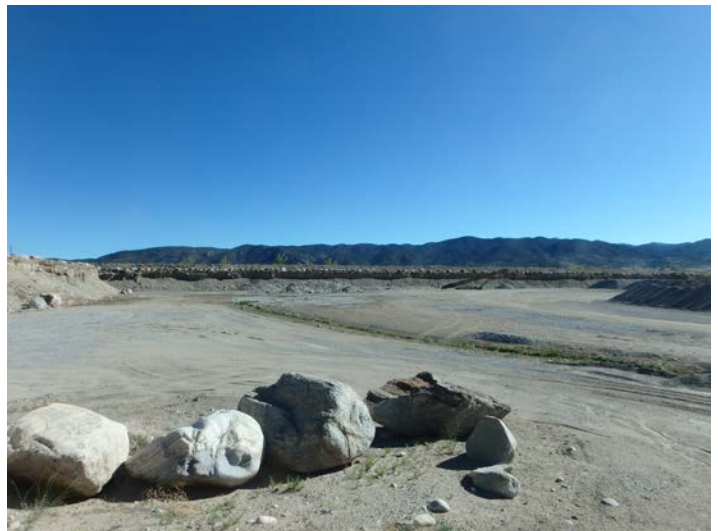
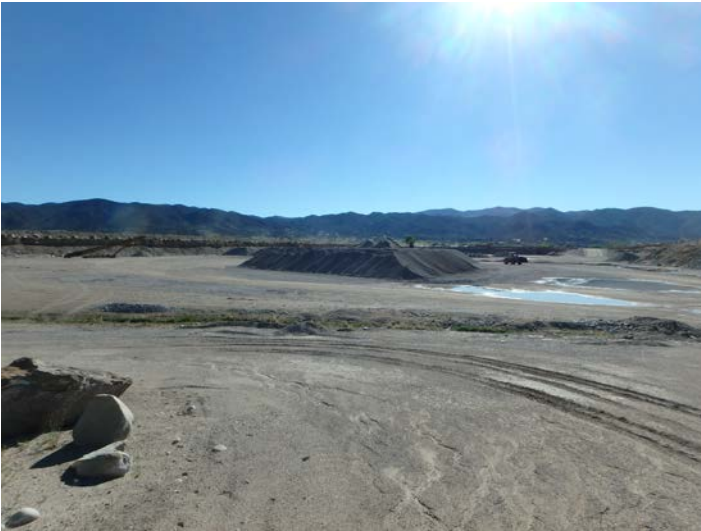
Mining is active in the Phase 3 and 4 areas, progressing to the east. The advancing face is a near vertical highwall on the east side of the pit, approximately 20-30 feet high. Backfilling the highwall slopes in mined out parts of the Phase 3 area has commenced and is currently approximately 1H:1V. Materials stockpiles are located throughout the pit floor.
