MINERALS PROGRAM INSPECTION REPORT
PHONE: (303) 866-3567

MINE NAME: Hard Rock 291 Pit	MINE/PROSPECTING ID#: M-1977-195	MINERAL: Sand and gravel	COUNTY: Chaffee
INSPECTION TYPE: Monitoring	INSPECTOR(S): Dustin Czapla	INSP. DATE: May 25, 2021	INSP. TIME: 08:20
OPERATOR: Hard Rock Paving and Redi-Mix, Inc.	OPERATOR REPRESENTATIVE:	TYPE OF OPERATION: 110c - Construction Limited Impact	
REASON FOR INSPECTION: Normal I&E Program	BOND CALCULATION TYPE: Complete Bond	BOND AMOUNT: \$26,823.65	
DATE OF COMPLAINT: NA	POST INSP. CONTACTS: None	JOINT INSP. AGENCY: None	
WEATHER: Clear	INSPECTOR'S SIGNATURE:

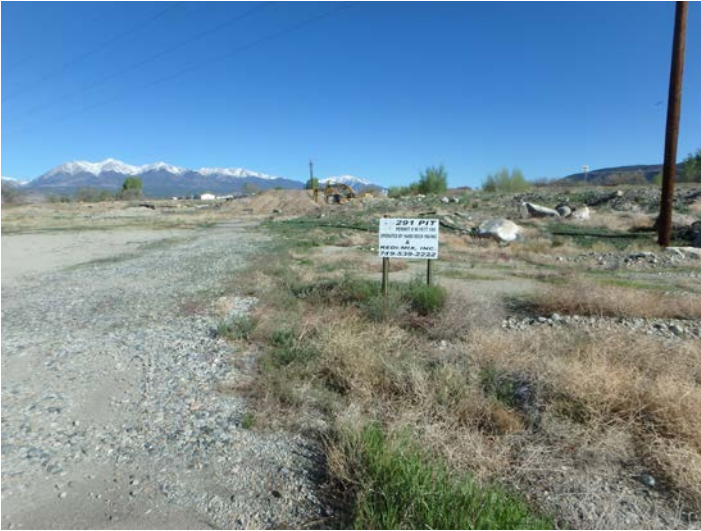
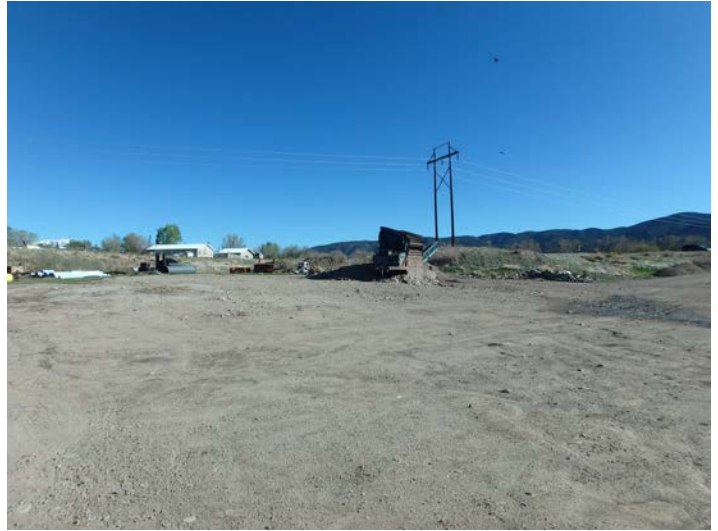
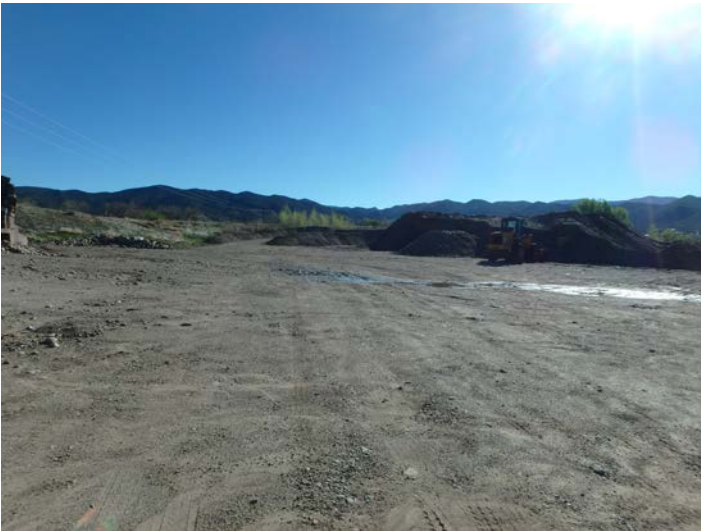
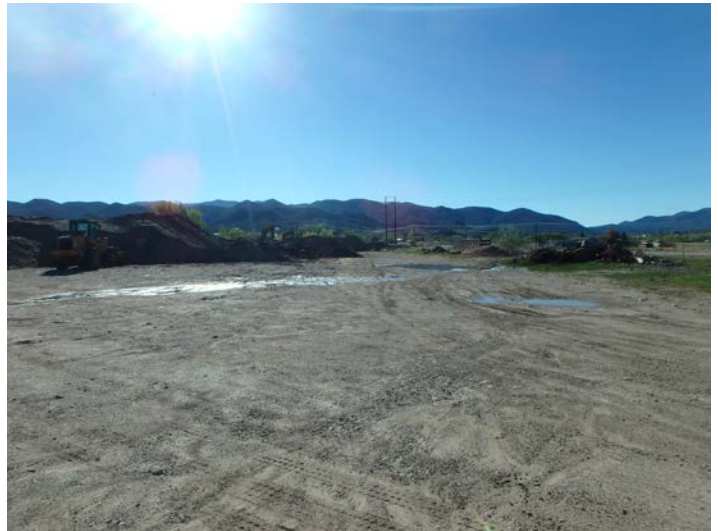
PHOTOGRAPHS

The final land use for this site was changed in August 2015, through AM-1, to industrial/commercial. The site is mined out and in final reclamation at this time. Final grading is complete and adequate. The slopes are stable and no erosion issues were noted. Vegetation is becoming established on the slopes. The pit floor is graded to a flat gravel surface. No standing water was noted on the pit floor. Gravel stockpiles and miscellaneous construction materials are stored on site.
