**MINERALS PROGRAM INSPECTION REPORT**  
**PHONE: (303) 866-3567**

<b>MINE NAME:</b> Pit Number One	<b>MINE/PROSPECTING ID#:</b> M-2000-099	<b>MINERAL:</b> Sand and gravel	<b>COUNTY:</b> Chaffee
<b>INSPECTION TYPE:</b> Monitoring	<b>INSPECTOR(S):</b> Dustin Czapla	<b>INSP. DATE:</b> May 25, 2021	<b>INSP. TIME:</b> 12:00
<b>OPERATOR:</b> Marilyn E. Diamond, Bruce A Diamond	<b>OPERATOR REPRESENTATIVE:</b>	<b>TYPE OF OPERATION:</b> 110c - Construction Limited Impact	
<b>REASON FOR INSPECTION:</b> Normal I&E Program	<b>BOND CALCULATION TYPE:</b> Complete Bond	<b>BOND AMOUNT:</b> \$18,835.00	
<b>DATE OF COMPLAINT:</b> NA	<b>POST INSP. CONTACTS:</b> None	<b>JOINT INSP. AGENCY:</b> None	
<b>WEATHER:</b> Clear	<b>INSPECTOR'S SIGNATURE:</b>

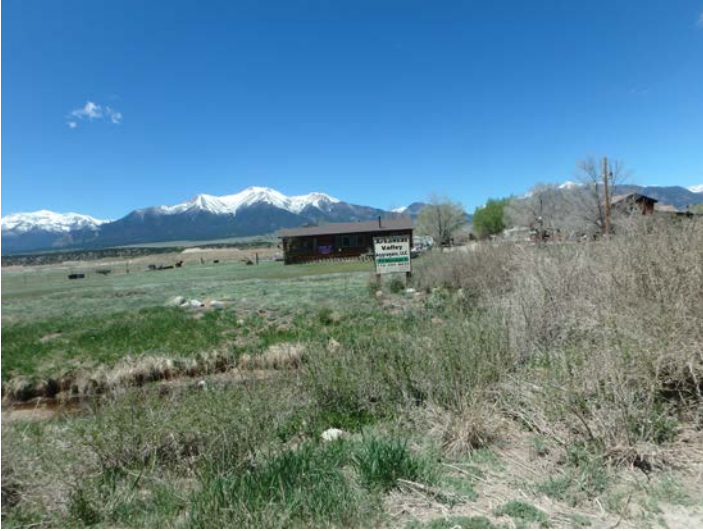
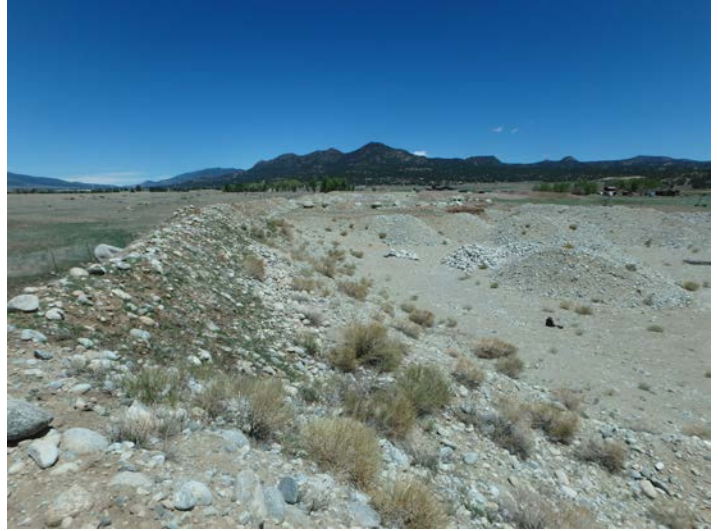
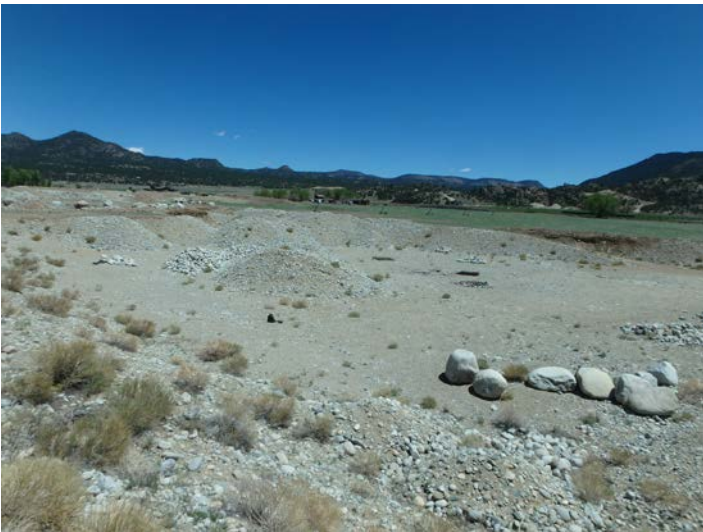
Several small pits have been excavated in different spots within the permit area, with materials stockpiles located throughout the pits. The slopes are on average 1H:1V. The largest pit is located in the south end of the permit area. Several old conveyers and a crusher are parked on site.
