Bowie 1 inspection report

Permit Number: C-1981-038 Mine Name: Bowie No. 1 Mine Operator: Bowie Resources, LLC Operator Address: Mr. Basil R Bear P.O. Box 1488 Paonia, CO 81428	County: Delta Operation Type: Underground Permit Status: Active Ownership: Private
	Operator Representative Present: None
Operator Representative Signature: (Field Issuance Only)

Inspection Start Date: June 9, 2021 Inspection Start Time: 12:30 Inspection End Date: June 9, 2021 Inspection End Time: 15:30		Inspection Type: Coal Complete Inspection Inspection Reason: Normal I&E Program Weather: Clear	
Joint Inspection Agency: None		Joint Inspection Contacts: 	
Post Inspection Agency: None		Post Inspection Contacts: 	
Inspector(s): Robert Zuber, P.E.	Inspector's Signature: <i>Robert D. Zuber</i>		Signature Date: 6/14/2021

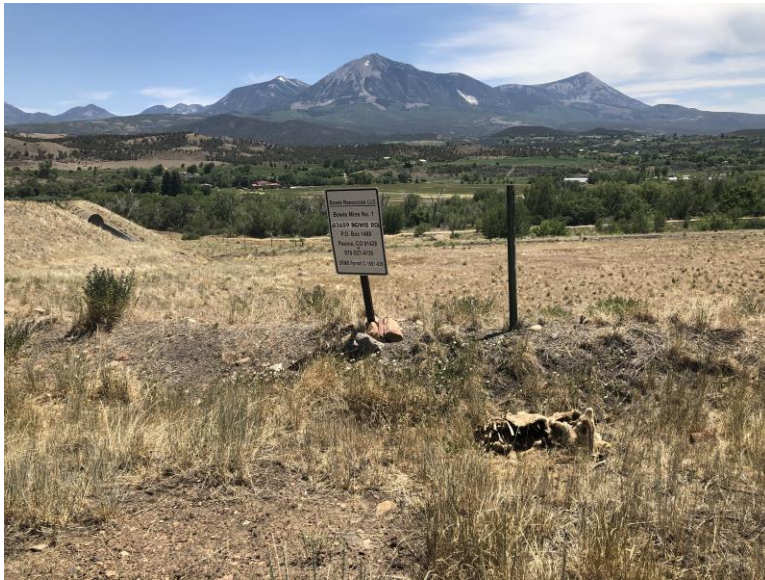
No problems were seen with the Coal Storage Area by Black Bridge Road.

Old coal storage area next to Black Bridge Road

Embankment for upper pond

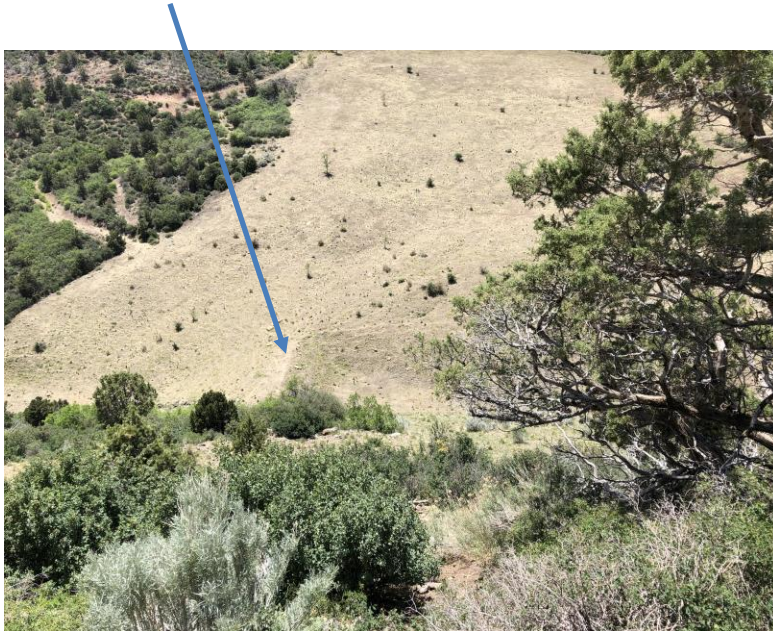
The vegetation at the West Mine is sparse compared to the East Mine and ROM area.

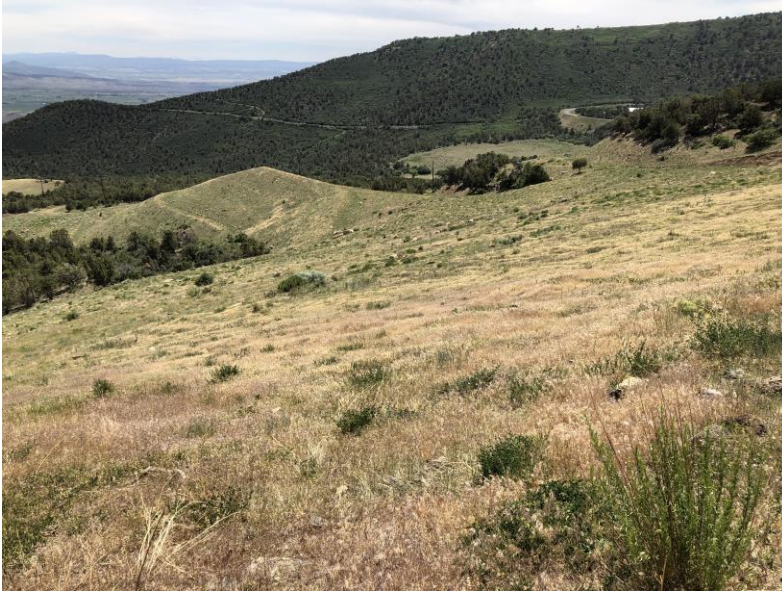
East Mine – lower portion with reclaimed Refuse Disposal Area

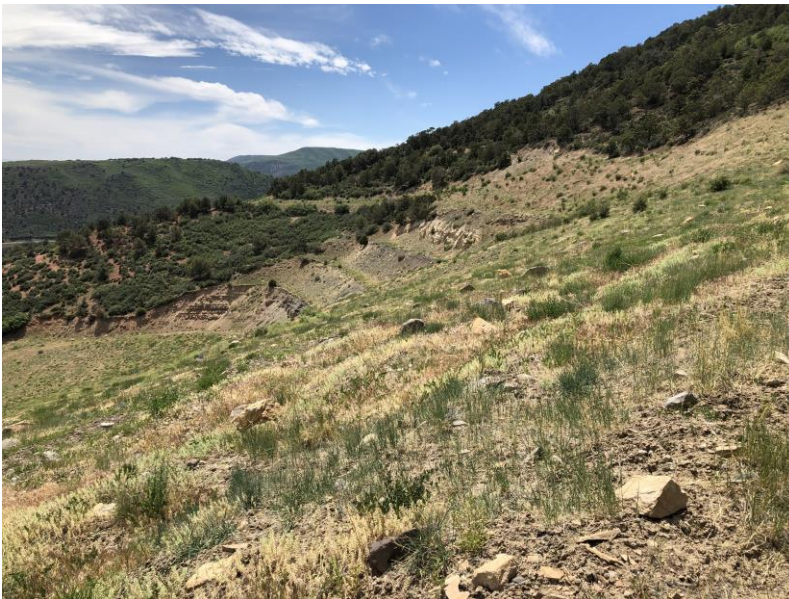
East Mine – upper portion with reclaimed portal bench
