Bureau of Land Management Colorado River Valley Field Office Minerals Inspection Report

General Information	
Date	06/02/2021
Project Name	Rifle Quarry
Operator	Colorado Lien Company
Serial Number	COC-077876
Project Classification	Plan of Operations
Project Location	T4S R92W Sec15, Garfield County
Inspection Purpose	Reclamation site inspection
Time Period Onsite	2 hours
Attendees	Brittany Cocina, BLM Geologist (report author) Amy Yeldell, DRMS Environmental Protection Specialist

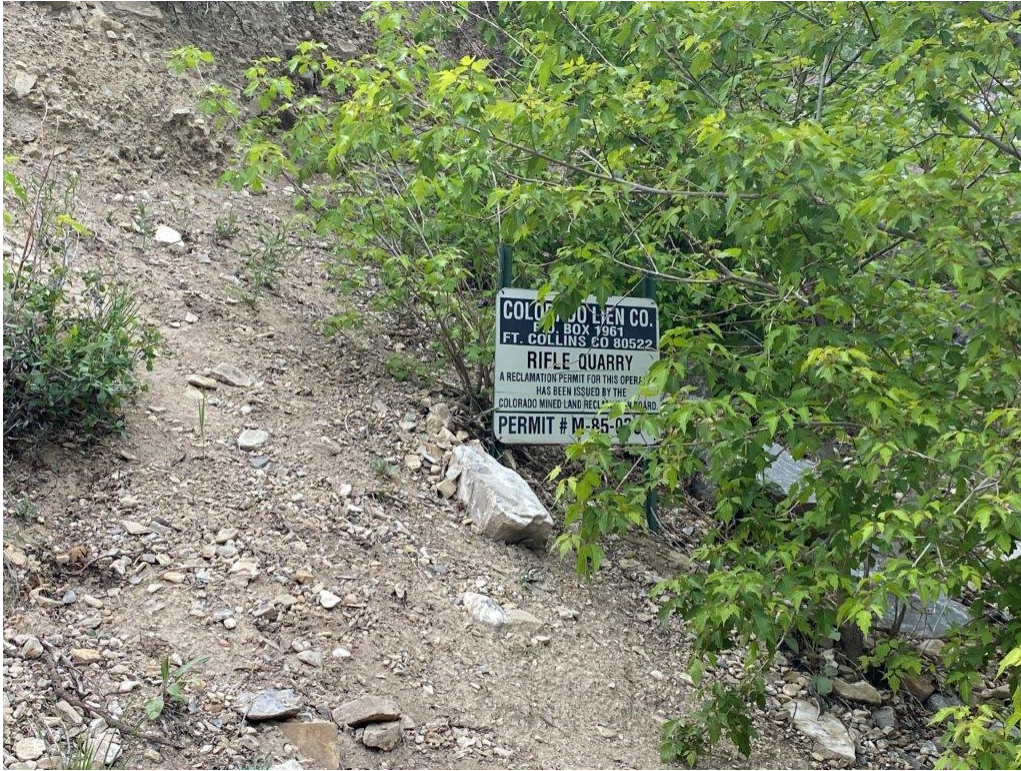
Photo 1: Signage at southeast corner of main quarry area.

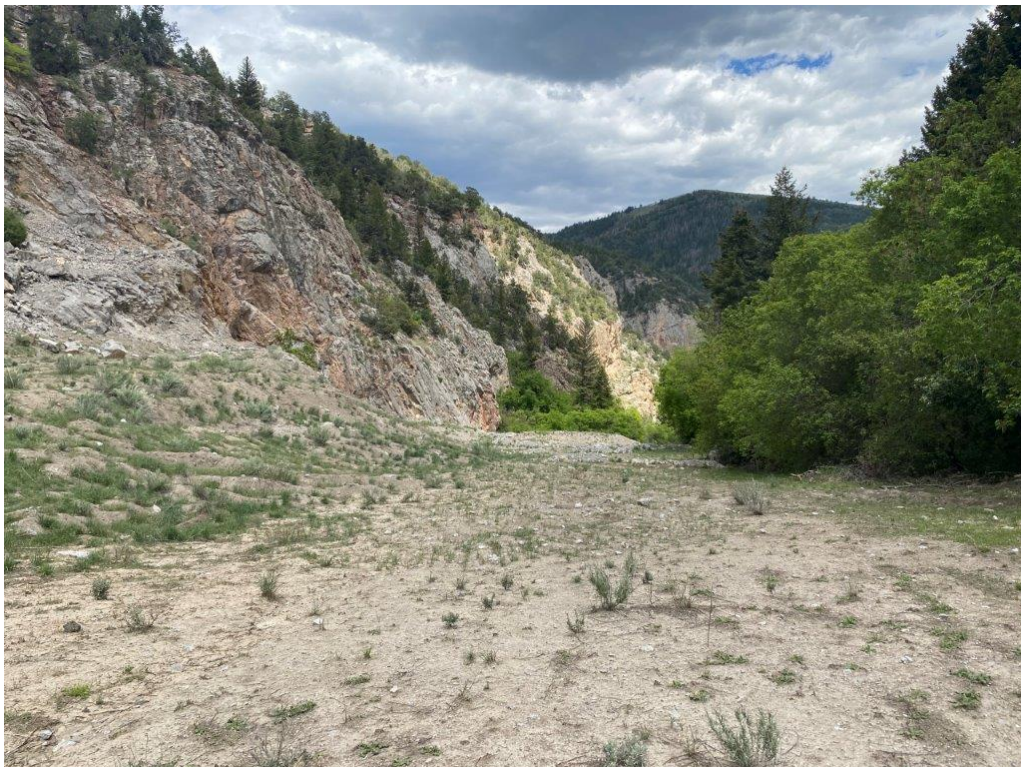
The eastern slope, the quarry floor, the northern upper access bench, as well as most of the remaining quarry area contained signs of adequate revegetation with new spring regrowth of grasses and sage present. There was no evidence of gullying or erosion, the elongated windrows and trench effective at trapping any eroded sediment. The vegetation on the quarry floor also appeared to prevent any additional erosion.

Photo 2: Looking east back at the quarry floor.

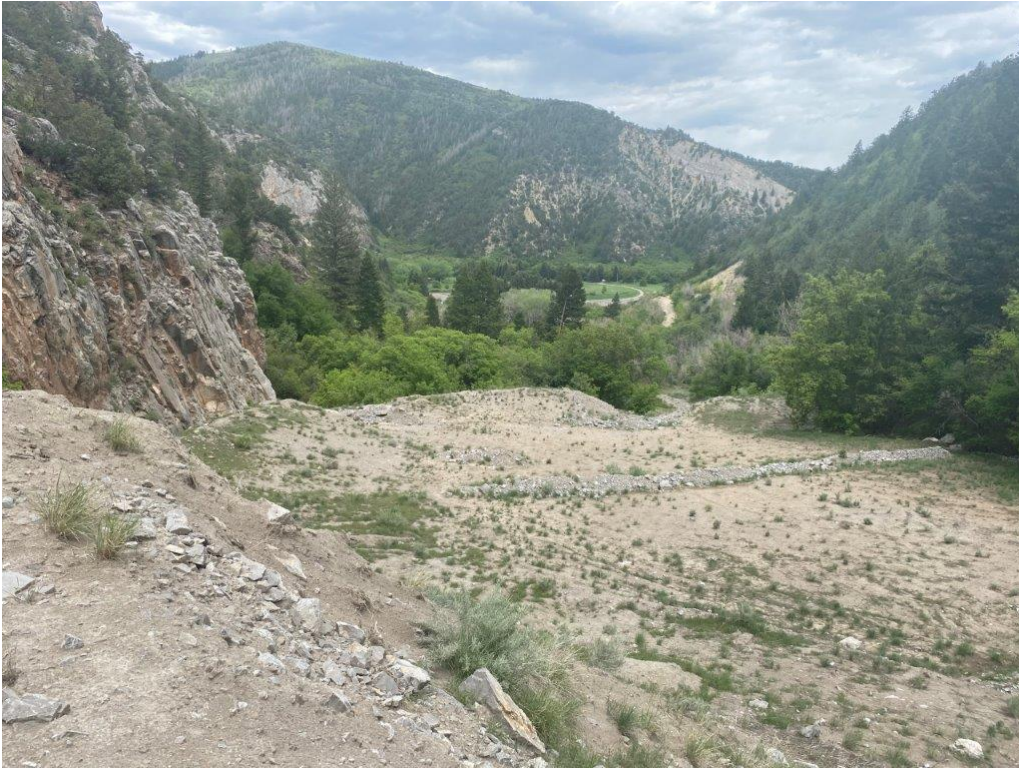
Photo 3: Looking west above the quarry floor.
