MINERALS PROGRAM INSPECTION REPORT
PHONE: (303) 866-3567

MINE NAME: River Park Recreation Access	MINE/PROSPECTING ID#: M-2005-051	MINERAL: Gravel	COUNTY: Chaffee
INSPECTION TYPE: Monitoring	INSPECTOR(S): Dustin Czapla	INSP. DATE: May 25, 2021	INSP. TIME: 11:15
OPERATOR: ACA Products, Inc.	OPERATOR REPRESENTATIVE:	TYPE OF OPERATION: 110c - Construction Limited Impact	
REASON FOR INSPECTION: Normal I&E Program	BOND CALCULATION TYPE: Complete Bond	BOND AMOUNT: \$32,550.00	
DATE OF COMPLAINT: NA	POST INSP. CONTACTS: None	JOINT INSP. AGENCY: None	
WEATHER: Clear	INSPECTOR'S SIGNATURE:

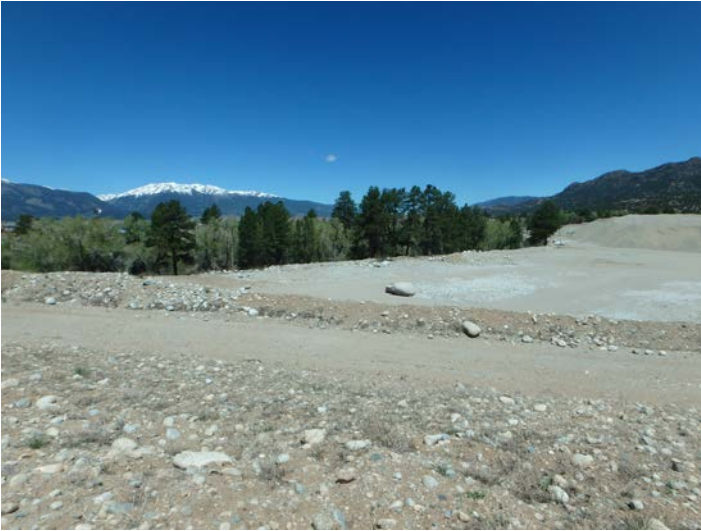
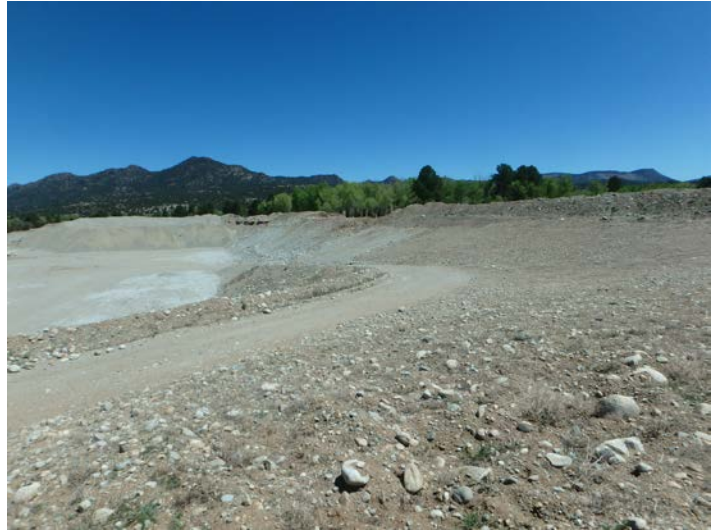
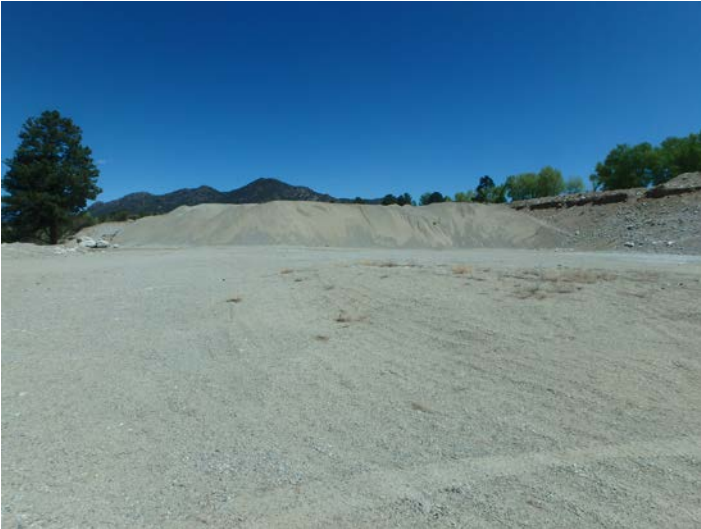
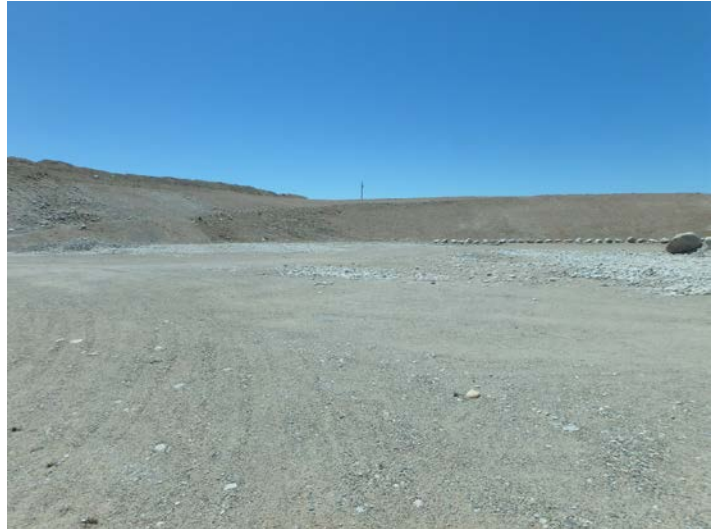
Mining is complete at the site and final reclamation has commenced. All equipment has been removed from the site. Backfilling of slopes is underway. Topsoil is staged in berms around the crest of the pit. The pit floor is graded flat and free of equipment or refuse. A gravel stockpile remains in the north end of the pit.
