MINERALS PROGRAM INSPECTION REPORT
PHONE: (303) 866-3567

MINE NAME: Priola Pit	MINE/PROSPECTING ID#: M-2007-087	MINERAL: Sand and gravel	COUNTY: Adams
INSPECTION TYPE: Surety Release Inspection	INSPECTOR(S): Patrick Lennberg	INSP. DATE: May 19, 2021	INSP. TIME: 09:30
OPERATOR: Albert Frei & Sons Inc.	OPERATOR REPRESENTATIVE: Ben Frei, Joel Bolduc, Steve O'Brian	TYPE OF OPERATION: 112c - Construction Regular Operation	
REASON FOR INSPECTION: Surety Release Requested	BOND CALCULATION TYPE: None	BOND AMOUNT: \$34,000.00	
DATE OF COMPLAINT: NA	POST INSP. CONTACTS: None	JOINT INSP. AGENCY: County	
WEATHER: Clear	INSPECTOR'S SIGNATURE:

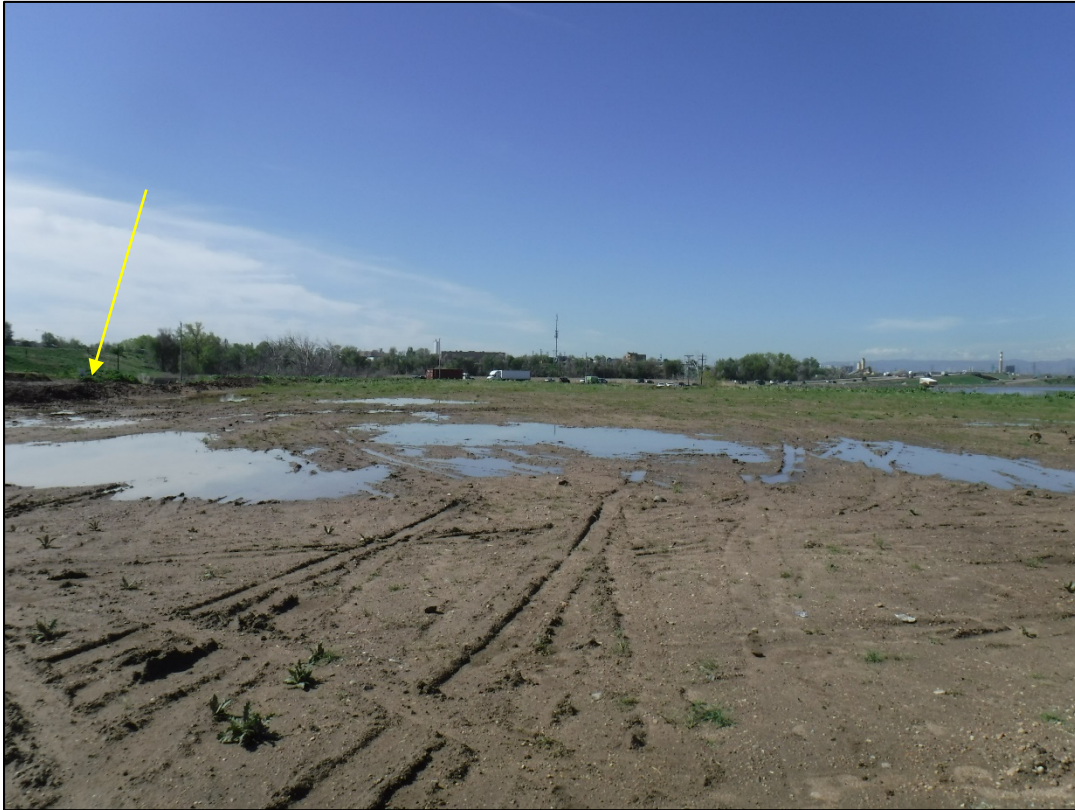
In the industrial zoned portion of the permit area, the landowner is using the north catch basin to allow vacuum trucks and other slurry waste products to dump. In the process of dumping, the trucks are travelling over seeded areas to the west and killing the vegetation that was establishing. Adams County has determined that the landowner's operation needs additional permits, such as a certificate of designation and appropriate stormwater permits to continue. Adams County has taken enforcement action against the landowner and issued a cease and desist order for them until the proper permitting is obtained. The landowner continues to allow dumping to take place at the basin.

Photo 9: Looking south at reclaimed area immediately east of the North Catch Basin, note tire tracks through revegetated area. Yellow arrow indicates berm that approximates boundary of industrial and revegetated areas

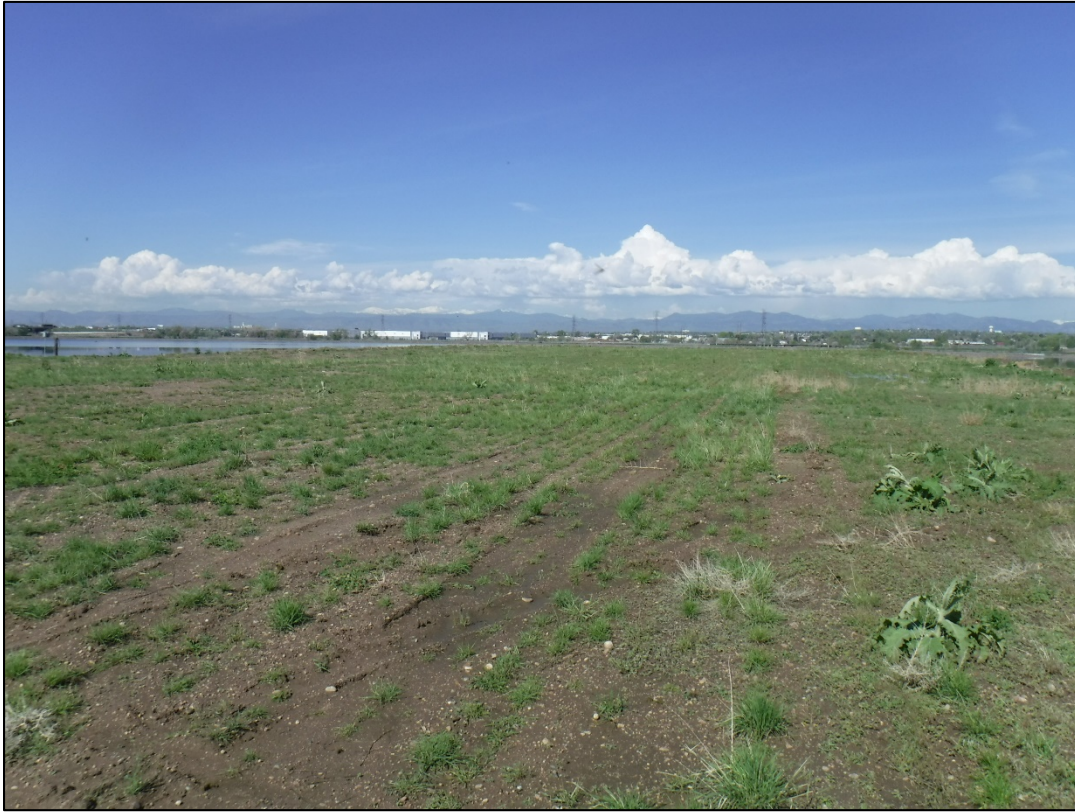
Photo 11: Typical vegetation on areas west of where passenger vehicles are parked

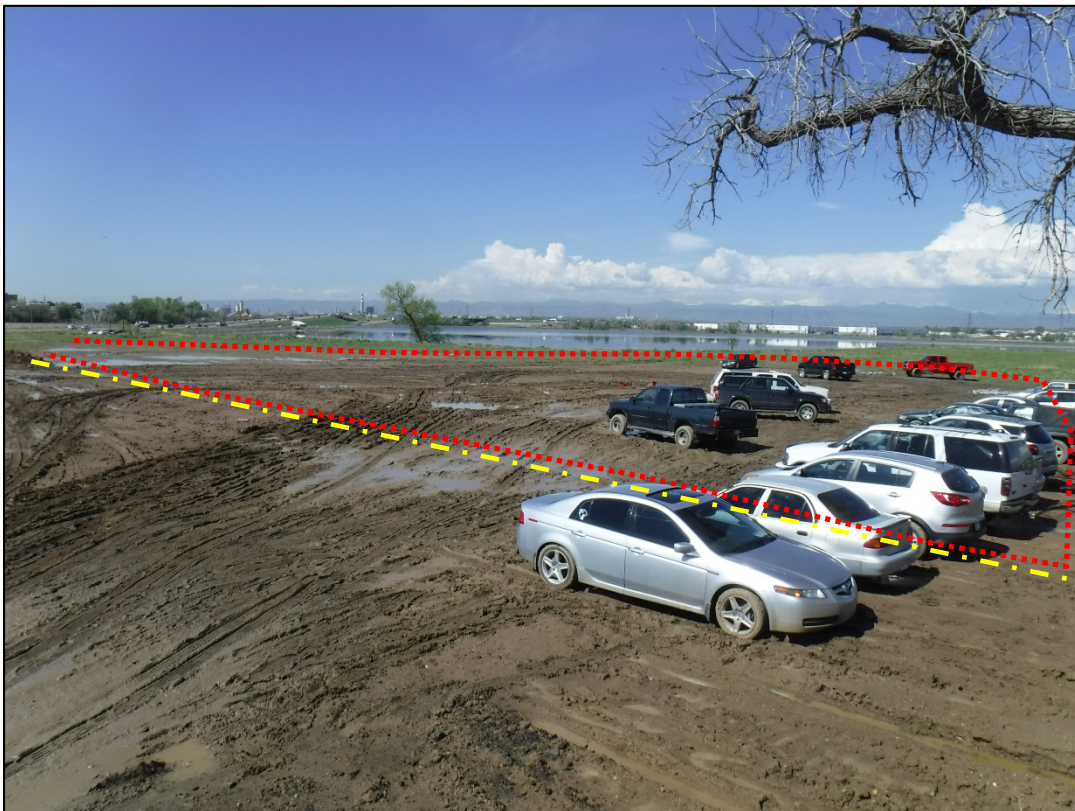
Based on observations made during this inspection, the operator has completed the reclamation in accordance with the reclamation plan. The majority of the revegetated area has suitable vegetation cover and appears stable. The landowner has affected a portion, approximately 2 acres, of the revegetated area outside of the area zoned for industrial/commercial use that the permittee had revegetated. This disturbance is not associated with the mining and reclamation operation. Also, the landowner is currently using the area zoned for industrial/commercial for such use. Therefore the release request of the permit will be approved. Notice of the Division's decision regarding the release request will be sent under a separate cover letter.

Photo 10: Yellow dashed line is the approximate boundary of industrial and revegetated areas, red dashed line indicates landowner disturbance
