Bowie 2 inspection report

COLORADO
Division of Reclamation,
Mining and Safety
Department of Natural Resources

Permit Number: C-1996-083 Mine Name: Bowie No. 2 Mine Operator: Bowie Resources, LLC Operator Address: Mr. Basil Bear P.O. Box 1488 Paonia, CO 81428	County: Delta Operation Type: Underground Permit Status: Active Ownership: Private
	Operator Representative Present: Basil Bear
Operator Representative Signature: (Field Issuance Only)

Inspection Start Date: June 10, 2021 Inspection Start Time: 07:00 Inspection End Date: June 10, 2021 Inspection End Time: 12:00		Inspection Type: Coal Complete Inspection Inspection Reason: Normal I&E Program Weather: Clear	
Joint Inspection Agency: None		Joint Inspection Contacts:	
Post Inspection Agency: None		Post Inspection Contacts:	
Inspector(s): Robert Zuber, P.E.	Inspector's Signature: <i>Robert D. Zuber</i>		Signature Date: 6/14/2021

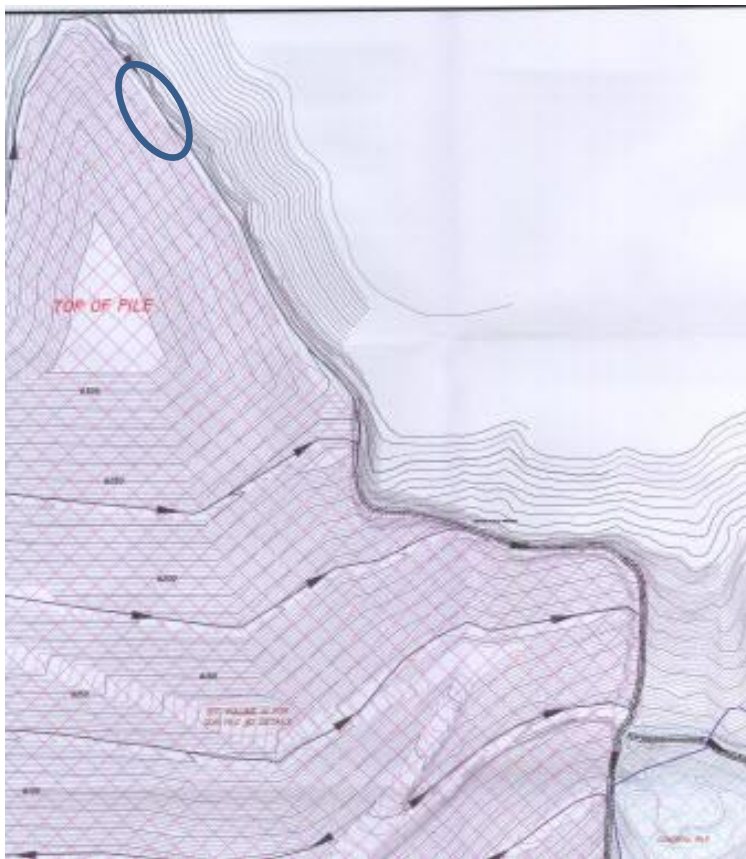
Figure with Approximate Location of Ditch that Requires Maintenance

No problems were seen with ditches or culverts around the site with the following exception. A reach of a diversion ditch above Gob Pile #2 (see location on figure) needs maintenance, because it is nearly full of silt.

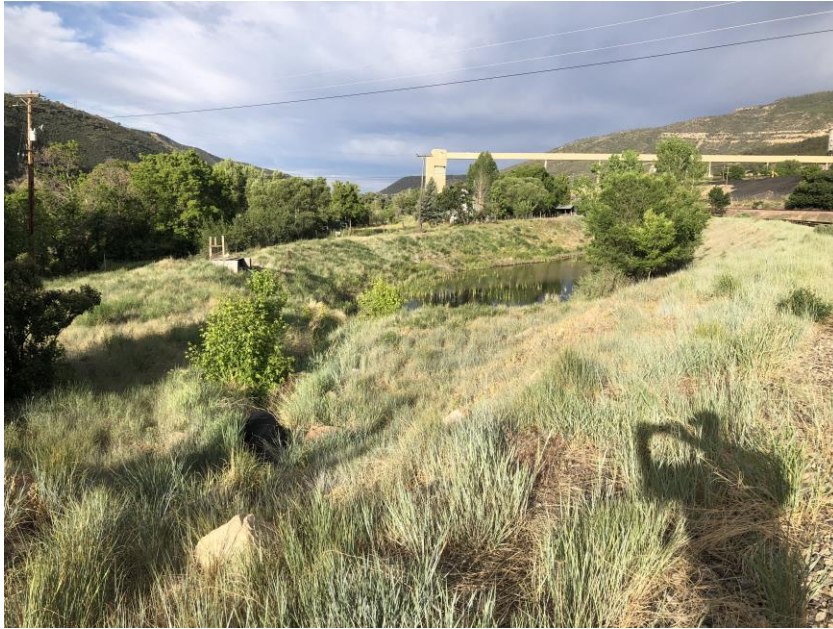
Six sediment ponds were inspected: B, C, D, F, J, and K. None of the ponds were discharging, and all but Pond J were dry or nearly dry. Pond J held water, but it was well below the spillways. No significant problems were identified with embankments, spillways, inlet channels, or other features of the ponds.

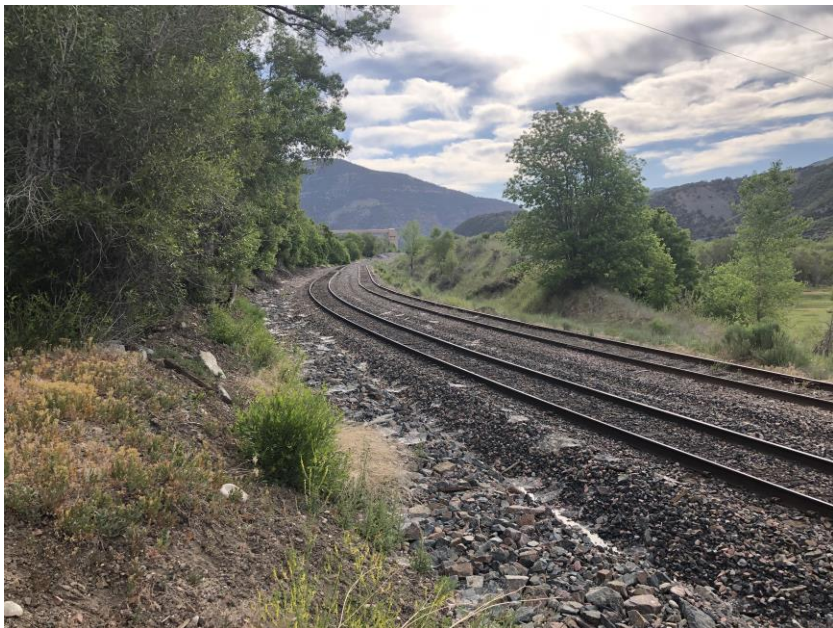
Unit Train Loadout (west portion)

- The SAE near Pond D is stable.
- The slopes near the Preparation Plant and nearby water tank are vegetated and stable.
- The SAEs adjacent to and below the Engineering Office are well vegetated and no erosion was seen.
- The slopes above and below the Coal Stockpile Pad are stable.
- The material storage area beside Topsoil Stockpile A is very stable.
- No erosion or other problems were seen along the conveyor corridors.
- The slope above the Utility Bench is stable.
- No erosion or other problems were identified at the western or eastern portions of the Unit Train Loadout.

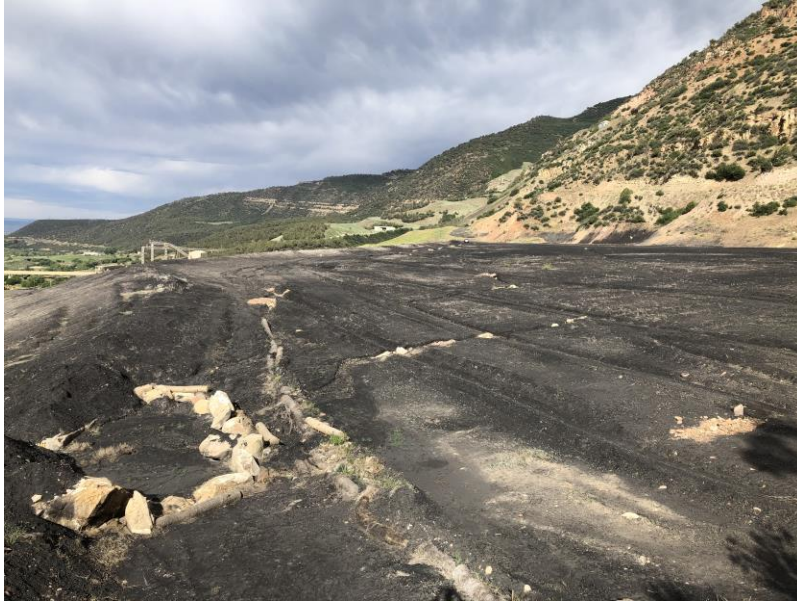
Gob Piles #1, #2 and #4 looked stable. On the upper and lower lifts of Gob Pile #2 only small rills were observed. Most of the drainage control practices on the upper (flat) portion of this pile appear to be functioning well, but some check dams should be repaired. No puddles were observed.

Gob Pile #2 with sediment trap

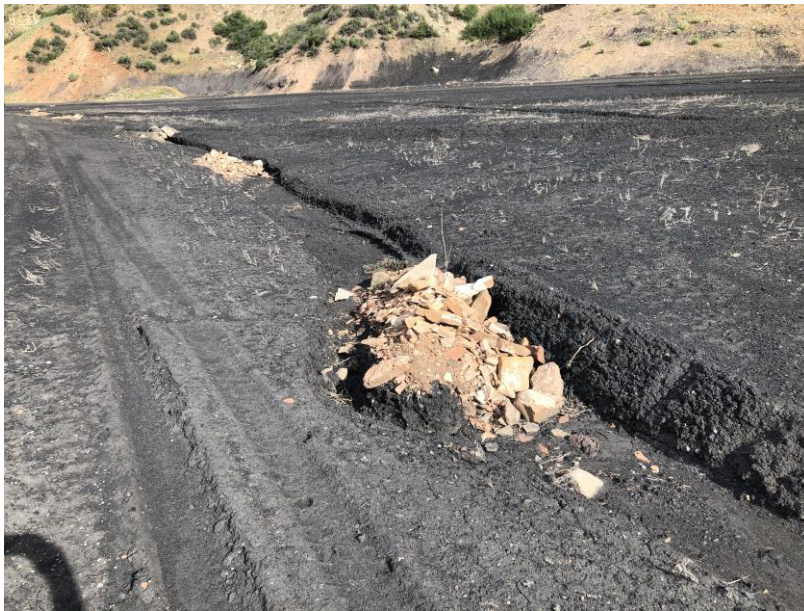
Check dams on Gob Pile #2 (in need of repair)

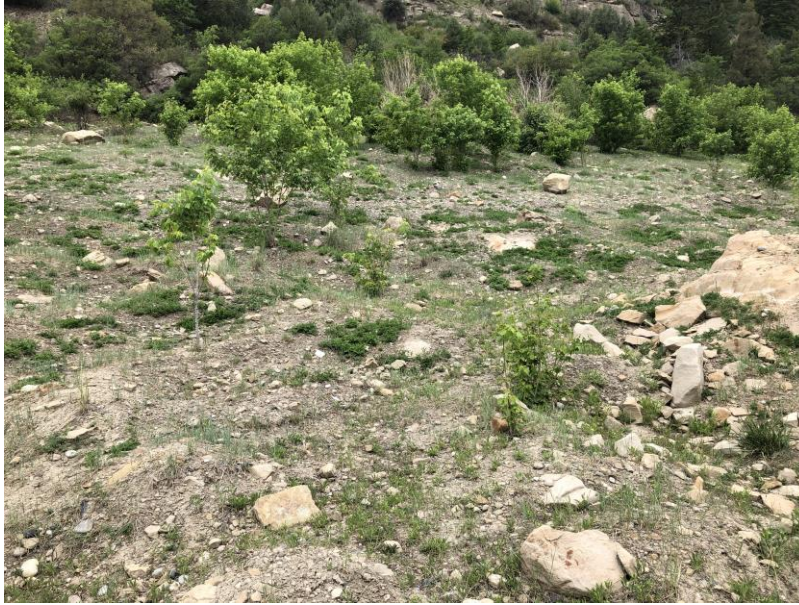
The reclaimed pad at the former Hubbard Creek Vent Shaft is in good shape. No problems were seen at the nearby Rock Laydown area.

Reclaimed area at the Hubbard Creek Vent Shaft

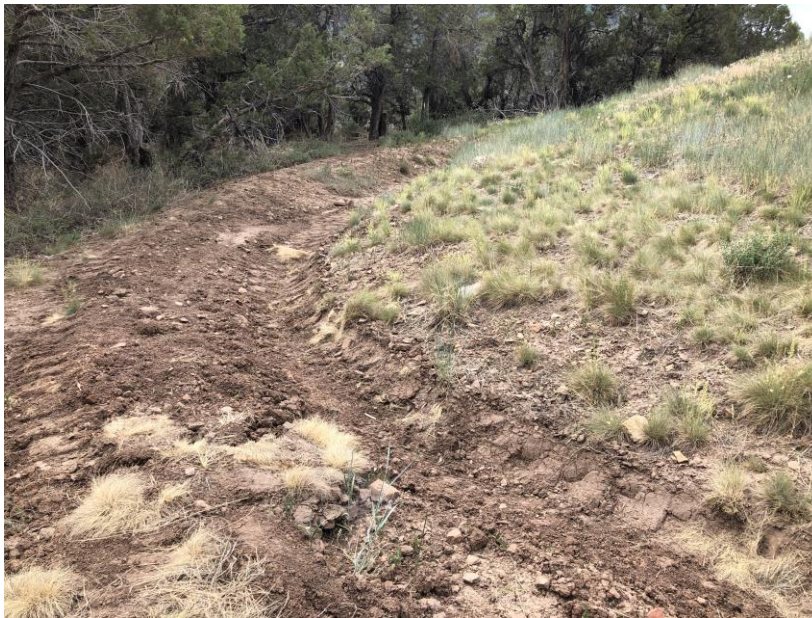
At topsoil stockpiles and coverfill piles, berms, vegetation, and silt fence are keeping these resources in place. It appears that the ditch on the east side of Topsoil Stockpile A has recently been maintained; no issues were observed at this location.

Maintained ditch beside Topsoil Stockpile A

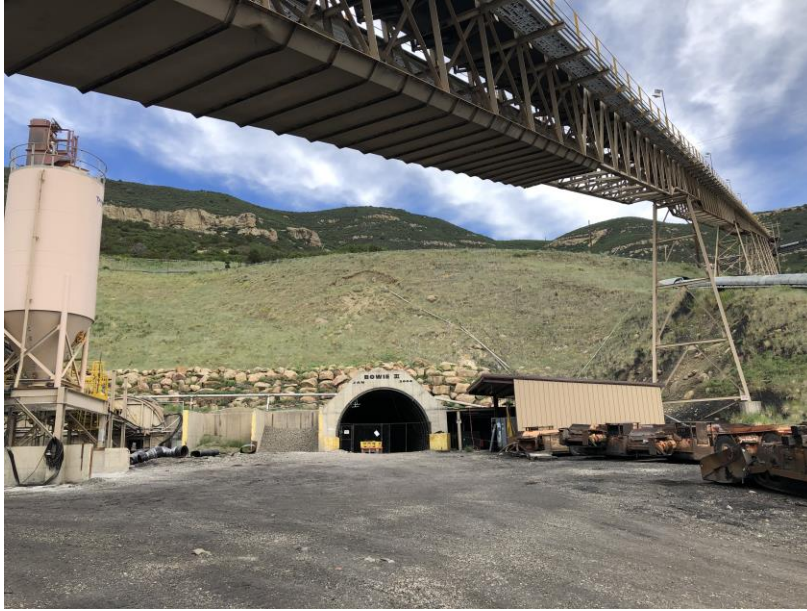
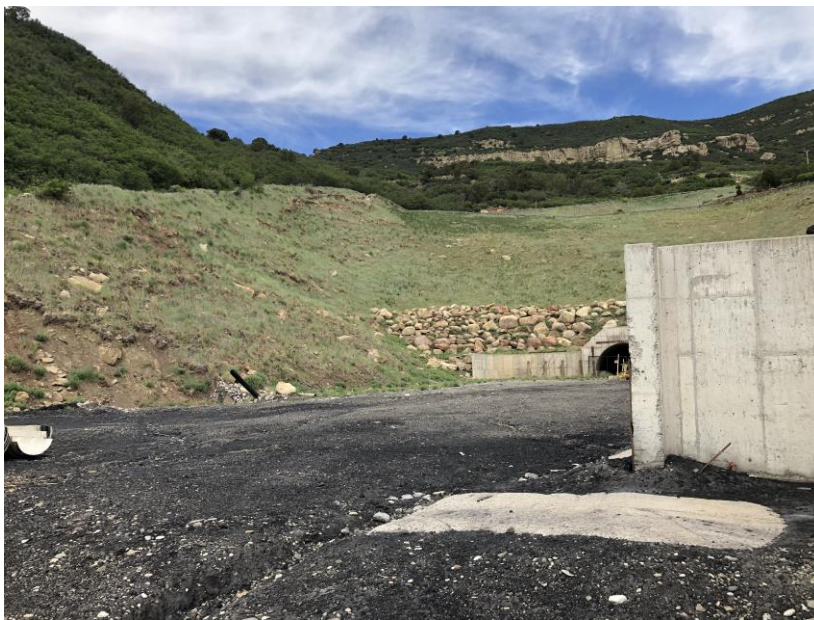
It appears that slumps have not moved significantly in the recent past. These include slumps by the B Portal and by Curve Number 11 along the Haul Road.

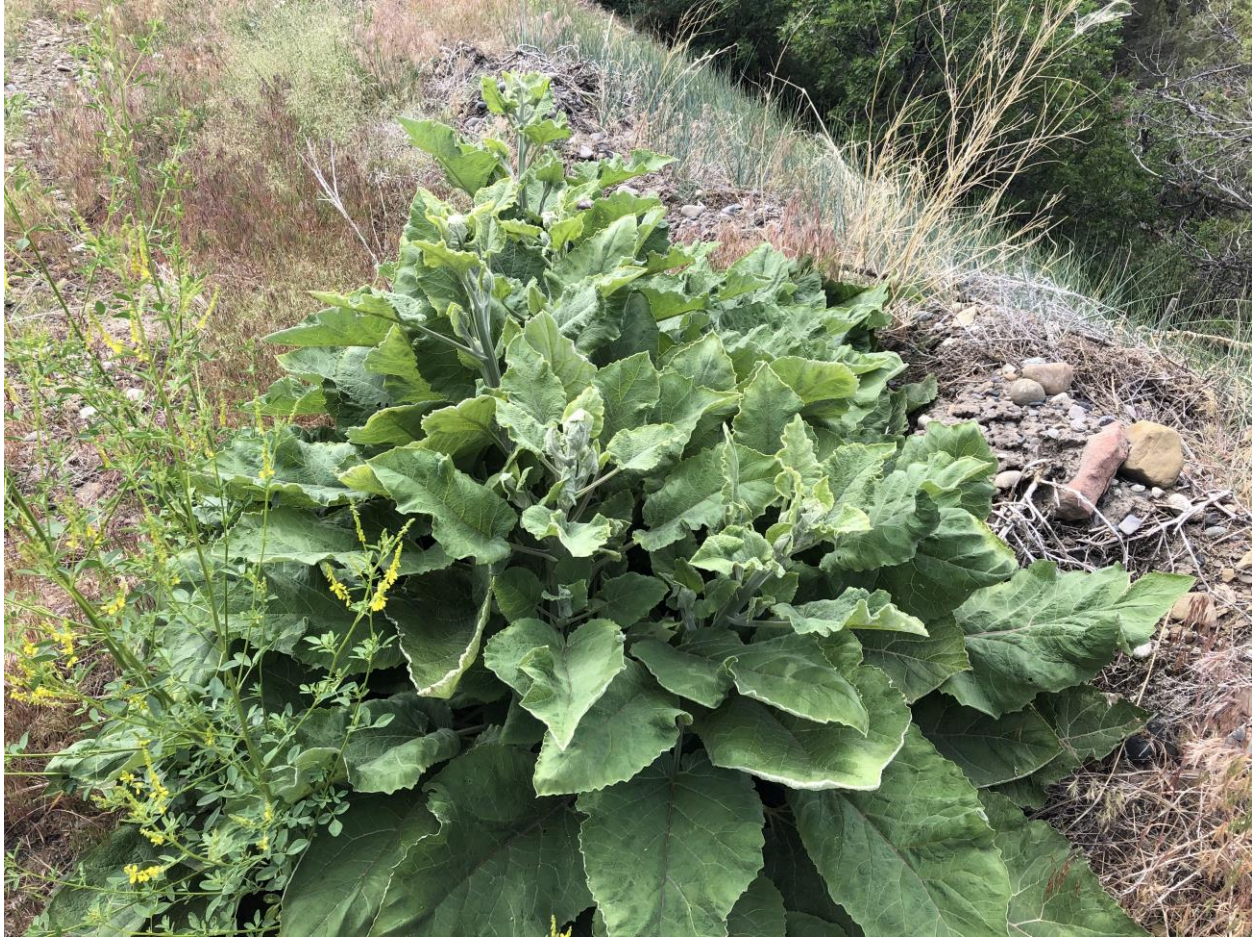
- Halogeton and Houndstongue near Gob Pile #2.
- Jointed goatgrass near the pump house and at the inlet to Pond F.
- Thistle and mullein at Topsoil Stockpile A (along the road to the portals).
- Thistle and burdock on the storage pad above (and to the east of) the D Portal area.

Burdock plant at storage yard east of D Portal area
