MINERALS PROGRAM INSPECTION REPORT
PHONE: (303) 866-3567

MINE NAME: Priola Pit	MINE/PROSPECTING ID#: M-2007-087	MINERAL: Sand and gravel	COUNTY: Adams
INSPECTION TYPE: Surety Release Inspection	INSPECTOR(S): Patrick Lennberg	INSP. DATE: May 19, 2021	INSP. TIME: 09:30
OPERATOR: Albert Frei & Sons Inc.	OPERATOR REPRESENTATIVE: Ben Frei, Joel Bolduc, Steve O'Brian	TYPE OF OPERATION: 112c - Construction Regular Operation	
REASON FOR INSPECTION: Surety Release Requested	BOND CALCULATION TYPE: None	BOND AMOUNT: \$34,000.00	
DATE OF COMPLAINT: NA	POST INSP. CONTACTS: None	JOINT INSP. AGENCY: County	
WEATHER: Clear	INSPECTOR'S SIGNATURE:

SURETY RELEASE MAP

PRIOLA PIT - M-2007-087

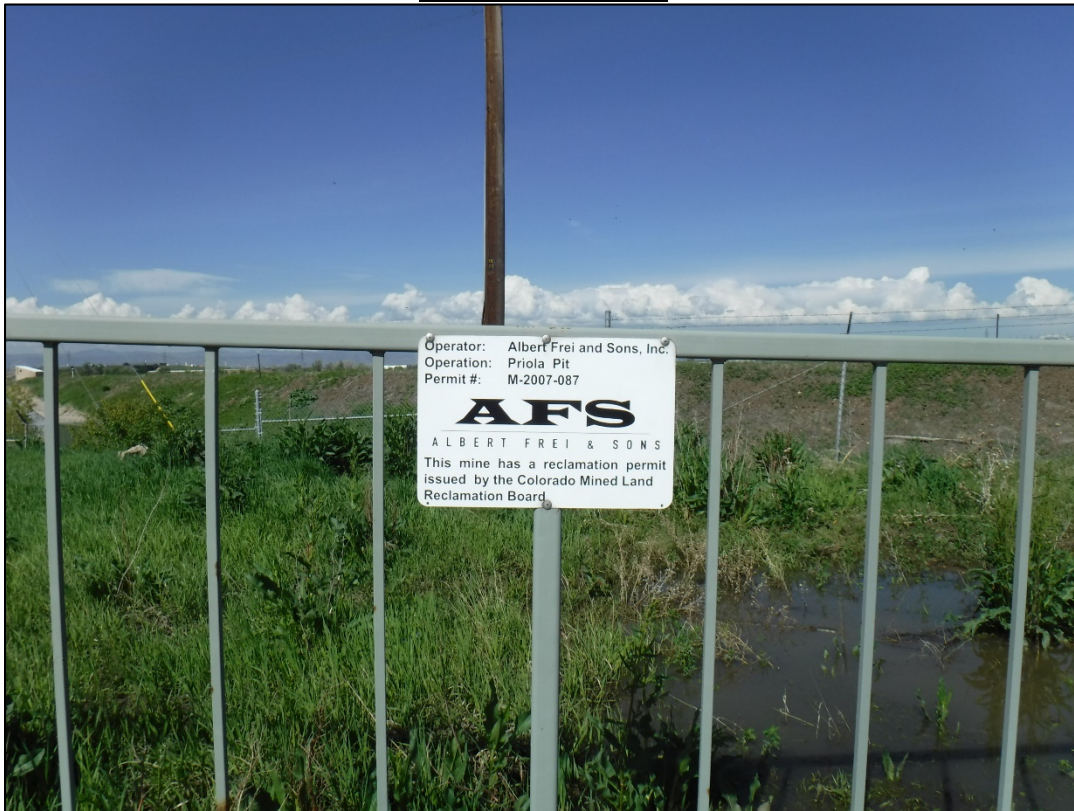
Photo 1: Mine sign at entrance

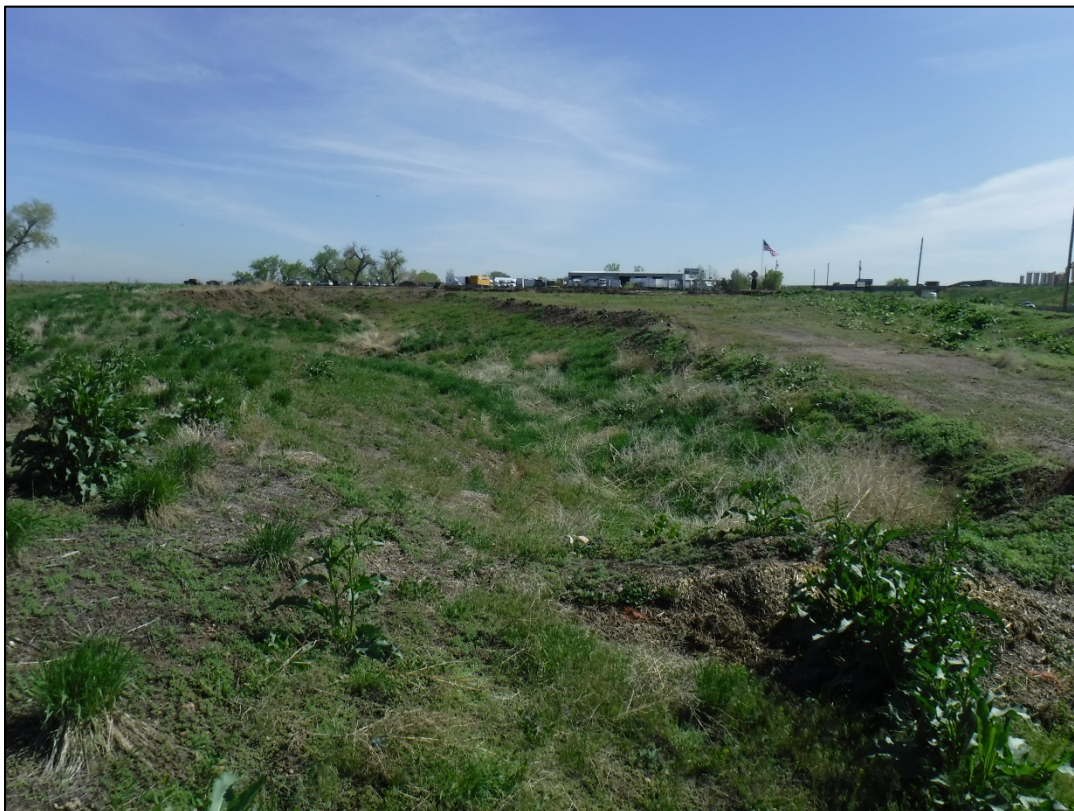
Photo 2: Looking north from the south end of the South Catch Basin

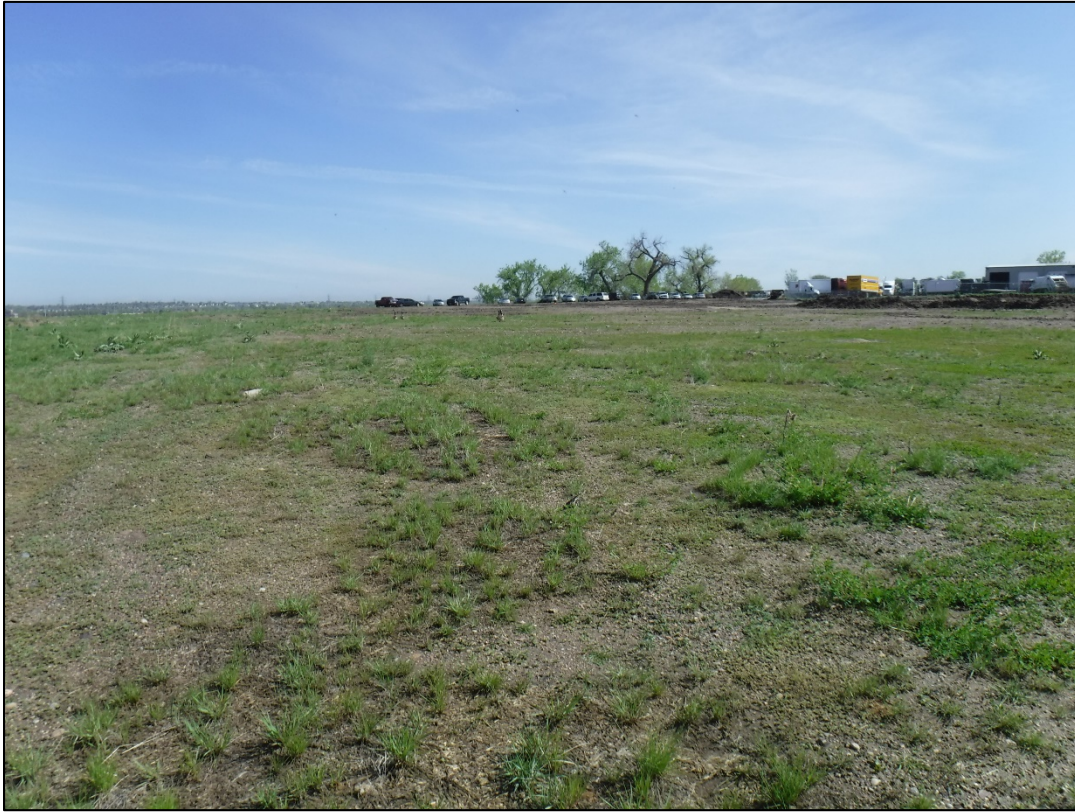
Photo 3: Typical vegetative cover of undisturbed areas, looking north

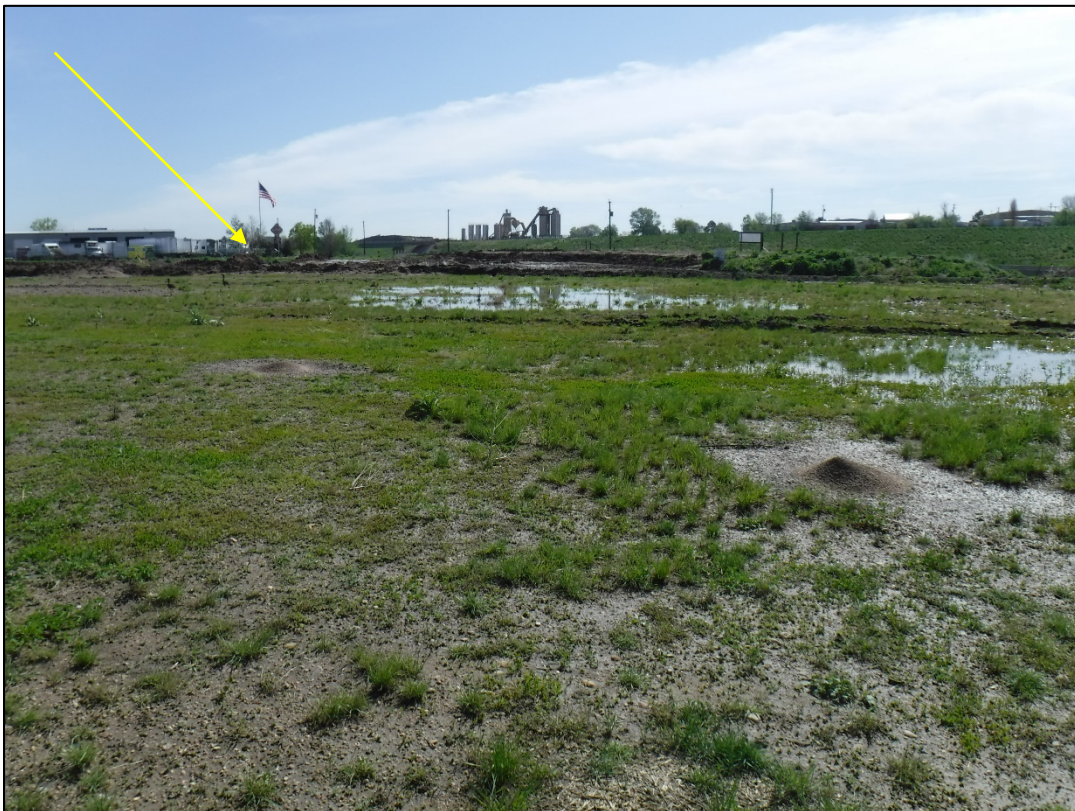
Photo 4: Looking north towards North Catch Basin (yellow arrow) ponded water from recent heavy rainfall in the area

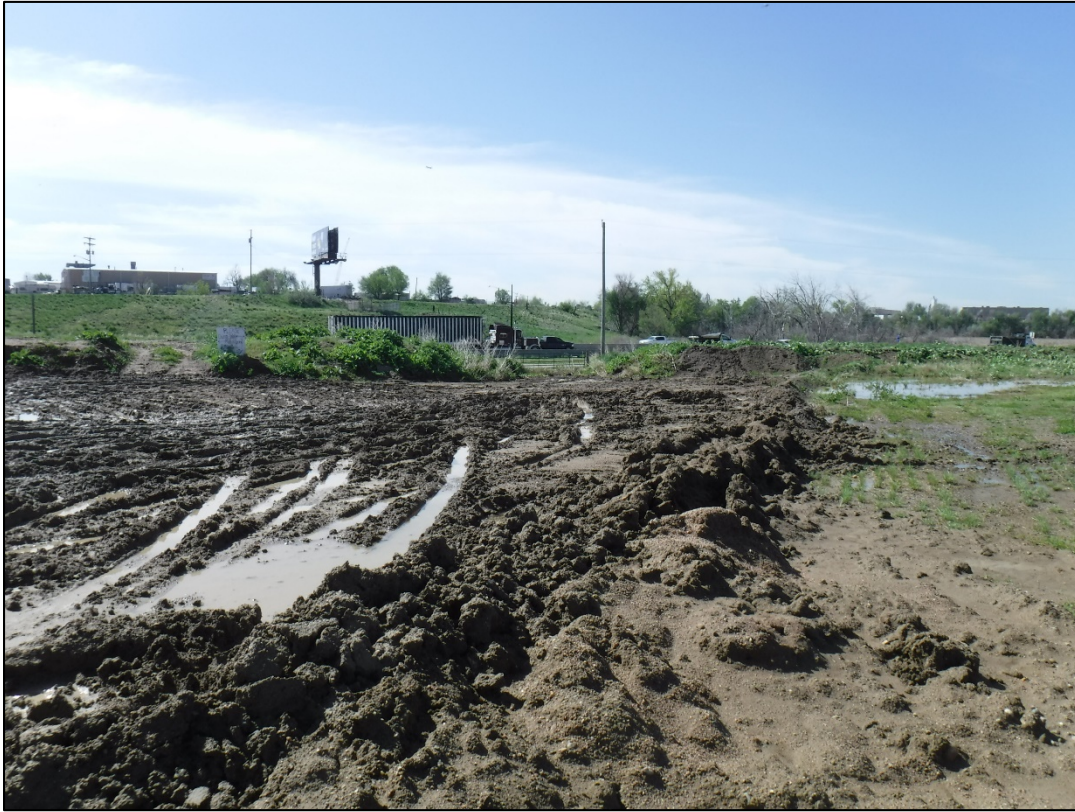
In the industrial zoned portion of the permit area, the landowner is using the north catch basin to allow vacuum trucks and other slurry waste products to dump. In the process of dumping, the trucks are travelling over seeded areas to the west and killing the vegetation that was establishing. Adams County has determined that the landowner's operation needs additional permits, such as a certificate of designation and appropriate stormwater permits to continue. Adams County has issued a Notice of Violation to the landowner and stated the facility must be brought into compliance. The landowner continues to allow dumping to take place across the industrial zoned side of the permit area.

Photo 5: Area immediately south of the North Catch Basin where trucks have disturbed reclaimed areas

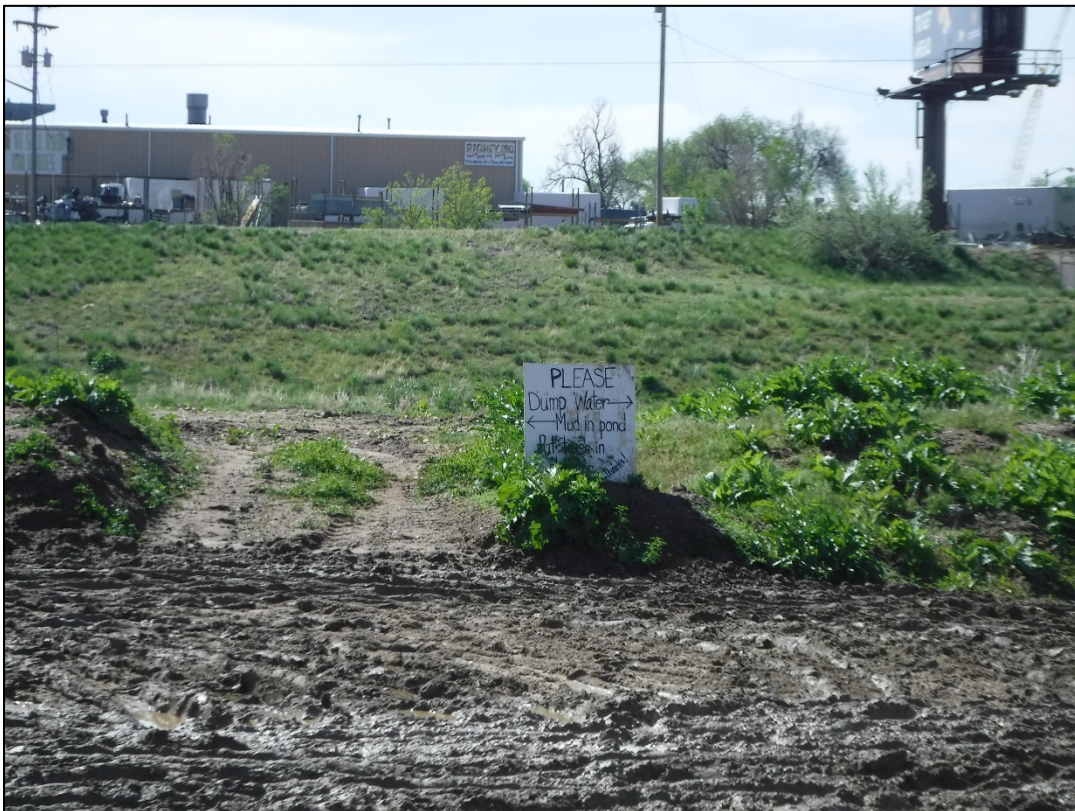
Photo 6: Sign directing truck traffic for dumping

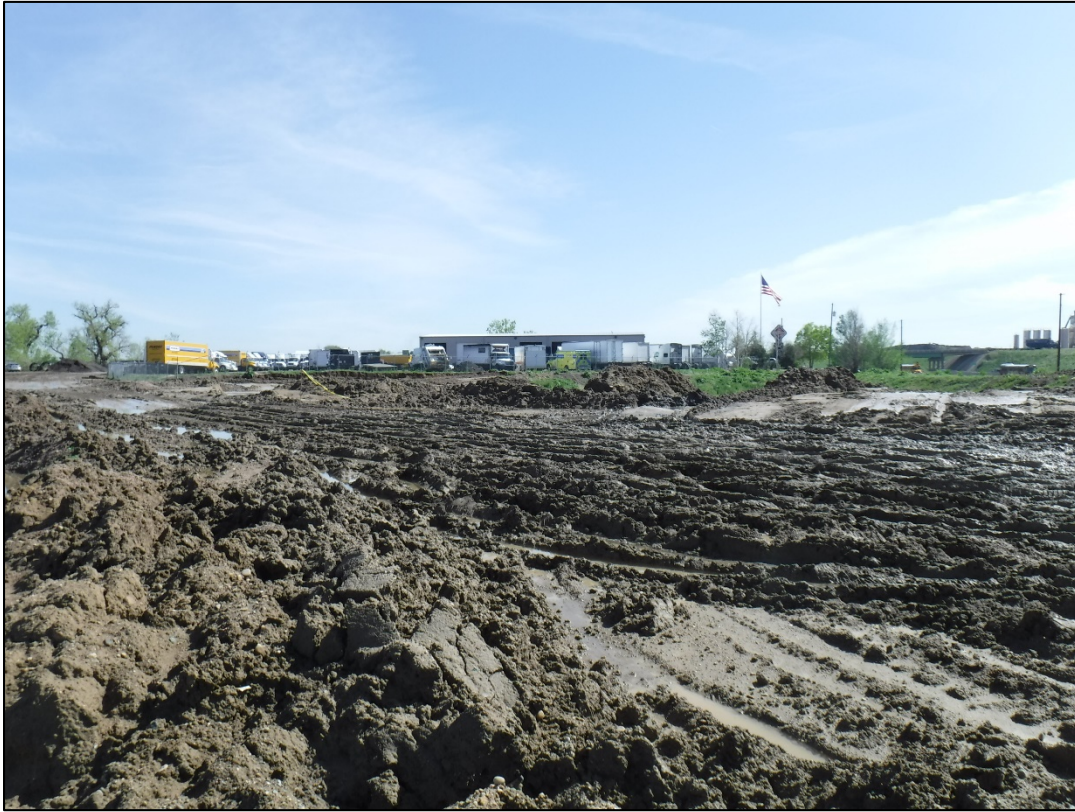
Photo 7: North Catch Basin center of picture

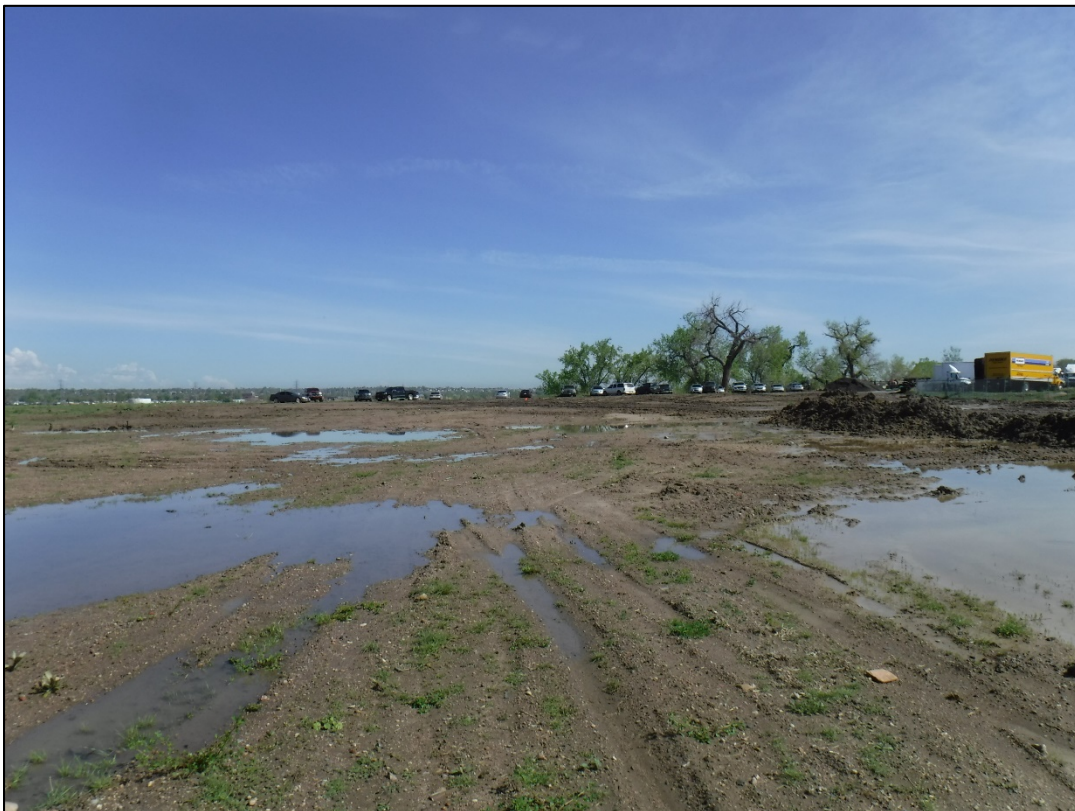
Photo 8: Looking north at reclaimed area immediately west of the North Catch Basin, note tire tracks through revegetated area

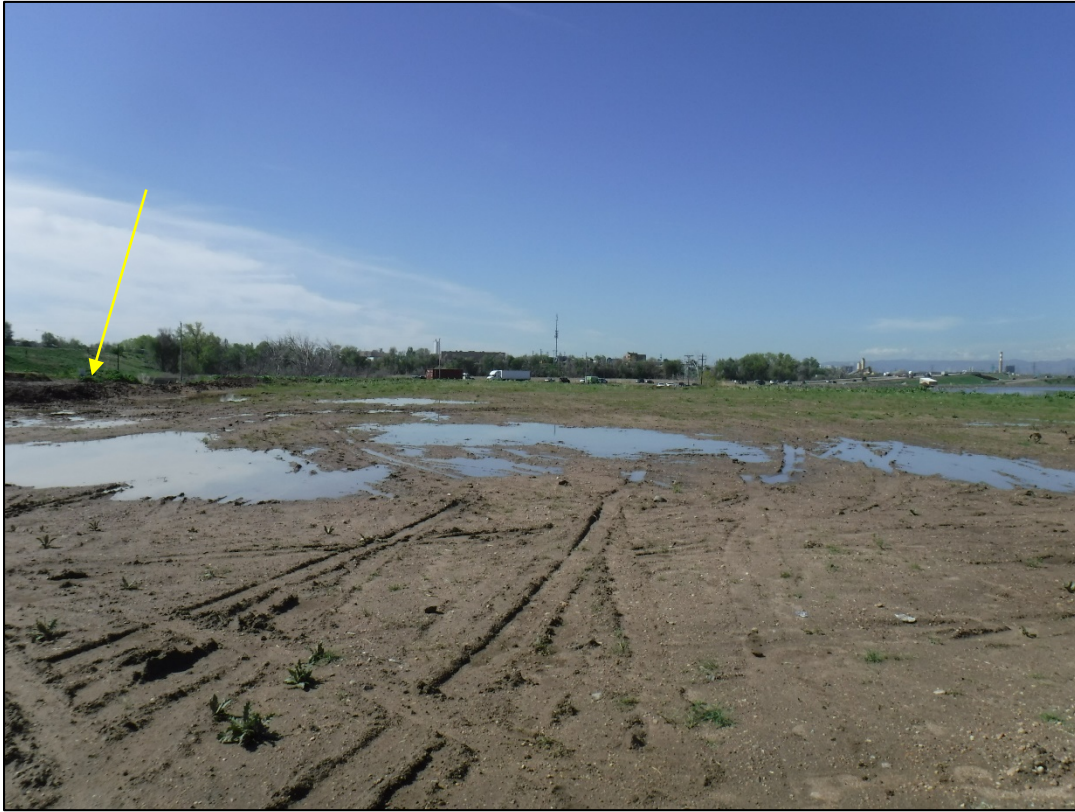
Photo 9: Looking south at reclaimed area immediately east of the North Catch Basin, note tire tracks through revegetated area. Yellow arrow indicates berm that approximates boundary of industrial and revegetated areas

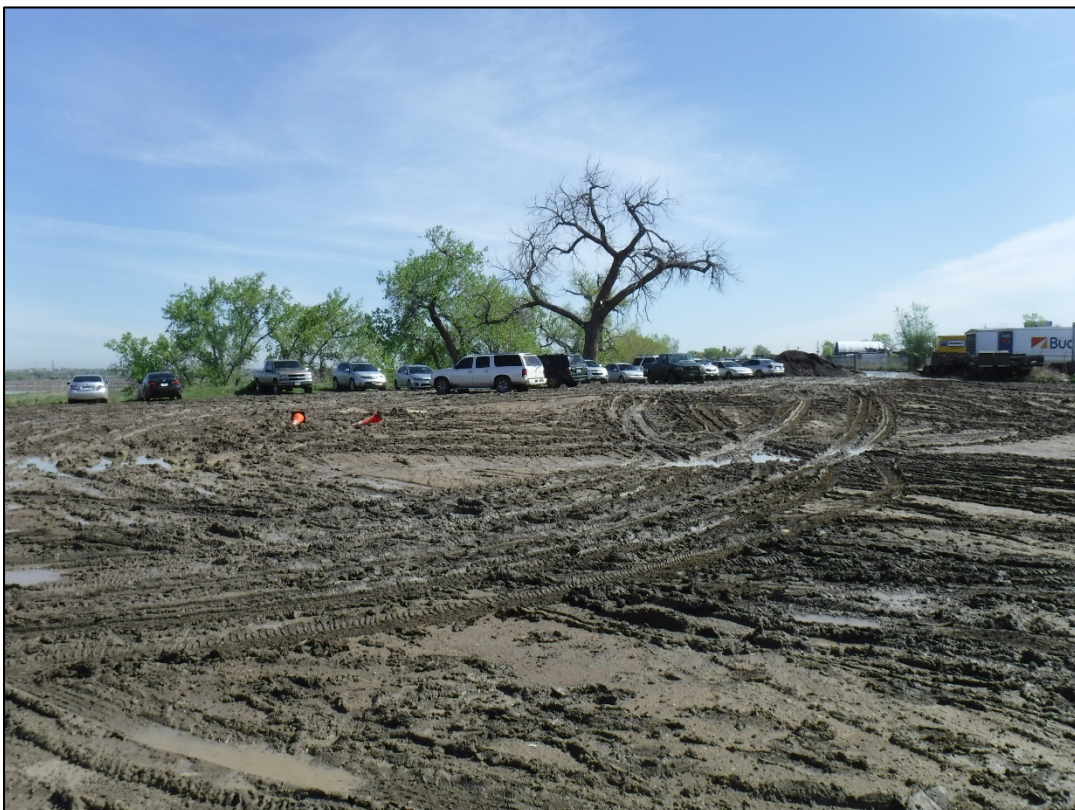
Photo 10: Passenger vehicles parked on revegetated area

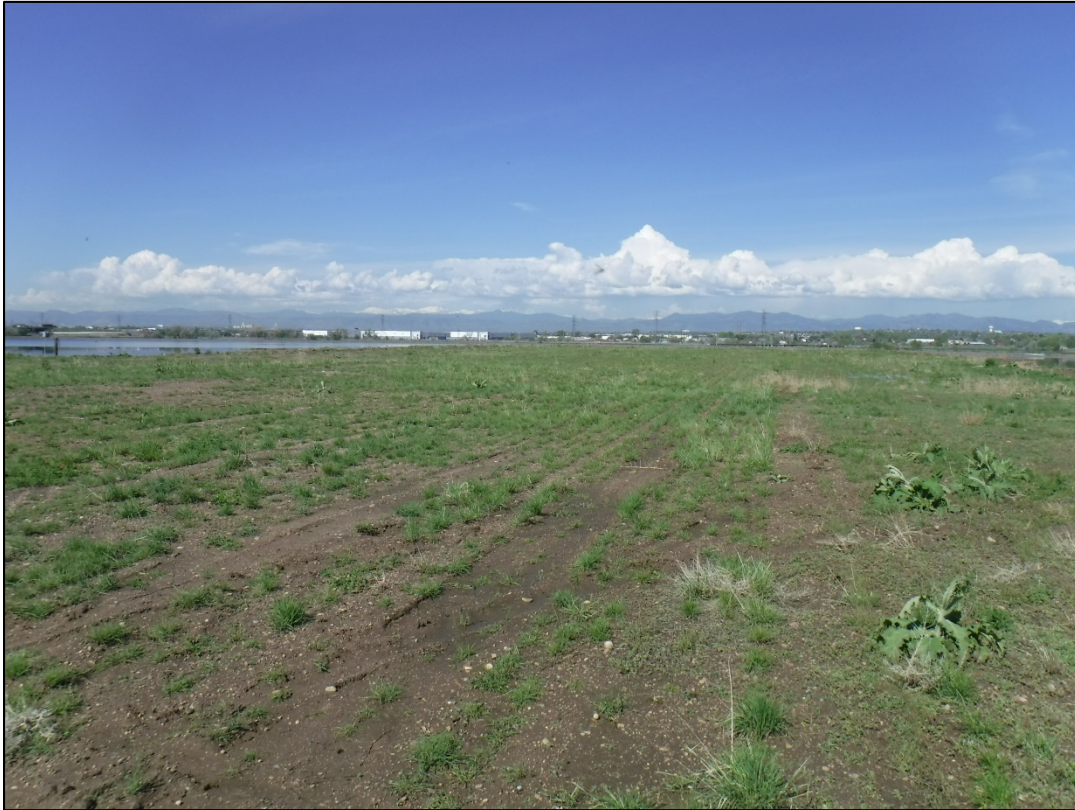
Photo 11: Typical vegetation on areas west of where passenger vehicles are parked

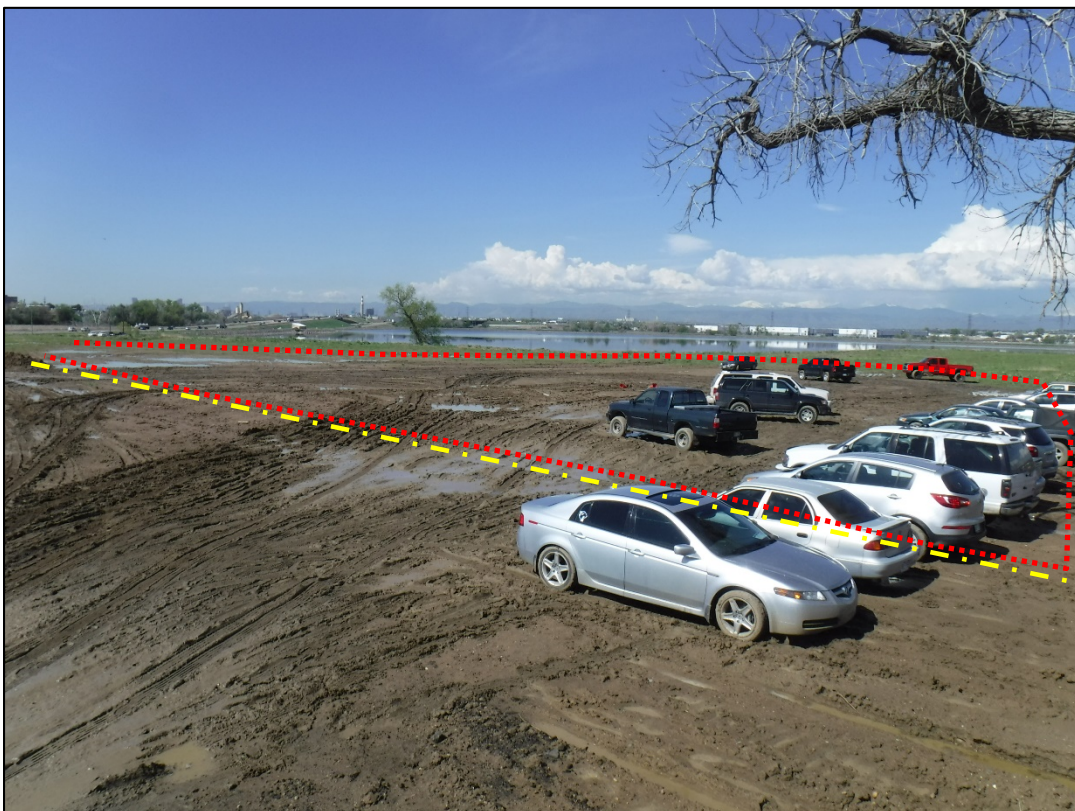
Based on observations made during this inspection, the operator has completed the reclamation in accordance with the reclamation plan. The majority of the revegetated area has suitable vegetation cover and appears stable. The landowner has affected a portion, approximately 2 acres, of the revegetated area outside of the area zoned for industrial/commercial use that the permittee had revegetated. This disturbance is not associated with the mining and reclamation operation. Also, the landowner is currently using the area zoned for industrial/commercial for such use. Therefore the release request of the permit will be approved. Notice of the Division's decision regarding the release request will be sent under a separate cover letter.

Photo 10: Yellow dashed line is the approximate boundary of industrial and revegetated areas, red dashed line indicates landowner disturbance

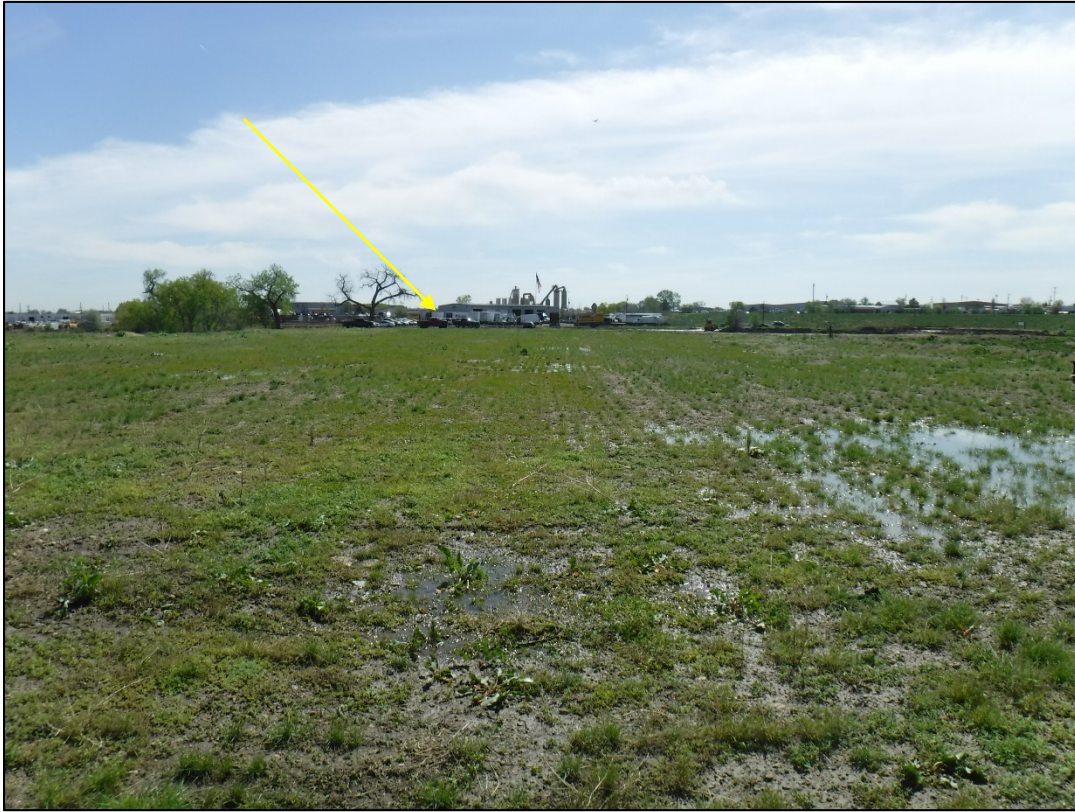
Photo 11: Looking east towards passenger vehicle parking (yellow arrow)

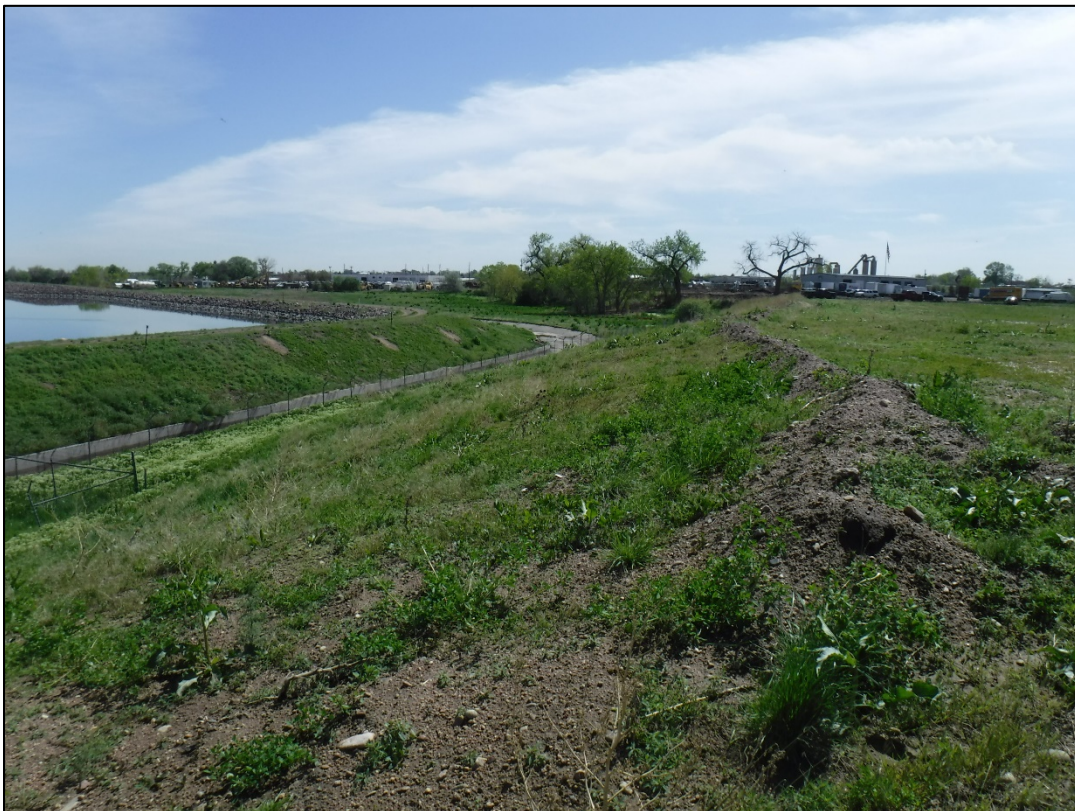
Photo 12: Typical side slope vegetative cover

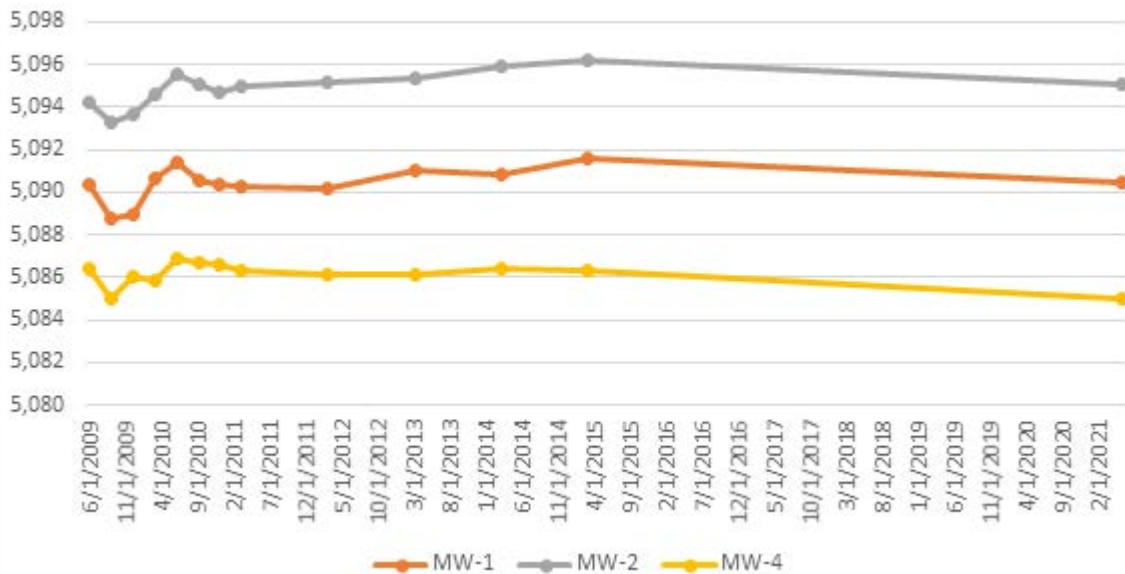
Groundwater Elevations (ft AMSL)

The mining permit was approved with a stipulation that groundwater level measurements be taken for a period of two years following completion of reclamation to ensure that groundwater mounding was not occurring to protect surrounding structures. Groundwater level measurements supplied by the operator, attachment 2, indicate there is no groundwater mounding occurring at the site.
