**MINERALS PROGRAM INSPECTION REPORT**  
**PHONE: (303) 866-3567**

<b>MINE NAME:</b> Lombard #4+5	<b>MINE/PROSPECTING ID#:</b> M-2018-012	<b>MINERAL:</b> Gold and silver	<b>COUNTY:</b> Clear Creek
<b>INSPECTION TYPE:</b> Monitoring	<b>INSPECTOR(S):</b> Peter Hays	<b>INSP. DATE:</b> June 9, 2021	<b>INSP. TIME:</b> 11:00
<b>OPERATOR:</b> Jeff Carter	<b>OPERATOR REPRESENTATIVE:</b> Jeff Carter	<b>TYPE OF OPERATION:</b> 110(1) - Hard Rock Limited Impact

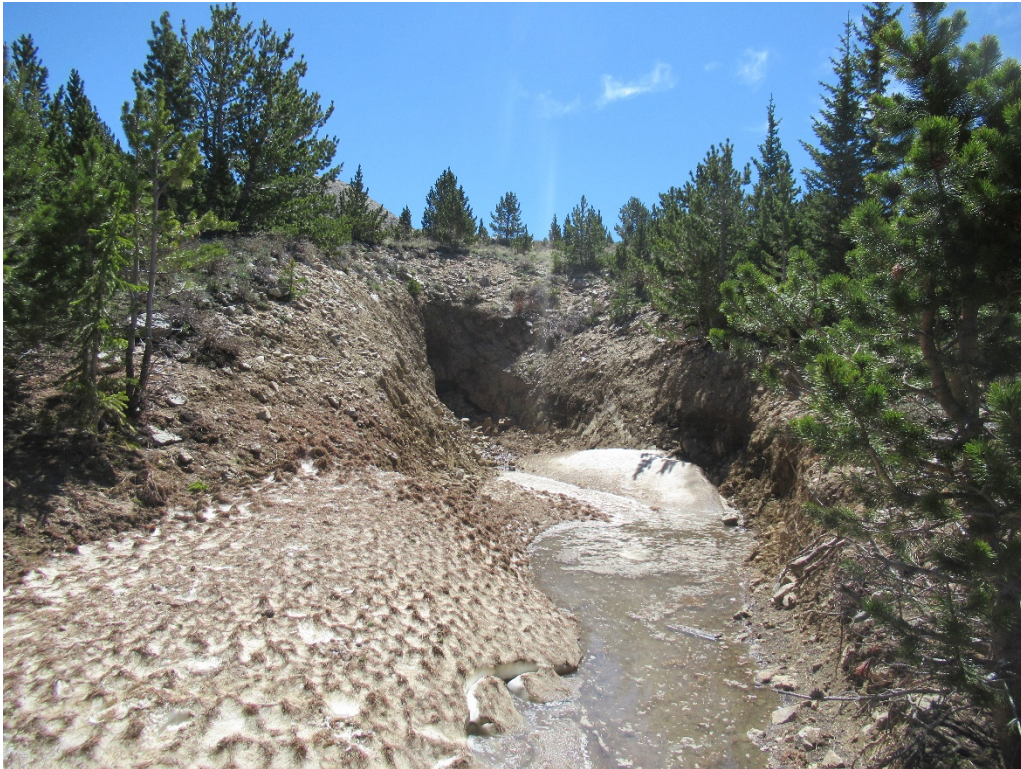
The lower adit has been excavated by the Operator. The adit excavation was estimate at a maximum height of 12 feet. The adit excavation material was used to create a pad estimated to be 60 feet x 70 feet x 2 feet in depth for an estimated volume of 311 cubic yards. The adit opening was secured with steel angle iron and chain link fence. The side of the adit had opened slightly due to a rock fall event over the past winter. The Operator stated the opening would be backfilled or secured soon. The Operator stated approximately 10 5 gallon buckets of material have been removed from the lower adit for testing. The material was removed from the site. No new stockpiles were observed during the inspection. The upper adit has not been disturbed by the Operator.

View of the excavated lower adit

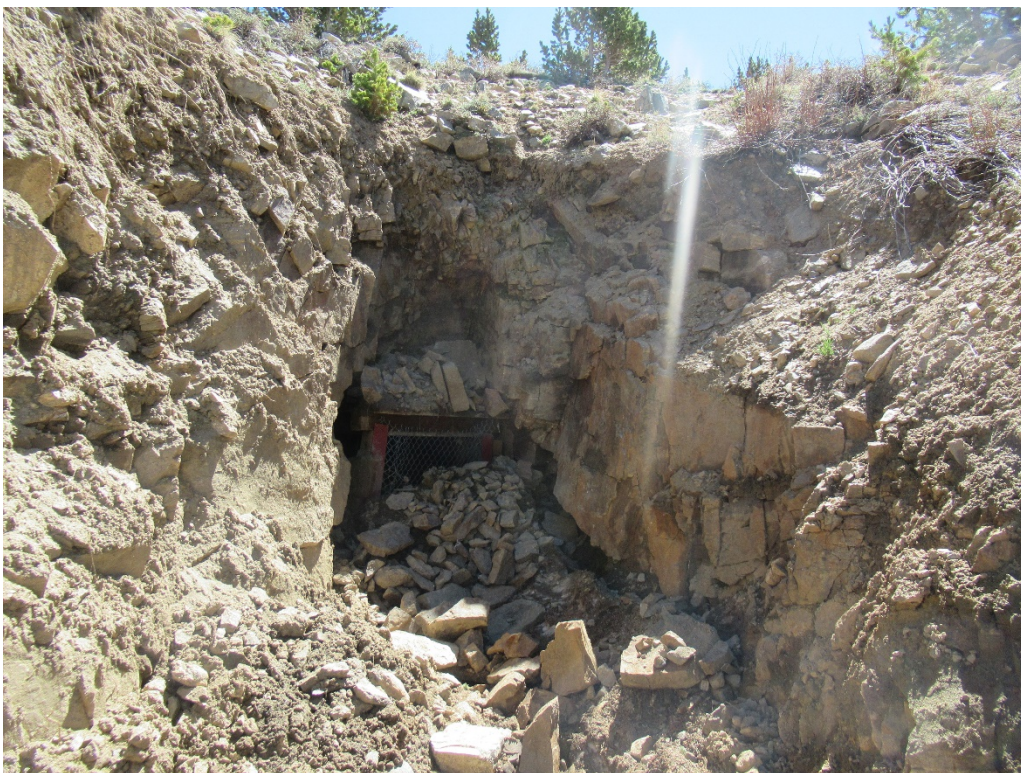
View of the lower adit closure and rock fall event

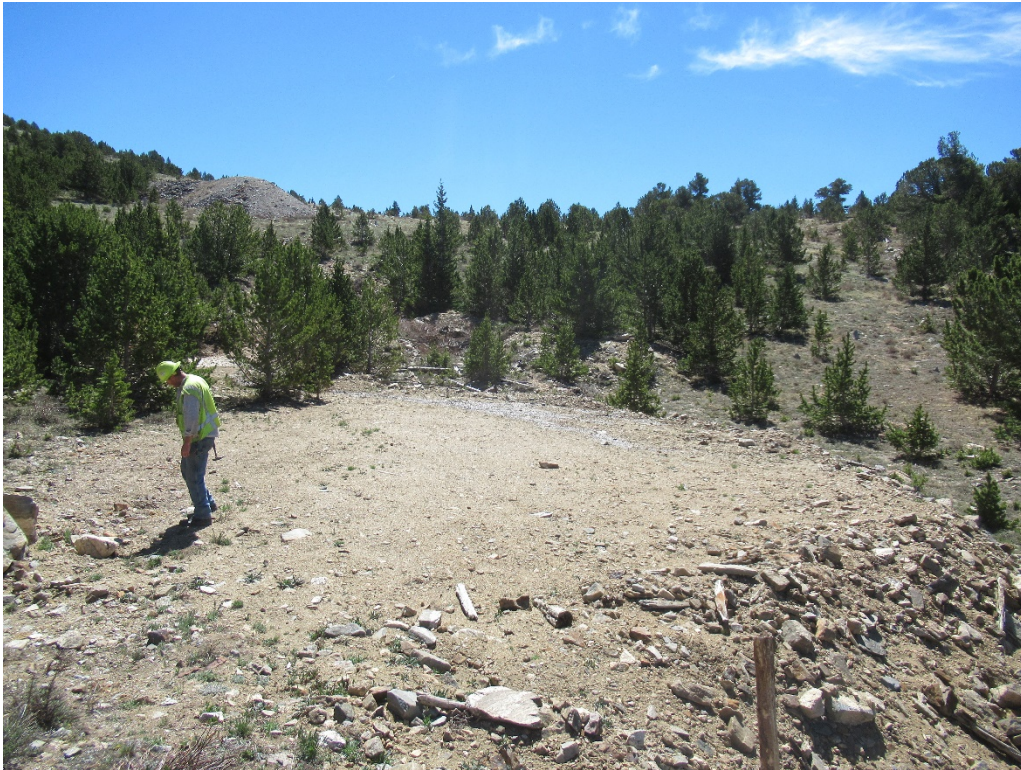
View of the lower adit waste rock pad from the northwest corner looking southeast

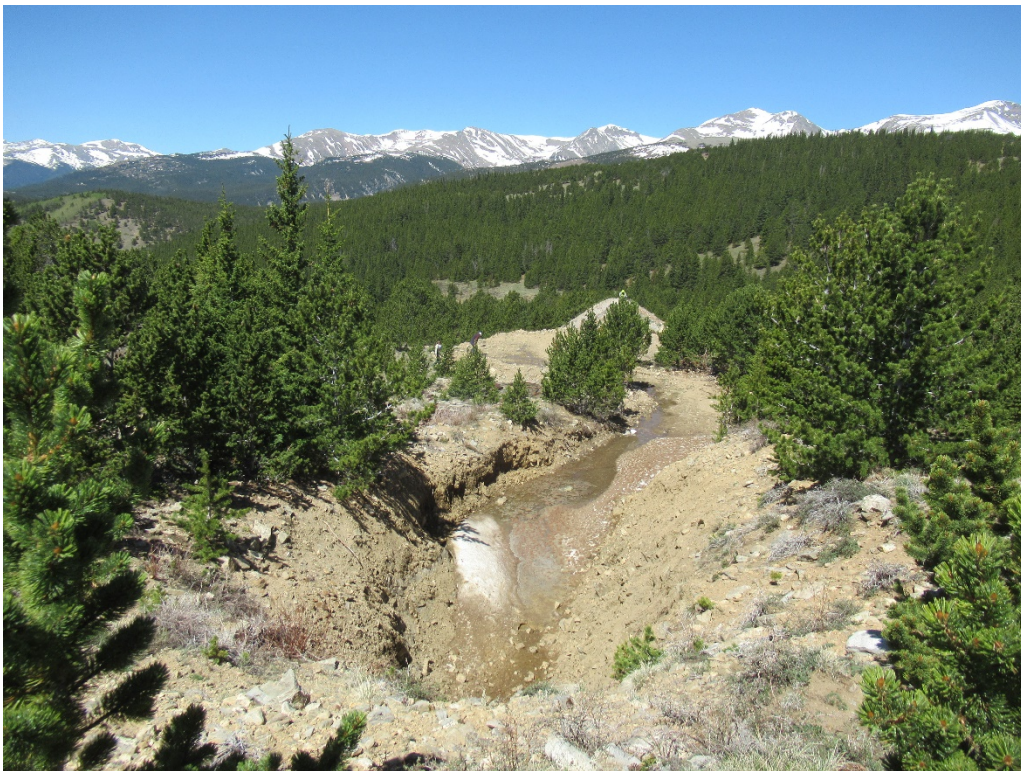
View from above the lower adit of the excavation and pad area

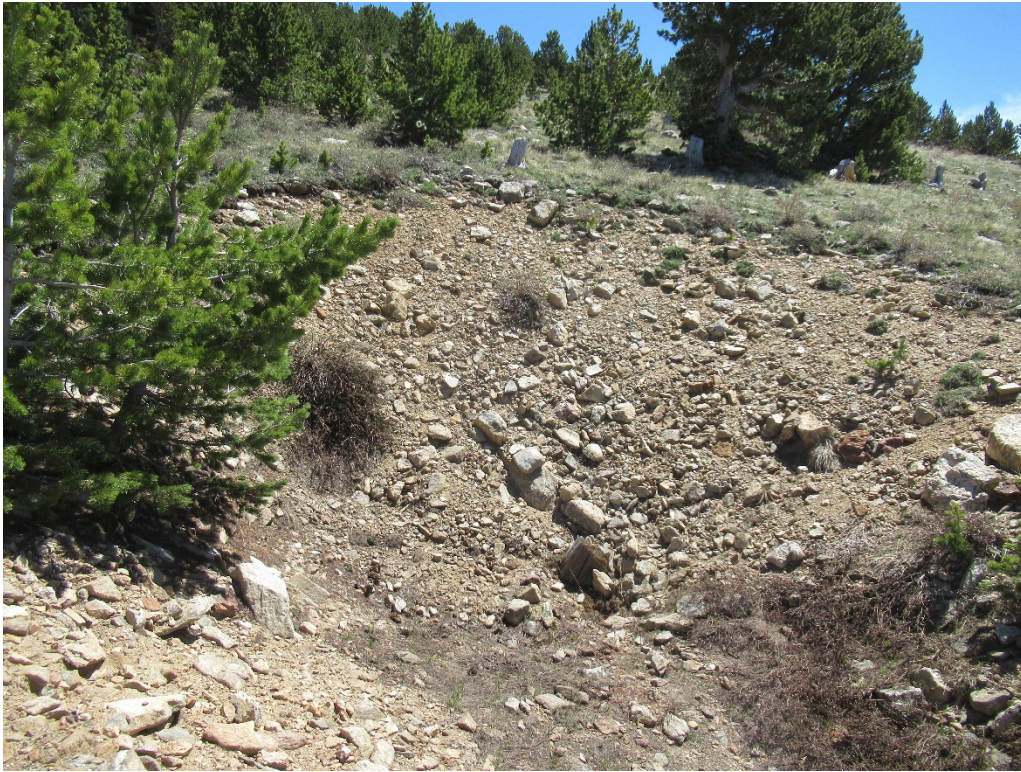
View of the collapsed upper adit

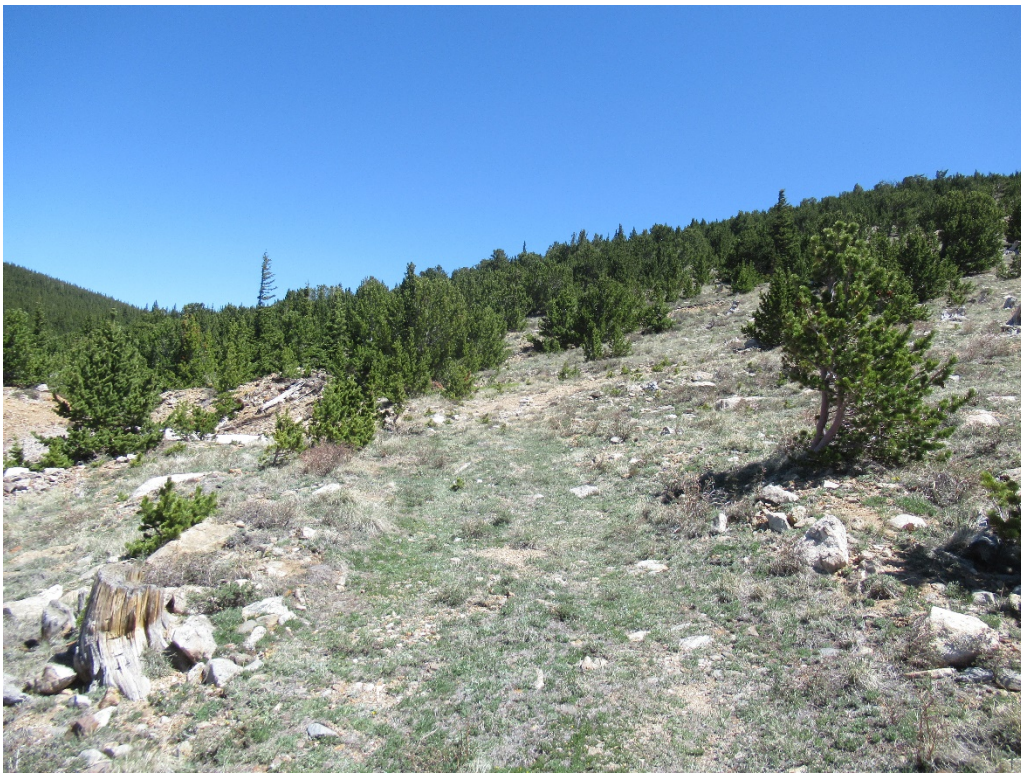
View of the road to the upper adit from the USFS road
