MINERALS PROGRAM INSPECTION REPORT
PHONE: (303) 866-3567

MINE NAME: Lombard #3	MINE/PROSPECTING ID#: M-2020-057	MINERAL: Silver and gold	COUNTY: Clear Creek
INSPECTION TYPE: Pre-Operation Inspection	INSPECTOR(S): Peter Hays	INSP. DATE: June 9, 2021	INSP. TIME: 10:00
OPERATOR: SSG Mining	OPERATOR REPRESENTATIVE: Jeff Carter	TYPE OF OPERATION: 110(1) - Hard Rock Limited Impact	
REASON FOR INSPECTION: Pre-Operation Inspection	BOND CALCULATION TYPE: None	BOND AMOUNT: No Bond Held	
DATE OF COMPLAINT: NA	POST INSP. CONTACTS: None	JOINT INSP. AGENCY: U.S. Forest Service	
WEATHER: Clear	INSPECTOR'S SIGNATURE:

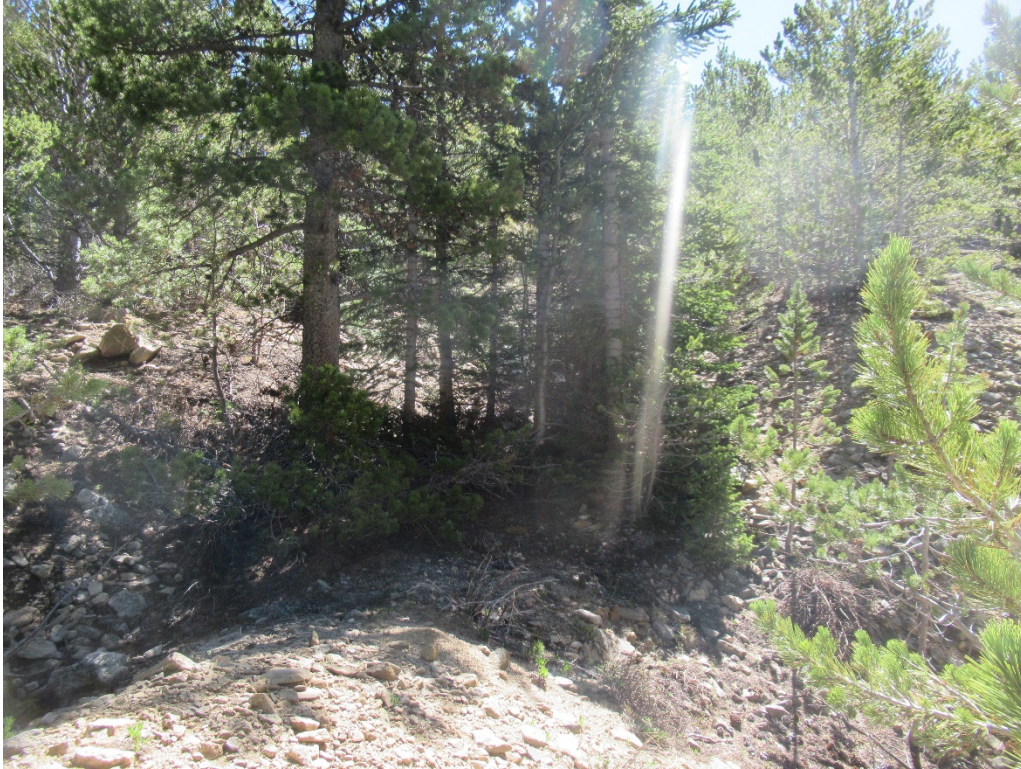
View of the collapsed Lombard #3 adit

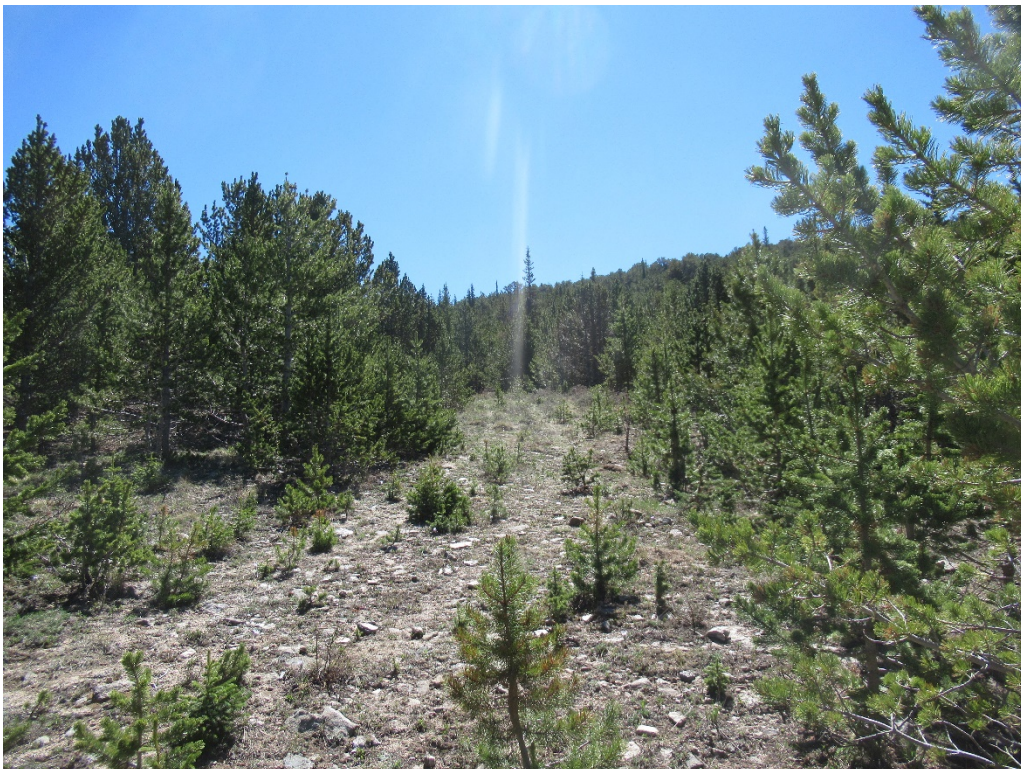
View of the access road from Cumberland Gulch Road to the Lombard #3 adit
