MINERALS PROGRAM INSPECTION REPORT
PHONE: (303) 866-3567

MINE NAME: Ace in the Hole- CMC284074	MINE/PROSPECTING ID#: M-2013-056	MINERAL: Gemstones	COUNTY: Teller
INSPECTION TYPE: Surety Release Inspection	INSPECTOR(S): Elliott Russell	INSP. DATE: May 20, 2021	INSP. TIME: 10:00
OPERATOR: Richard Fretterd	OPERATOR REPRESENTATIVE: Jean Cowman	TYPE OF OPERATION: 110(2) - Hard Rock Limited Impact	
REASON FOR INSPECTION: Surety Release Requested	BOND CALCULATION TYPE: None	BOND AMOUNT: \$3,900.00	
DATE OF COMPLAINT: NA	POST INSP. CONTACTS: U.S. Forest Service	JOINT INSP. AGENCY: U.S. Forest Service	
WEATHER: Clear	INSPECTOR'S SIGNATURE:

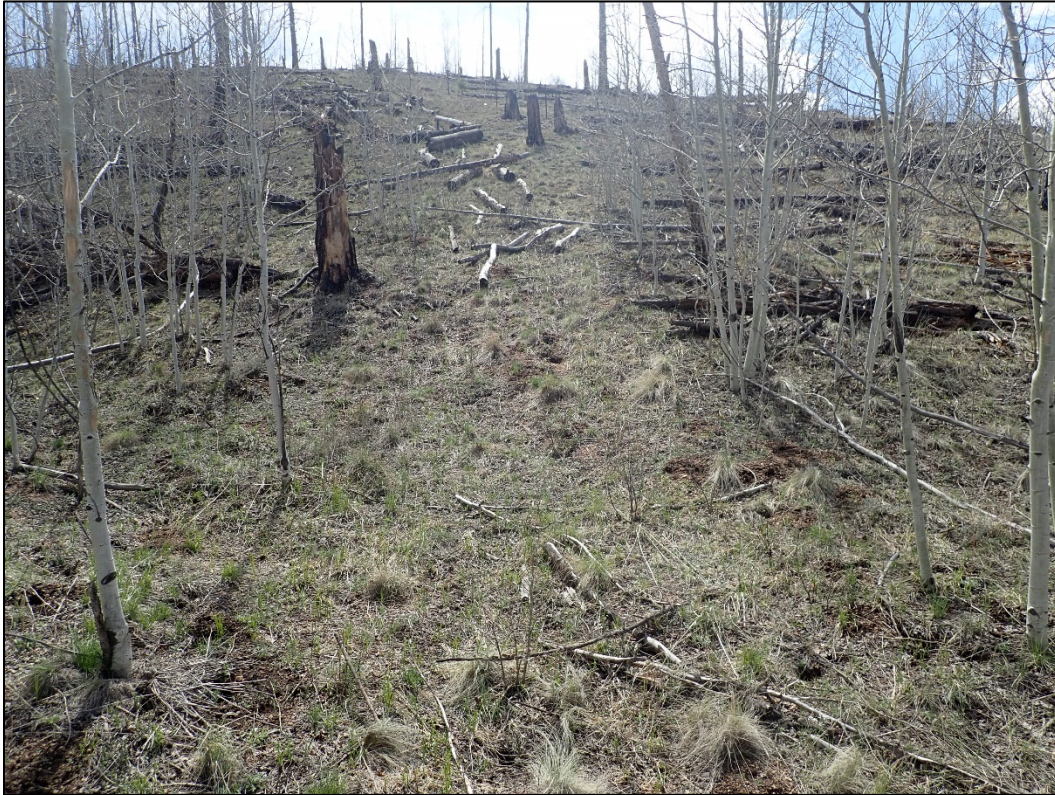
Photo 1. Reclaimed access road; looking north.

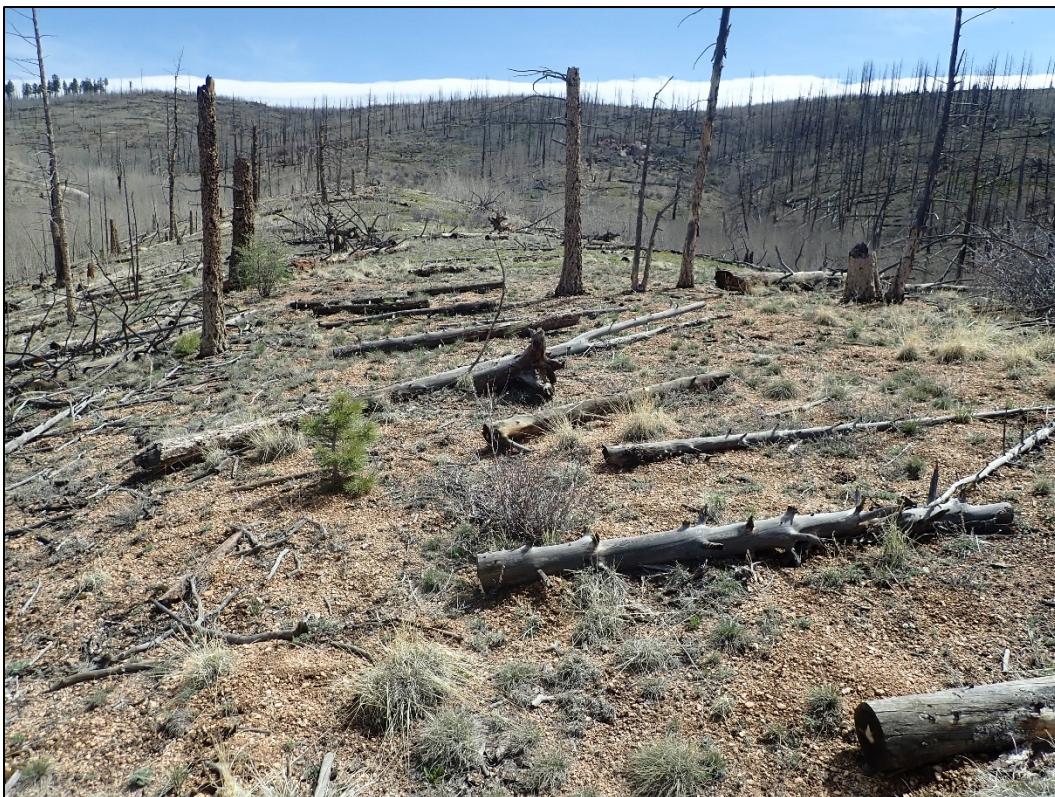
Photo 2. Reclaimed access road; looking north.

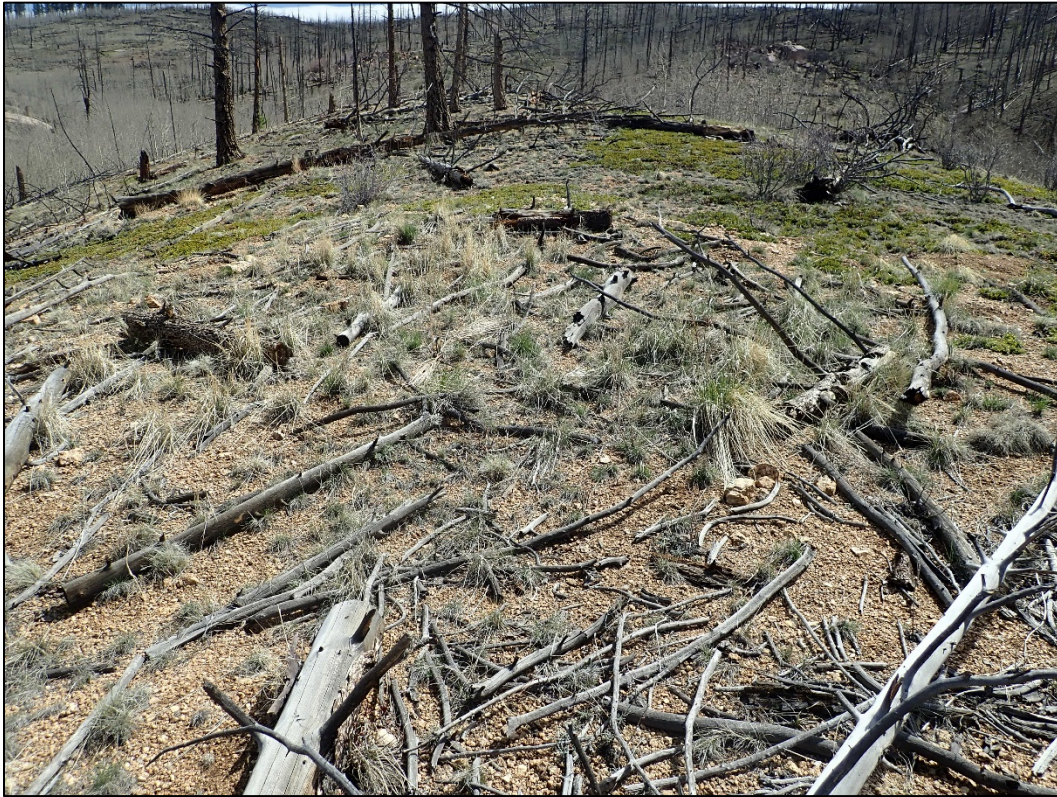
Photo 3. Reclaimed dig site; looking north.

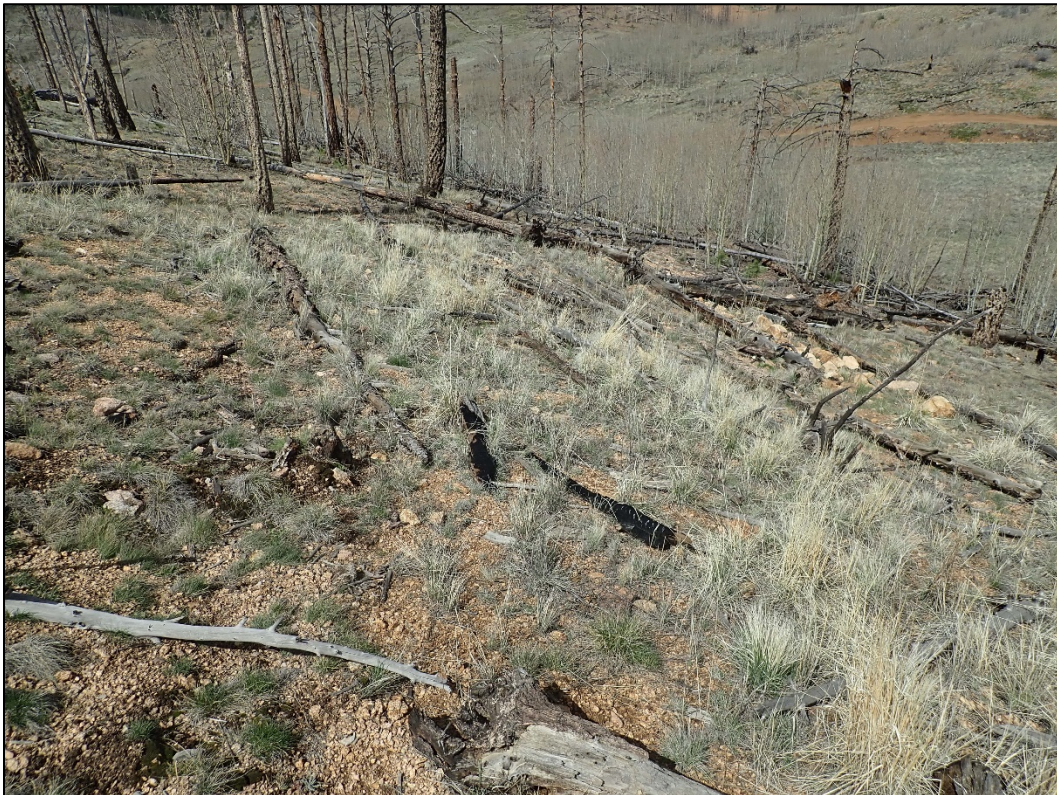
Photo 4. Reclaimed dig site; looking southwest.

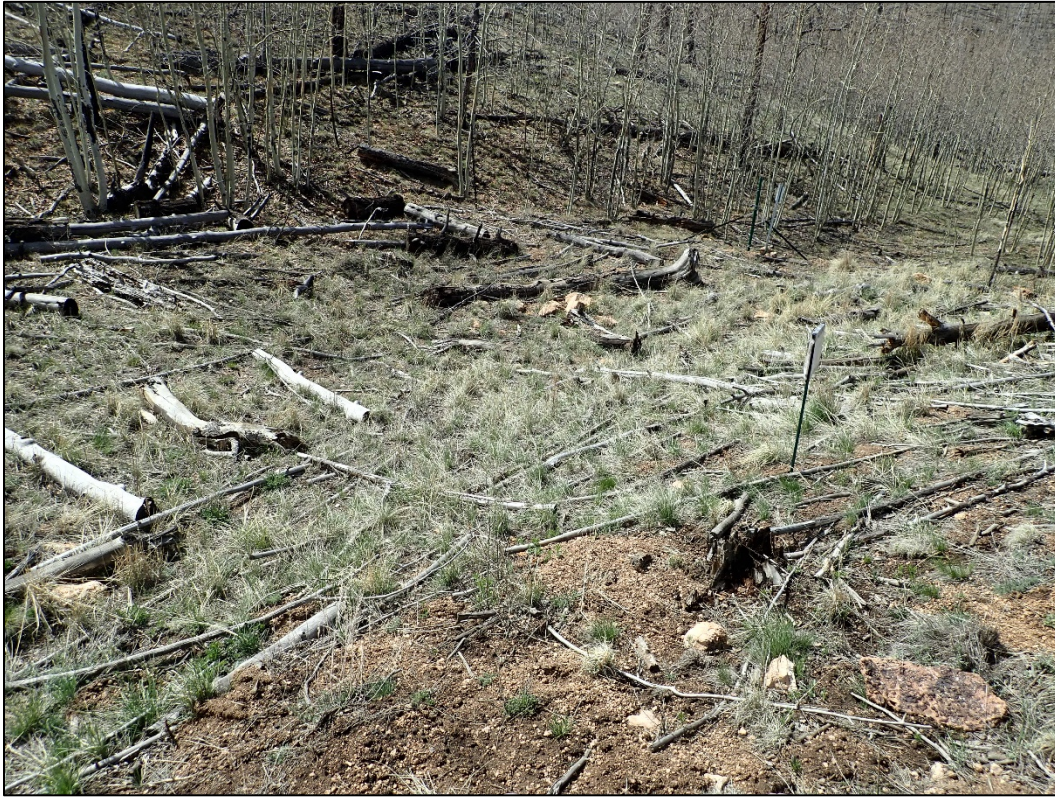
Photo 5. Reclaimed dig site; looking south.
