**MINERALS PROGRAM INSPECTION REPORT**  
**PHONE: (303) 866-3567**

<b>MINE NAME:</b> Lyster Pit	<b>MINE/PROSPECTING ID#:</b> M-2008-009	<b>MINERAL:</b> Sand and gravel	<b>COUNTY:</b> Moffat
<b>INSPECTION TYPE:</b> Surety-Related Inspection	<b>INSPECTOR(S):</b> Clayton Wein	<b>INSP. DATE:</b> June 2, 2021	<b>INSP. TIME:</b> 12:00
<b>OPERATOR:</b> Oldcastle SW Group, Inc. dba United Compai	<b>OPERATOR REPRESENTATIVE:</b> Jason Burkey, Tyra Bartuska	<b>TYPE OF OPERATION:</b> 112c - Construction Regular Operation	
<b>REASON FOR INSPECTION:</b> Normal I&E Program	<b>BOND CALCULATION TYPE:</b>	<b>BOND AMOUNT:</b> \$214,270.00	
<b>DATE OF COMPLAINT:</b> NA	<b>POST INSP. CONTACTS:</b> None	<b>JOINT INSP. AGENCY:</b> None	
<b>WEATHER:</b> Clear	<b>INSPECTOR'S SIGNATURE:</b> <i>Clayton Wein</i>	<b>SIGNATURE DATE:</b> June 18, 2021

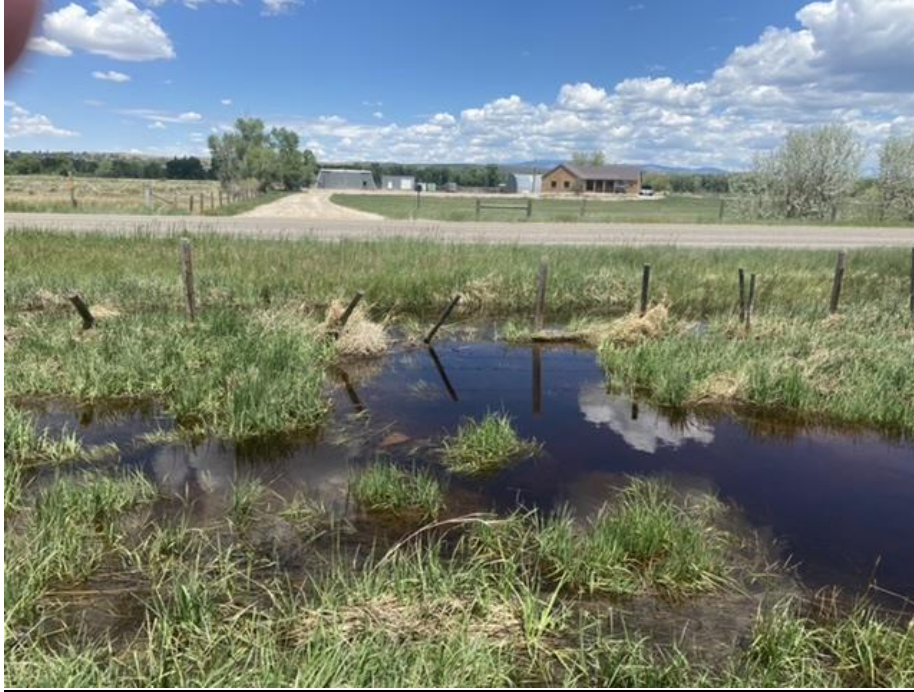
**Photo 1:** The outlet of the east ditch intersecting with the ditch paralleling State Highway 394.

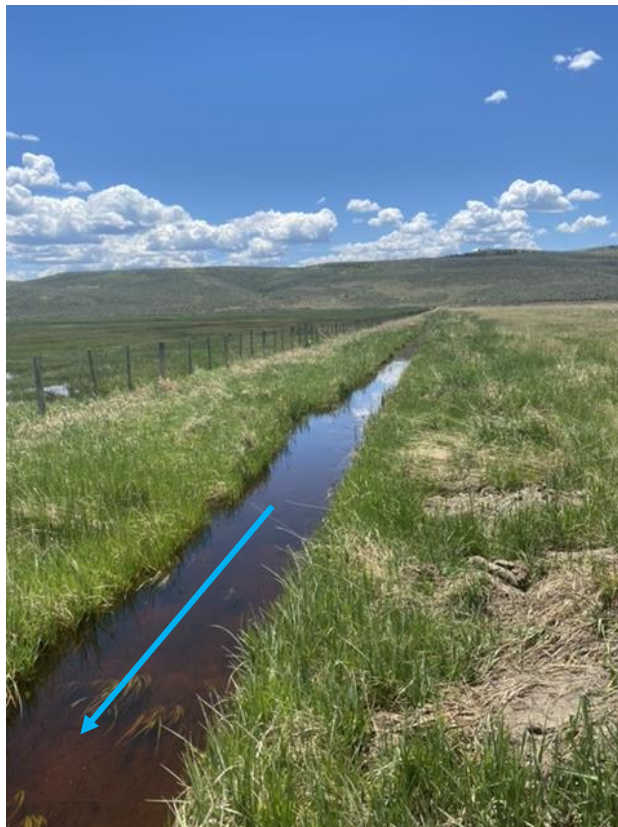
During the inspection, the east ditch was inspected. On December 7, 2020, Technical Revision No. 3 was approved. The revision incorporated United's commitment to clean the east ditch during the spring of 2021. Maintenance was conducted on the east ditch in April of 2021. At the time of the inspection the east ditch was holding and transporting water to the outlet located at the northeastern permit boundary (Photo 1). The ditch was cleaned and there were no blockages observed (Photo 2). Vegetation around and within the ditch had been cleared. The east ditch was created prior to mining operations, when the parcel was split into two. During the Division's review of TR-3, data from United's groundwater wells was reviewed. The Division determined from the data that natural conditions at the northeast corner of the permit area show a high groundwater table. The data showed that the level of the groundwater table can be at or near the surface during some seasons. Site conditions during this inspection reflect the data reviewed by the Division. Exposed groundwater was observed to be ponded at the northeast corner of the permit area (Photo 3). Exposed groundwater continued south along the permit boundary. The water was noted to be within both the Lyster Pit's permit area, as well as, the adjacent landowner's property to the east of the mine. Data reviewed by the Division indicates that the natural flow within the groundwater table is to the northwest. The exposed groundwater observed during the inspection is received from up-gradient flow off-site.

**Photo 2:** The east ditch. Flow is indicated in the photo by the blue arrow.

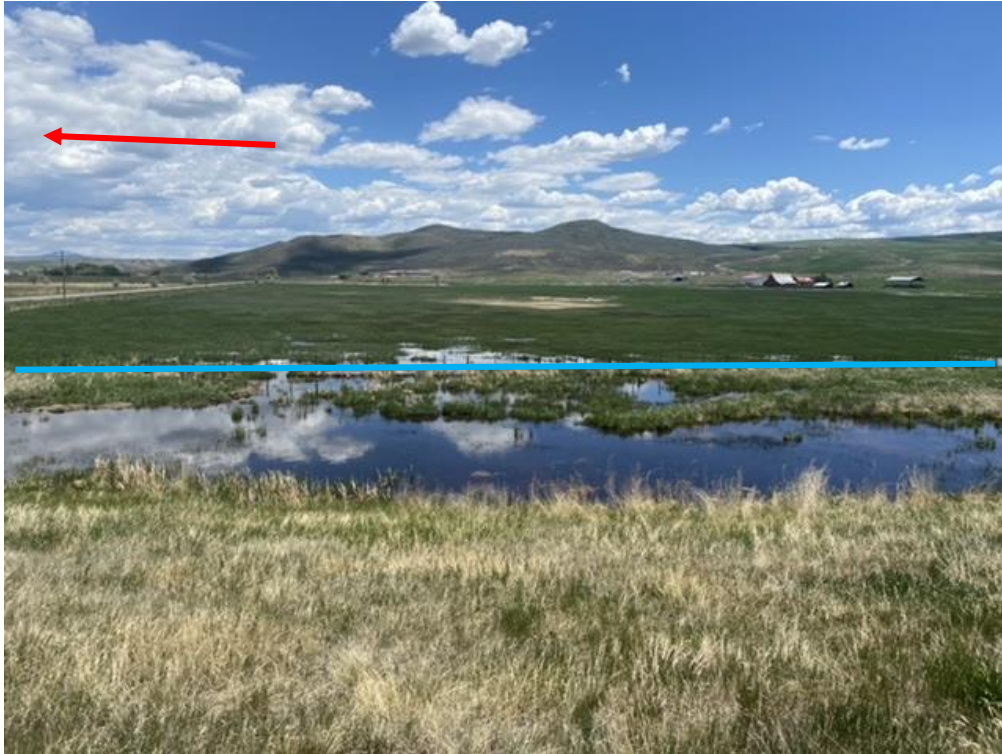
**Photo 3:** The ponded water located on the eastern permit boundary. The boundary is indicated by the blue line in the photo. North is indicated by the red arrow in the photo.

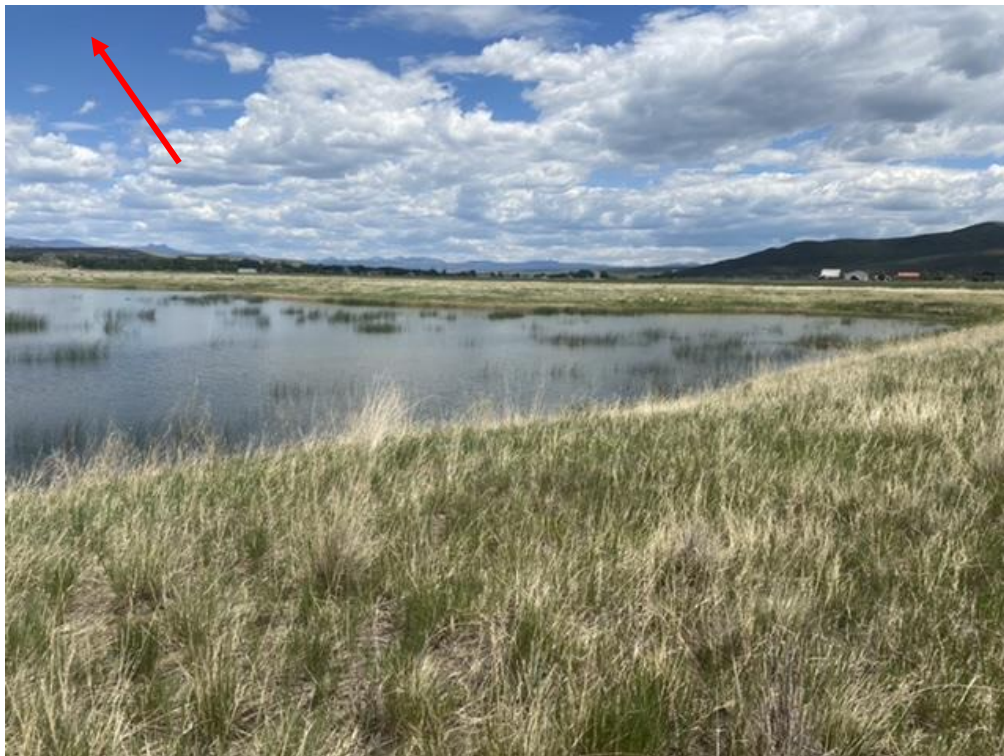
**Photo 4:** The eastern portion of the permanent pond. The red arrow in the photo indicates north.

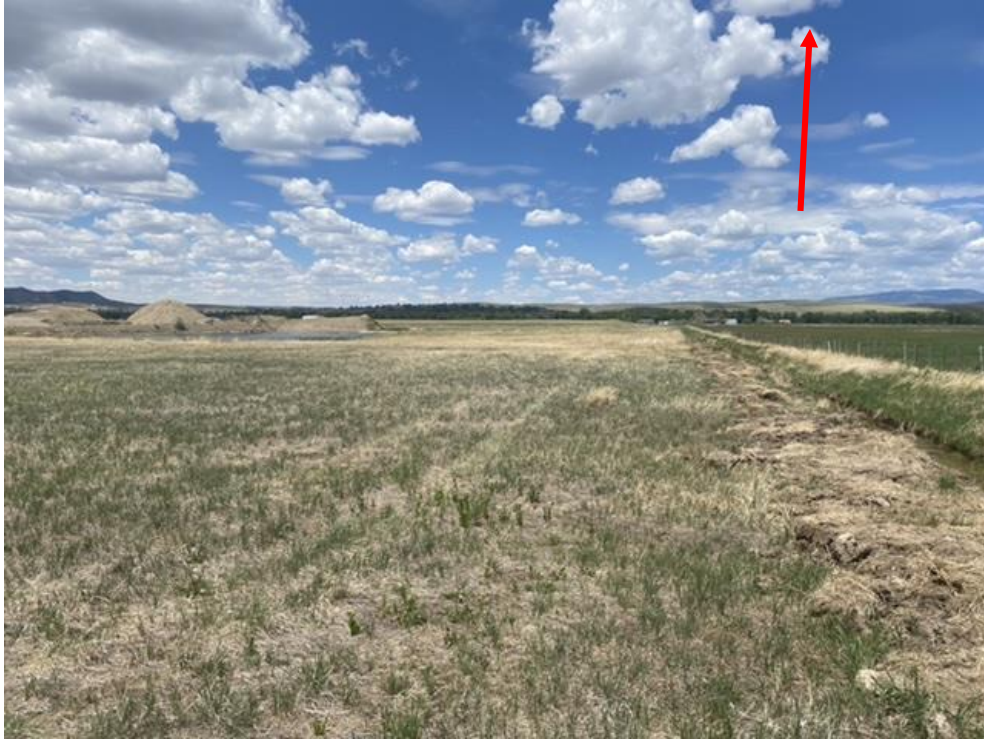
**Photo 5:** The eastern portion of the reclaimed area. The east ditch is located on the right side of the photo. The red arrow indicates north.

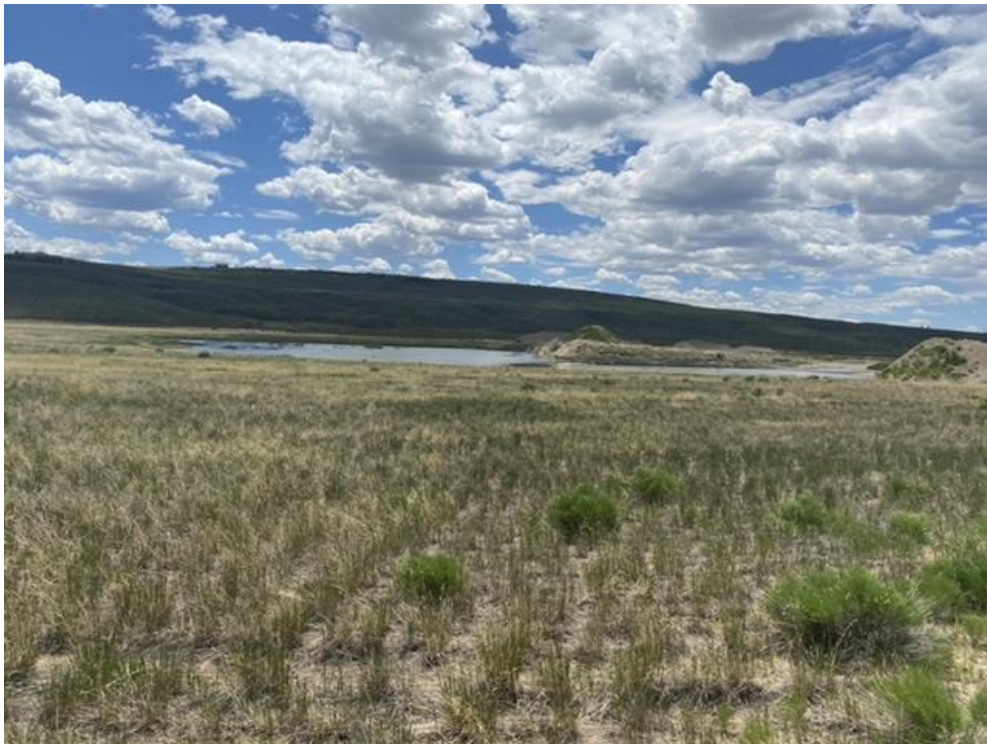
**Photo 6:** The northern portion of the reclaimed area looking to the south towards the pond.
