MINERALS PROGRAM INSPECTION REPORT
PHONE: (303) 866-3567

MINE NAME: Builders Ag. Pit	MINE/PROSPECTING ID#: M-1981-112	MINERAL: Sand and gravel	COUNTY: Morgan
INSPECTION TYPE: Monitoring	INSPECTOR(S): Brock Bowles	INSP. DATE: March 19, 2021	INSP. TIME: 12:00
OPERATOR: Builder's Aggregate, Inc.	OPERATOR REPRESENTATIVE: James Miner	TYPE OF OPERATION: 112c - Construction Regular Operation	
REASON FOR INSPECTION: Normal I&E Program		BOND CALCULATION TYPE:	BOND AMOUNT: \$25,500.00
DATE OF COMPLAINT: NA		POST INSP. CONTACTS: None	JOINT INSP. AGENCY: None
WEATHER: Clear	INSPECTOR'S SIGNATURE:

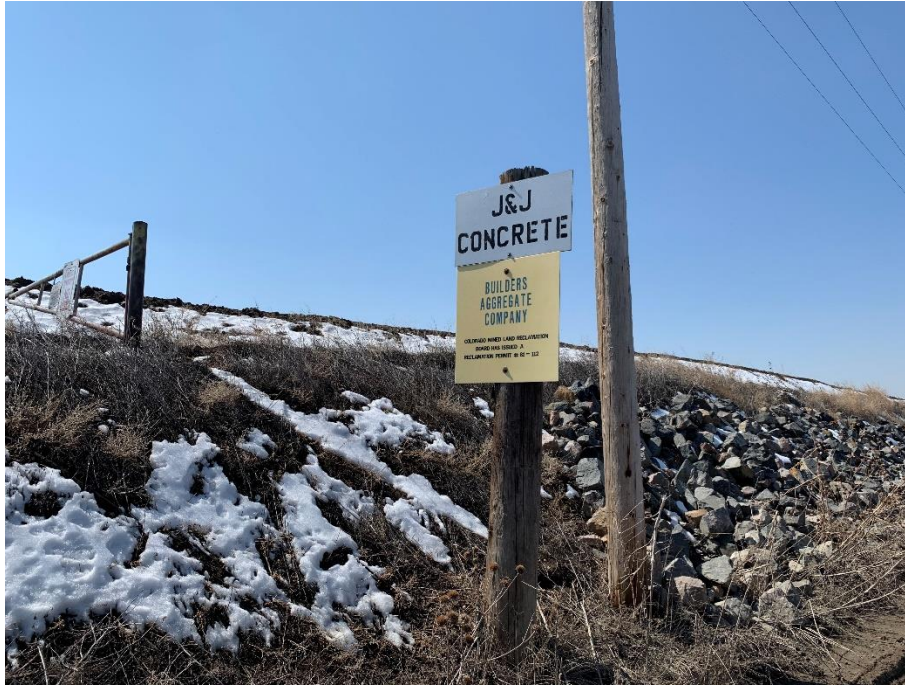
The mine entrance identification sign was in place and was legible (photo 1). The southwest permit boundary corner was marked with a t-post marker. The other corner post were inaccessible due to the muddy conditions. No mining activity was being conducted at the time of the inspection.

Photo 1 – Mine entrance sign

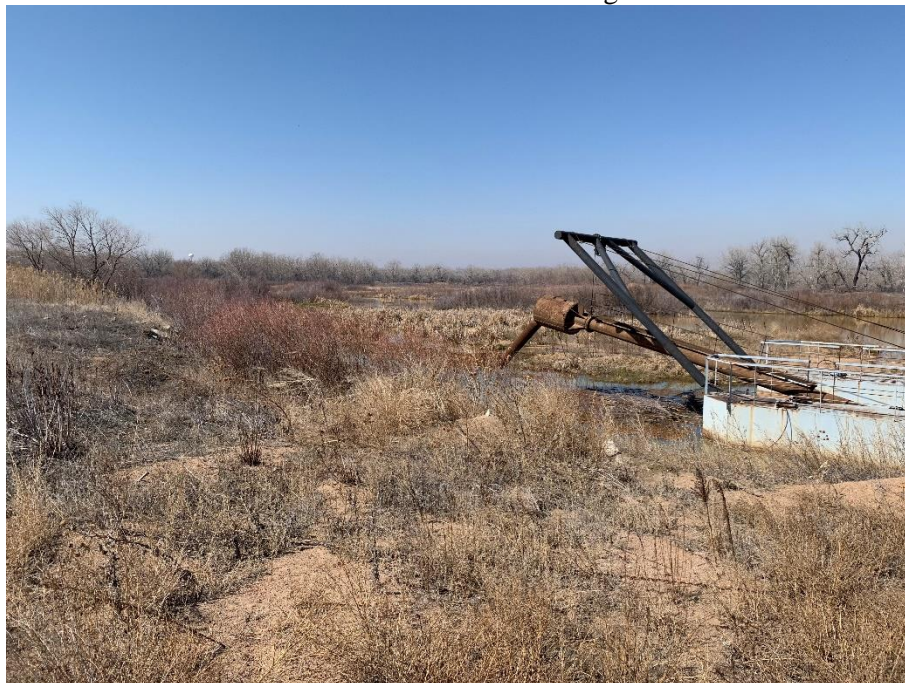
Photo 2- Side channel on the west side of the permit area

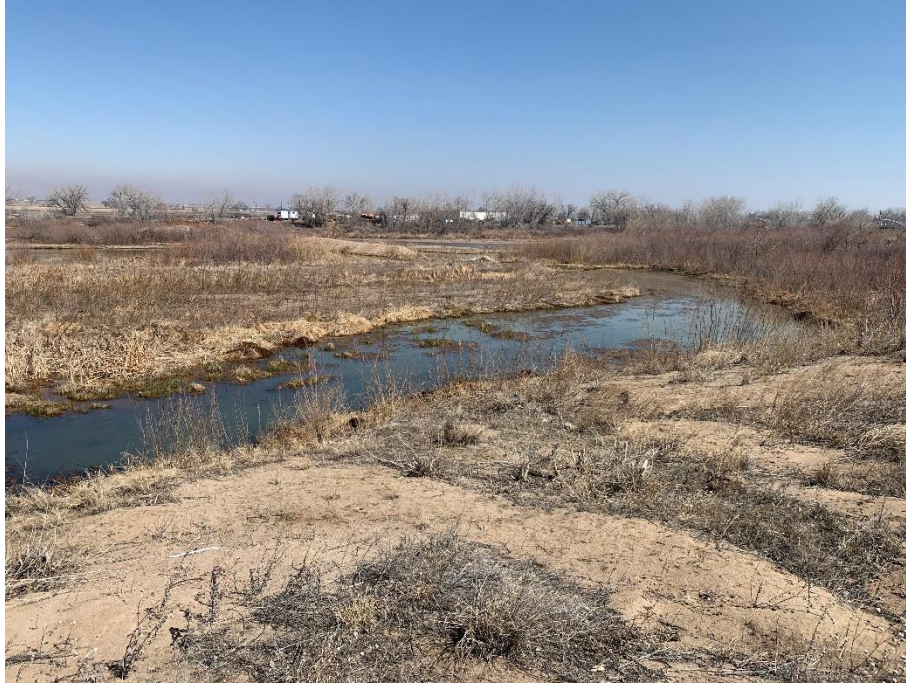
Photo 3 – Side channel on the east side of the permit area before it meets up with the Main channel, picture facing northeast

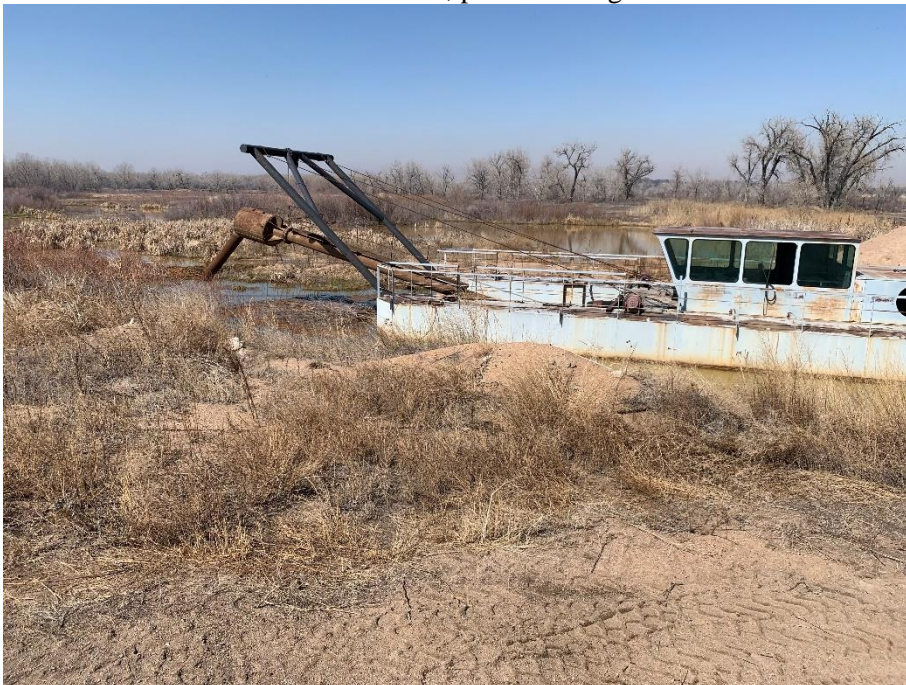
PROBLEM/POSSIBLE VIOLATION: Problem: Mining at the Builder's Aggregate Pit has been complete for over five years and the Operator has failed to complete reclamation. Rule 3.1.3 states that all reclamation shall be carried to completion within 5 years from the date the operator informs the Division that mining is complete.

The mining plan approved a small pond to be installed on the south flood plain, adjacent to the Platte River, and to use a floating dredge in the pond to excavate material. The land in the permit area was significantly changed during the Flood of 2013. The approved dredge pond no longer exists and it does not appear there has been an attempt to repair it. The permit area now consists of a side channel of the Platte River that meanders through the area and back to the main river channel (photos 2 & 3). This side channel varies in width, is lined with vegetation, contains several beaver dams, and has formed a wetland area just before it re-joins the main channel (photo 3). The suction dredge is anchored to the shore line with chains and is floating in the side channel running through the area (photos 4 & 5).

Photo 4 – Front section of floating dredge

CORRECTIVE ACTIONS: The Division requires the Operator to submit a Reclamation Schedule by July 31, 2021. The Reclamation Schedule will provide a timeline for completion of the remaining reclamation task: remove the floating dredge.

- **Date by which the floating dredge will be removed from the permitted area.**

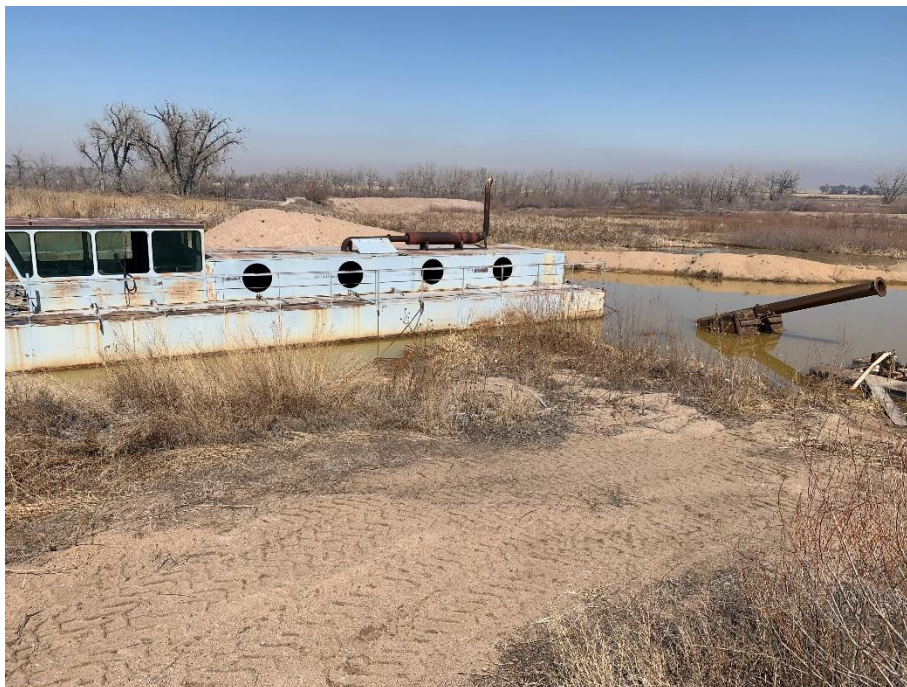
Photo 5 – Back section of floating dredge, picture facing north
