MINERALS PROGRAM INSPECTION REPORT

MINE NAME: DPG Pit	MINE/PROSPECTING ID#: M-2019-028	MINERAL: Sand and gravel	COUNTY: Weld
INSPECTION TYPE: Monitoring	INSPECTOR(S): Peter Hays	INSP. DATE: May 26, 2021	INSP. TIME: 10:30
OPERATOR: J-2 Contracting Company	OPERATOR REPRESENTATIVE: Chris Leone, J.C. York	TYPE OF OPERATION: 112c - Construction Regular Operation	
REASON FOR INSPECTION: Normal I&E Program	BOND CALCULATION TYPE: None	BOND AMOUNT: \$984,566.00	
DATE OF COMPLAINT: NA	POST INSP. CONTACTS: None	JOINT INSP. AGENCY: None	
WEATHER: Clear	INSPECTOR'S SIGNATURE:

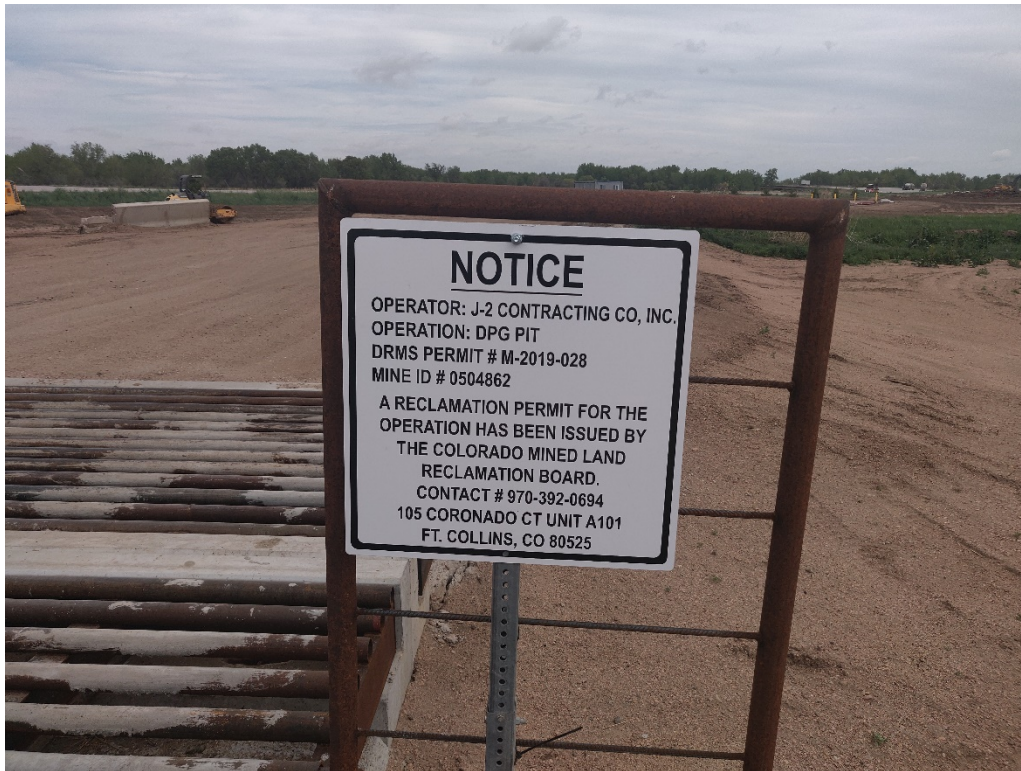
The required mine sign was observed and the site boundaries were delineated as required by Rule 3.1.12.

DPG Pit mine sign

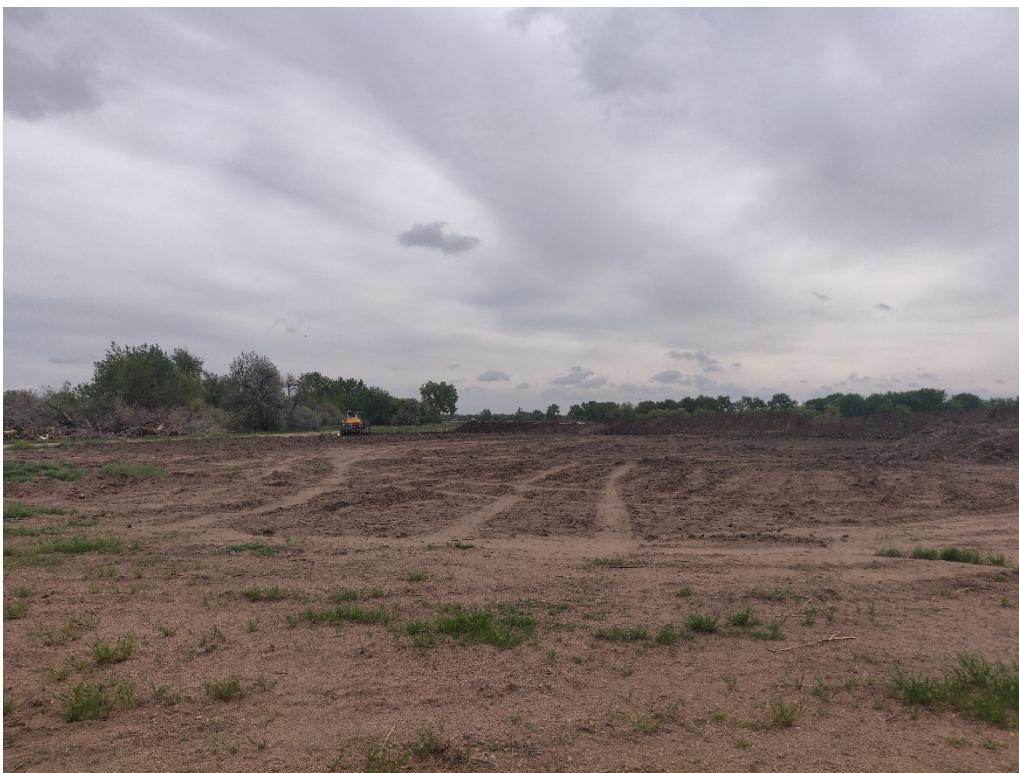
the perimeter of Phase 2 for the slurry wall installation by stripping the topsoil from the area. The stripped topsoil was stockpiled along the perimeter of the corridor. Additionally, the haul road through the revised Phase 4 and the equipment storage area located in the southwest corner of Phase 4 were stripped of topsoil. The stripped topsoil was stockpiled adjacent to these areas.

View of stripped equipment storage area in Phase 4 looking northeast from the southwest corner of the area

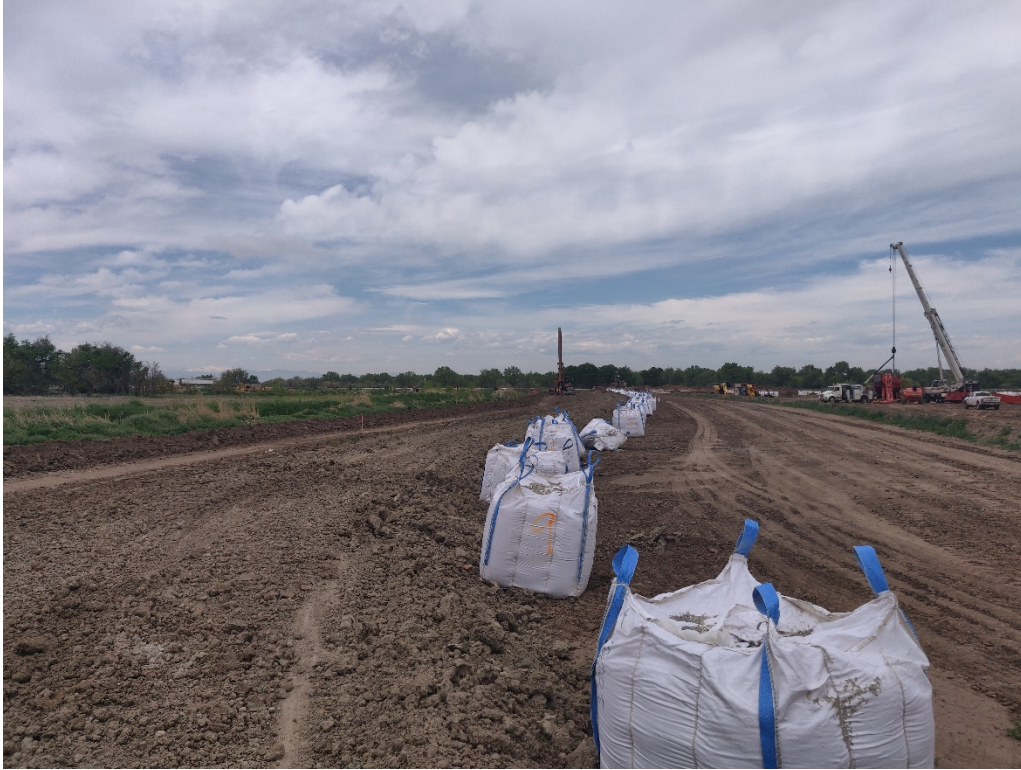
The approved post-mine land use for the site is developed water resource. The slurry wall installation was occurring during the inspection. The installation started on the north end of Phase 2 and was planned to proceed counter-clockwise around the Phase 2 and Phase 5. A 120 feet wide corridor was established around

View of the stripped 120' slurry wall installation corridor

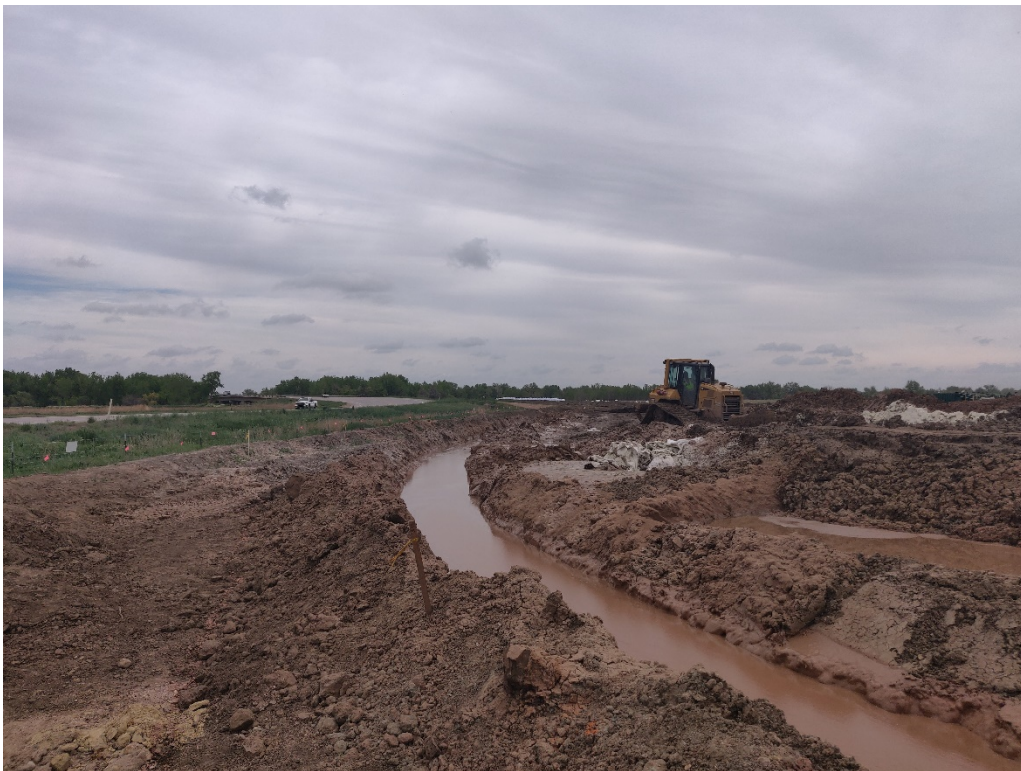
View of the slurry wall installation in the northwest corner of Phase 2
