**MINERALS PROGRAM INSPECTION REPORT**  
**PHONE: (303) 866-3567**

<b>MINE NAME:</b> Wellington Cattle Borrow Pit	<b>MINE/PROSPECTING ID#:</b> M-2021-025	<b>MINERAL:</b> Commod_Table	<b>COUNTY:</b> Teller
<b>INSPECTION TYPE:</b> Illegal(Unpermitted Operation)	<b>INSPECTOR(S):</b> Elliott Russell	<b>INSP. DATE:</b> May 20, 2021	<b>INSP. TIME:</b> 15:30
<b>OPERATOR:</b> Bruce Newell	<b>OPERATOR REPRESENTATIVE:</b> Bruce Newell	<b>TYPE OF OPERATION:</b> ILL - Illegal

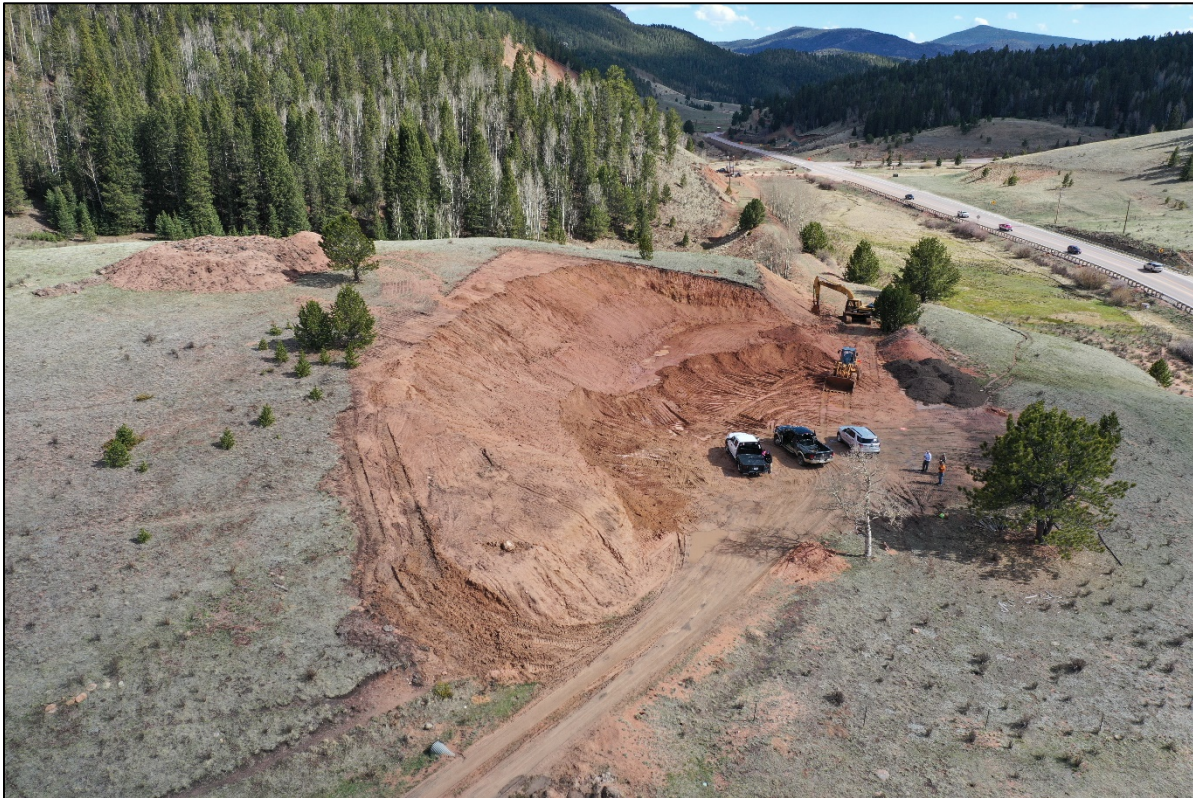
**Photo 1.** Overview of excavation area; looking south.

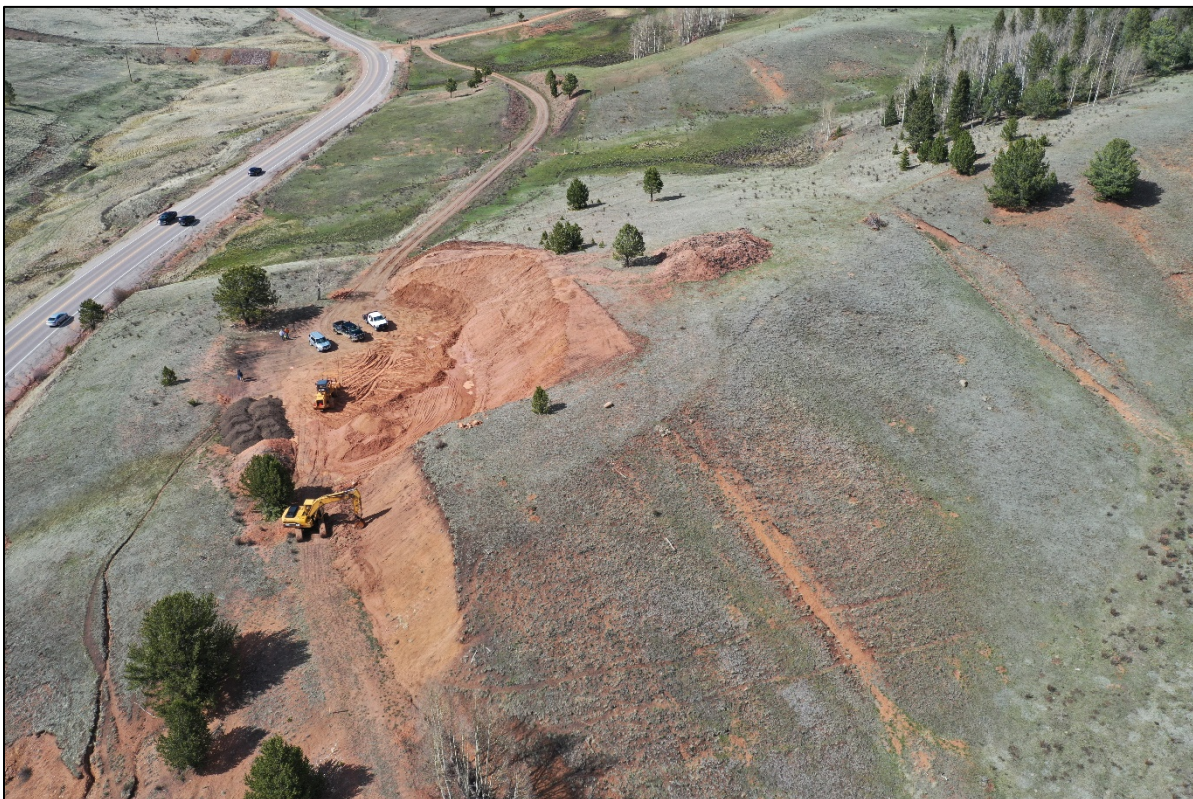
**Photo 2.** Overview of excavation area; looking north.

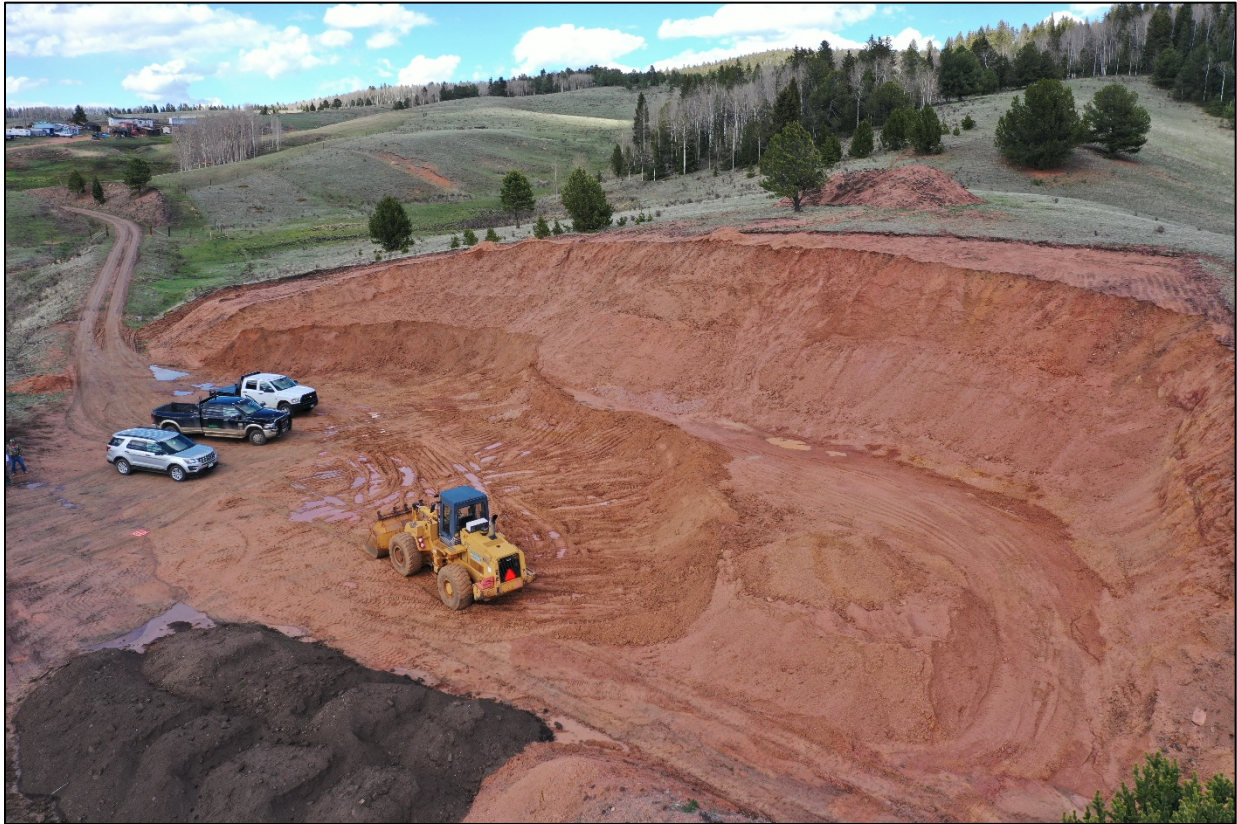
**Photo 3.** Excavation area; looking northeast.

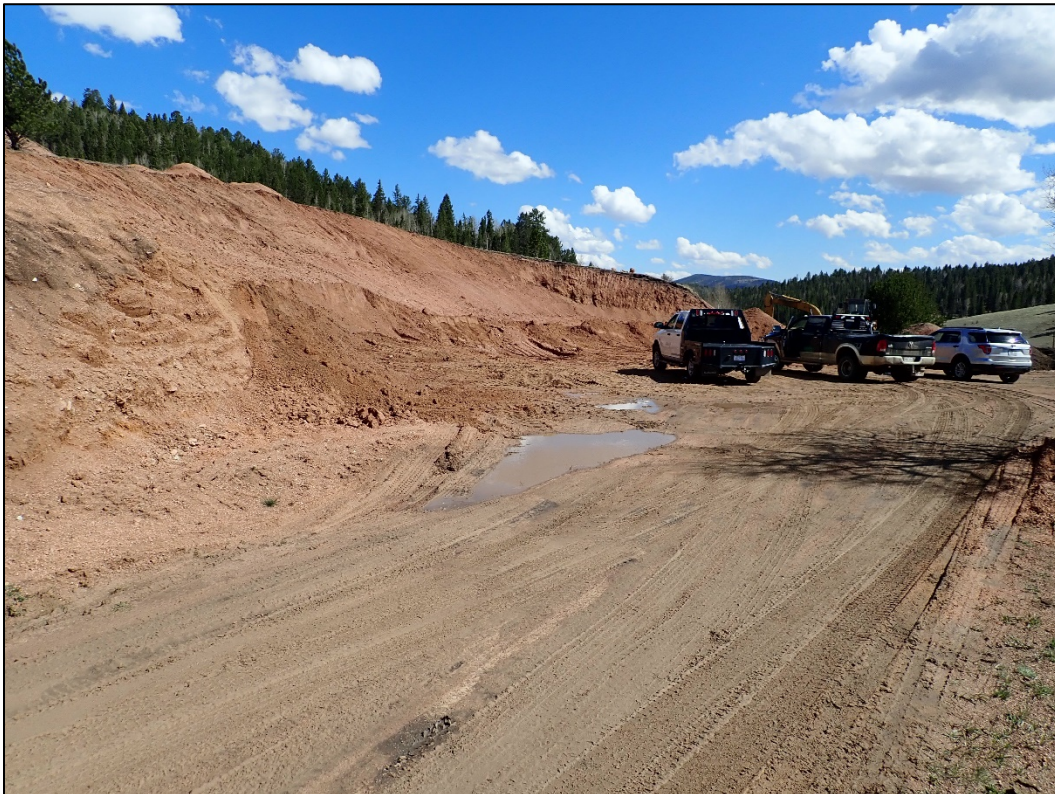
**Photo 4.** Excavation area; looking south.

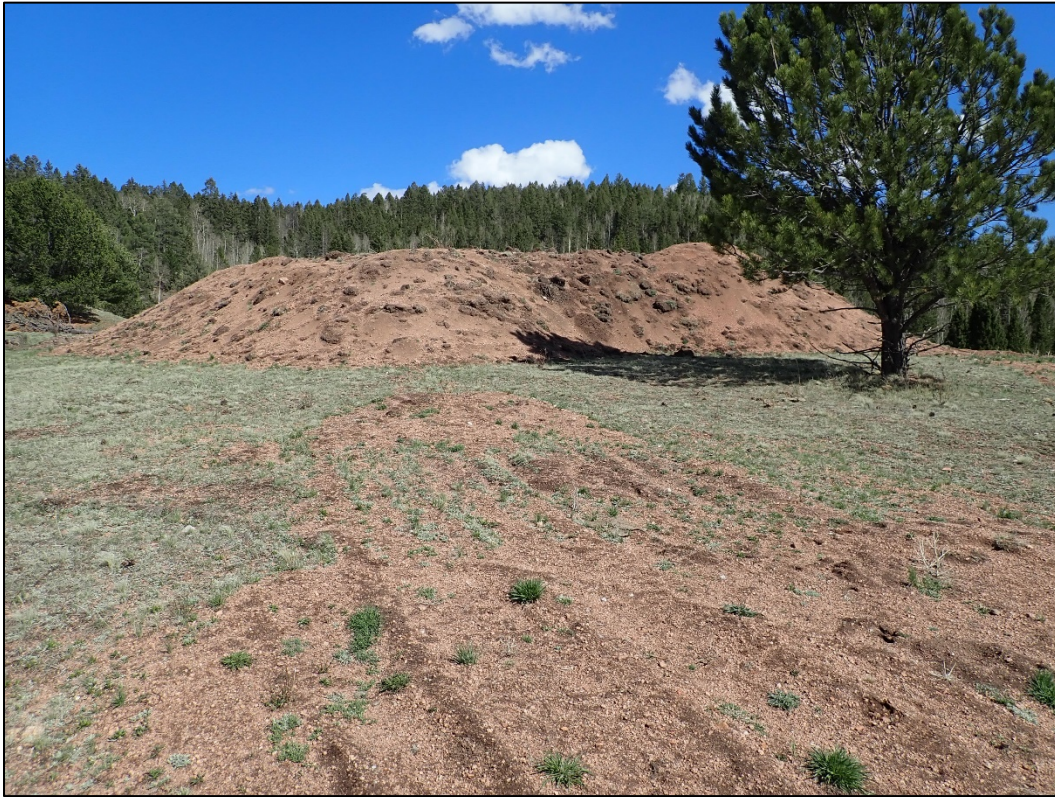
The site consisted of a single excavated area into a hill side and a large topsoil stockpile located above and east of the excavation. The eastern slope of the excavated material was approximately 20-25 feet high and was set at the angle of repose. One small stockpile of material and another of imported dark topsoil was located on the southwest portion of the disturbance. One excavator and one front-end loader were on site at the time of the inspection. The Division acquired GPS data with a Trimble Juno 3B and used Google Earth to determine the disturbance was approximately 0.92 acres in size. The Division has attached *DRMS 5-20-2021 Inspection Map M2021025* to this report which depicts the size of the disturbance area. The Division estimates the aerial extent of the excavated material that has been hauled off site is approximately 170 feet by 70 feet. The remainder of the disturbance consisted of areas that have been stripped of topsoil. Mr. Regester stated he puts pride into his

**Photo 5.** Topsoil stockpile located above and east of excavation; looking southeast.

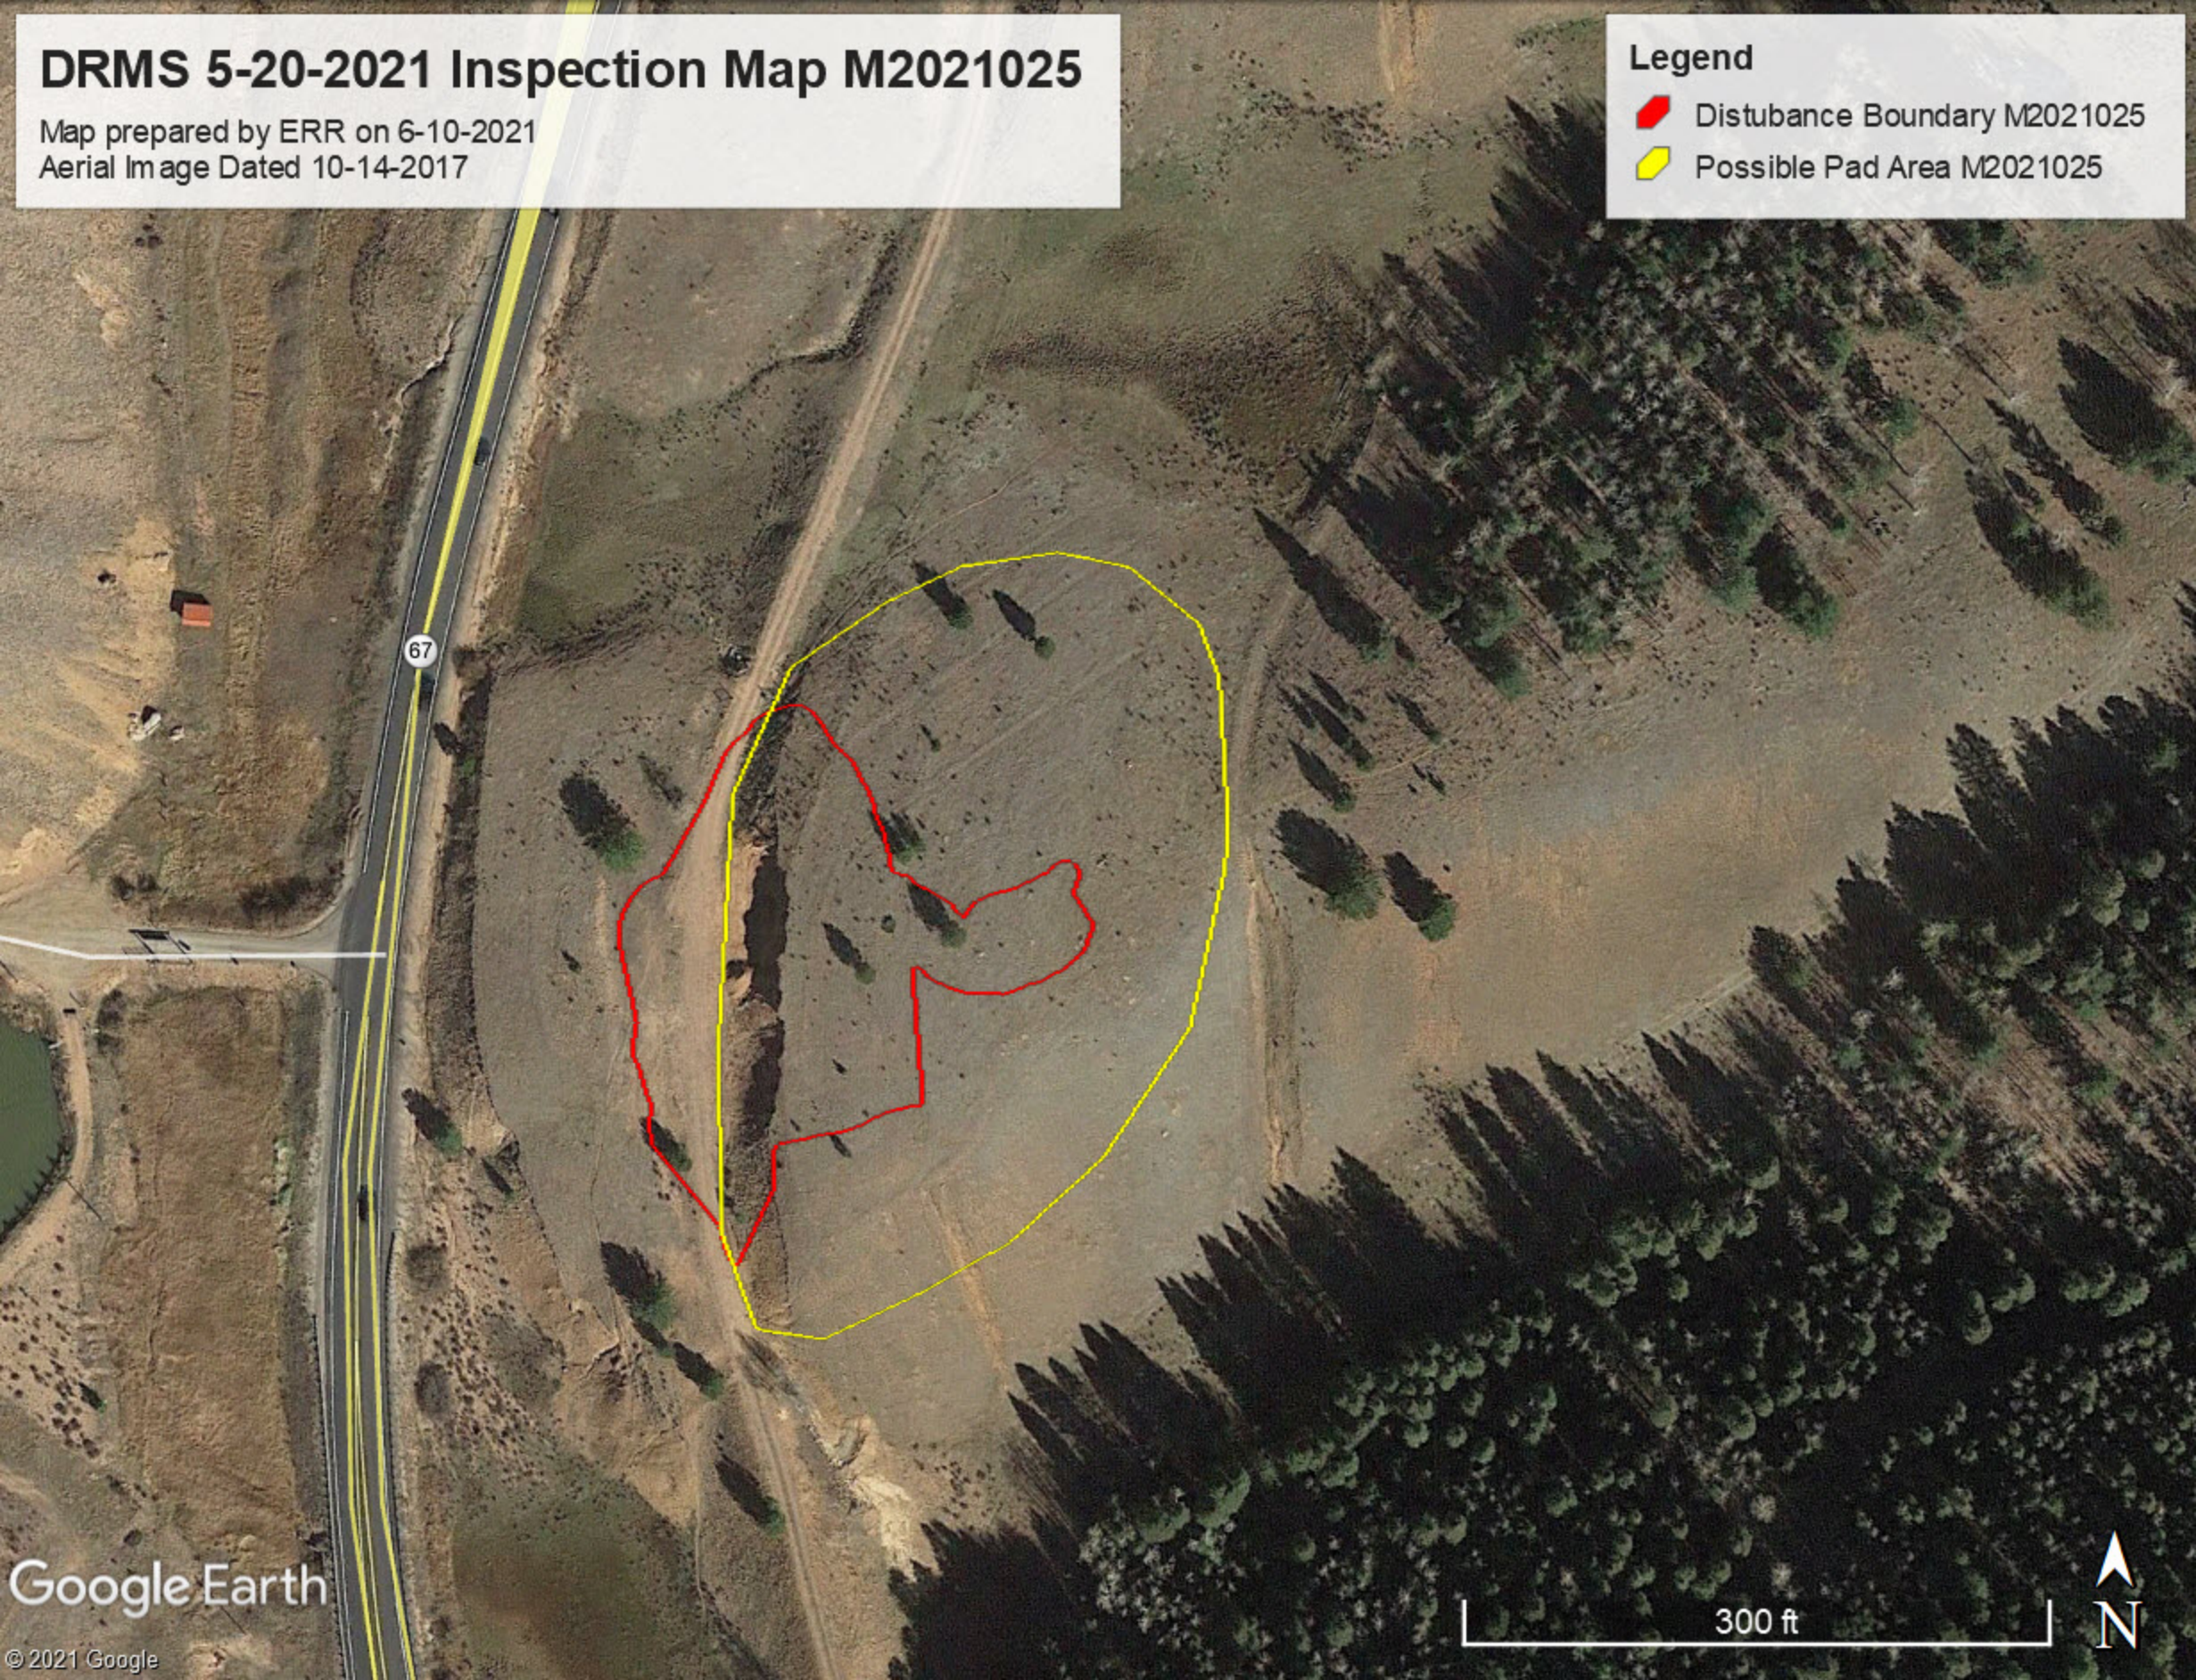
# DRMS 5-20-2021 Inspection Map M2021025

work and knew topsoil needed to be salvaged to complete future reclamation and seeding on the final eastern slope of the pad area. On the attached map, the Division has also estimated the size of area that Mr. Newell believes is needed for the truck turnaround and hay storage area. This approximate 2.3 acre area was determined based on discussions with Mr. Newell and Mr. Regester during the inspection.
