MINERALS PROGRAM INSPECTION REPORT
PHONE: (303) 866-3567

MINE NAME: Sunnyside Gold Mine	MINE/PROSPECTING ID#: M-1977-378	MINERAL: Lead, zinc, copper, iron	COUNTY: San Juan
INSPECTION TYPE: Monitoring	INSPECTOR(S): Lucas West	INSP. DATE: June 16, 2021	INSP. TIME: 12:40
OPERATOR: Sunnyside Gold Corp	OPERATOR REPRESENTATIVE: Pat Maley	TYPE OF OPERATION: 112 - Hard Rock Regular Operation	
REASON FOR INSPECTION: Normal I&E Program	BOND CALCULATION TYPE: None	BOND AMOUNT: \$60,534.00	
DATE OF COMPLAINT: NA	POST INSP. CONTACTS: None	JOINT INSP. AGENCY: None	
WEATHER: Clear	INSPECTOR'S SIGNATURE:

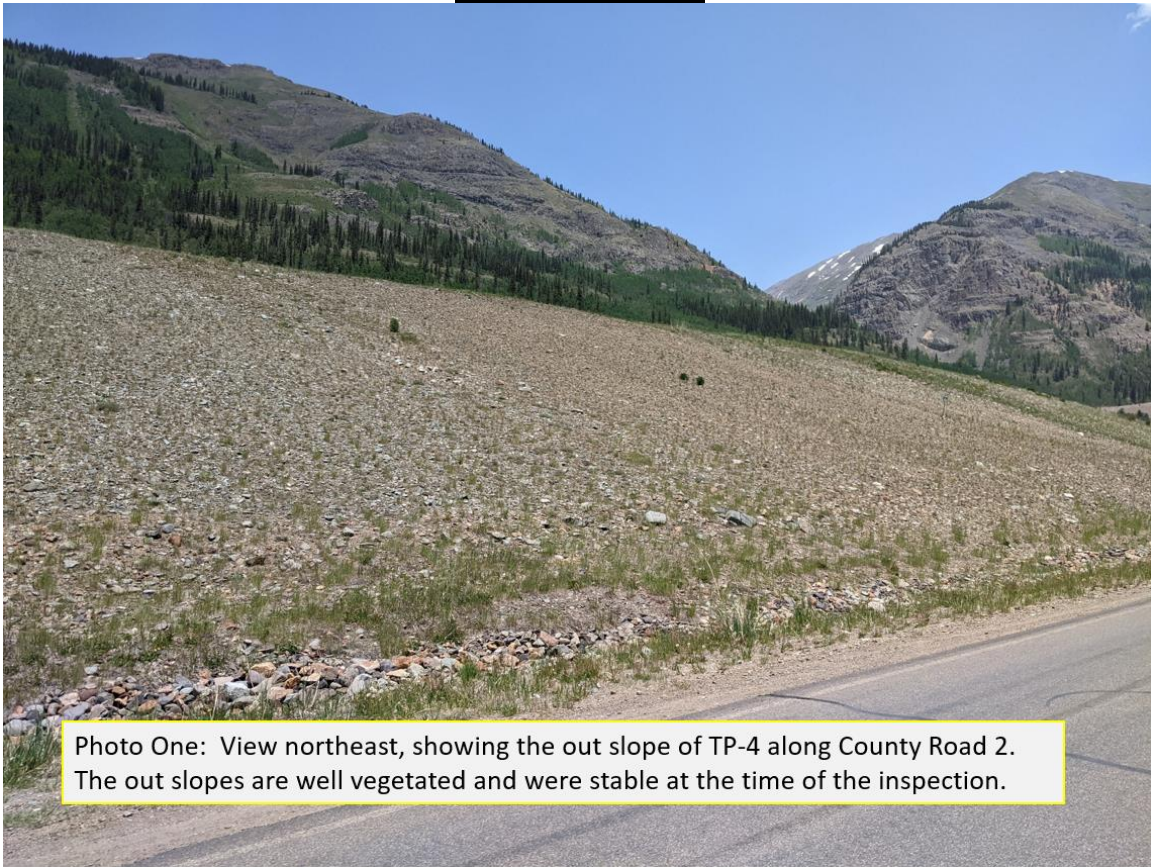
Proper mine identification signage was posted at the entrance to the site. Access to the site is controlled by a locked gate just off County Road 2. The side slopes and top of the constructed repository were stable at the time of the inspection and are in excellent condition. Photos One through three show various aspects of the out slopes of the reclaimed area. The vegetative cover on the side slopes of the facility is in excellent condition. The vegetative cover in these areas is dense and diverse, showing multiple years biomass indicating the vegetation is self-sufficient. The top of the repository was also observed to be in excellent condition. No evidence of settling, slumping or erosion was noted. The vegetative cover of the top area is in similar condition to the side slopes in being dense and diverse. Photos Four and Five show examples of the vegetative cover observed across the site.

Photo One: View northeast, showing the out slope of TP-4 along County Road 2. The out slopes are well vegetated and were stable at the time of the inspection.

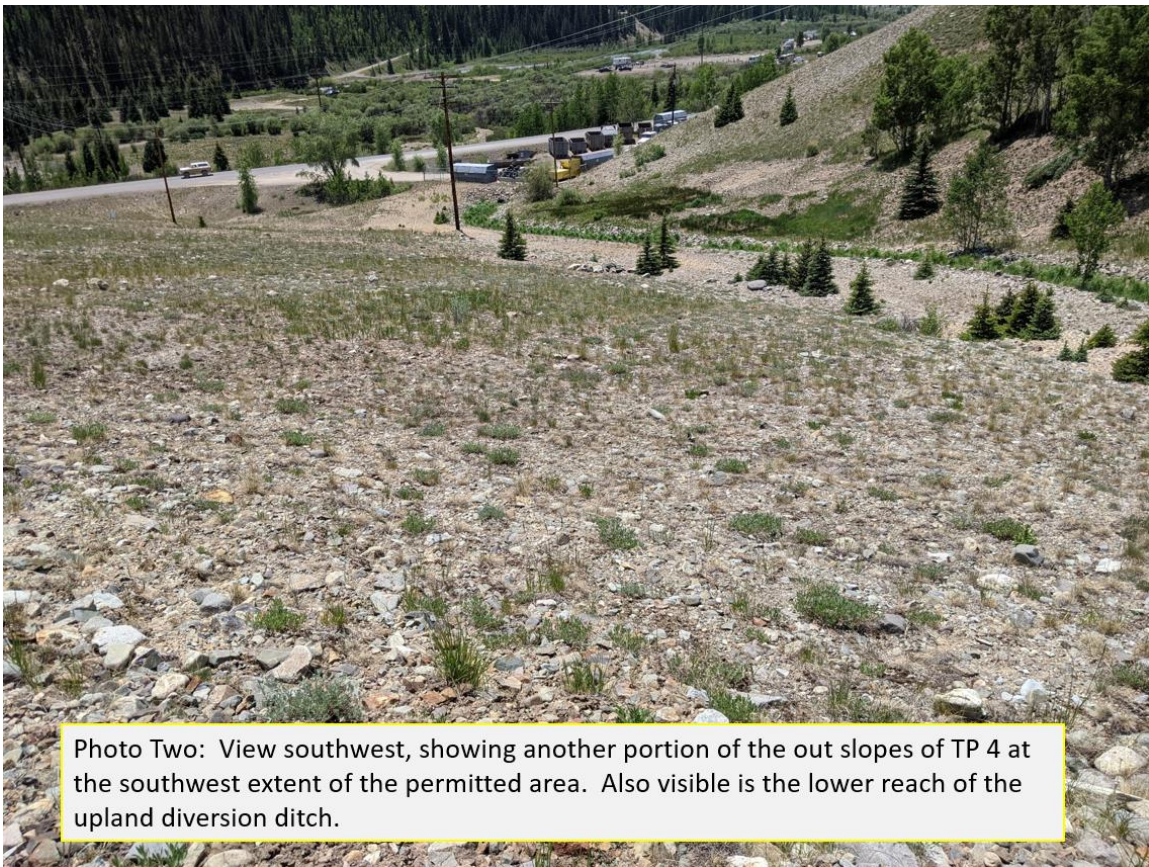
Photo Two: View southwest, showing another portion of the out slopes of TP 4 at the southwest extent of the permitted area. Also visible is the lower reach of the upland diversion ditch.

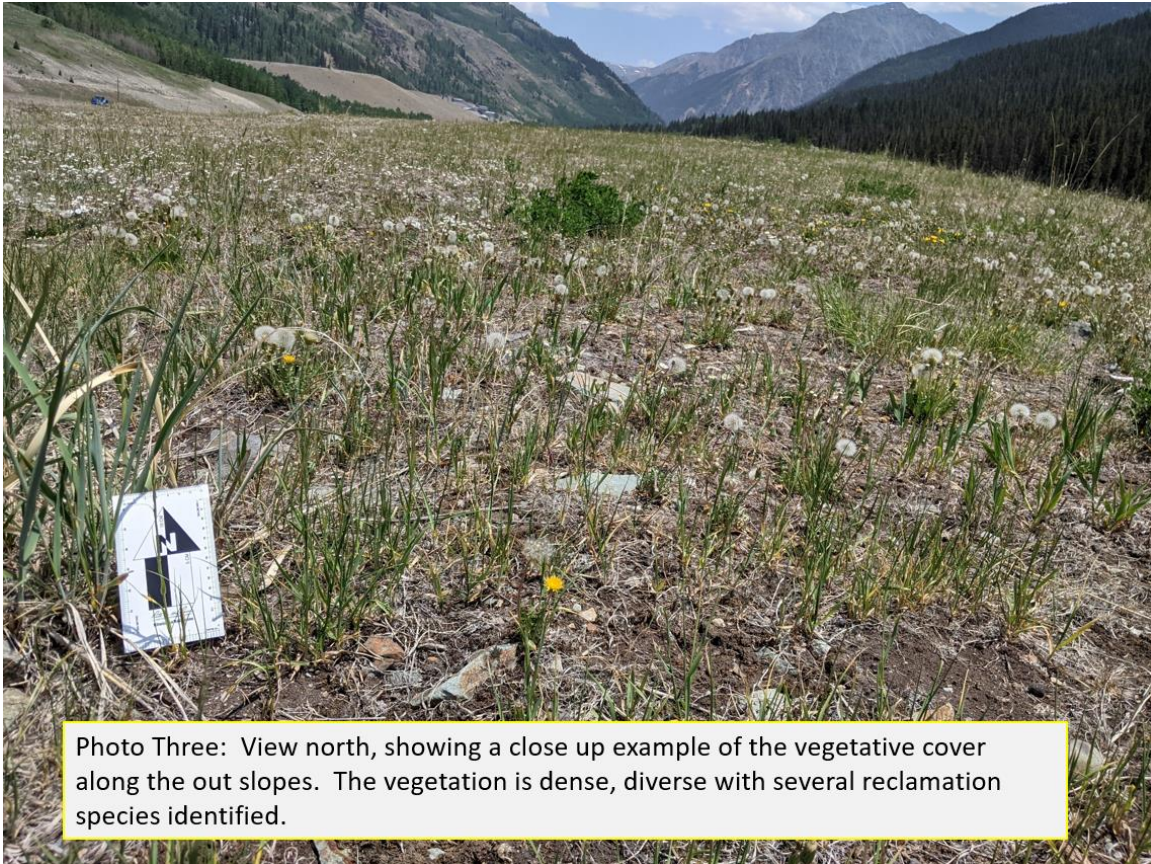
Photo Three: View north, showing a close up example of the vegetative cover along the out slopes. The vegetation is dense, diverse with several reclamation species identified.

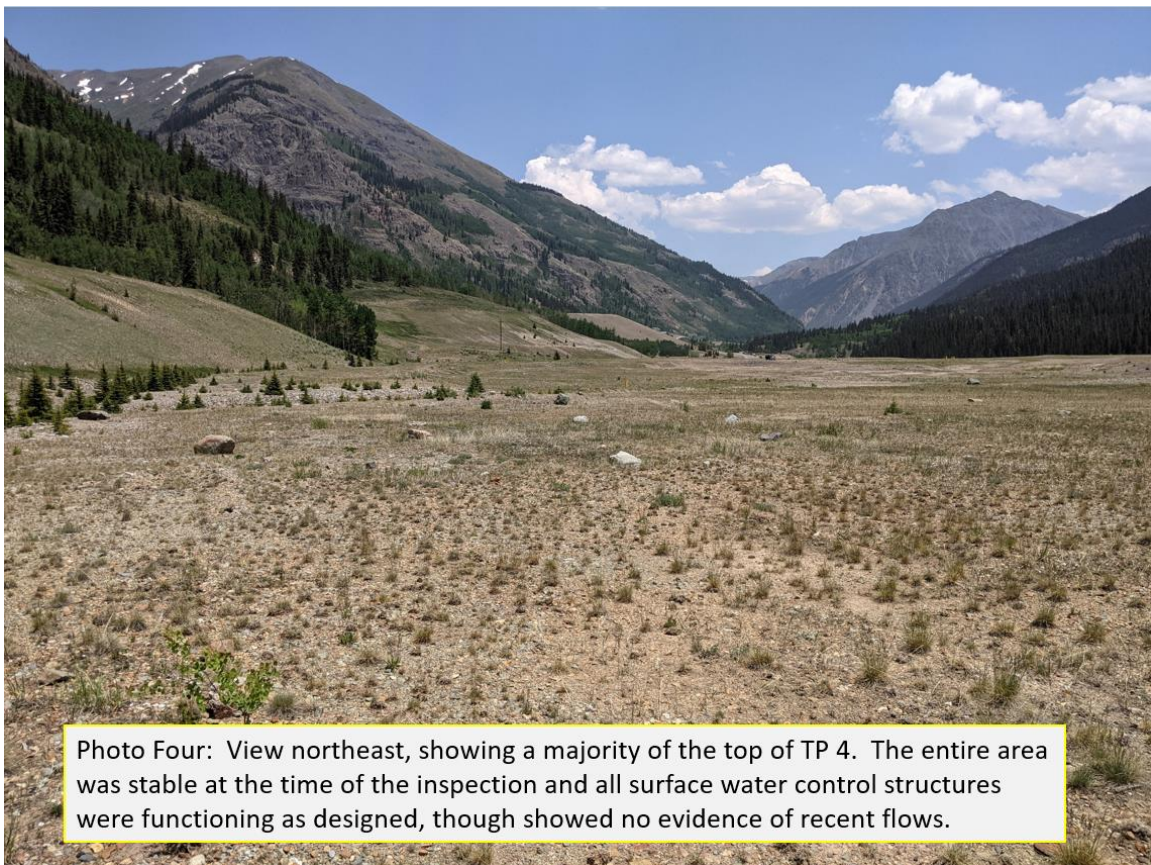
Photo Four: View northeast, showing a majority of the top of TP 4. The entire area was stable at the time of the inspection and all surface water control structures were functioning as designed, though showed no evidence of recent flows.

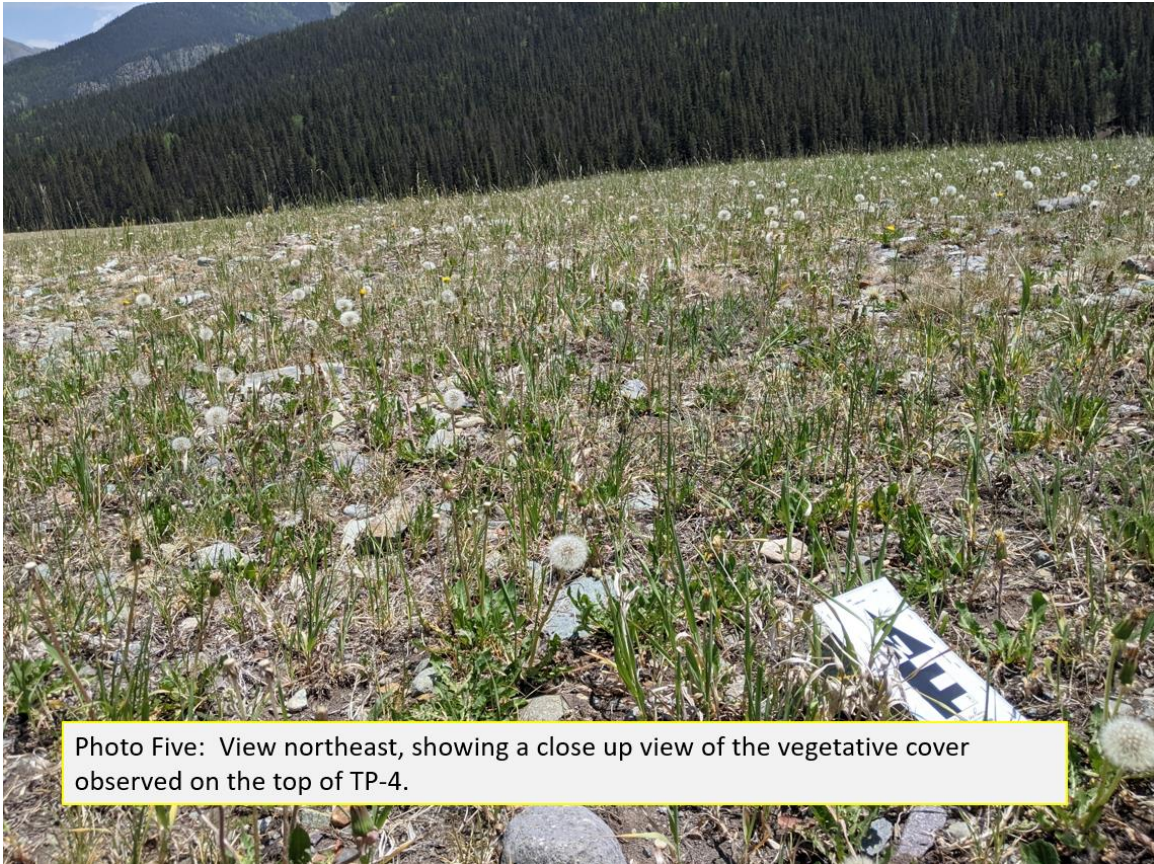
Photo Five: View northeast, showing a close up view of the vegetative cover observed on the top of TP-4.

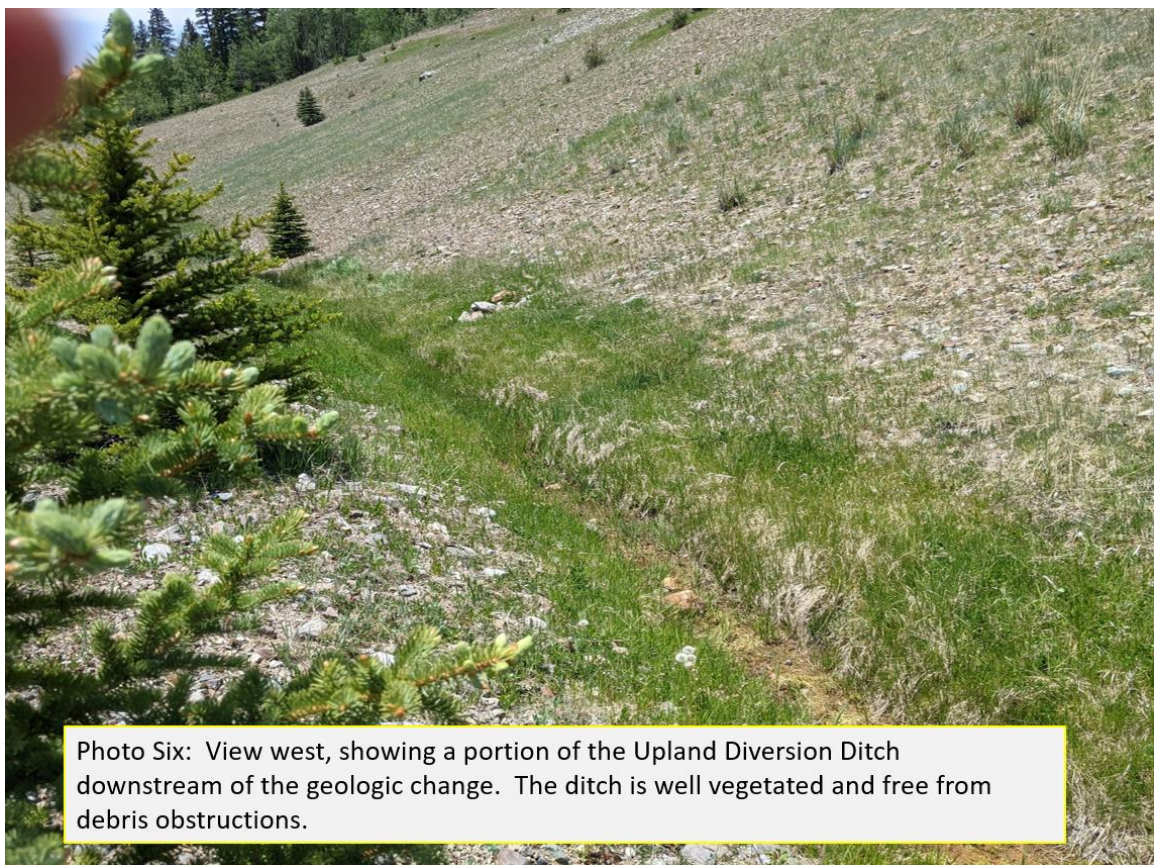
The repository exhibits positive drainage and no impounded storm water or erosional issues were noted. All surface water control features were observed, and appeared to be functioning as designed though they showed no signs of recent flows. The upland diversion ditch that runs along the northern edge of the permitted area was observed and in excellent condition. The ditch is split by an apparent underground geologic change causing a visual difference in flows. The western portion of the ditch contained minimal flow as has been observed in previous inspections. The eastern portion of the ditch, east of the geologic change, contained no flow and no evidence of recent flows. The ditch as a whole is vegetated, and clear from any debris obstructions to allow for unimpeded flows. The ditch can be seen in Photos Six through Eight.

Photo Six: View west, showing a portion of the Upland Diversion Ditch downstream of the geologic change. The ditch is well vegetated and free from debris obstructions.
