MINERALS PROGRAM INSPECTION REPORT
PHONE: (303) 866-3567

MINE NAME: Pikeview Quarry	MINE/PROSPECTING ID#: M-1977-211	MINERAL: Limestone (general), granite, granite gneiss and dolomite	COUNTY: El Paso
INSPECTION TYPE: Monitoring	INSPECTOR(S): Timothy Cazier, P.E.	INSP. DATE: May 20, 2021	INSP. TIME: 10:05
OPERATOR: Continental Materials Corporation	OPERATOR REPRESENTATIVE: Jerry Schnabel	TYPE OF OPERATION: 112c - Construction Regular Operation	
REASON FOR INSPECTION: Normal I&E Program	BOND CALCULATION TYPE: None	BOND AMOUNT: \$15,000,000.00	
DATE OF COMPLAINT: NA	POST INSP. CONTACTS: None	JOINT INSP. AGENCY: None	
WEATHER: Clear	INSPECTOR'S SIGNATURE:

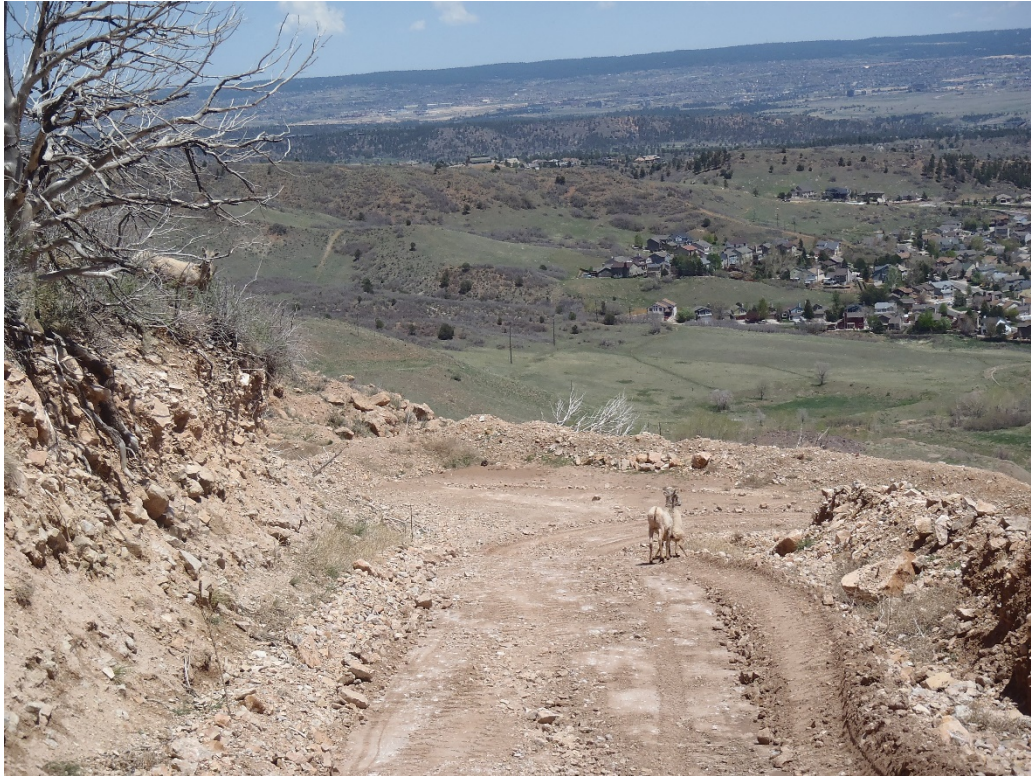
Fish and Wildlife: No impact to wildlife was observed. Bighorn sheep are common on the south end of the pit and were observed here during the inspection (see **Photo 1**).

Photo 1. Bighorn sheep on access road (south of pit, looking NE).

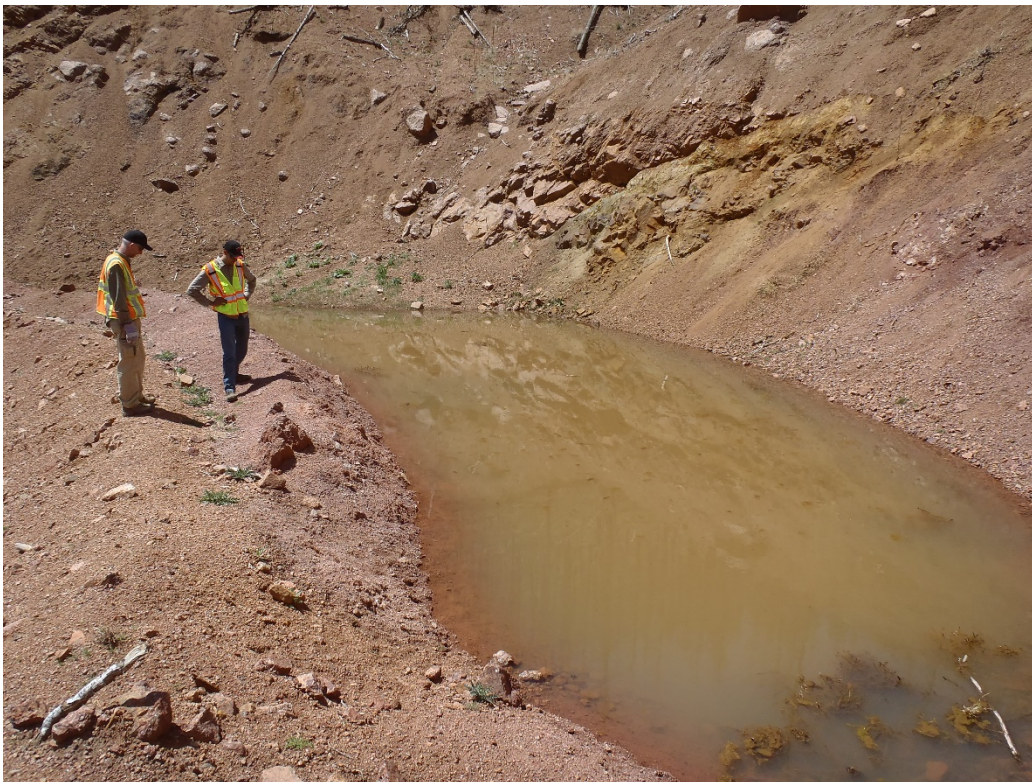
Hydrologic Balance: No standing water was observed in the pit and no exposed groundwater was observed. A small pond has formed at the top of the highwall, away from the crest (see **Photo 2**). The DRMS and site representatives discussed whether the pond might contribute to potential sliding of the highwall. Based on the observed geology that the pond is confined to the granite and away from the crest it was determined to not likely present a meaningful risk. However, it was decided to improve the outlet of the pond such that the water level could not increase above the level observed during the inspection. Site representatives agreed with this assessment and committed to lowering the pond outlet, which directs overflow to the north end of the highwall.

Photo 2. Pond above highwall – water source for wildlife.

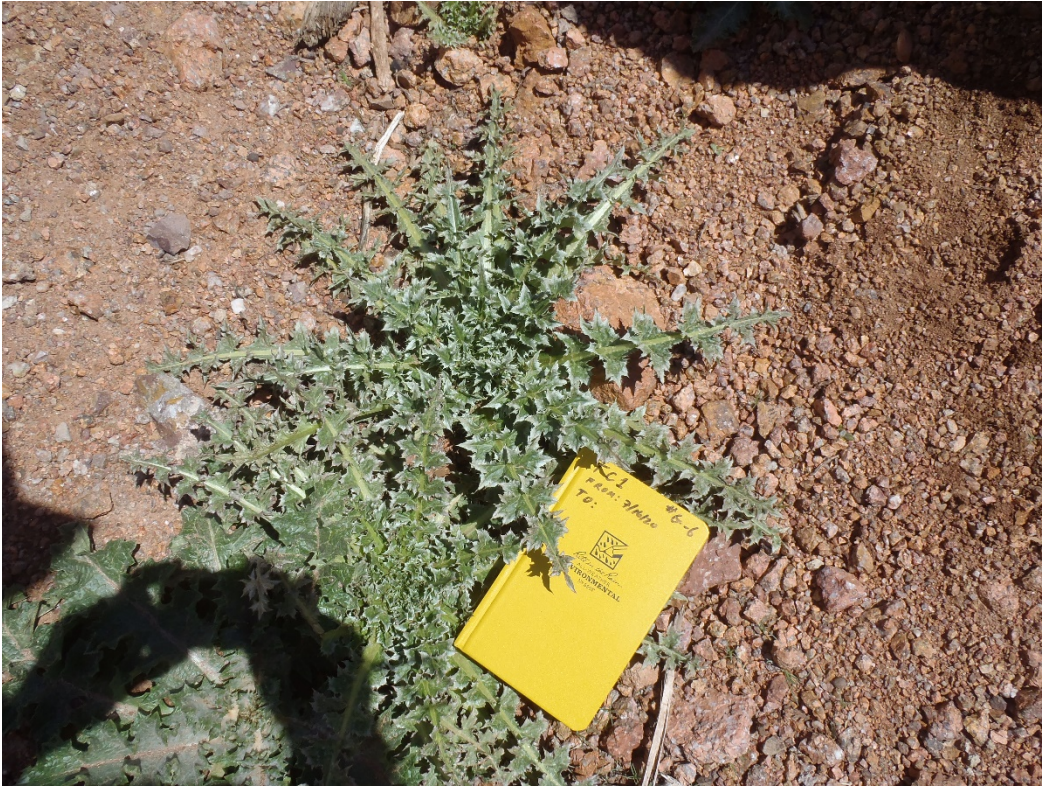
Revegetation: No new re-vegetation had been initiated since the previous inspection. Some emerging thistles (see **Photo 3**) were observed near the crest of the highwall. The specific species was indeterminate. Mr. Schnabel stated they were scheduling weed spraying a bit later than last year to better control the spread.

Photo 3. Possible musk thistle (above highwall).

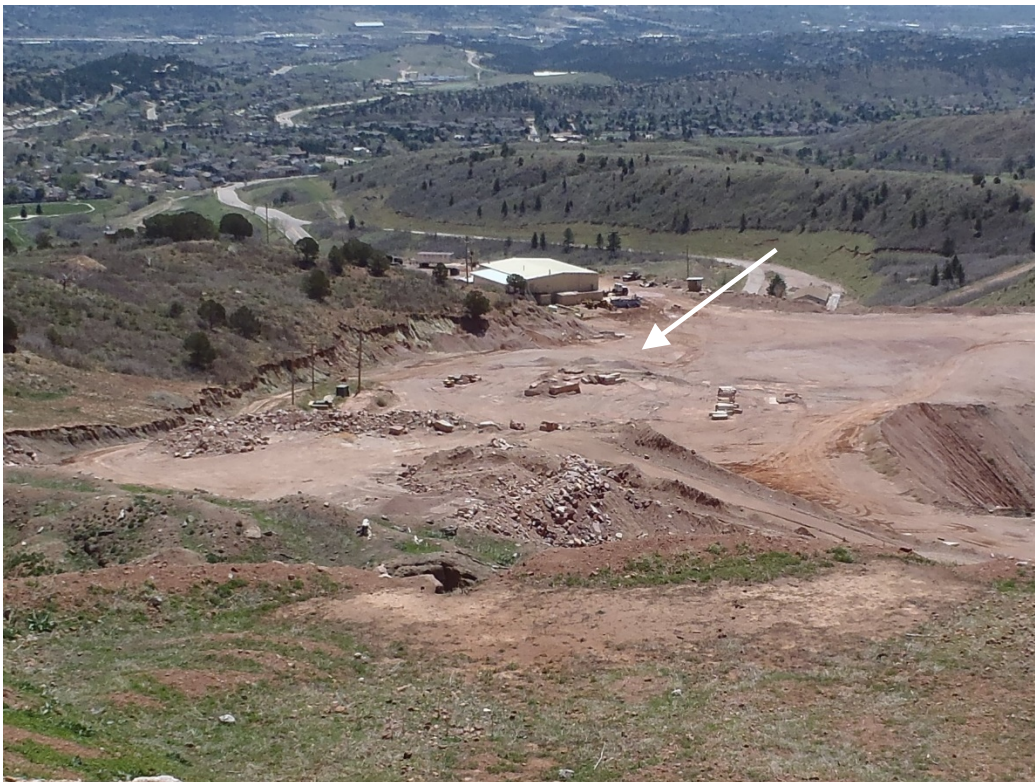
Support Facilities On-site: The screen plant and crusher had been removed from the site. Some concrete foundations remain (see **Photo 4**).

Photo 4. Processing plant foundations (looking SE).

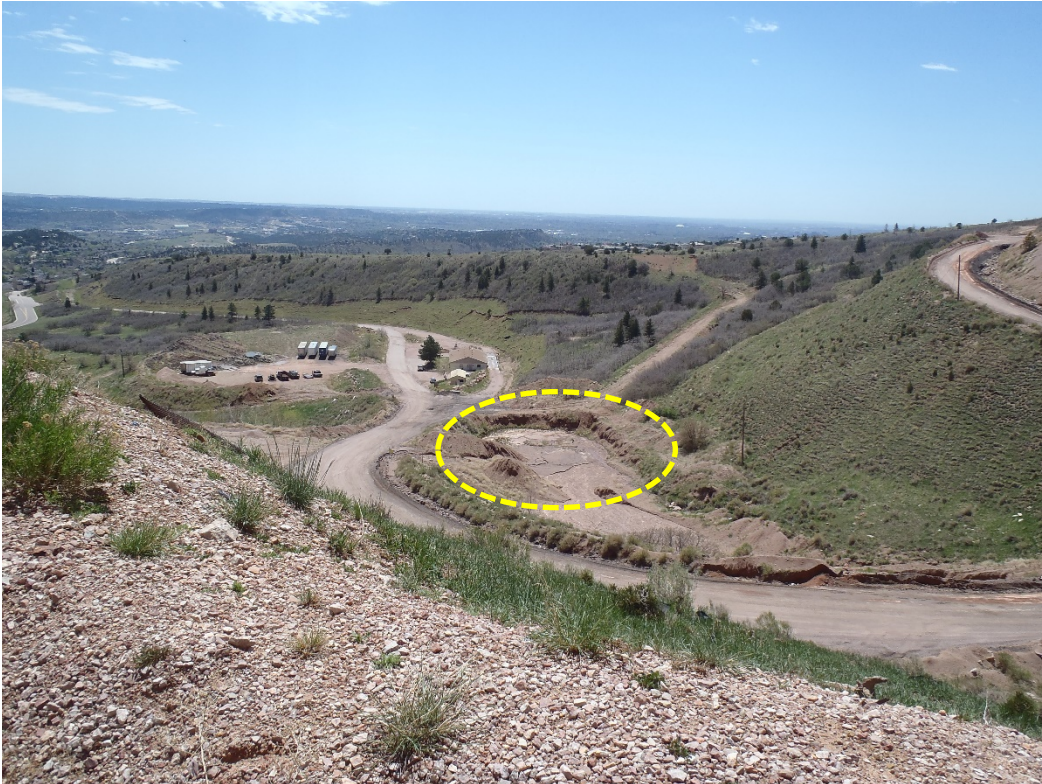
Storm Water MGT Plan: No oil or fuel spills were observed. Stormwater ponds appeared to be functioning properly, but may soon require some sediment removal, notably Pond #514 (see **Photo 5**). The blocked culvert on the northwest corner of the site had been partially cleared (see **Photo 6**) and a small amount of daylight could be seen through the culvert. CMC was planning to hydraulically remove the remaining sediment and will inform the DRMS when this is completed.

Photo 5. Sediment pond 514 (TR-07 designation) likely to need maintenance soon.

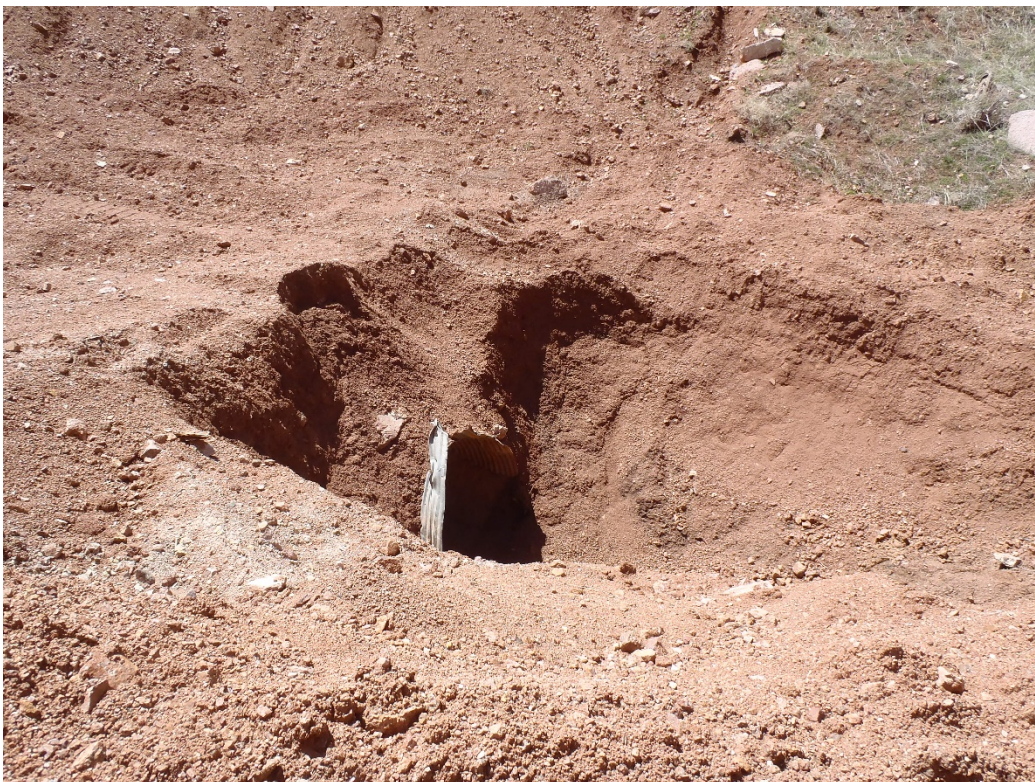
Photo 6. Partially unblocked northwest culvert.

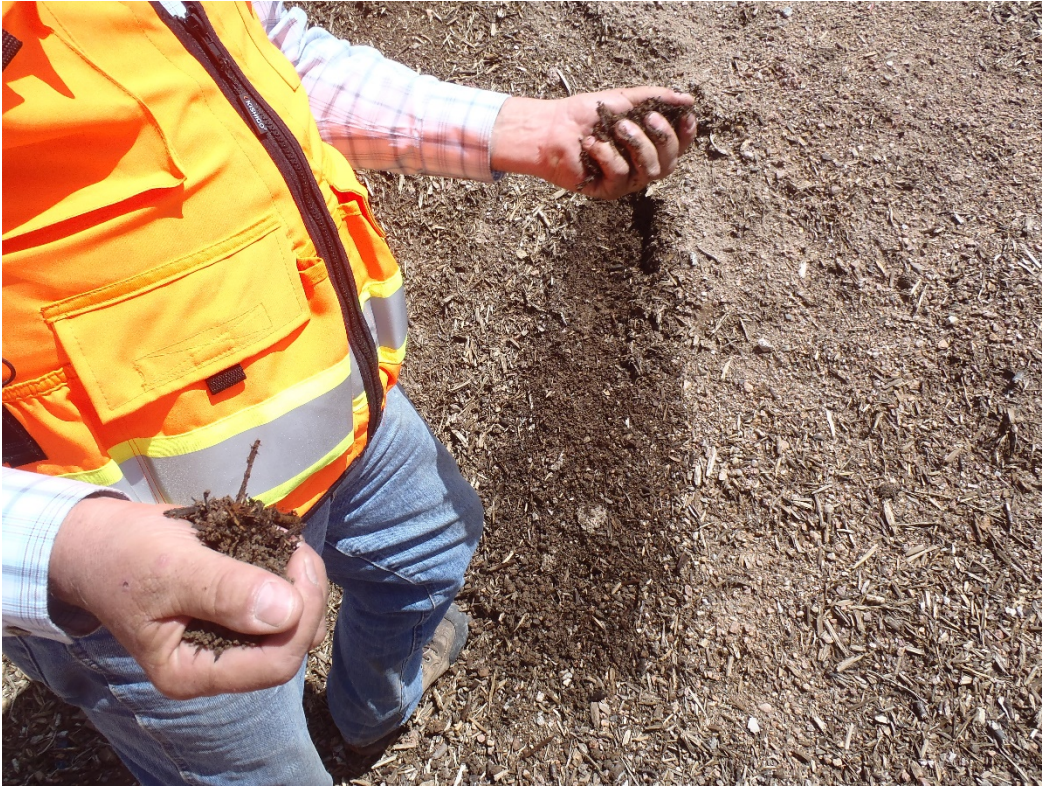
Topsoil: CMC continues to mix mulch (see **Photo 7**) with soil on site to stockpile additional growth media for reclamation (see **Photo 8**).

Photo 7. Mulch used to mix with on-site soils.

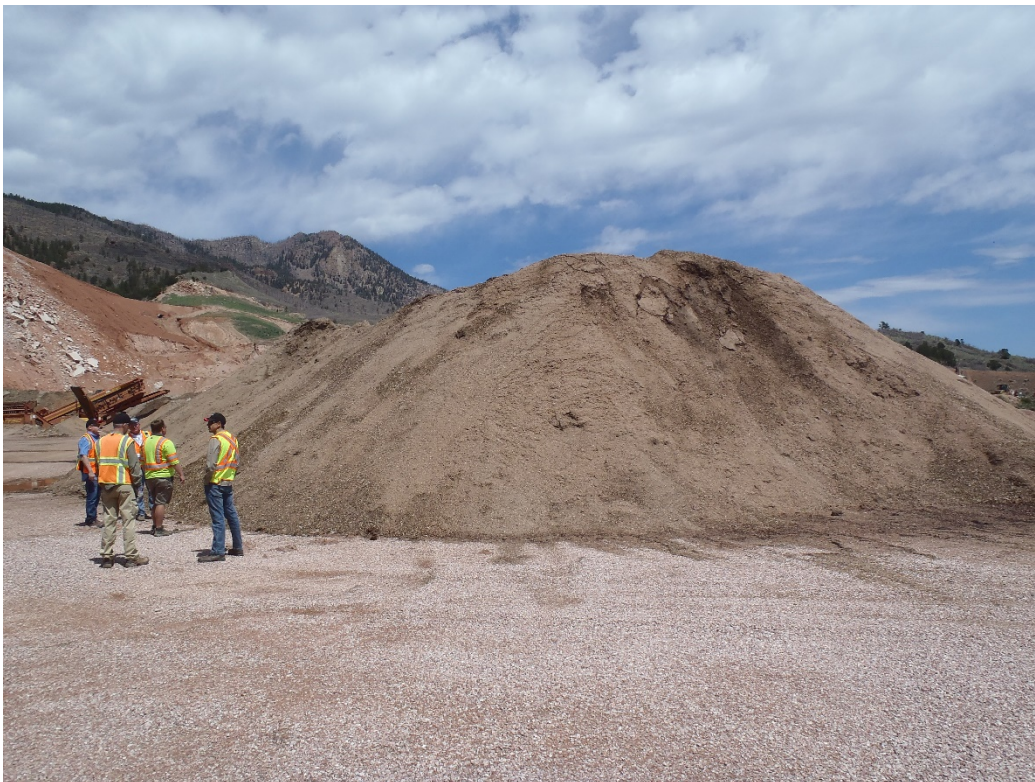
Photo 8. Growth media stockpile (Area H, looking north).
