## MINERALS PROGRAM INSPECTION REPORT

| <b>MINE NAME:</b><br>Schwartzwalder Mine | <b>MINE/PROSPECTING ID#:</b><br>M-1977-300 | <b>MINERAL:</b><br>Uranium | <b>COUNTY:</b><br>Jefferson |
| <b>INSPECTION TYPE:</b><br>Monitoring | <b>INSPECTOR(S):</b><br>Amy Eschberger, Michael Cunningham | <b>INSP. DATE:</b><br>June 11, 2021 | <b>INSP. TIME:</b><br>13:00 |

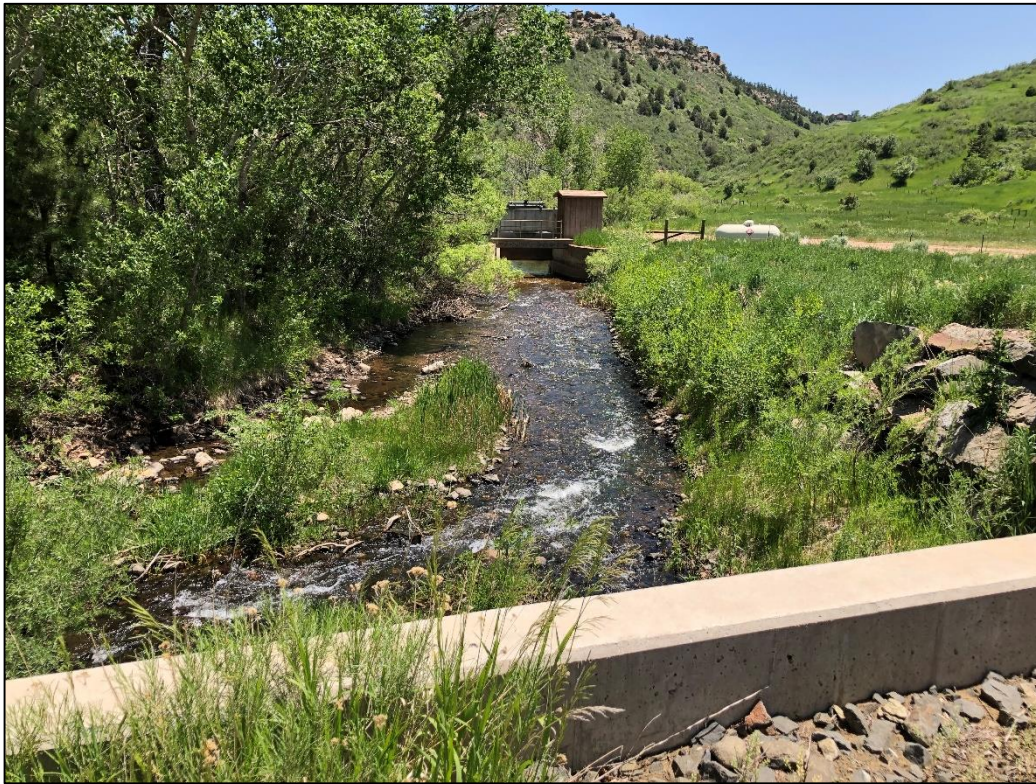
- Observation of 4 of the 5 downstream surface water monitoring locations (SW-WEIR, SW-LLHG, SW-FBRG, and SW-BPL) along Ralston Creek. Water quality samples are obtained from these locations and the results submitted to the Division on a quarterly basis. Sampling occurs more frequently at the operator's permitted discharge point at SW-BPL, per CDPHE requirements.

**Photo 1.** View looking downstream on Ralston Creek at surface water monitoring location SW-WEIR, located furthest downstream of mine site (outside of permit area).

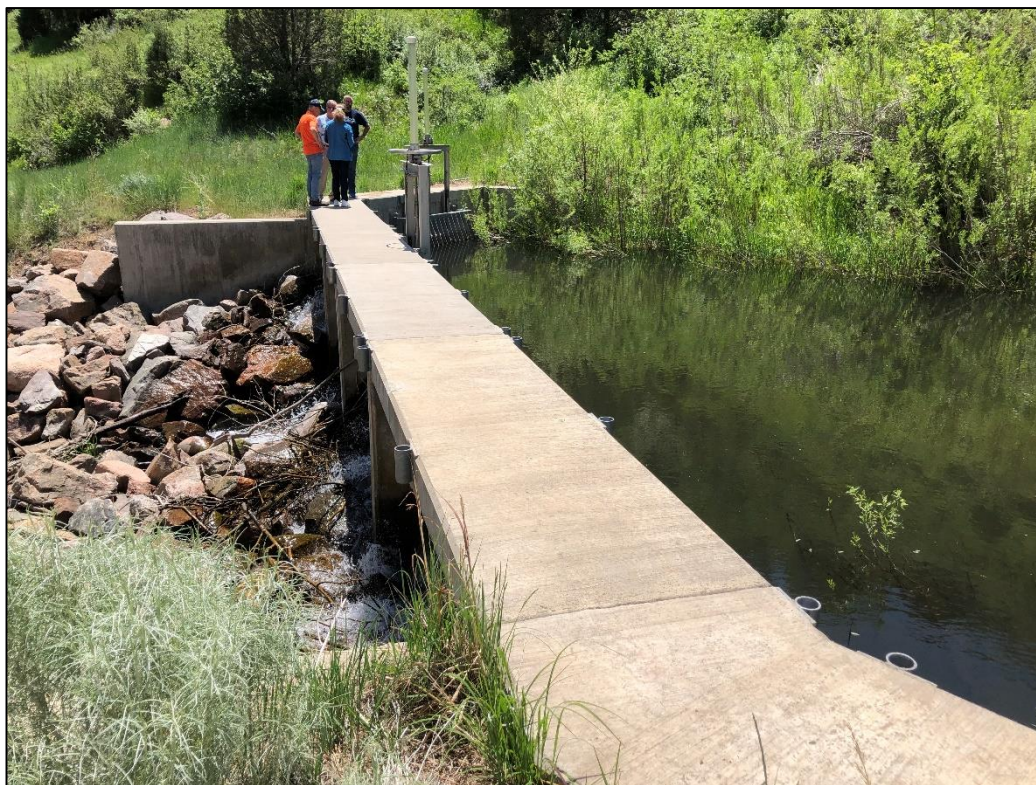
**Photo 2.** View looking across Ralston Creek at surface water monitoring location SW-LLHG, located downstream of mine site (outside of permit area), below SW-ARH (not observed during this site tour).

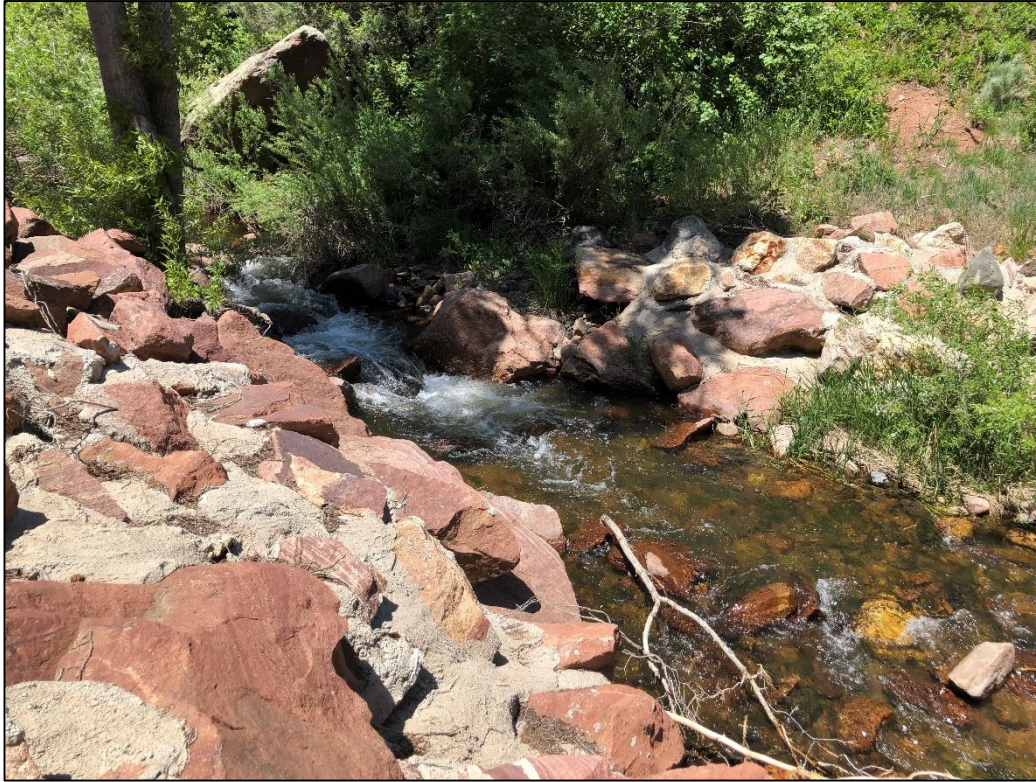
**Photo 3.** View looking upstream on Ralston Creek at surface water monitoring location SW-FBRG, located downstream of mine site (outside of permit area), below SW-BPL.

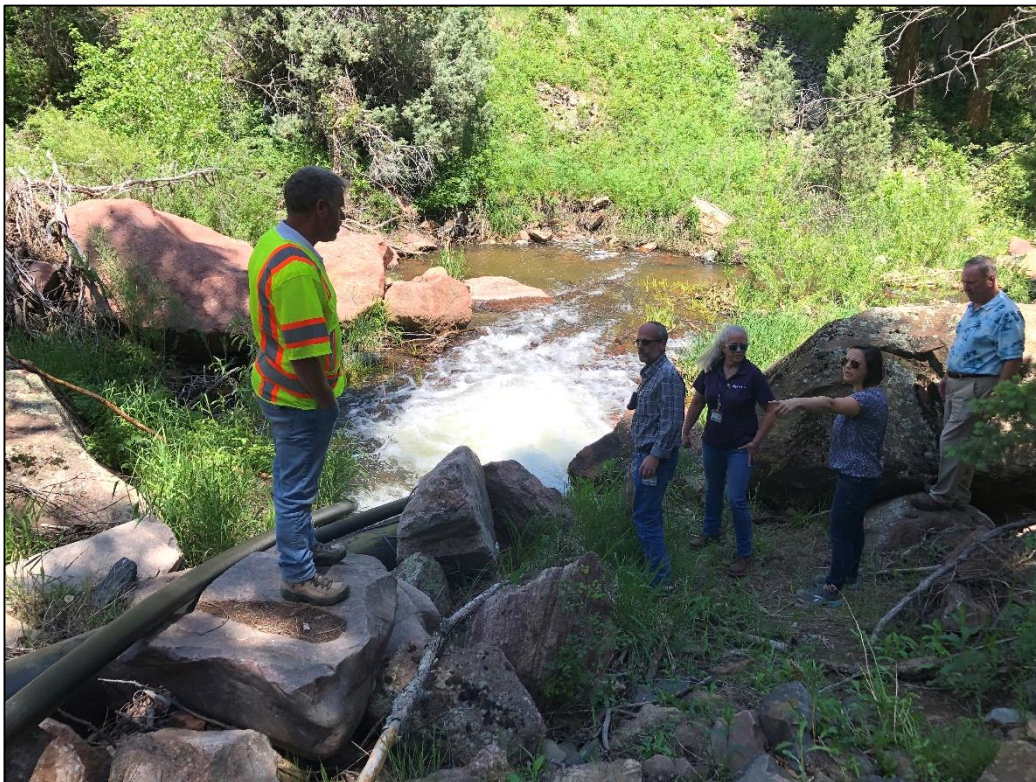
**Photo 4.** View looking across Ralston Creek at surface water monitoring location SW-BPL, located immediately downstream of mine site (outside of permit area). This location is also the operator's discharge point permitted under the CDPHE, at which, treated mine water and captured creek flows above the upgradient cutoff wall are discharged into the creek.

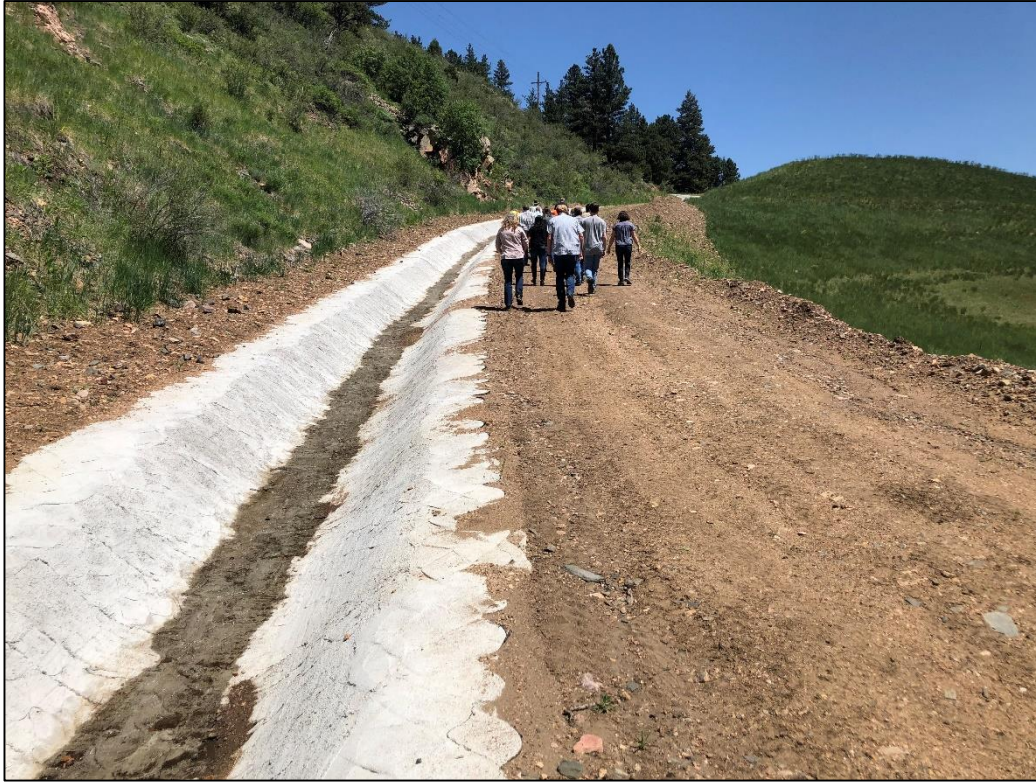
- Observation of the North Waste Rock Pile (NWRP) diversion channel, which was completed in November of 2020. A trickle of water was discharging from the outlet pipe into the channel during the site visit.

**Photo 5.** View looking upgradient at diversion channel installed along northern edge of North Waste Rock Pile (NWRP). Construction of this channel was completed in November of 2020.

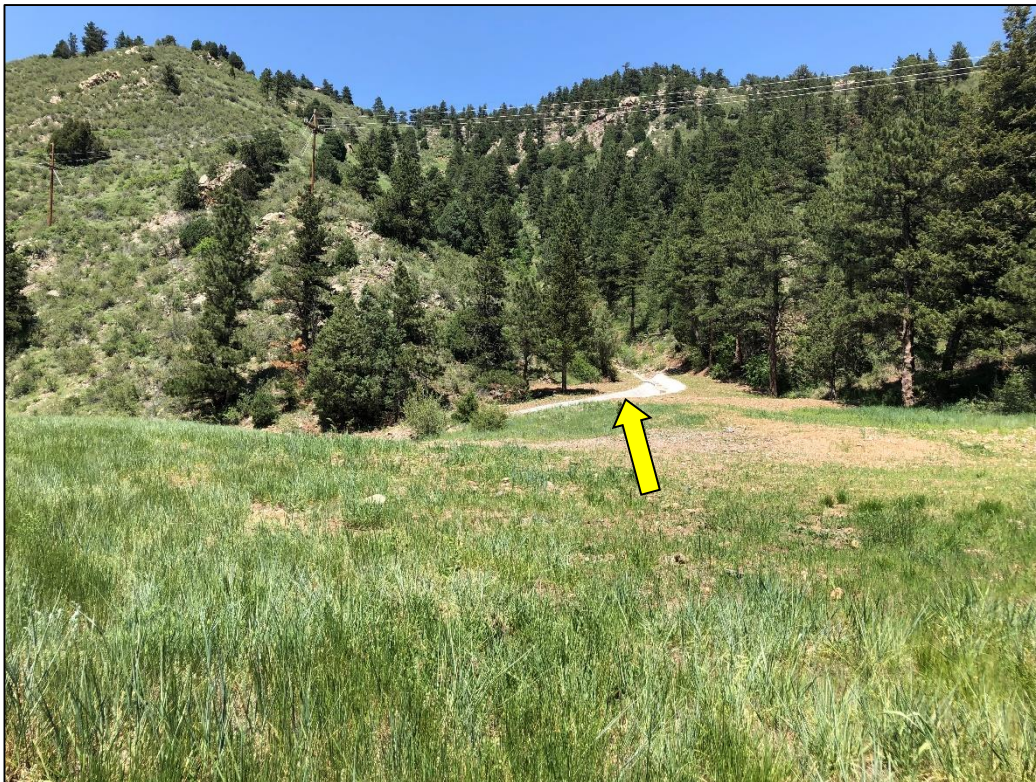
**Photo 6.** View looking east/northeast across top of NWRP. Note portion of diversion channel visible in background (indicated).

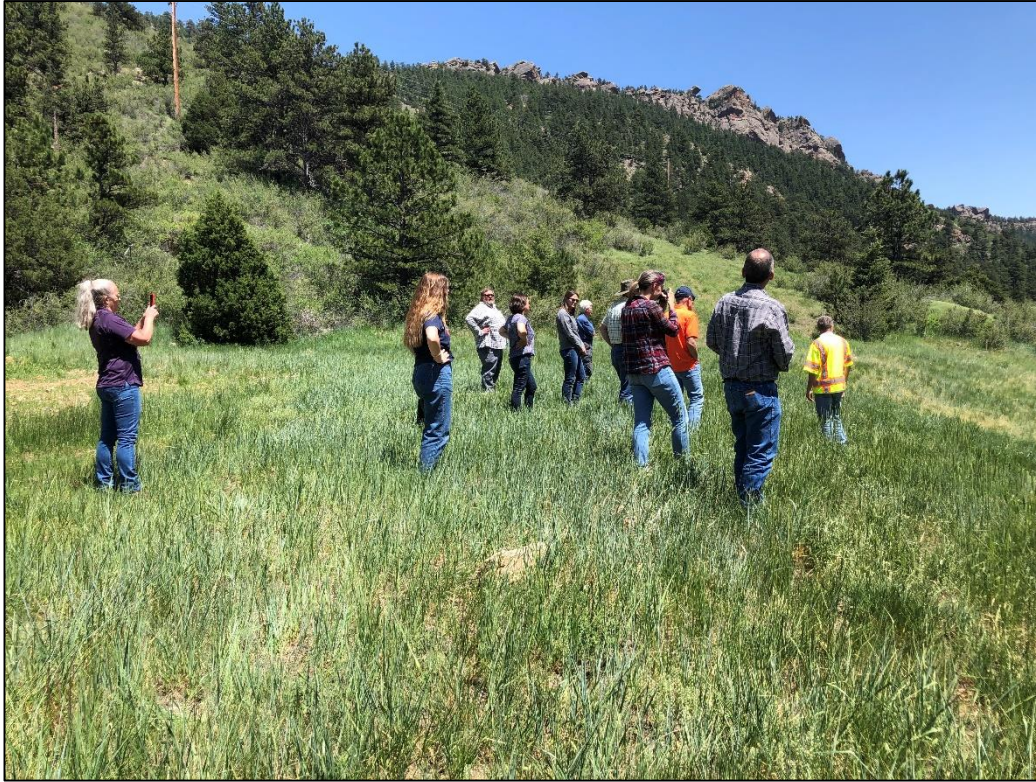
**Photo 7.** View looking south across top of NWRP.

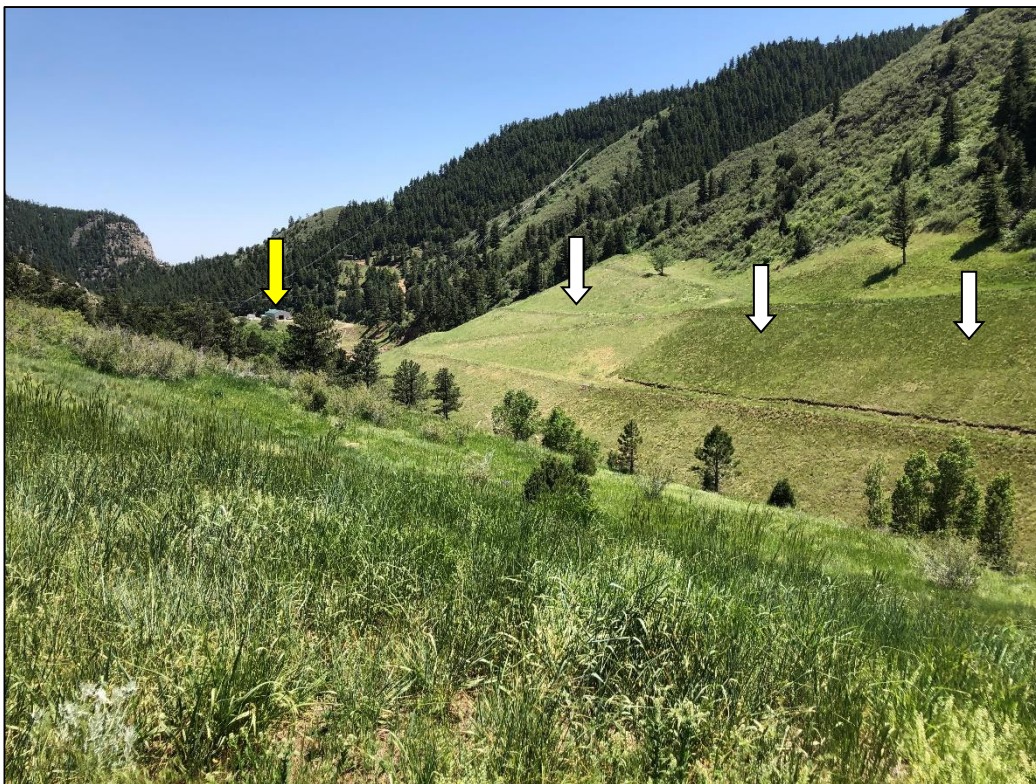
**Photo 8.** View looking southeast across mine site from top of NWRP. Note reclaimed South Waste Rock Pile at right (indicated with white arrows), and water treatment plant in far background (indicated with yellow arrow).

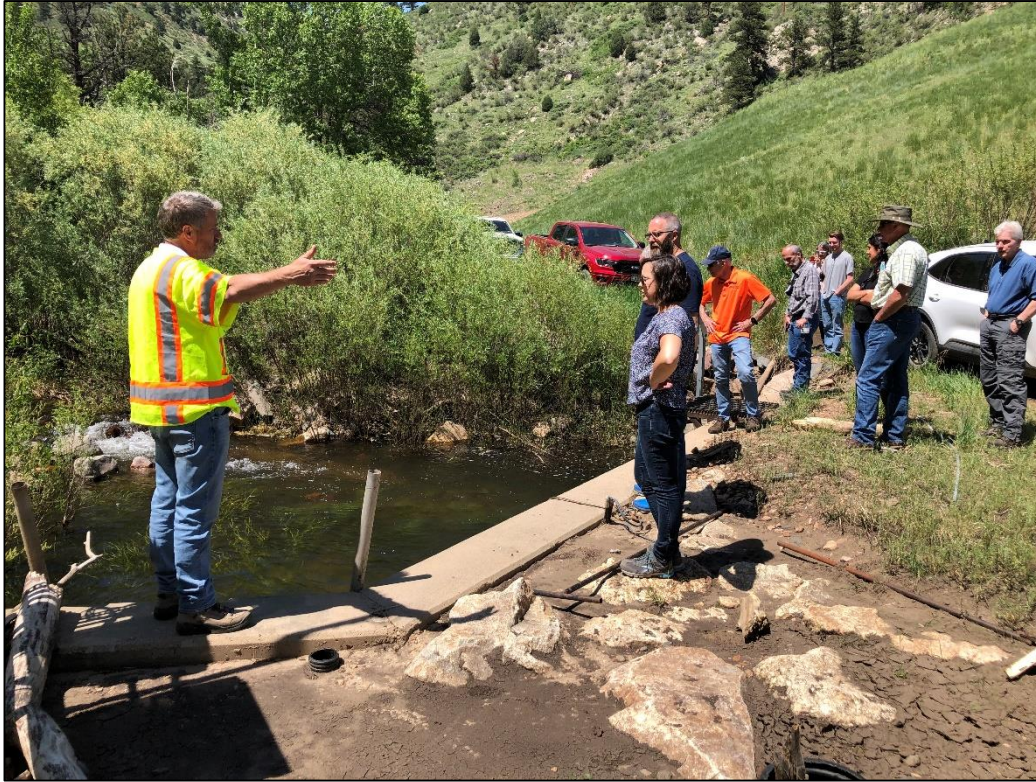
- Overlook of the mine site from the top of the NWRP.
- Observation of the upgradient cutoff wall installed in Ralston Creek just downstream of the two waste rock piles and upstream of the mine site where radionuclide-impacted alluvial valley soils are being excavated and disposed of underground. Creek flows were being captured above the cutoff wall, routed around the mine site via the bypass pipeline, and discharged into the creek at the operator's permitted outfall located downstream of the mine site.

**Photo 9.** View looking at upgradient cutoff wall/headgate in Ralston Creek, showing creek flowing upstream of cutoff wall during site visit.

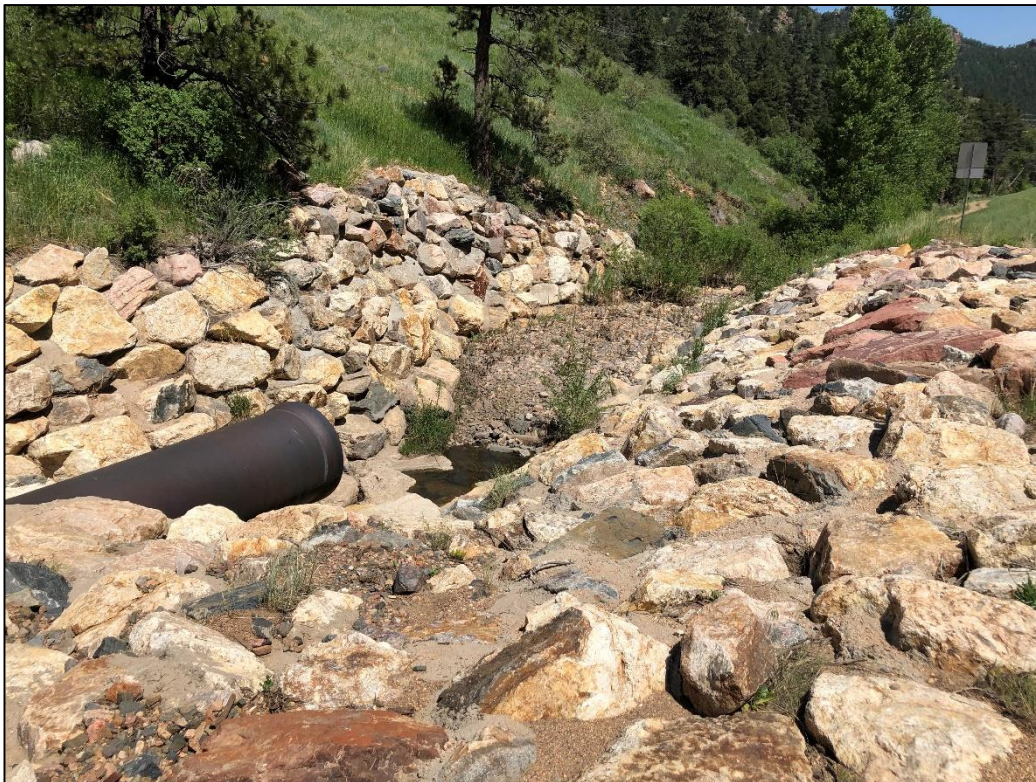
**Photo 10.** View looking downstream from upgradient cutoff wall in Ralston Creek, showing creek channel dry downstream of cutoff wall during site visit.

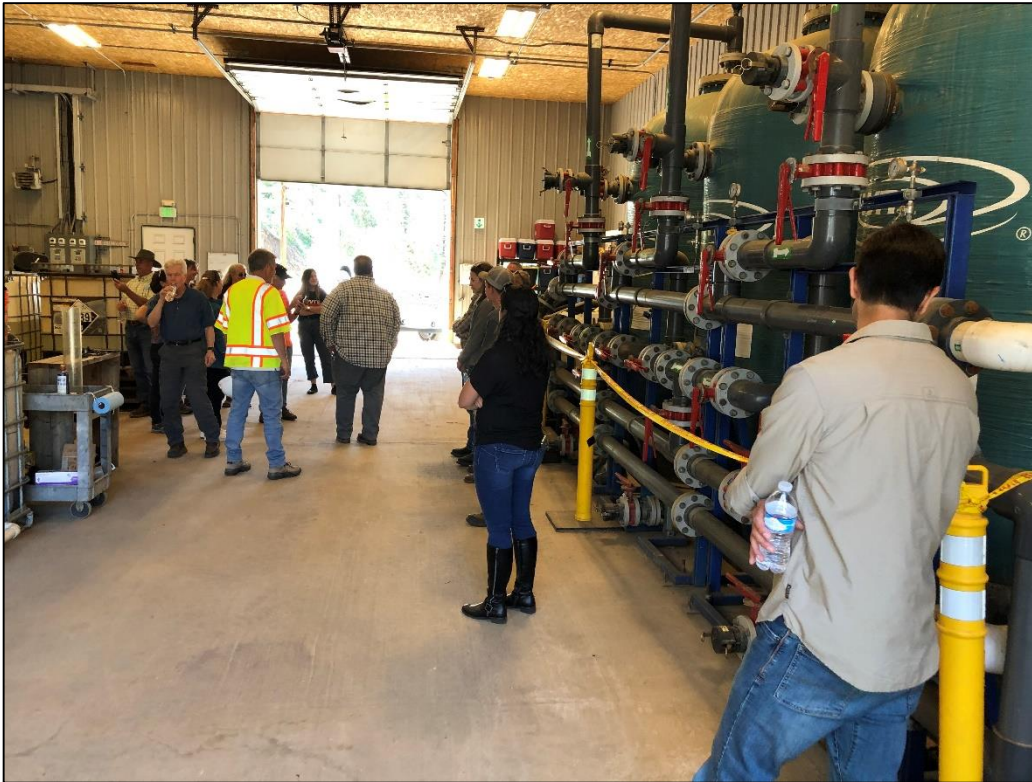
- Observation of the water treatment plant located on top of the mesa along the southern edge of the valley. The plant was online during the site visit. The operator collects daily average mine pool elevations and quarterly water quality samples from the mine pool and reports this data with other site sampling data in its quarterly monitoring reports submitted to the Division.

**Photo 11.** View looking inside water treatment plant located on top of mesa. This plant treats water pumped from the mine pool, any alluvial water collected in the downgradient sump, and any surface water that comes into contact with contaminated valley soils within the mine disturbance area. Treated water is discharged at operator's permitted outfall (SW-BPL) on Ralston Creek.

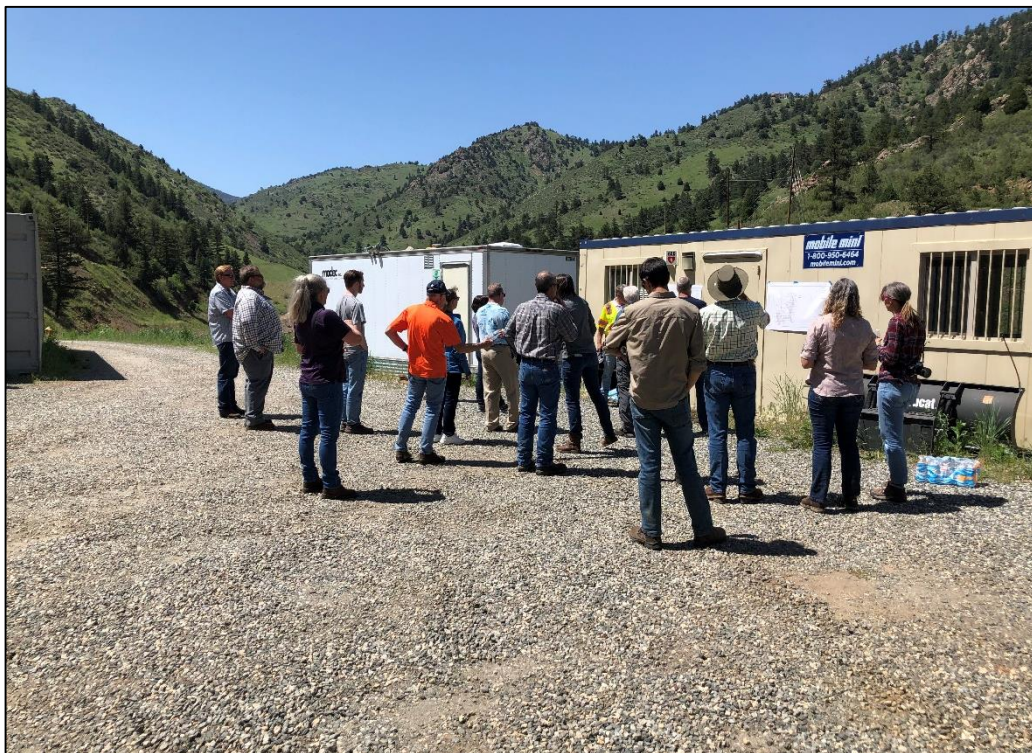
**Photo 12.** View looking north across top of mesa (where water treatment plant is located), showing tour group discussing the mine site.
