TRAPPER MINING INC.
CRAIG, COLORADO

HORSE GULCH FILL
QUARTERLY FILL CERTIFICATION

Horse Gulch Fill Quarterly Inspection Report

Second Quarter 2021

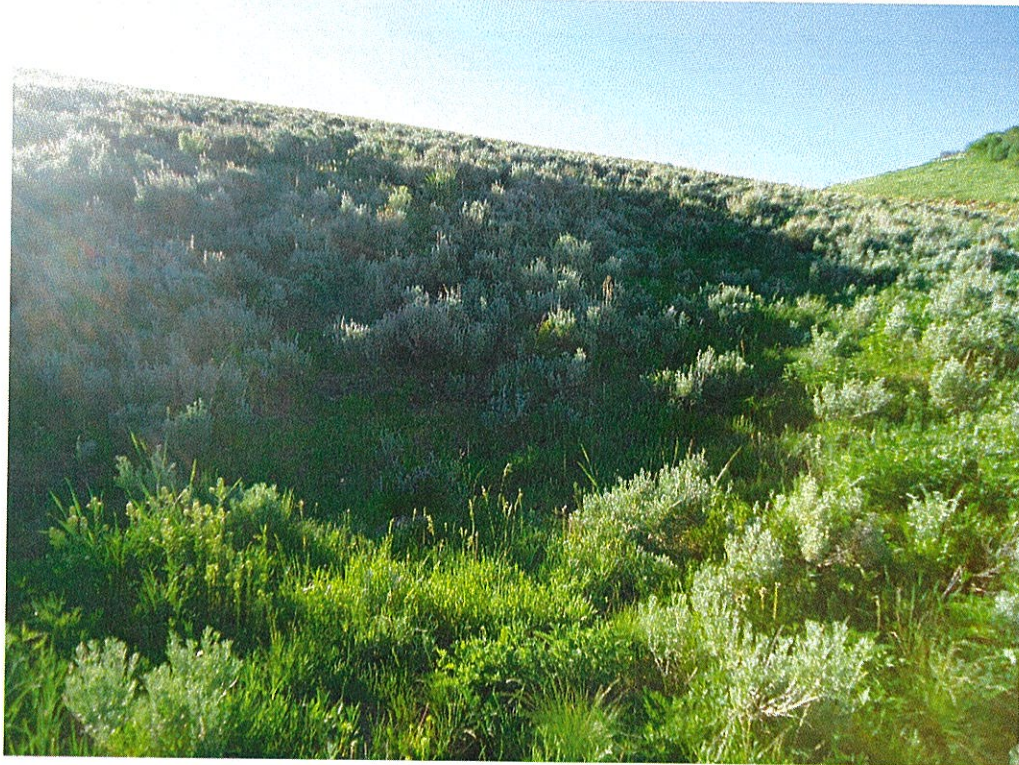
The two spots above the 7350' elevation on the south side of the dump that showed some differential settling in the second quarter of 2013 were inspected and there was no additional settling (Photographs 1 and 2). These two sites were surveyed on June 14, 2021 (via drone). The recent survey shows the volume for the north and south depressions are less than the volume from the 2020 survey. The vegetation growth has caused discrepancies with the calculated volumes. It appears there has been no change in volume for either depression areas in the past year. Monitoring these areas on a regular basis will continue. The table below shows how the recent survey compares to the surveys done in 2018, 2019 and 2020 (via drone):

Photograph 1: South Site above the 7350 Bench Elevation (6/9/2021)

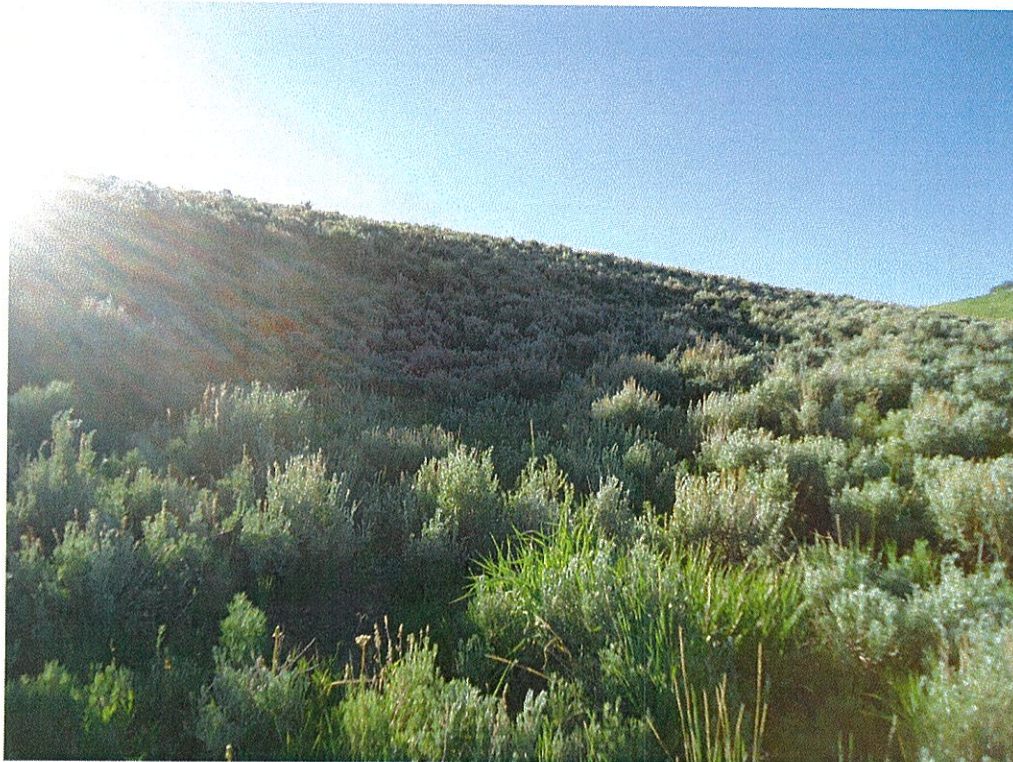
Photograph 2: North Site above the 7350 Bench Elevation (6/9/2021)

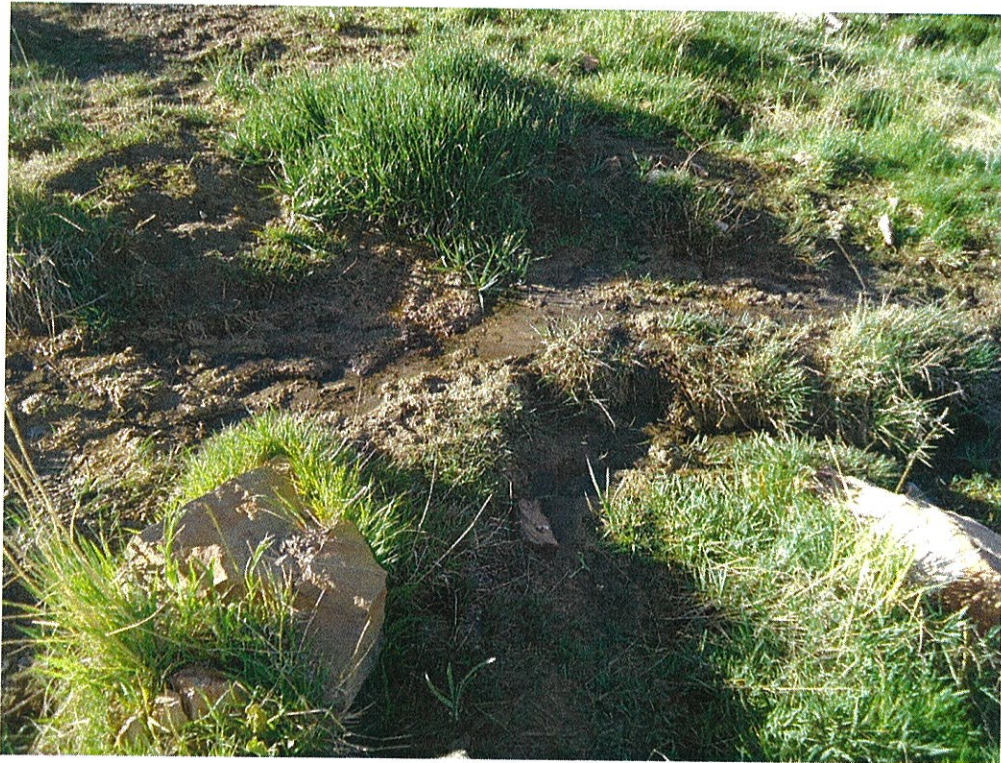
The underdrainage system was completed in the first quarter of 2010; additional work on this system is not anticipated. During the time of the inspection, there was approximately a half gallon per minute of water flow. (Photograph 3).

Photograph 3: Water from the Underdrainage System (6/9/2021)

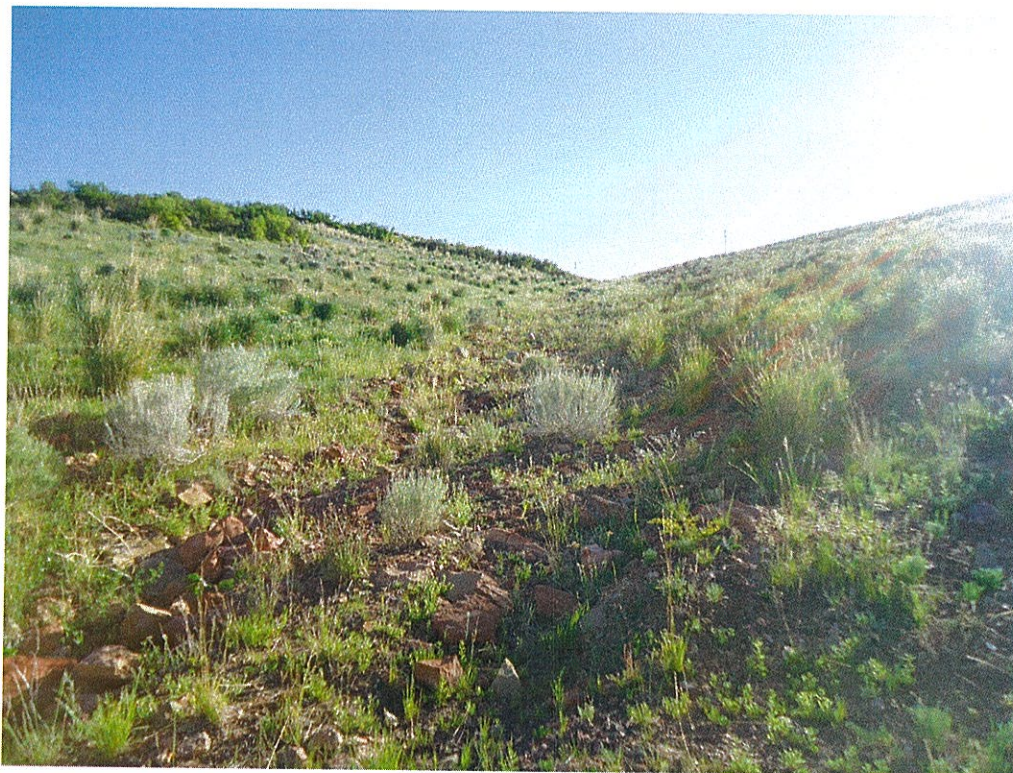
Both the north and south surface drains were inspected (Photographs 4 and 5). At the time of the inspection there was no water flow.

Photograph 4: North Surface Drain Looking North-east (6/9/2021)

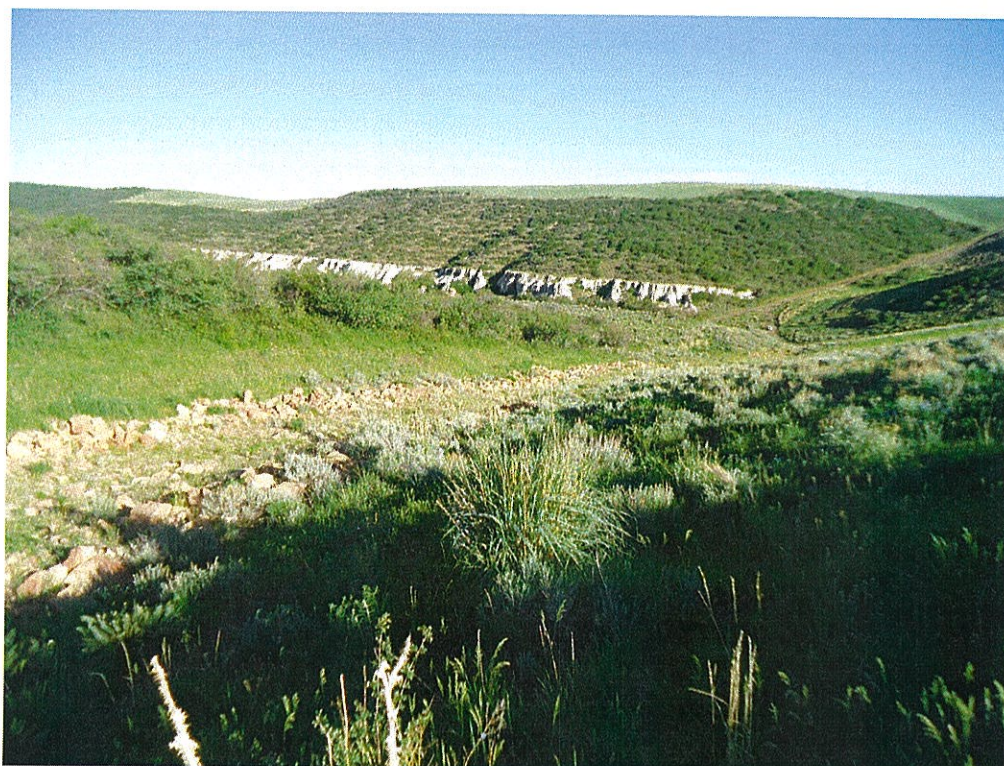
Photograph 5: South Surface Drain Looking West (6/9/2021)

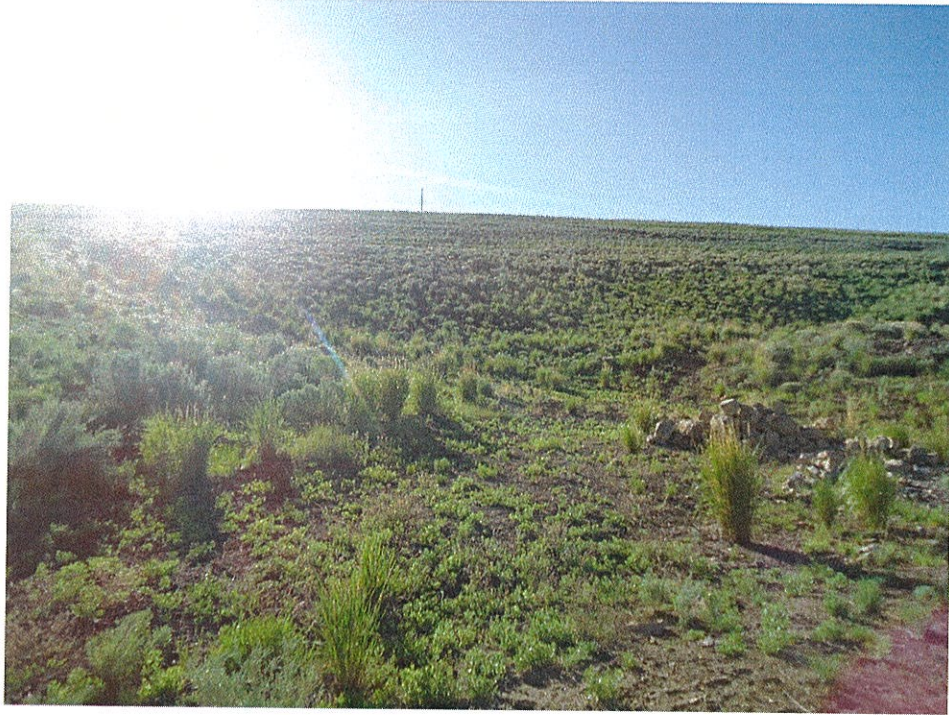
Photograph 6 depicts the west facing slope of the fill in the area where the slope of the fill is at 3H: 1V.

Photograph 6: West Side Fill 3H: 1V Face Looking East (6/9/2021)
