### MINERALS PROGRAM INSPECTION REPORT

<b>MINE NAME:</b> Menzer Quarry	<b>MINE/PROSPECTING ID#:</b> M-1976-009-HR	<b>MINERAL:</b> Granite, granite gneiss	<b>COUNTY:</b> El Paso
<b>INSPECTION TYPE:</b> Multi Person Inspection	<b>INSPECTOR(S):</b> Timothy Cazier, P.E.	<b>INSP. DATE:</b> May 20, 2021	<b>INSP. TIME:</b> 13:20
<b>OPERATOR:</b> Schmidt Construction Company	<b>OPERATOR REPRESENTATIVE:</b> Scott Davis, Dan Chavez	<b>TYPE OF OPERATION:</b> 112c - Construction Regular Operation

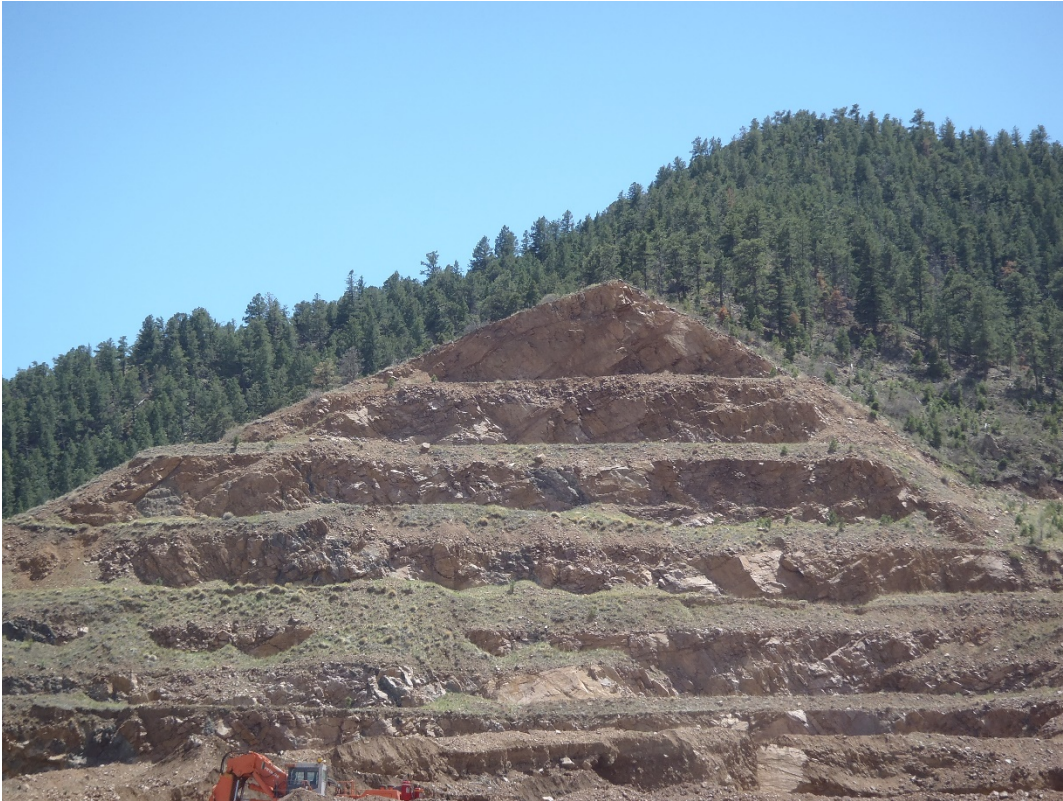
Backfilling and Grading: Benches are to be backfilled no flatter than 10H:1V. Site representatives stated they use the limited overburden and supplement with crusher fines when necessary. Most of the benches on the south side of the pit have been backfilled and revegetated (see **Photo 1**).

Photo 1. Reclaimed portion of south highwall, Phase 1 (looking south).

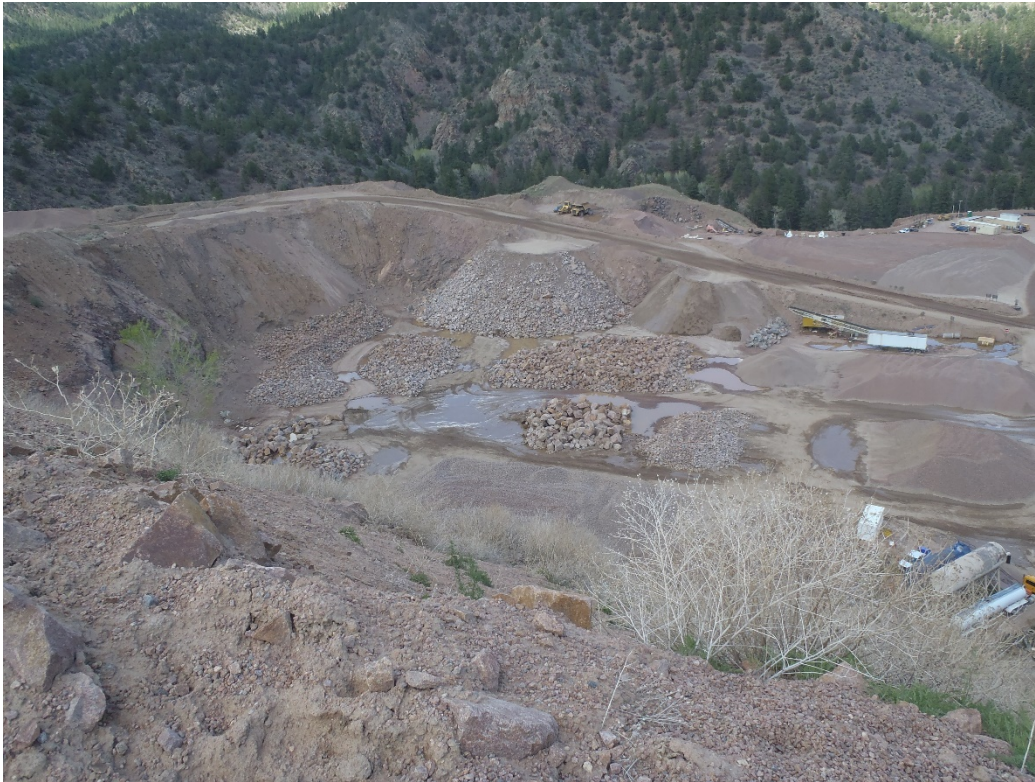
Hydrologic Balance: Shallow standing water was observed on the pit floor (see **Photo 2**) but was determined not to be exposed groundwater, but a result of very recent rainfall. Management of the sediment pond water and subject of the citizen complaint is discussed under Storm Water MGT Plan below.

Photo 2. Shallow water on pit floor (looking NE from active bench).

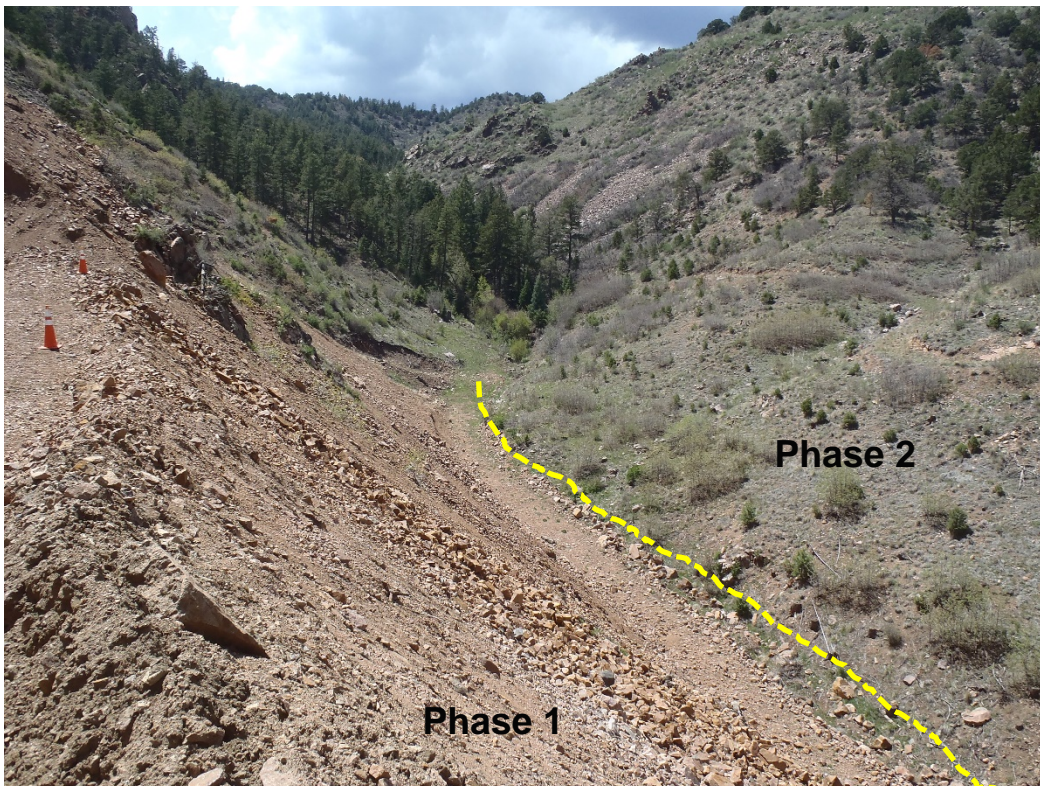
Signs and Markers: The permit sign was properly posted (see **Photo 6**) and PVC pipes on T-posts were observed above the highwalls to delineate the affected area boundary. The boundary between Phase 1 and Phase 2 is the unnamed drainage on the north edge of Phase 1 (see **Photos 3 and 7**).

Photo 3. Unnamed drainage boundary between Phases 1 and 2 (looking WSW).

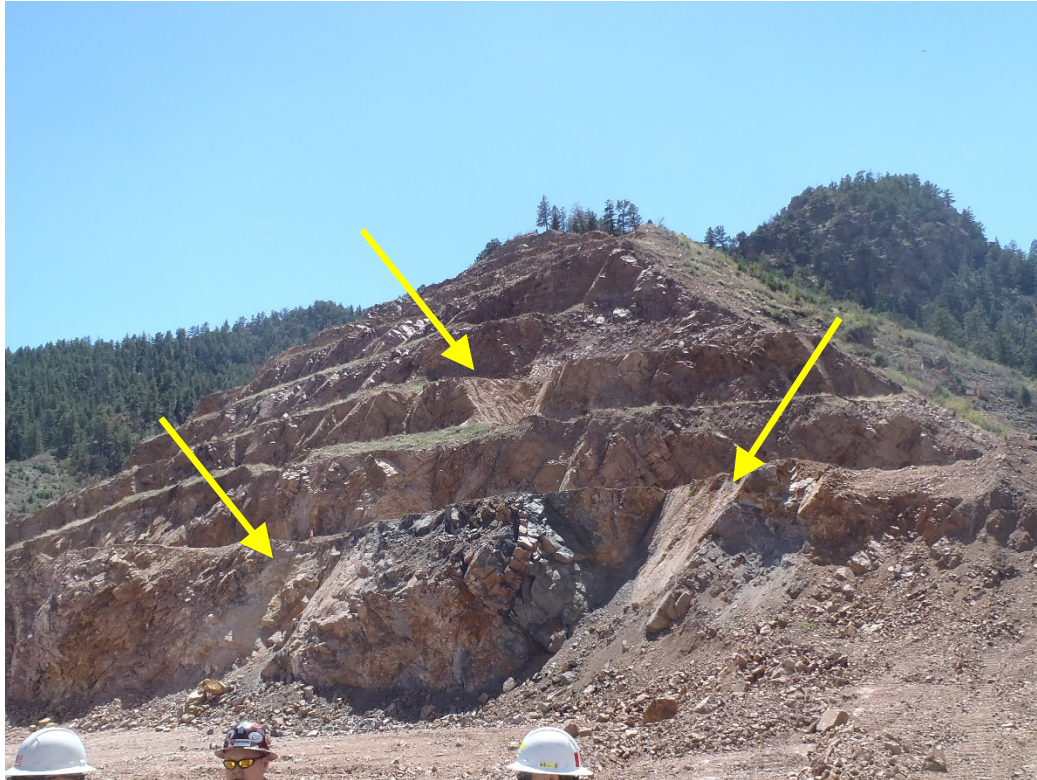
Gen. Compliance with Mine Plan: The operation appeared to be in compliance with the approved mine plan. The maximum allowed disturbed area is 141.4 acres. Google Earth was used to measure the disturbed area, which was estimated to be approximately 82 acres, based on 2019 imagery. Their 2020 annual report states 110.5 acres are affected. The Menzer quarry is still operating in the Phase 1 boundary. They are mining the west end of the pit, and mining has reached the north limit of Phase 1 (see **Photo 3**). Mr. Chavez stated they will bring the current operating bench down to the current pit floor prior to expanding into Phase 2, which is not expected to happen for many years. The original highwall benches were 50 to 60 feet high and 25 to 30 feet wide. Mr. Chavez stated MSHA has required them to shorten the bench heights for rock scaling operations. The standard bench height is now 40 feet. Scaling operations appear to have been successful in stabilizing the highwalls. Evidence of larger block movement/slides was observed (see **Photo 4**). Mr. Chavez indicated this was a result of the varied geology and why MSHA had modified the bench configuration.

Photo 4. Evidence of larger block movement/slides (looking SW at west highwall).

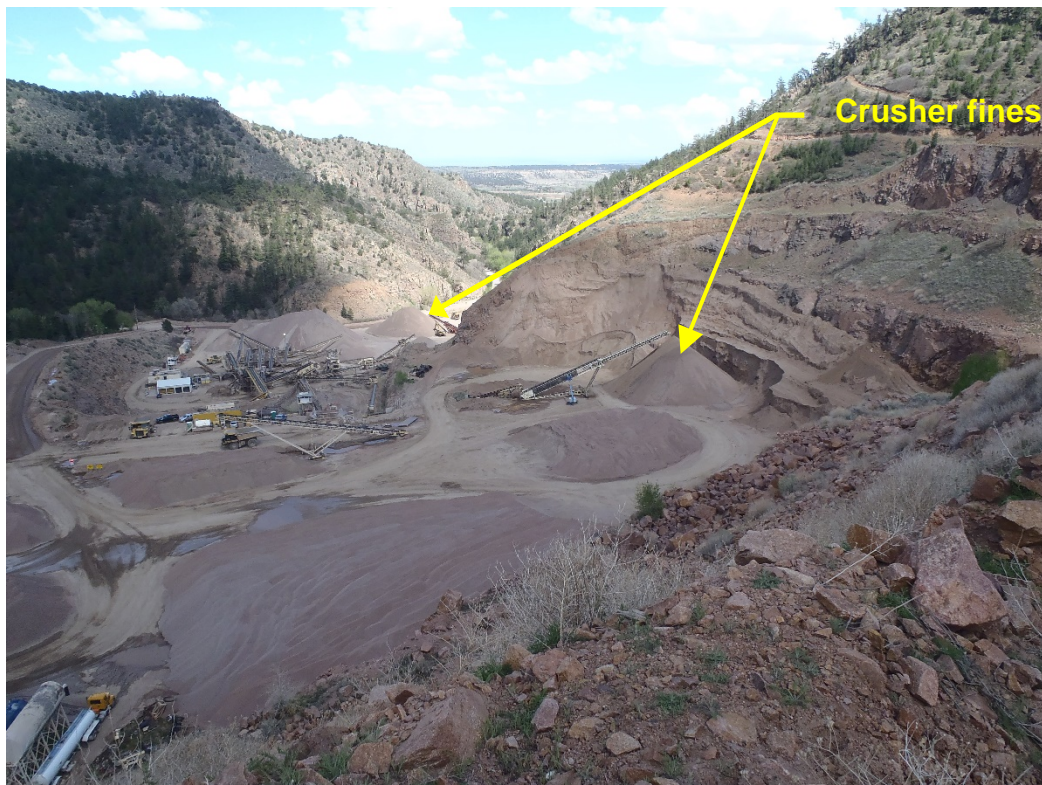
Processing Waste: Large stockpiles of crusher fines were observed on the southeast and east areas of the process area on the pit floor (see **Photo 5**). Mr. Chavez stated fines removed from the sediment pond as part of their periodic maintenance plan are stockpiled on the pit floor and fed into the process plant.

Photo 5. Pit floor stockpiles & processing facilities (looking east).

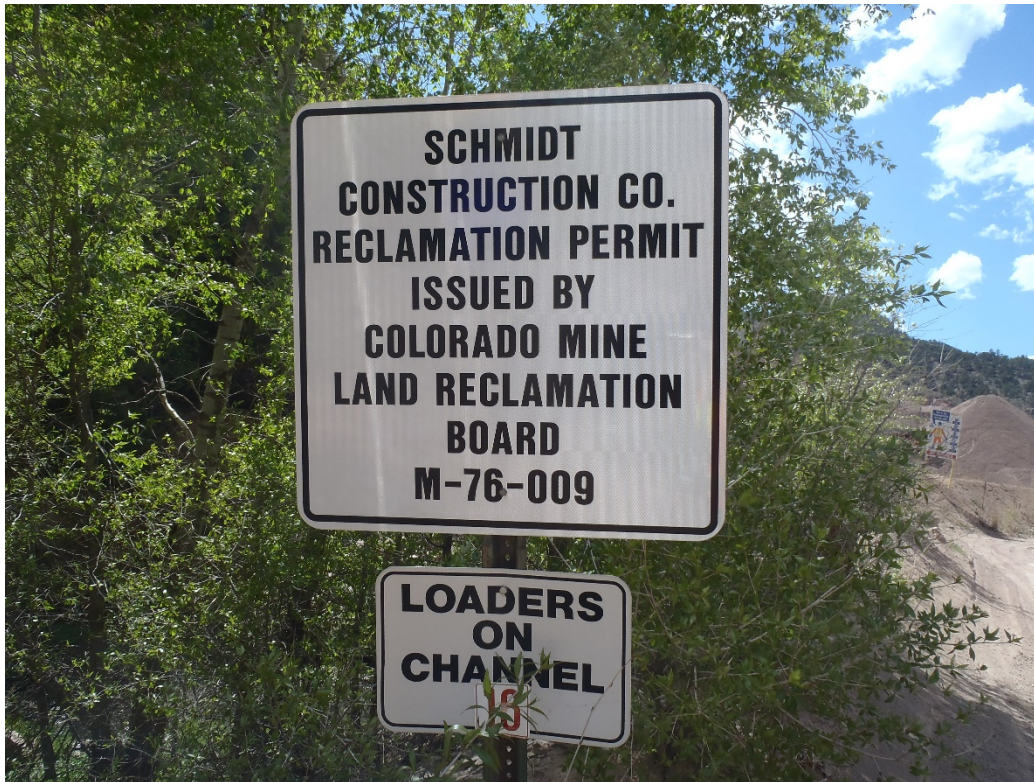
Photo 6. Permit sign at entrance.

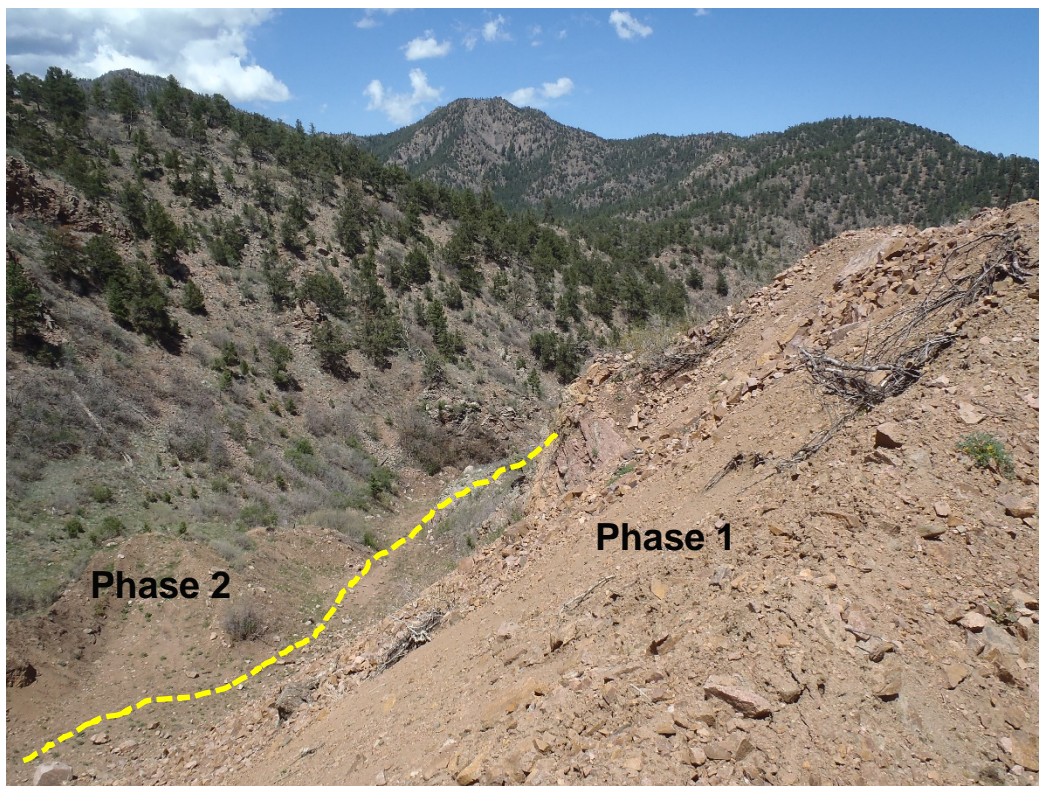
Photo 7. Unnamed drainage boundary between Phases 1 and 2 (looking ENE) .

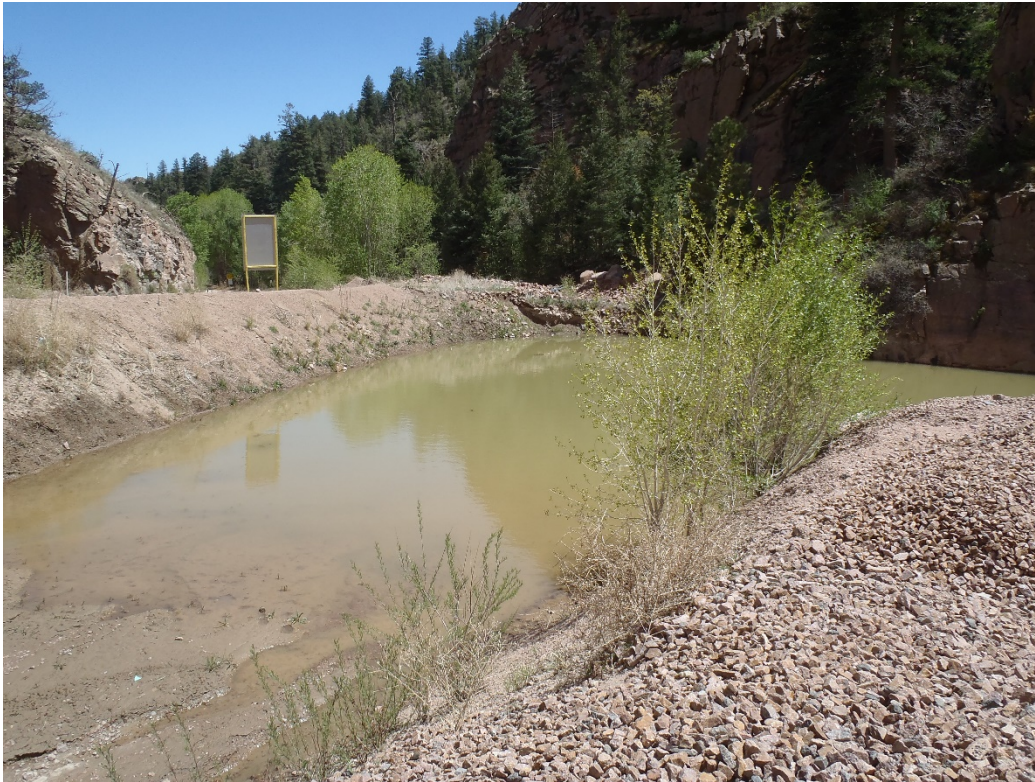
**PROBLEM/POSSIBLE VIOLATION:** Problem: The site is improperly managing impounded surface drainage/runoff.

Storm Water MGT Plan: Mr. Hollister (DWR water commissioner) made himself available for this inspection to clarify stormwater regulations with respect to water rights. The challenge for the quarry was how to release water captured in their sediment pond (see **Photo 8**) in the timeframe required by DWR, while meeting discharge standards required by the Colorado Department of Public Health and Environment (CDPHE). Site representatives explained they had been experimenting with the use of filter socks (see **Photo 9**) to meet water quality discharge standards since shortly after the DRMS notified them of the citizen's complaint. As part of a demonstration, water from the sediment was pumped into a water truck and brought to the area where the tests were being performed to show DRMS representatives and Mr. Hollister how effective it appeared to be (see **Photo 10**). Quarry staff have collected water samples for laboratory testing and are awaiting results. Site representatives committed to submitting a technical revision (TR) to revise the site mine plan in order to comply with DWR regulations regarding the timely discharge of captured stormwater. Mr. Heifner contacted this inspector on June 25<sup>th</sup> saying he had tried to hand deliver the TR on June 24<sup>th</sup>, but could not as the office is still closed to the public. He stated he then sent the TR to the DRMS via certified mail. **The need to modify how sediment pond water is handled is cited as a Problem on page 1 of this report.**

Photo 8. Sediment pond near entrance (looking east).

**CORRECTIVE ACTIONS:** Submit a technical revision to update the mine plan and Exhibit G describing how impounded stormwater will be managed to comply with the Division of Water Resources regulations as they relate to water rights.

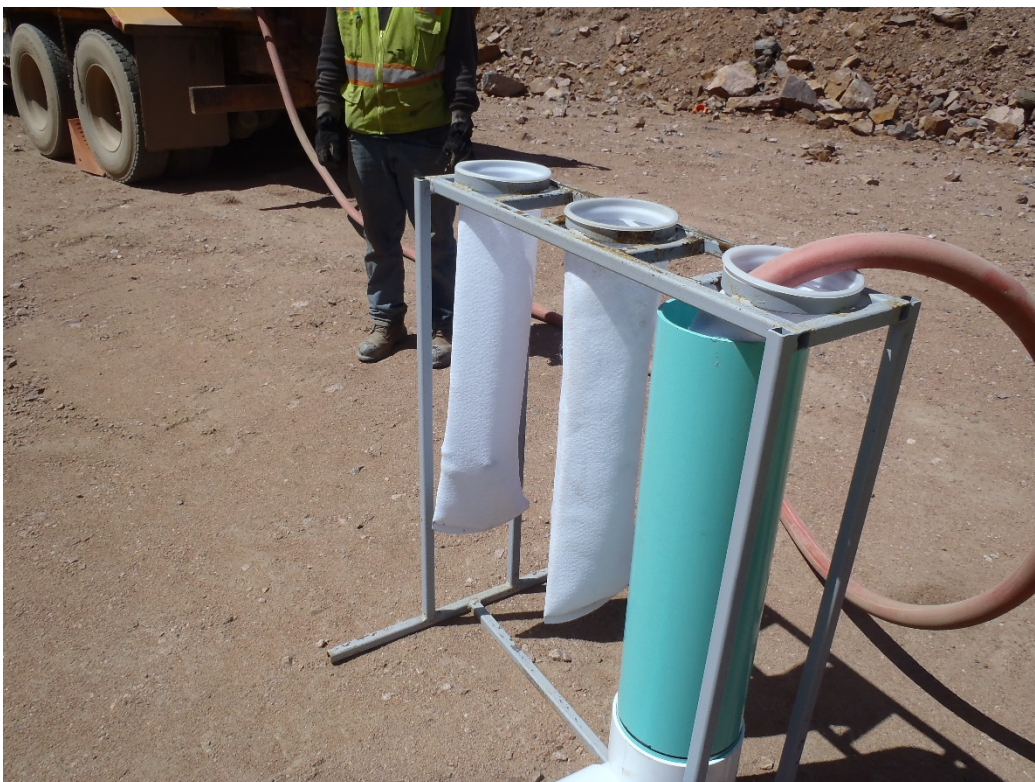
Photo 9. Filter socks for sediment pond water discharge demonstration.

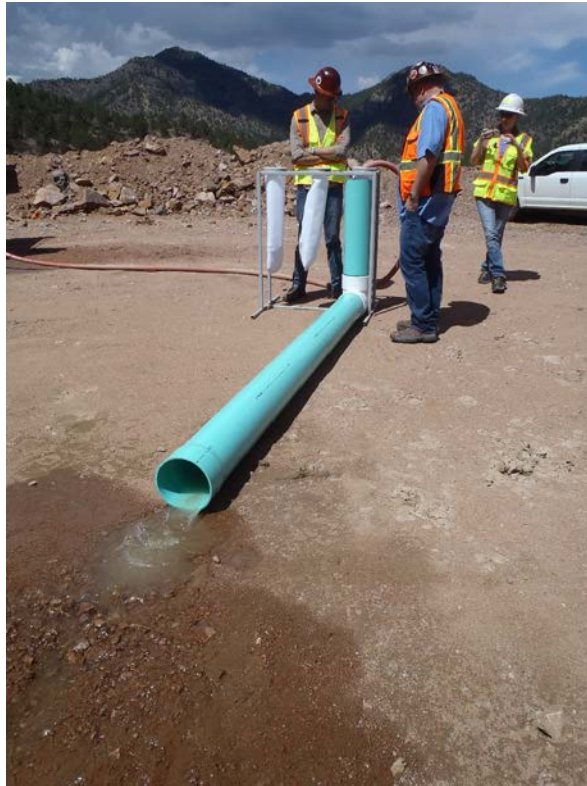
Photo 10. Sediment pond water discharge demonstration.
