Bowie #2 inspection report

PERMIT INFORMATION

Permit Number: C-1996-083 Mine Name: Bowie No. 2 Mine Operator: Bowie Resources, LLC Operator Address: Mr. Basil Bear P.O. Box 1488 Paonia, CO 81428	County: Delta Operation Type: Underground Permit Status: Active Ownership: Private
	Operator Representative Present: Basil Bear
Operator Representative Signature: (Field Issuance Only)

Inspection Start Date: March 30, 2021 Inspection Start Time: 08:15 Inspection End Date: March 30, 2021 Inspection End Time: 14:00		Inspection Type: Coal Complete Inspection Inspection Reason: Normal I&E Program Weather: Clear	
Joint Inspection Agency: None		Joint Inspection Contacts: 	
Post Inspection Agency: None		Post Inspection Contacts: 	
Inspector(s): Robert Zuber, P.E.	Inspector's Signature: <i>Robert D. Zuber</i>		Signature Date: 4/1/2021

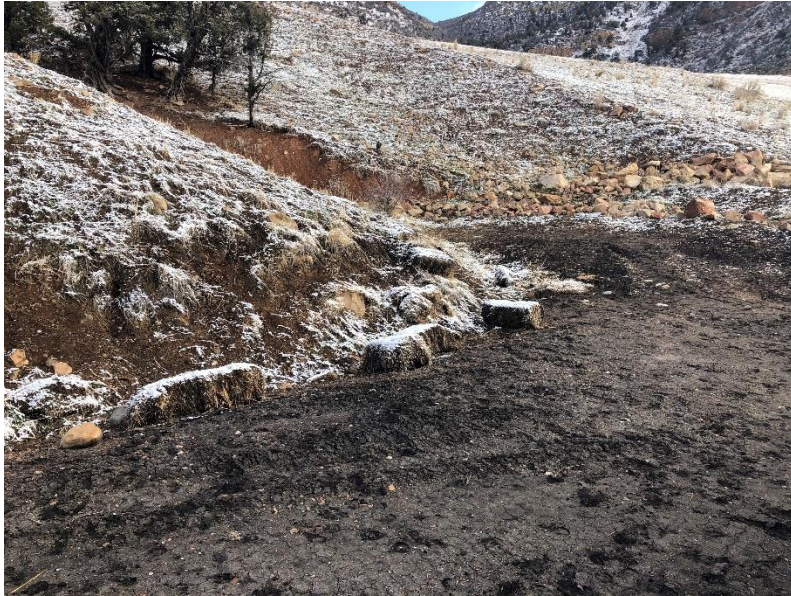
Erosion bales and wattles that are near the topsoil stockpiles by Gob Pile #4 are not functioning (they appear to be very old and dilapidated). BRL should assess these BMPs, and repair or replace them as necessary to reduce sediment loads to the road and preserve the soil.

Old bales by Topsoil Stockpile D

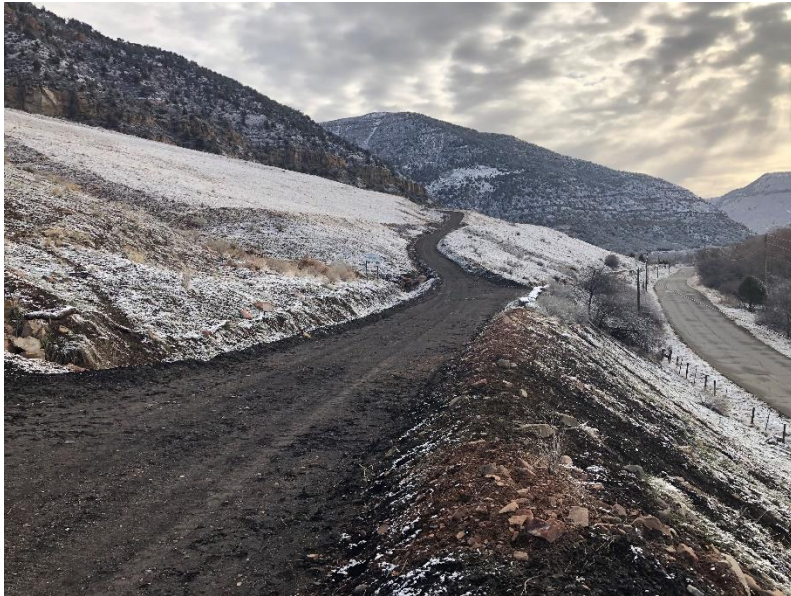
The roads near Gob Pile #2 and at other parts of the mine site were in good condition.

Road to Gob Pile #2 and pile itself

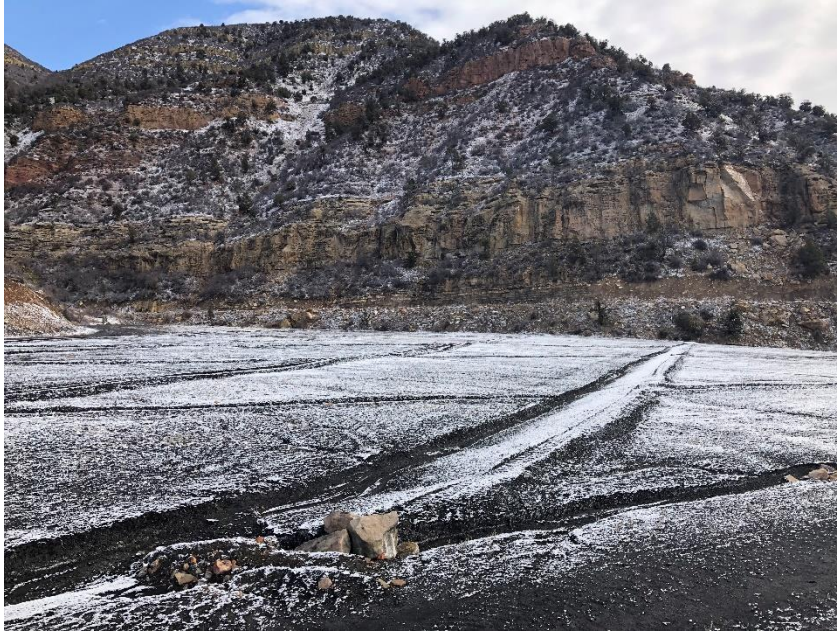
The upper and lower lifts of Gob Pile #2 appeared stable. Only small rills were observed. The drainage control practices on the upper (flat) portion of this pile appear to be functioning well, and no puddles or other problems were observed.

Upper portion of Gob Pile #2

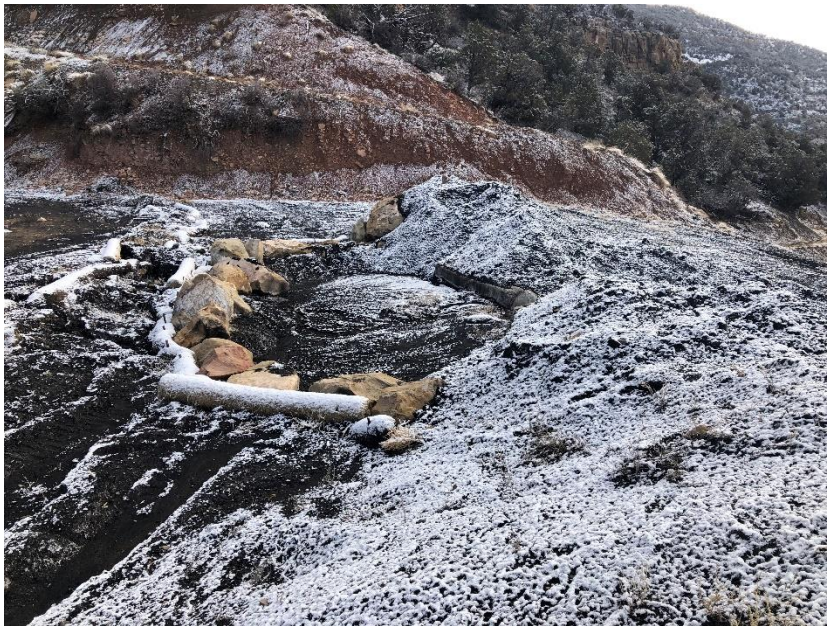
Sediment trap on Gob Pile #2

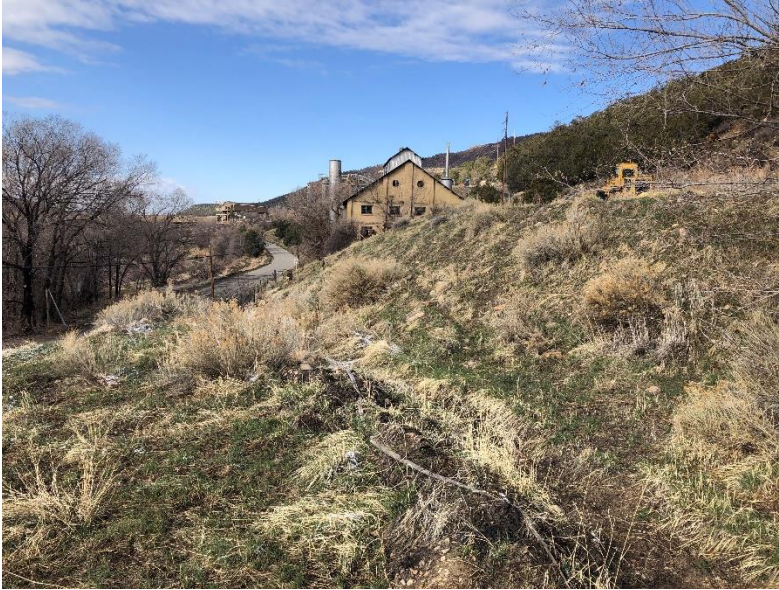
SAE west of Pond D

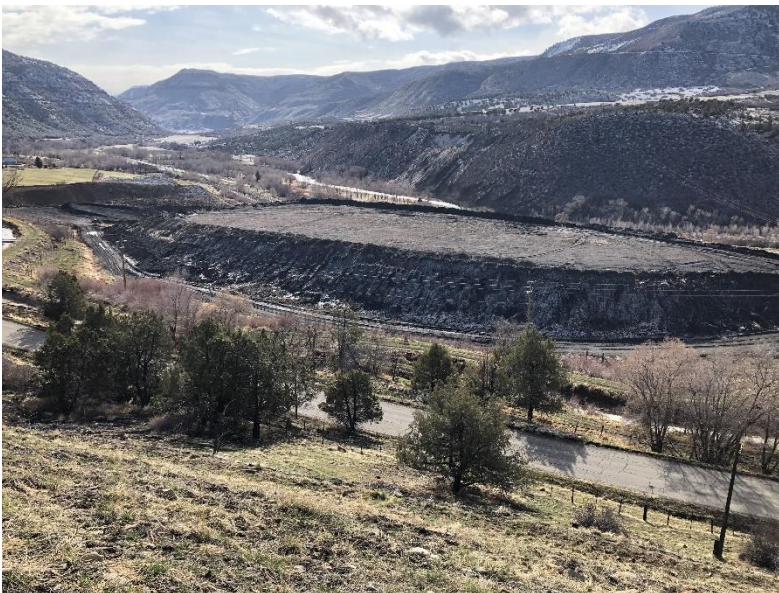
BRL performed considerable work on Gob Pile #3 during the winter. Much of the waste material in the drying area has been moved to the west side of the pile.

Gob Pile #3 from above

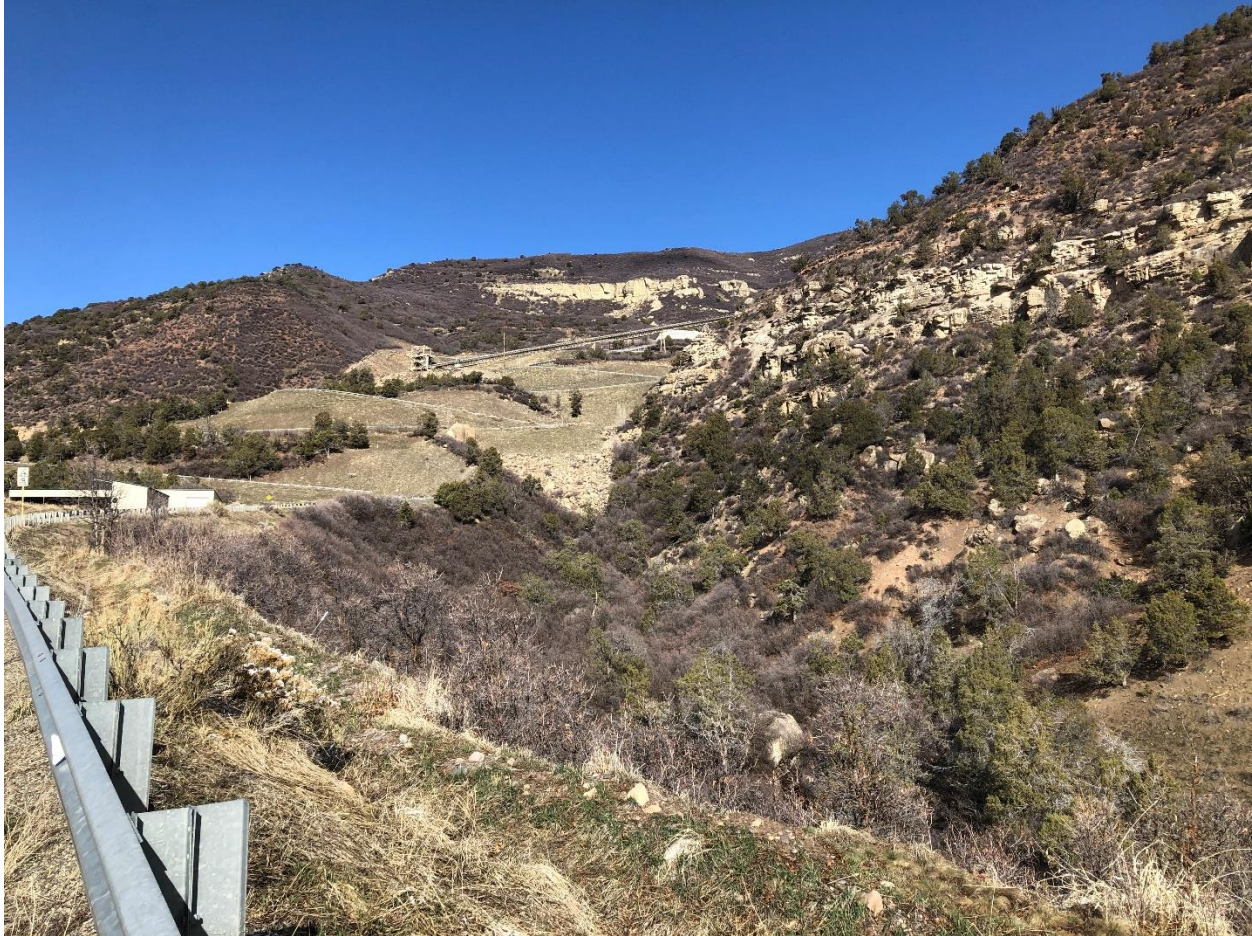
No problems were seen with the haul road to the portals or the hillsides above and below the haul road. The ditches beside these roads appeared to be in excellent condition.

Photo from Curve #3 on Haul Road to portals

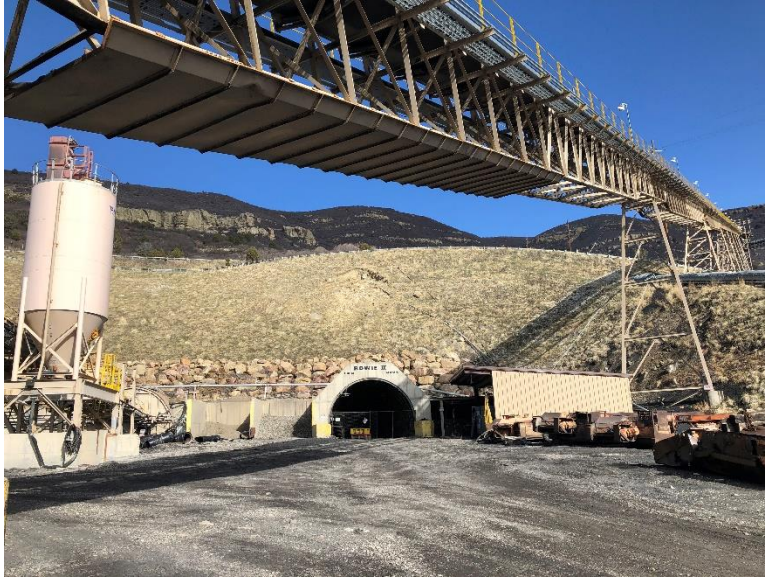
It appears that slumps have not moved significantly in the recent past. These include slumps by the B Portal and by Curve Number 11 along the Haul Road.

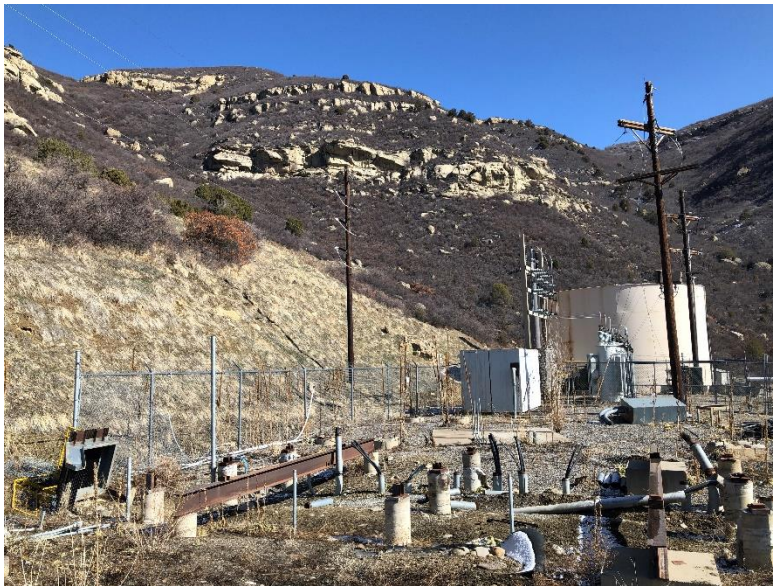
Hill above Utility Bench

No issues with signs and markers were noted. Disturbance markers, topsoil stockpile markers, and entrance signs were seen in many locations. At the Utility Bench, a sign warns of subsidence impacts along road to southwest.

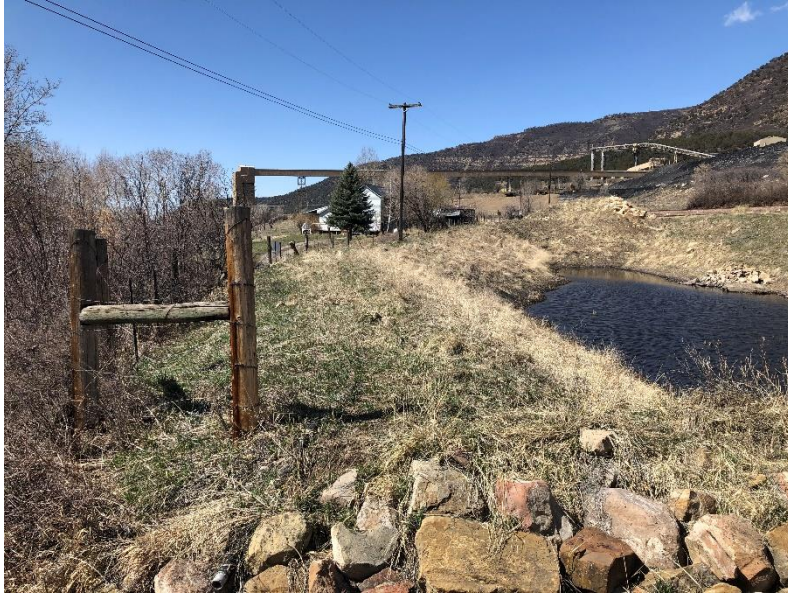
Pond J embankment

Six sediment ponds were inspected: B, C, D, F, J, and K. None of the ponds were discharging, and all but Pond J were dry or nearly dry. Pond J held water, but it was well below the spillways. No significant problems were identified with embankments, spillways, inlet channels, or other features of the ponds.

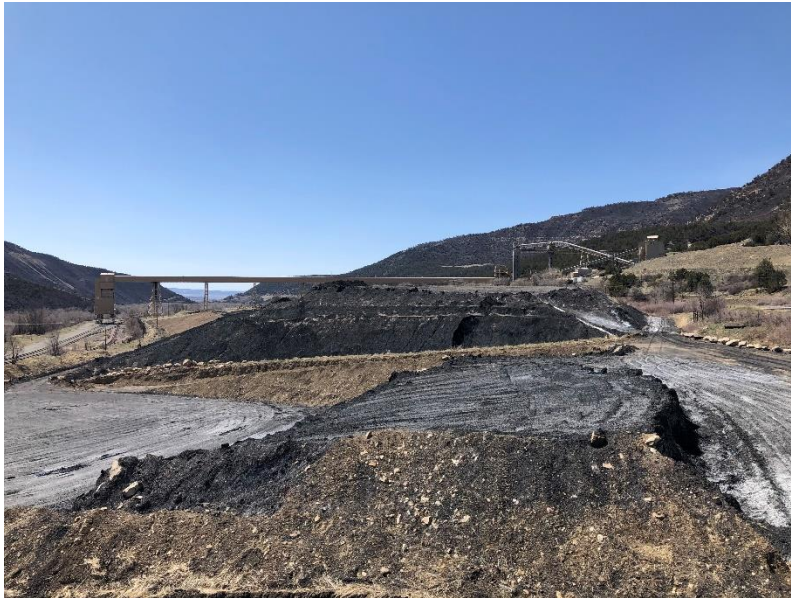
Gob Pile #3, looking west
